# **TROUBLESHOOT ROD PUMPED WELLS USING TUBING FLUID LEVEL SHOTS**

John Sparks, COG OPERATING LLCU  
Lynn Rowlan, Echometer Company

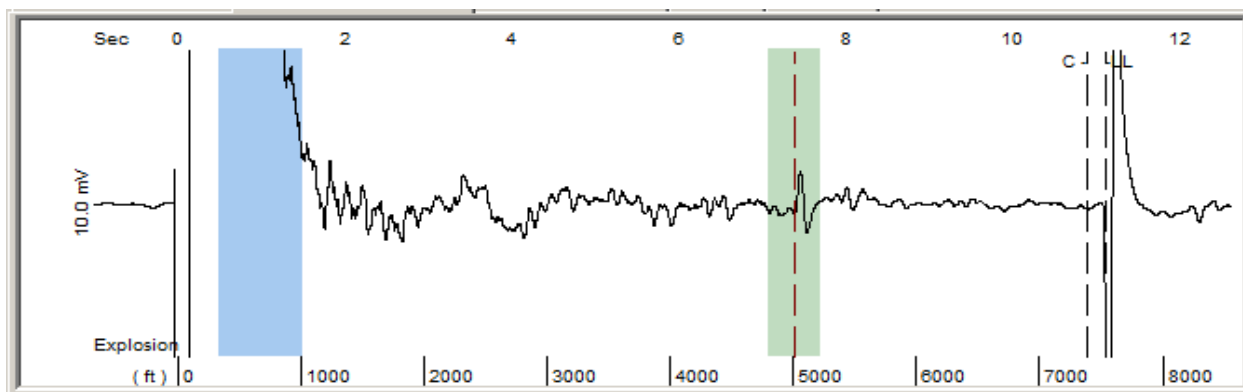
**Fig.1** displays an acoustic trace acquired by shooting down the casing annulus. The liquid level down kick is selected correctly at a RTTT of 11.116 seconds. Direction of kick of echoes on the acoustic traces is used to trouble shoot sucker rod pumped wells having problems. A representative well bore schematic should be used to identify all changes in cross-sectional area along the wellbore. Echoes on the acoustic trace from any change in cross-sectional area should be expected on the acoustic trace at the depth of the anomaly, if the anomaly is above the liquid level. Identifying an unexpected upkick on the acoustic trace at a certain time on the acoustic trace can mean that there is a hole in the tubing. The upkick at a RTTT of 7.389 seconds is due to a hole in the tubing or casing. There is no anomaly shown on the wellbore schematic of this well to indicate an increase in cross-sectional area of the well bore and an upkick echo should NOT be expected at this time/location/depth.

Figure 1 – Upkick on Acoustic Trace from a Hole in the Tubing

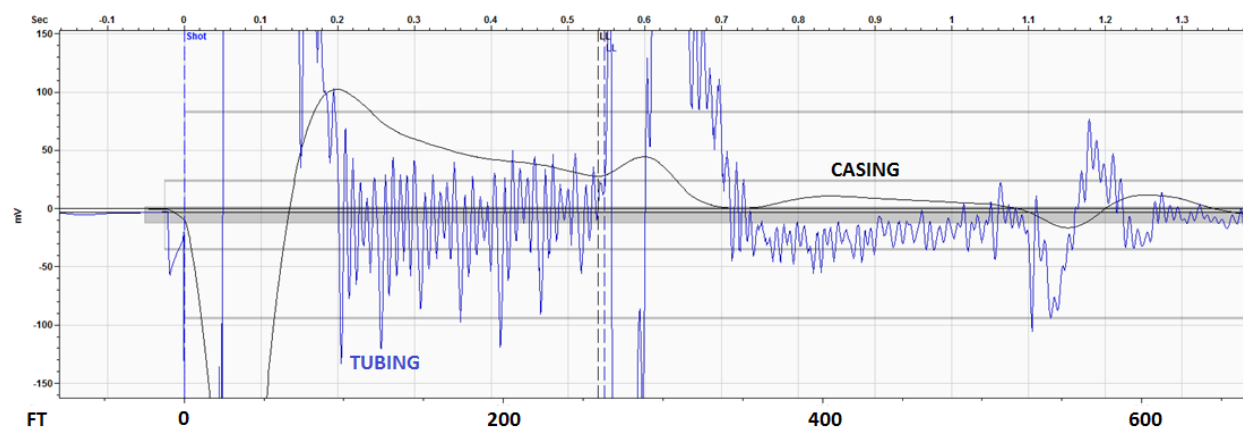
Once the casing fluid level and the tubing fluid levels are properly analyzed, then the tubing and casing acoustic traces can be overlaid and checked for an upkick from the tubing hole appearing on both traces at or near the same depth. The liquid level marker is moved to the beginning of the upkick from the hole on the tubing shot and to the beginning of the upkick from the hole on the casing shot. **Fig. 2** is the overlay plot comparing the acoustic traces acquired on well BKU #554 down the casing and tubing, where the upkick echo from the hole can be seen. Determining the distance to the upkick from the hole in the tubing:

Figure 2 – Comparing Hole in Tubing Echo Overlay of Low Pass Filter Casing Shot to Raw Tubing Shot

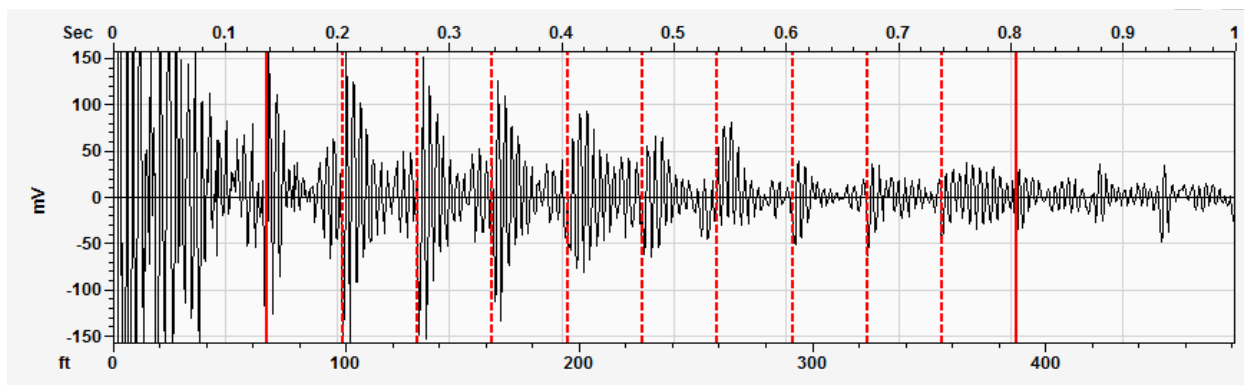
- **Fig. 3** rod couplings frequency down the tubing of  $19.46 \text{ Jts/Sec} \times 25 \text{ ft/joint} \times 0.541 \text{ seconds RTTT} = 263 \text{ ft}$  to the hole. The tubing pressure at the time of the shot is 48.8 psi(g).
- **Fig. 4** tubing collars frequency down the casing of  $14.96 \text{ Jts/Sec} \times 32.15 \text{ ft/joint} \times 0.539 \text{ sec RTTT} = 259 \text{ ft}$  to the hole. The casing pressure at the time of the shot is 46.9 Psi(g).

Figure 4 - Tubing Collars Frequency in Casing of 14.96 Joints/second at 32.15 feet/joint

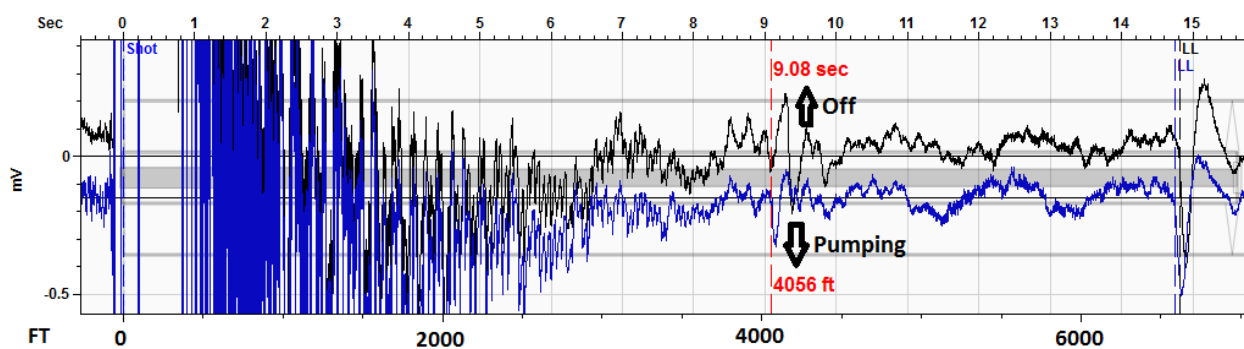
**Fig. 5** is an overlay plot of two acoustic traces acquired down the casing on a rod pumped well where there is a hole in the tubing at 4056 feet from the surface and no liquid is being produced to the surface. The echo from the hole on both acoustic traces is located at 9.08 seconds from the surface. While pumping, a fluid level shot was acquired at 1:48:12 PM. The echo from the hole is displayed as a down kick due to produced liquid discharging from the hole and the liquid discharge is partially filling the wellbore at the hole to create a decrease in cross-section area. With the pump turned off for 50 minutes, a fluid level shot was acquired at 2:38:35 PM. The echo from the hole is displayed as an upkick since all of the liquid in the tubing had enough time to drain out of the split tubing joint thereby creating an increase in cross-section area in the wellbore at the hole. When the pump is producing liquid up the tubing an echo from a hole can be masked or hidden due to liquid filling the tubing at the hole. A recommended practice is to shut the pump down for a period of time to allow any liquid in the tubing above the hole to drain out of the tubing and allow the echo from the hole visible on the acoustic trace.

Figure 5 – Hole in Tubing Shown as Up Kick when Pump Off and Down Kick when Pumping

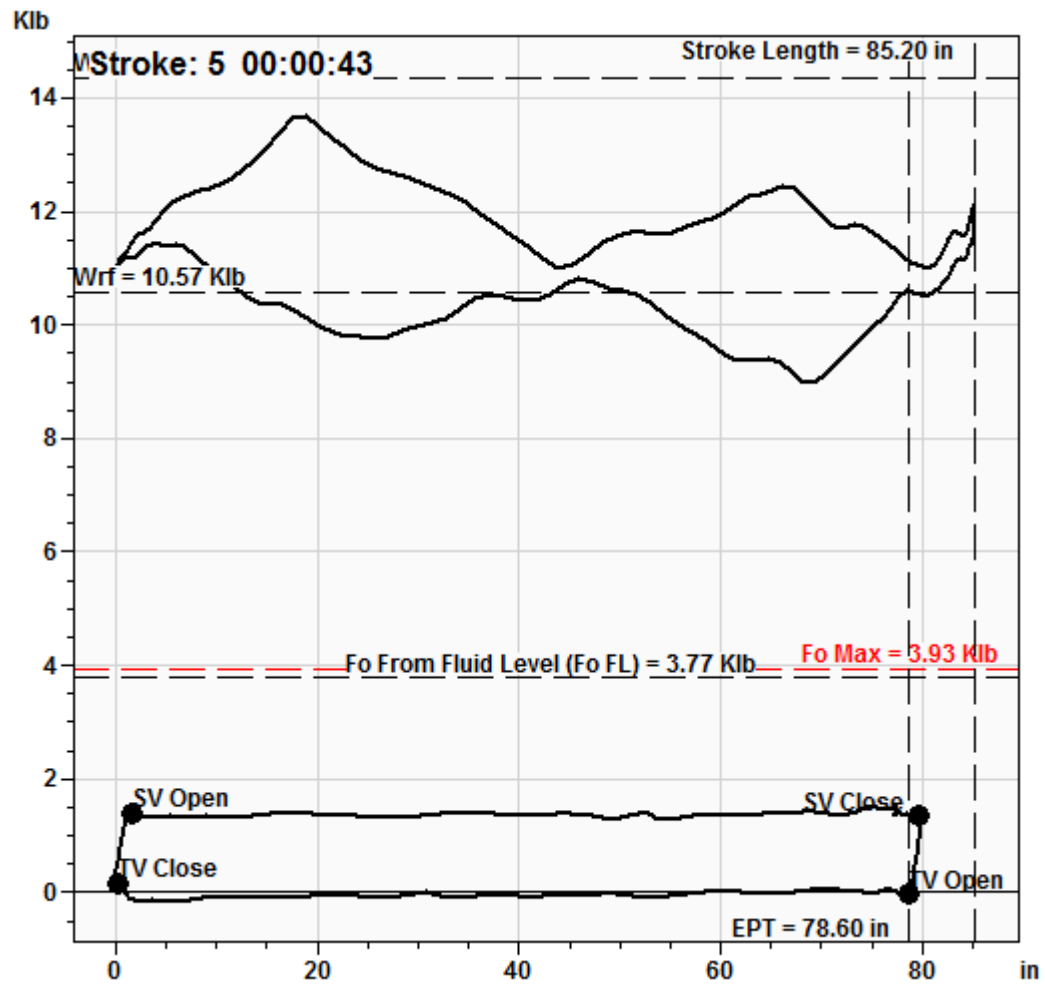
**Fig. 6** shows an abnormally low pump card load of 1355 lbs. The fluid level is 6583 feet from the surface and the pump card loads should be near the 3774 lbs fluid load calculated from the differential pressure acting on the 1.25 inch diameter plunger. The hole in the tubing is 4056 feet from the surface and the pump is lifting liquid up the tubing approximately 2500 feet to discharge out the tubing hole into the casing and circulating liquid back down the casing to keep the pump filled with liquid. The 3744 lbs calculated pump card height is equal the load required to lift the liquid from the pump intake pressure to the surface. The hole in the tubing is 4056 feet from the surface and pump card load on the upstroke is too low because the pump only lifts the liquid approximately 35% of the distance to the surface to discharge out the hole. The reduced height of the pump card can be used as an indicator of a

possible hole in the tubing when the net lift shown by the pump card height is much less than fluid load required to lift the liquid to the surface determined from the fluid level. The full pump card also indicates that there is not a problem with the pump and valves appear to be operating correctly.

Figure 6 – Pump Card Abnormal Loads Due to Lifting Liquid out a Hole and Not Lifting to the Surface

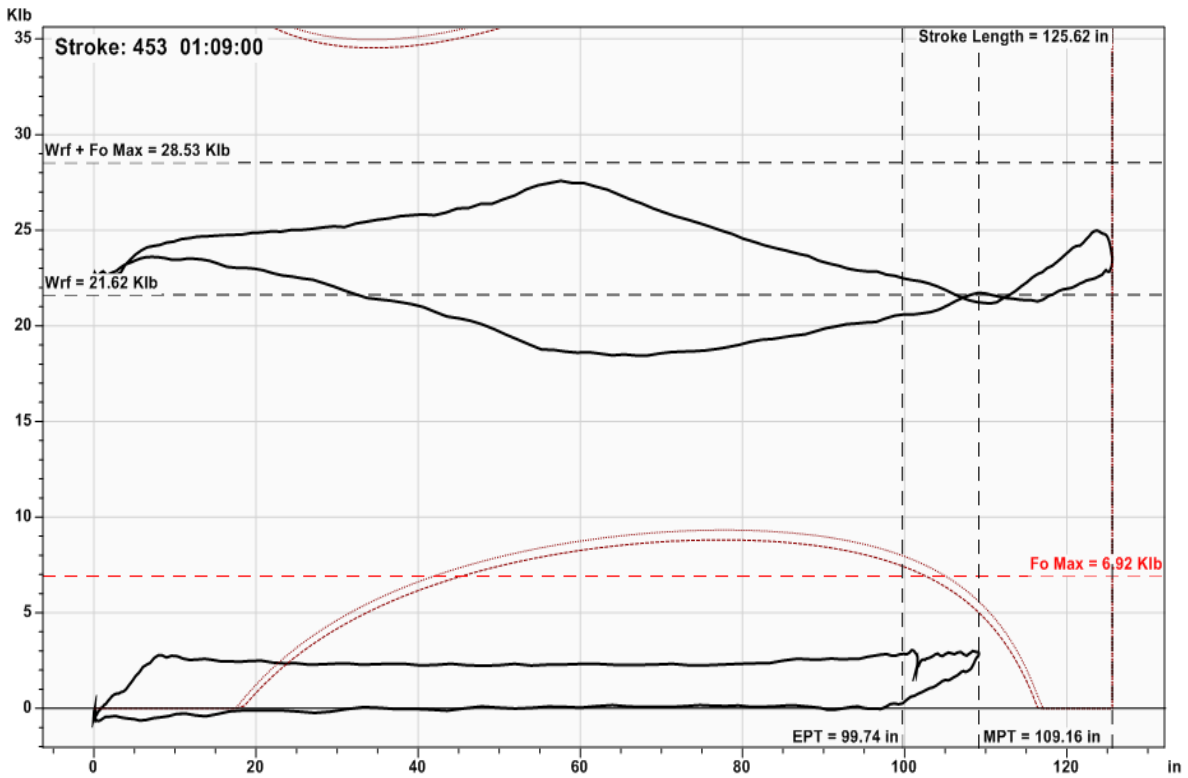
Successive tubing fluid shots in **Table 1** show the pump installed in the well was under-performing and was not pumping sufficient liquid per stroke into the tubing. **Fig. 7** the dynamometer pump card shows good pump action, but liquid was not being pumped into the tubing due to a leaky pump. The pump card shows tubing movement and a valve test on this well could have shown high plunger/barrel leakage (if performed). The fluid level shots down the tubing were used to make the determination on whether or not the pump in this well is truly pumping.

Based on experience from watching other wells “pump up”, there definitely was something wrong with the pump. A visit to the pump shop on the next day discovered that we had mistakenly run a pump with a PAP plunger in this 10,955 foot deep well. With high differential pressure acting across the PAP plunger, lost pump displacement due to slippage accounts for the very slow rise of liquid in the tubing. Initially the well had a high fluid level with low differential pressure acting across the PAP plunger, so the production from the well was good. As the well was produced, the lowered fluid level increased the pressure acting across the plunger and pump slippage increased. When the liquid level was drawn down to 7300 feet from surface, then the pump displacement could not exceed the amount of slippage past the plunger and the pump could no longer lift fluid to the surface. No matter what the “cards” look like, if the fluid level shot down the tubing shows the pump is not bringing fluid to the surface, then it’s time to call the pulling unit. Using an acoustic instrument and shooting fluid levels down the tubing, even without a pump card, an operator can still “make a good call” without incurring the additional expense of a pump truck and determine whether or not his well needs to be pulled.

Figure 7 – Good Pump Action and Not Lifting to the Surface Due to Leaky Pump

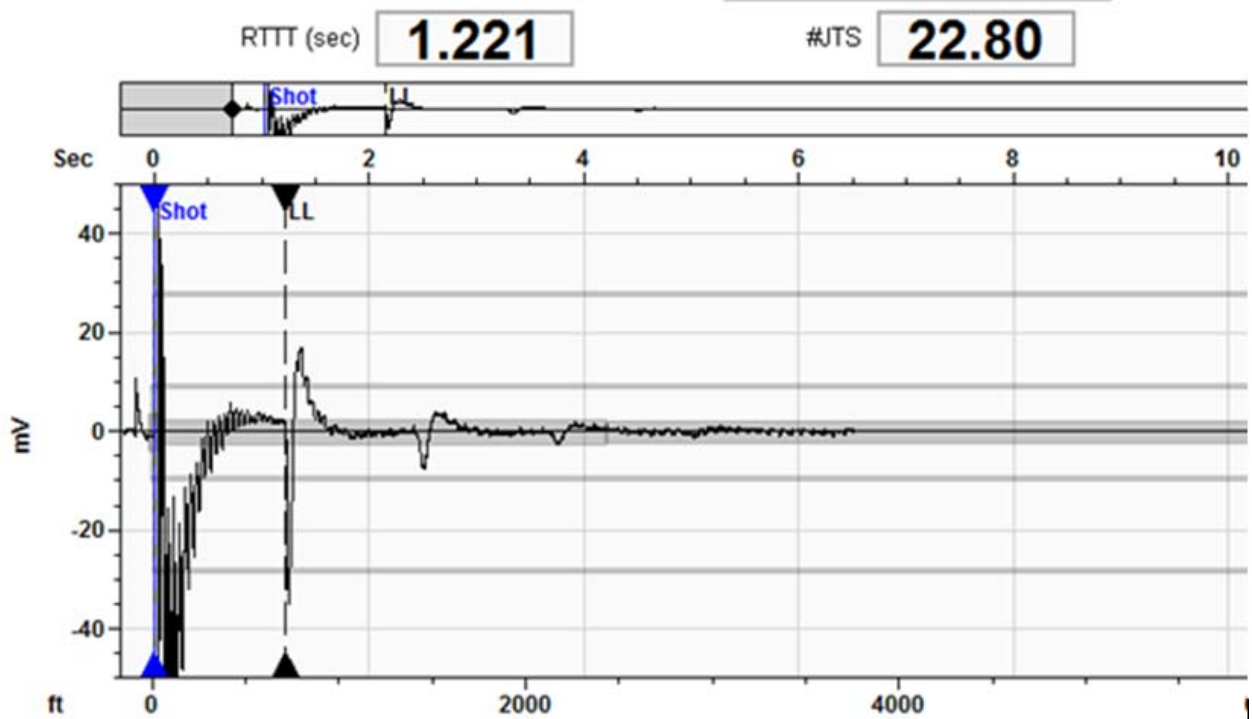
After 53 minutes of continuous pumping a fluid level was acquired on the casing and the distance to the liquid level was determined to be 7300 feet from surface. Thirty-four minutes after taking the casing fluid level shot, there was still no fluid to the surface at the tubing bleeder valve, despite the fact that each pump stroke appeared to be filled with liquid. With no pump slippage at 120 barrels per day pump displacement, the pump should have been filling approximately 3 foot of tubing/sucker rod annular volume per each stroke. **Fig. 8** fluid level acquired inside the tubing at 01:4828PM determined the fluid level was 727.7 feet from the surface, using the acoustic velocity of 1192 ft/sec obtained from the casing fluid level shot.

lot of the tubing liquid, but fluid should soon be at the surface. Thirty-one minutes later with no fluid to surface, the next tubing fluid level shot showed fluid to be 672.9 feet from surface. The fluid level inside the tubing had only risen 55 feet in 31 minutes, rising at a rate of 1.736 feet/minute.

Figure 8 – Fluid Level in Tubing
