# PREDICTING THE USEFUL LIFE OF A SUCKER ROD CONNECTION

## Fred Newman and Jonathan Huseman. Robota Energy Equipment Co, LLC.

This paper will present datasets gathered from the recently developed Circumferential Displacement Tool ("CDT") to illustrate "the useful life" of the sucker rod connection, ranging from its initial make up to a point where permanent deformation might call for the retirement of the rod and/or connector.

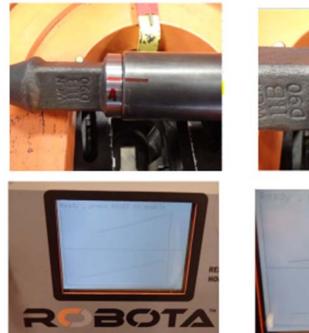
### Shoulder Point Walk and Coupling Fretting

visual inspection was made of the rod and coupling; scoring and fretting was evident on the coupling face. Some minor degree of fretting was observed on the rod face, but that was minor compared to the coupling. The CDT software rejected the connection based on a curve fit.

The photos in Figure 6 portray what happened. The upper left photo is the initial make markings for a hand tight SP. The lower left photo is the torque-turn chart of the initial make, which was almost a straight line. The upper right photo is the same coupling and rod, but with an apparent hand tight SP shift. The torque-turn curve in the lower photo has varying slopes during the tightening process, suggesting excessive and uneven frictional forces between the mating surfaces.

Clearly the damage was in the coupling and not the rod after connection 7. The coupling had exceeded the end of its useful life and left unattended to, the roughness of the coupling would start transferring to the rod's mating surface and permanently damaging it. This anomaly begs the question: Why does the coupling face fail before the rod's face?

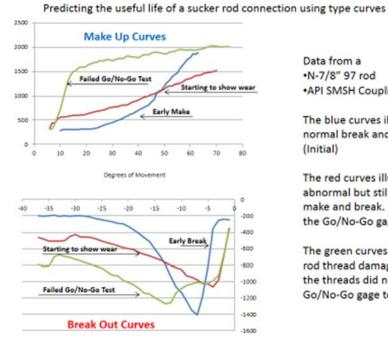
Figure 13 illustrates apparent thread damage occurring due to over tightening. Actually, during the over make process, damage was being inflected to the mating surface at the same time the threads were being overstressed, as that could not be avoided. The blue curve is an early make, still passing the GO-NO-GO make. It shows a clear SP and the slope is normal until the connection goes past CD where the slope takes another bend indicating yielding is taking place. The red curve still passes the GO-NO-GO, test but it has a marked different slope, possibly due to the damaged threads being burnished in. The green curve is the final make on this rod coupling combination, as the rod pin failed the GO-NO-GO test. The coupling passed the thread GO-NO-GO test, but the face was obviously damaged beyond use. The following can be concluded from this portion of the tests:

Data from a •N-7/8" 97 rod API SMSH Coupling

The blue curves illustrate a normal break and make. (Initial)

The red curves illustrate a abnormal but still useable make and break. (passed the Go/No-Go gage test.

The green curves illustrate rod thread damage wherein the threads did not pass the Go/No-Go gage test.

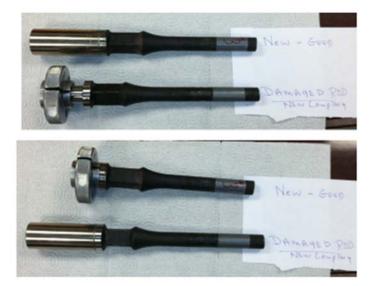
#### GO-NO-GO GAGE TESTS

There was more to be learned from this experiment. Figure 14 is two photographs of the GO-NO-GO test that failed as exhibited in figure 13.

- In the upper photograph, lower rod, a GO-NO-GO test was performed on the damaged 7/8" rod and as shown, the threads were damaged. The rod failed the test. In the same photo, just above the damaged rod, a new rod and coupling are shown.
- The lower photograph reveals a different story if you use a new coupling for a gage. The upper rod is the GO-NO-GO on a new rod -- the lower rod in the lower photograph is the damaged rod with a new coupling screwed up all the way to the SP.

Conclusion: A GO-NO-GO gage will detect pending thread damage. A new coupling may not.
