FIELD TESTS TO DETERMINE CEMENT BOND QUALITY AFTER YEARS OF PRODUCTION

PAUL E. PILKINGTON and JAMES B. SCOTT
Continental Oil Company

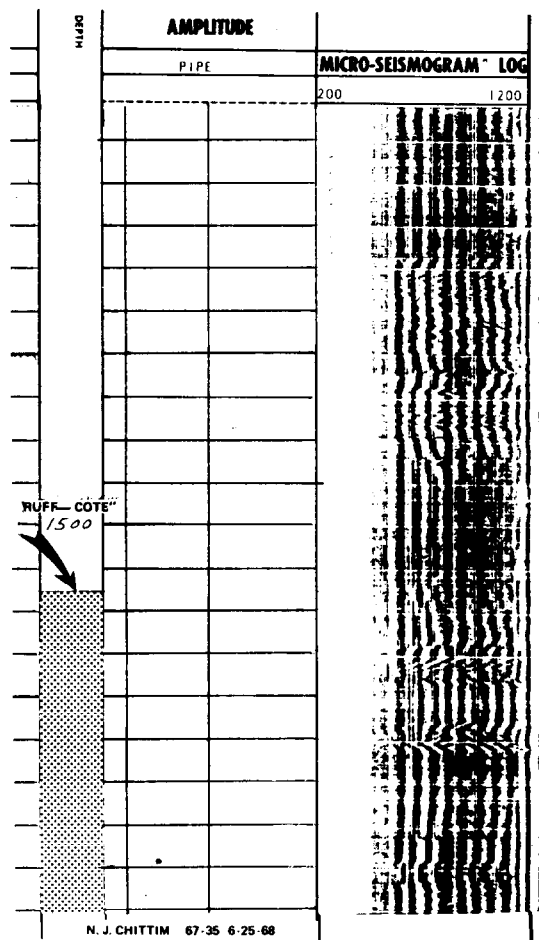
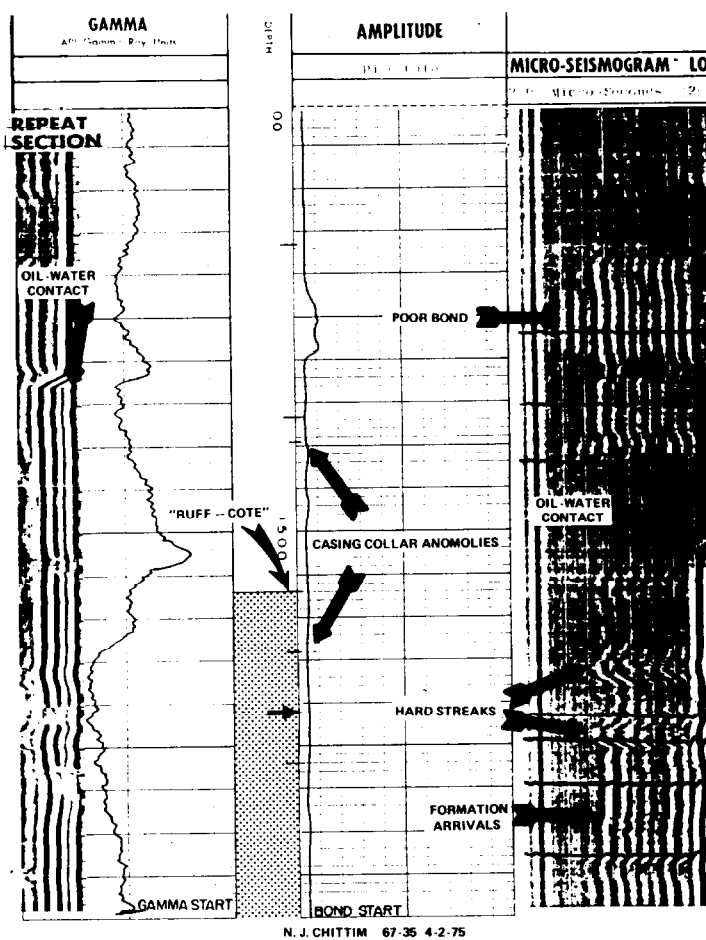
FIGURE 2

This well was completed on June 22, 1968. Casing was cemented at 1635 ft with 113 sacks type "H" with 8% gel plus 85 sacks type "H" with 2% gel. A cement bond log run found good bonding in the interval of interest. (Figure 2) The well was perforated at 1542 ft.

On April 2, 1975, GR-CCL and CBL were run. The CBL showed good bond through the coated section with deterioration of bond occurring above the coated section in the interval 1442-1460 ft. The MSG confirms the amplitude curve. The interval noted as poor bond on the MSG shows pipe ring coming in ahead of the formation arrivals. No pipe ring was present in the same interval on the original CBL (previous log section).

section was relogged. Crude was being flowed to maintain the fluid level in the casing, while logging was in progress. Water in the wellbore was displaced out the perforations by the additional hydrostatic head. This is shown by the downward displacement of the oil-water fluid interface on the MSG. The water may be produced water as the well was reported to have produced 825 bbl water in 1974. The fracture is indicated by the discontinuity in the fluid

wave opposite the perforations.

Some anomalies appeared on the CCL which were neither collars nor perforations. The anomalies, which repeated perfectly on the repeat run, were not present on the original GR-CCL run in 1968. This may be indicative of casing damage.

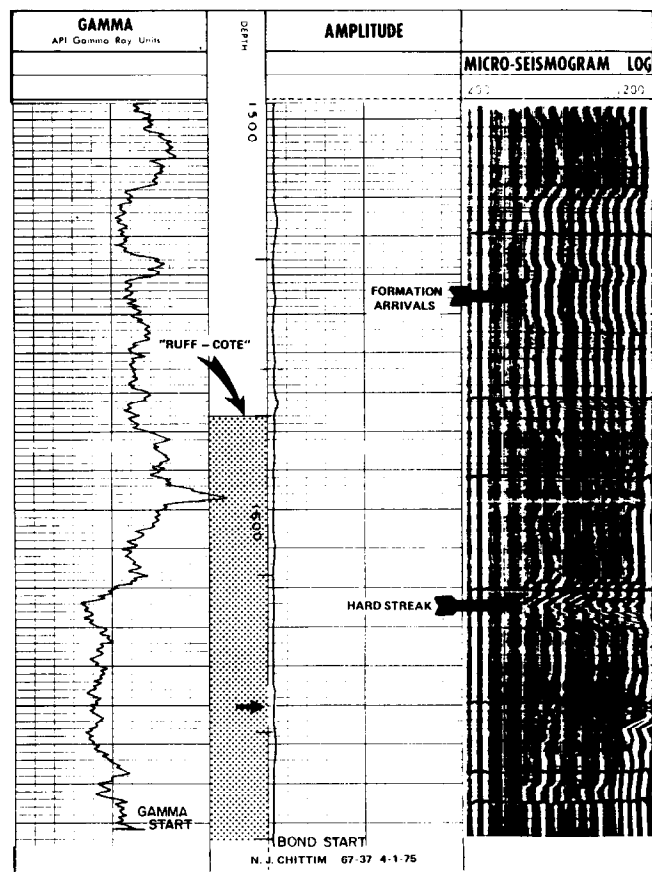
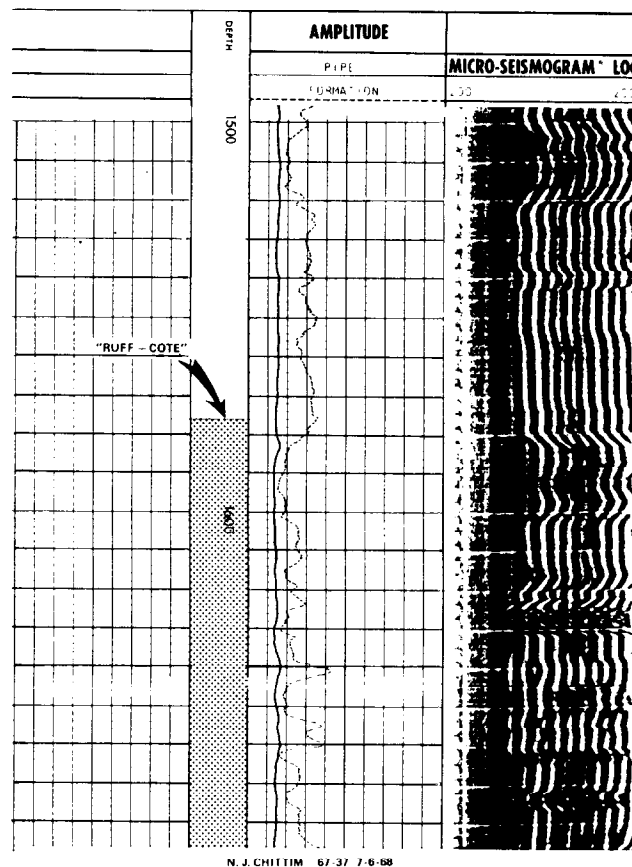
FIGURE 3

"H" with 8% gel plus 87 sacks type "H" with 2% gel. A CBL (Fig. 3) run on July 6, 1968 indicated good bond. Casing was perforated at 1650 ft.

amplitude kicks at 1624 ft and 1644 ft are caused by formation signals entering the pipe amplitude gate which was set about 50/sec late. Poor bond

The CBL run on April 1, 1975, indicated no deterioration of bonding conditions in the coated interval. Pipe ring appears at 1526-1530 ft and 1571-1574 ft, indicating minor damage to the cement-casing bond.

The fluid wave opposite the perforations (immediately above the oil-water contact in the casing) is discontinuous, indicating the horizontal fracture.

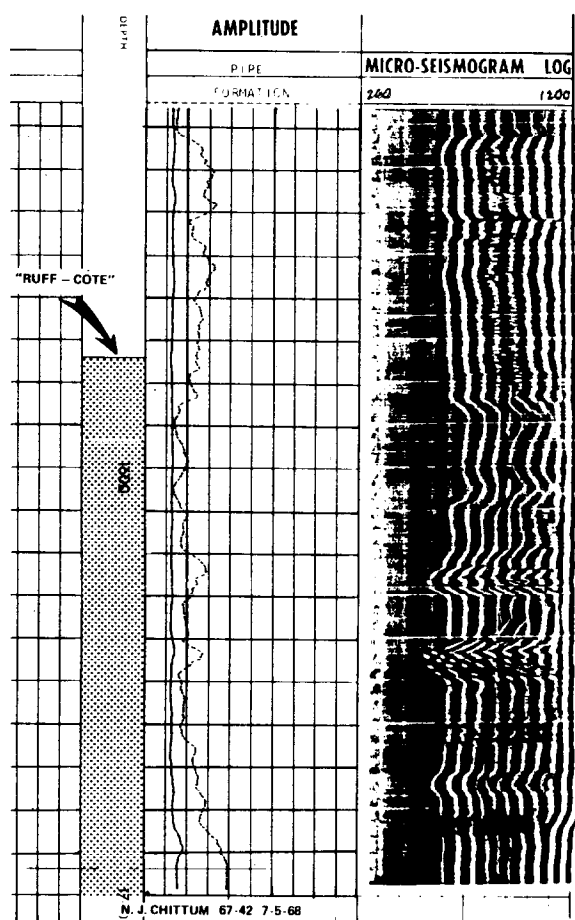
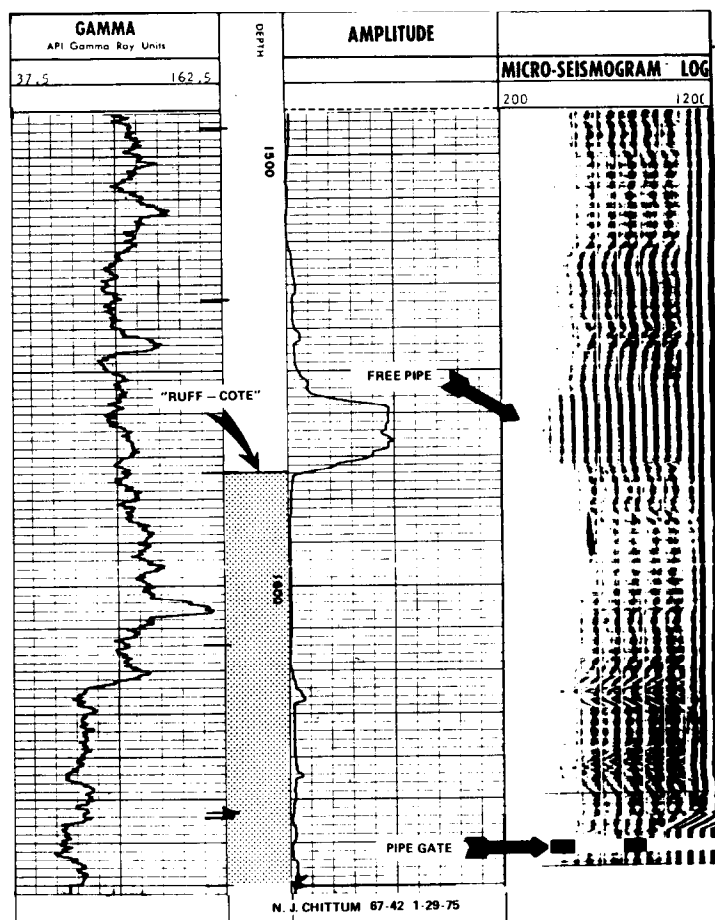
FIGURE 4

A CBL (Fig. 4) run on January 29, 1975 indicated good bond through the coated interval. The

(probably perforating damage) is present only from 1550-1574 ft above the coated interval. The fracture is not well-defined on the fluid wave, possibly because it is right above the fluid contact.

Much of the damage to cement bond seen on these logs is probably due to perforating. Some extension of perforating damage may have occurred during fracturing operations. Figure 5 was an example of possible bond damage extension by fracturing. In other cases, such as shown by Fig. 4, fracturing probably had nothing to do with the deterioration of bond.

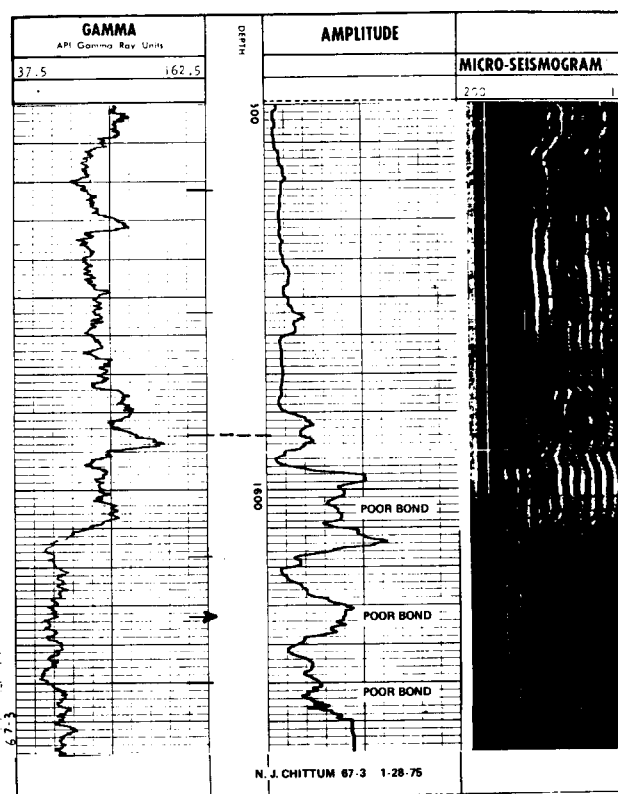
FIGURE 5

A CBL (Fig. 5) run in the well on January 28, 1975 indicated poor bond-free pipe in the interval of interest (bottom three joints below the dashed line in the depth track). Mostly good bond was present above this section to 700 ft. It is believed that the poor bond is a result of perforating with the single-plane gun. The fracture could not be identified on the fluid wave due to poor bond opposite the perforations.

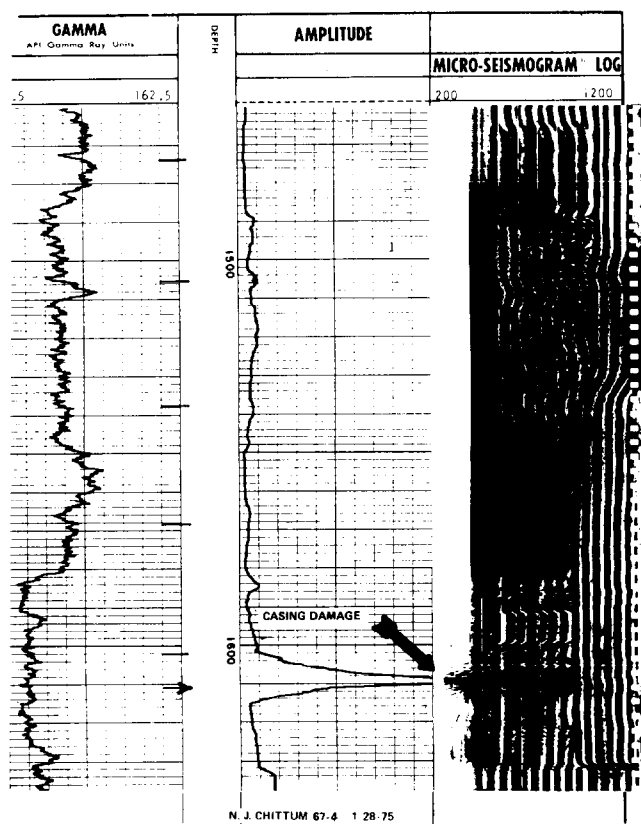
FIGURE 6

This well was logged on January 28, 1975. The CBL (Fig. 6) shows poor bond in the interval from 1600-1616 ft. The MSG shows a possible split in the casing where the early multiple reflections show up opposite the perforations. Good bond exists above the interval of interest to 700 ft. The poor bond and possible casing damage are probably caused by perforating.

Five of the eight wells completed with bare casing had damage to the cement bond in the bottom three-joint interval. This damage, attributed to the type of perforating guns used, and possibly fracturing operations, ranged from severely localized (possible casing split in 67-4) to moderate over a longer

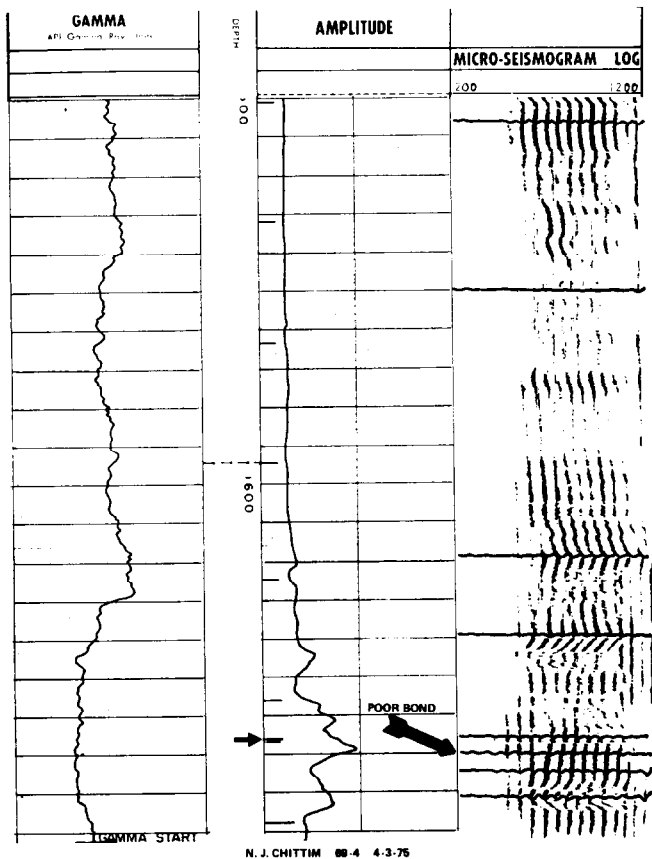
FIGURE 7

The CBL run on April 3, 1975 (Fig. 7) in 69-4

shows fair to poor bond in the interval of interest. This is the only section showing any probable damage to pipe cement bond in this well.
