# EXTENDING RUN TIMES IN DEVIATED WELLS

## CASE STUDIES

Gary Abdo  
R&M Energy Systems

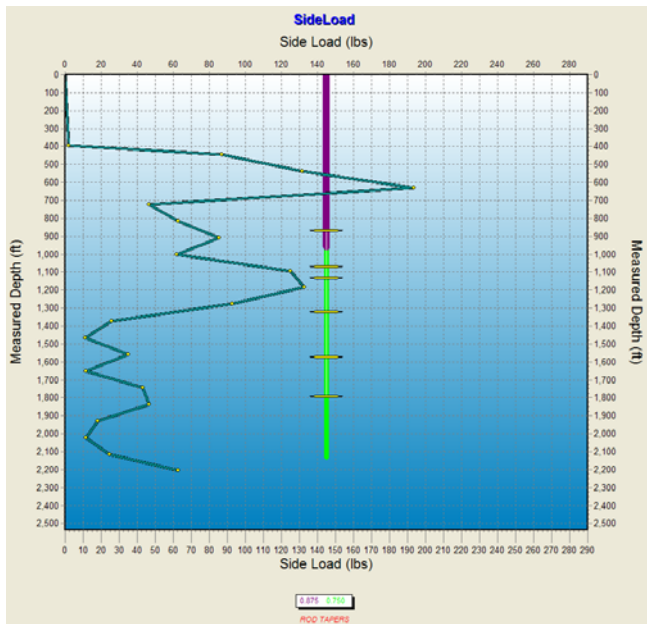
Figure 5 - Z-233 Side Load Chart

The first well, Z-233, history starts in August 1992. This well has eleven failures, nine related to rod and tubing wear since that time. The average run time between wear related failures is 297 days. **Figures 5** and **6** show the side load and 3-D chart with the failure locations. The horizontal bars indicate failure depths. RGAP made the following recommendation from 0 – 2128 ft (bottom):

- 8 guides per rod
- Stealth XL rod guides
- SB1 Material
- New Era Spacing
- Rod Rotator

This recommendation was installed on March 14, 2001. On May 1, 2002 this well was pulled for a plunger problem. Since the March 14th installation to date (January 9, 2004), the well has had no wear related failures. This gives a run time without a wear related failure of 1032 days.

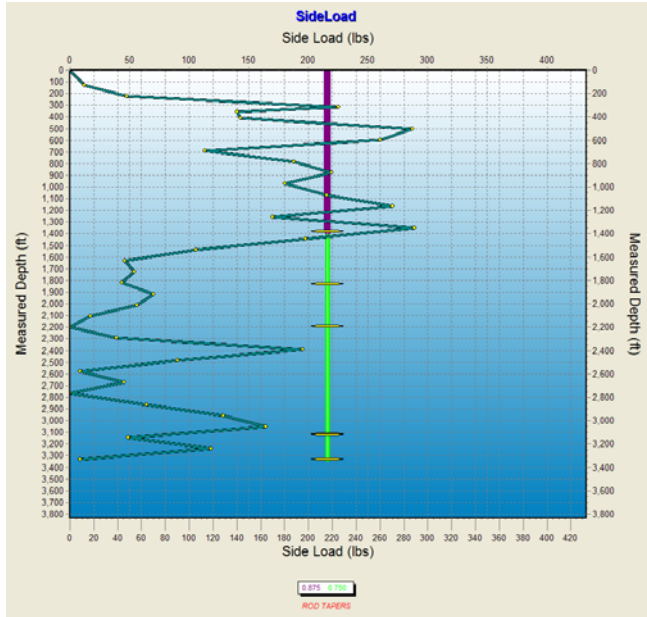
Figure 7 - J-111 Side Load Chart

Well number two, J-111, well history starts in April 1996. Since 1996, this well has had eight failures, six of which are wear related. **Figures 7** and **8** show the side load and 3-D chart with failure locations. The average run time between failures is 231 days, with the longest run time between failures of 704 days. RGAP recommended the following from 1- 3330 ft (bottom):

- 8 guides per rod

- Stealth XL rod guides
- SB1 Material
- New Era Spacing
- Rod Rotator

The above recommendation was installed on March 28, 2001. To date, this well has not failed, giving a run time of 1018 days.

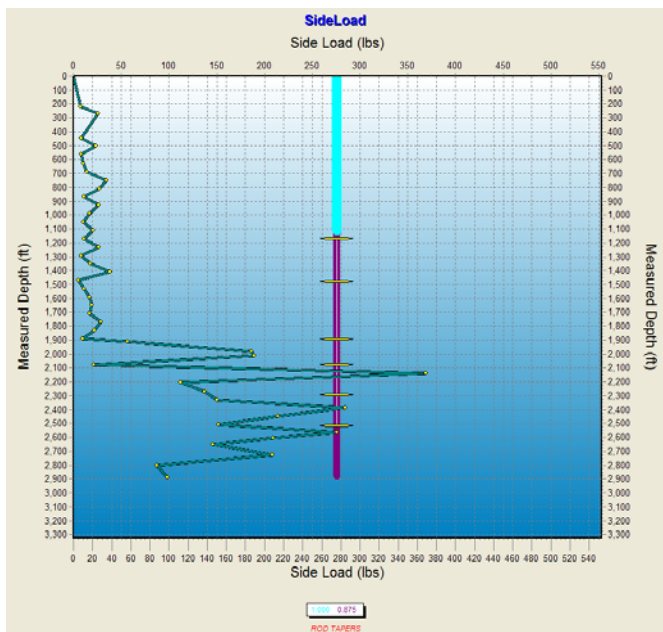
Figure 9 - E-138 Side Load Chart

Well number three, E-138, history starts in January 2000. Since then, well rig work history shows six pulls, four of which are wear related. The average run time between failures is 89 days, with the longest run time between failures of 192 days. **Figures 9 and 10** show the side load and 3-D chart with failure locations. RGAP recommended the following from 990ft – 2075ft:

- 4 guides per rod
- Stealth XL rod guides
- SB1 Material
- Wear Spacing
- Rod Rotator

This recommendation was installed on February 22, 2001. To date (January 9, 2004), the well has not failed, giving a run time of 1052 days.

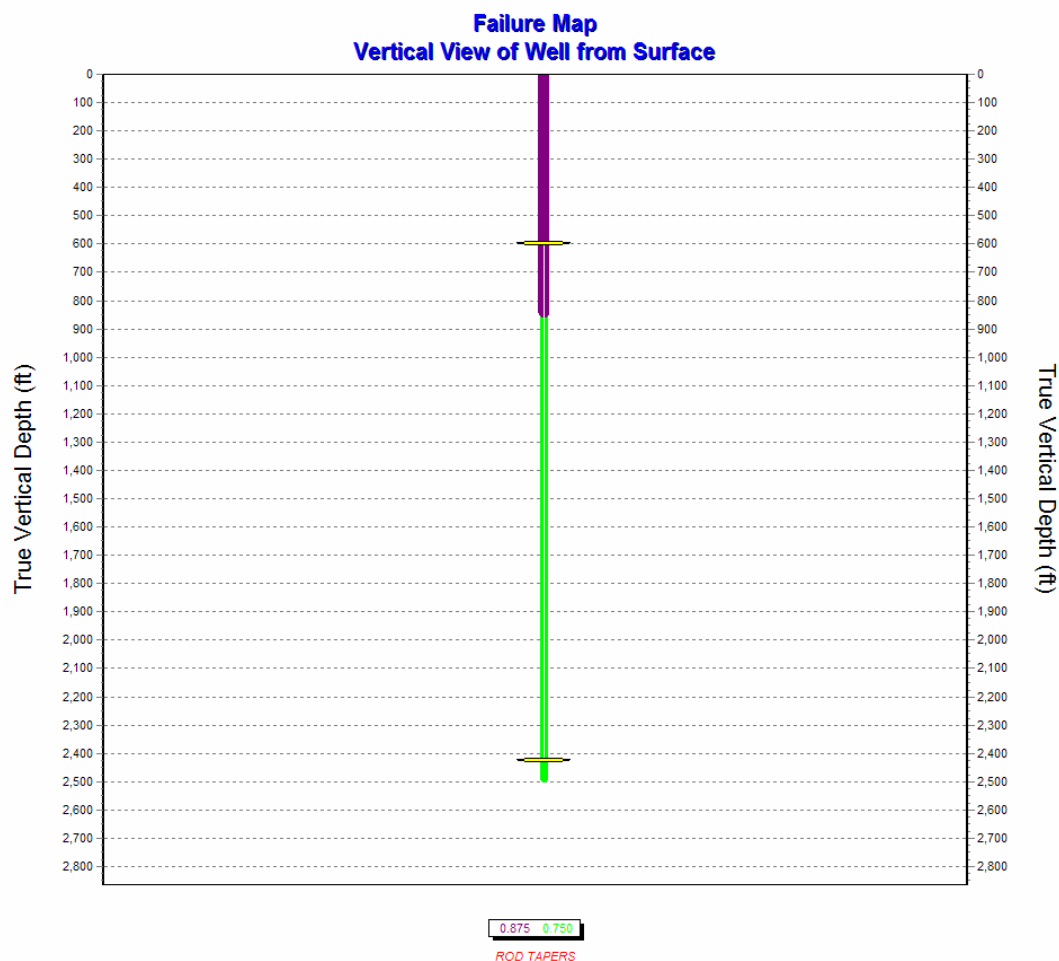
Figure 11- M-253 Failure Map

Well number four, M-253, history starts in May 2000. Since then, well rig work history shows two failures. Both of these failures are wear related. The average time between failures is 140 days, with the longest run time of 156 days. A plot showing failure locations can be seen in **Figure 11**. RGAP recommended the following from 1884ft – 2490ft:

This recommendation was installed on February 14, 2001. Since installation this well has had two failures, one tubing leak in the unguided portion of the well and a corrosion failure. This give an average run time of 173 days (extended down time after failure). This well does not have a deviation survey and predicting high wear problem areas becomes more difficult. This could attribute to the lower than average return rate for this well.

- 8 guides per rod
- NETB rod guides
- SB1 Material
- New Era Spacing
- Rod Rotator
