Effect of Abuse and Missapplication On Pumping Unit Gears

By F. BEN ELLIOTT
Lufkin Foundry & Machine Co.

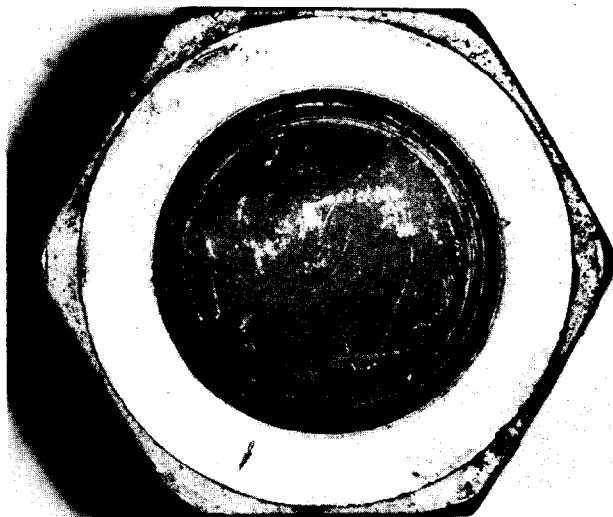
Fig. 1 Bolt failure, fatigue, at first thread of nut.

manner: they either tie together halves or attach the reducer to a sub base. However, in almost all instances the type of failure encountered in bolts will be fatigue, and the cause of failure will be insufficient tightness. Fatigue failure is a progressive type and is illustrated by the clam shell pattern as shown on Figures 1 and 2. The texture of a fatigue break is smooth and satin like, and the fracture will generally be in the first thread inside the nut (Fig. 1), or next to the bolt head (Fig. 2).

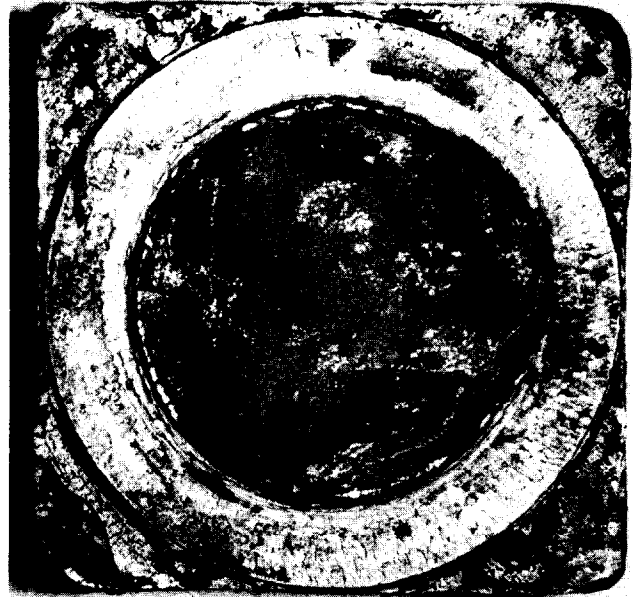
Fig. 2 Bolt failure, fatigue, at bolt head.

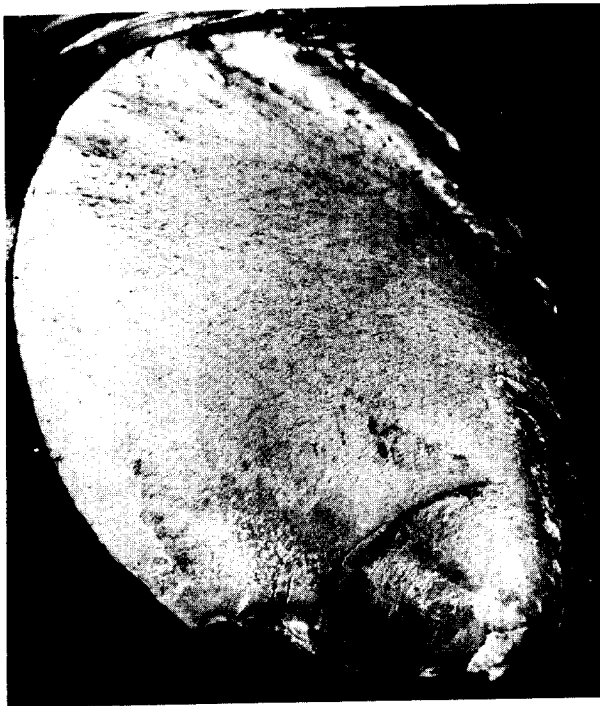
The type of shaft breakage illustrated in Figure 3 is fatigue, and was caused by variable torsional loads. To be noted is the spiral shape of the fracture and the clam shell progression of the failure.

Both type of fractures from torsion and reversed bending were caused by excessive loads. Excessive belt tightness, shock loads, and eccentric loading within the reducer will all increase shaft stresses.

Fig. 3 Shaft failure, fatigue, from torsional overload.

The manufacturer must carefully design to eliminate sharp corners which will cause stress concentration; and the material must be properly heat treated and free from flaws.

The manufacturer must design adequate sized shafts with conservative design stresses.

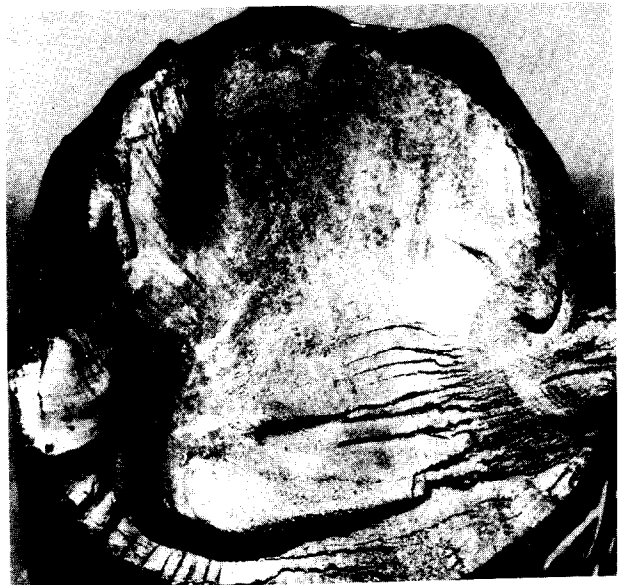
Figure 4 illustrates a more complicated type of shaft failure in which there was not only excessive torsional load but also reversed bending as well.

Fig. 4 Shaft failure, fatigue, from reversed bending and torsional overload.

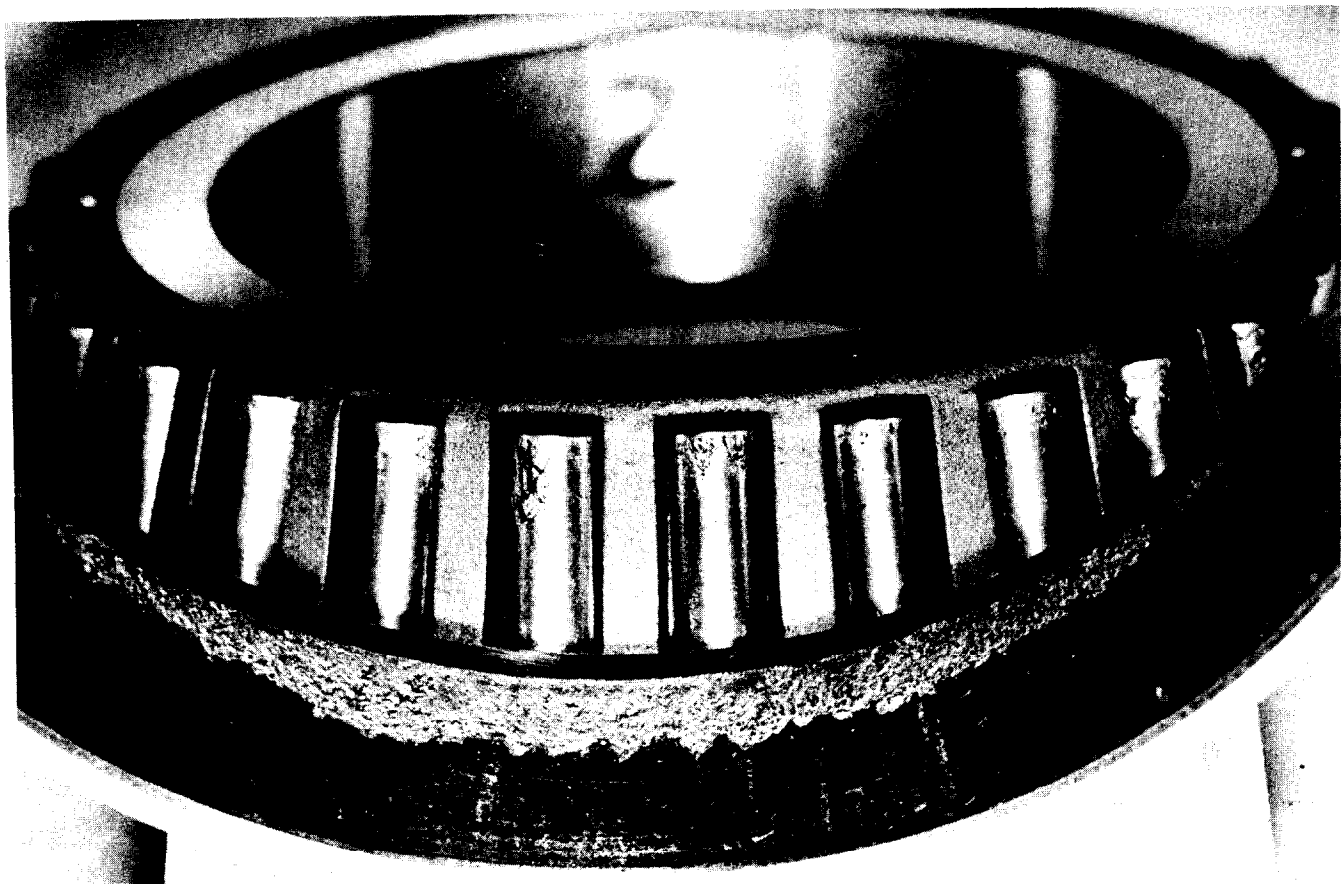
Fig. 5 Bearing failure, spalling and pitting, due to overload from misalignment.

The bearing roller surfaces may be deeply pitted or spalled (Fig. 5). This tapered roller bearing was subjected to eccentric loading or misalignment of some type. This condition can originate from an excessive bending load on a relatively small shaft.

If the condition shown in Figure 5 had not progressed so far it would have been known as pitting, and this can actually take place without wear of the race or roller surfaces. As separated pits get larger and joint together, the condition known as "spalling" occurs as it did here.

The reducer manufacturer must carefully design to obtain the proper size and type of bearings used in his equipment. The load sources from gear mesh separation, belt loading, and the well load must be considered to establish bearing loading and expected life. Bearing life is very sensitive to load; in fact, it varies as the cube of load, e. g., a bearing subjected to a 100% overload will have its life reduced to 1/8 of normal.

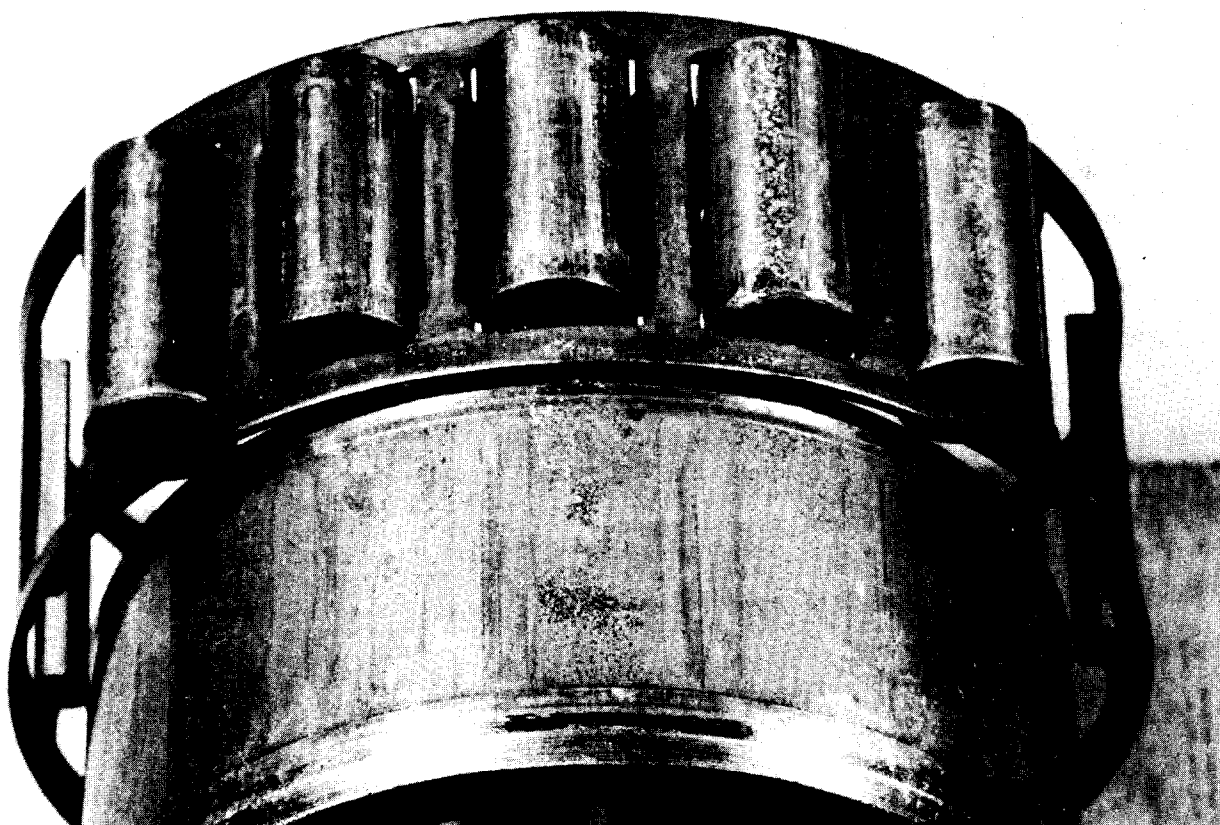
Fig. 6 Bearing failure, corrosion and wear, due to moisture in housing.

The straight roller bearing illustrated in Figure 6 shows a combination of conditions. Corrosion spots are visible on both the rollers and inner race surface. The corrosion can be brought on by exterior moisture leaking into the housing or by condensation, which is in turn aggravated by intermittent reducer operation; but the proper lubricant, changed at regular intervals, will minimize this condition. Further, the inner race shows different surface textures of the race way, for abrasive materials from rust or dirt actually lapped away sec-

tions of the race and roll surfaces.

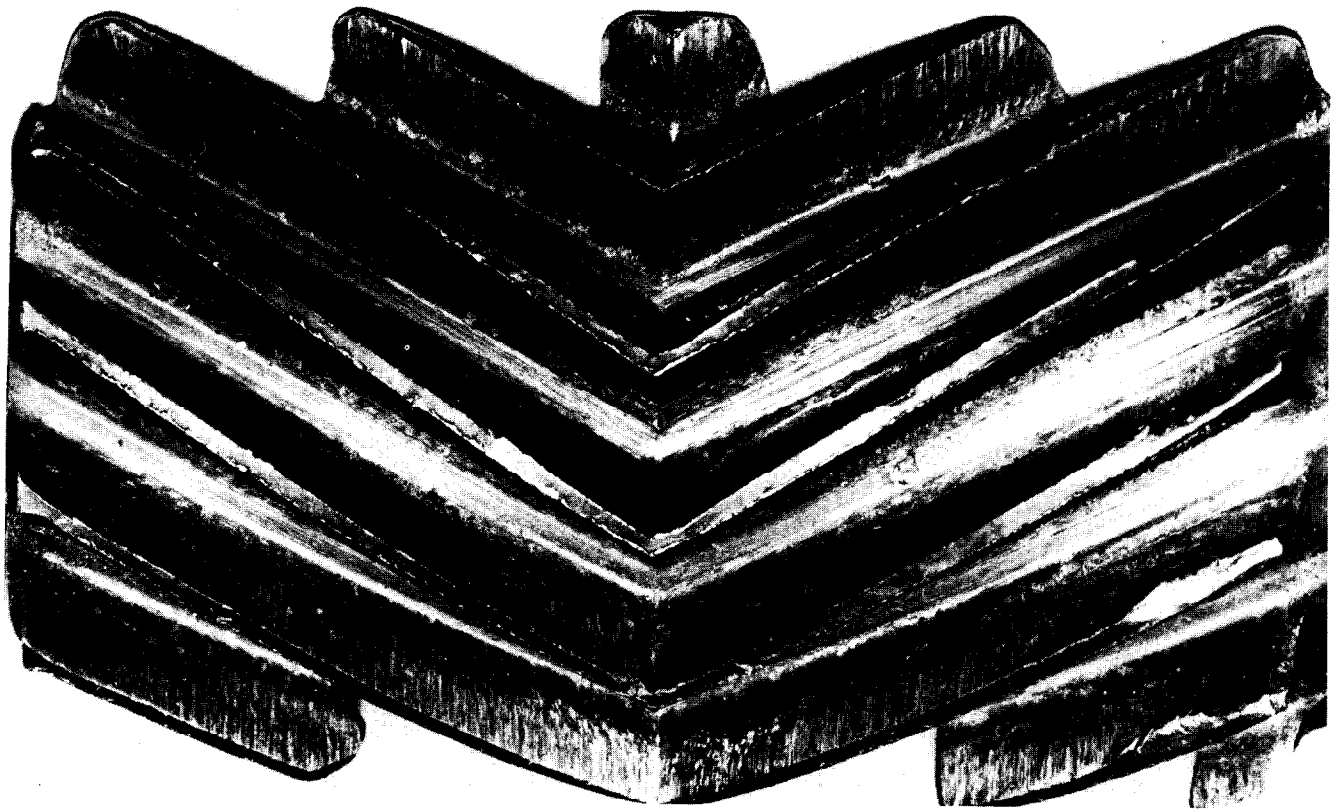
Fig. 8 Pinion teeth scoring from marginal lubrication.

Scoring of the tooth surfaces can happen. Figure 8 shows the pinion of a reducer which is over 10 yr old. In this instance the lubricant lost effectiveness with the resultant scoring shown. The age of the lubricant is unknown; however, it probably went far past the change time recommended by the manufacturer. Figure 9 shows a pinion and gear in which the reducer operated for a short period of time without any oil. After a few days operation oil was placed in the reducer; and there elapsed a total operating time of 30 days before the box was returned to the manufacturer. In this instance the gear material was ductile iron and it had been undercut considerably, although it smoothed out somewhat once lubricant had been added.

It is most important that the producer use the proper type of lubricant, check it occasionally for appearance, smell, and feel, and change it at the recommended intervals.

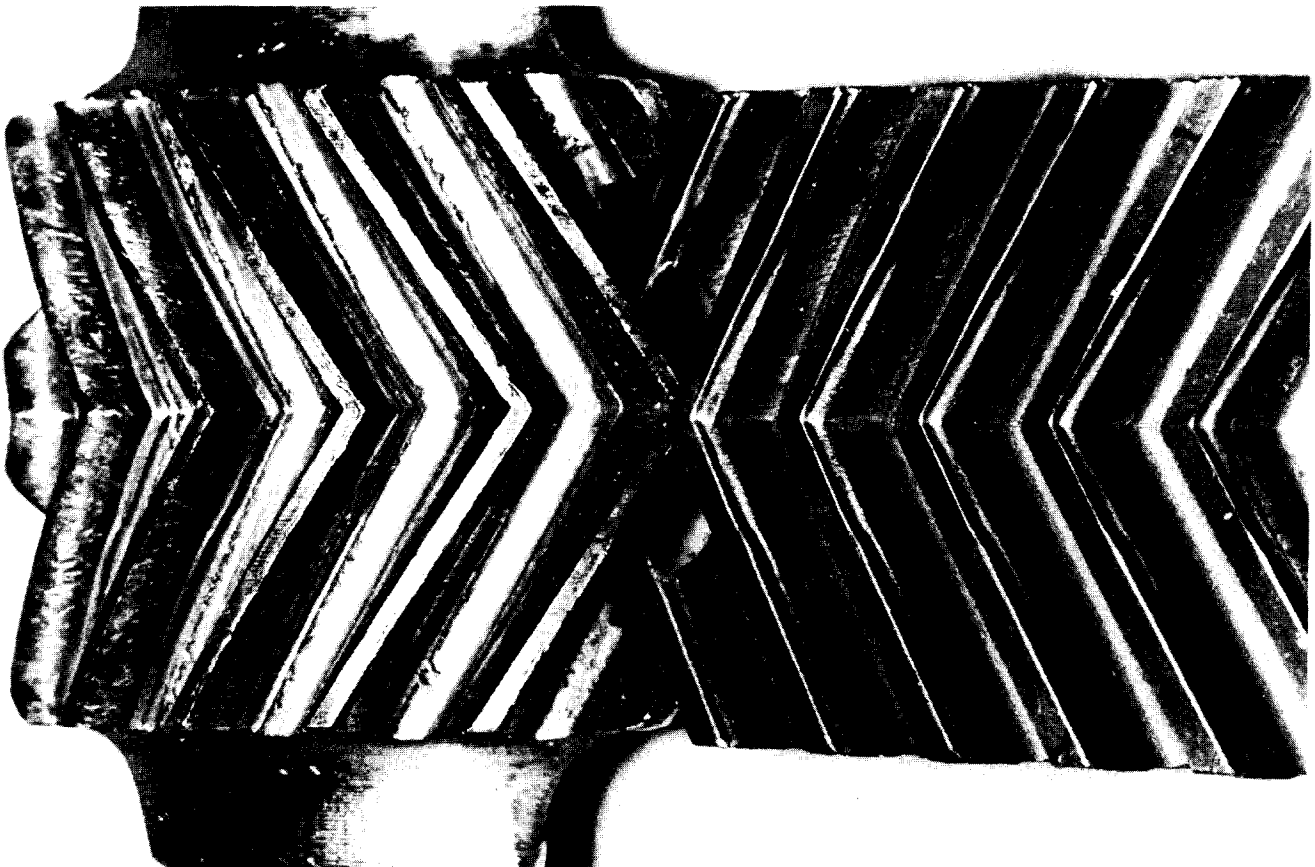
Fig. 9 Pinion and gear tooth scoring, started without oil.

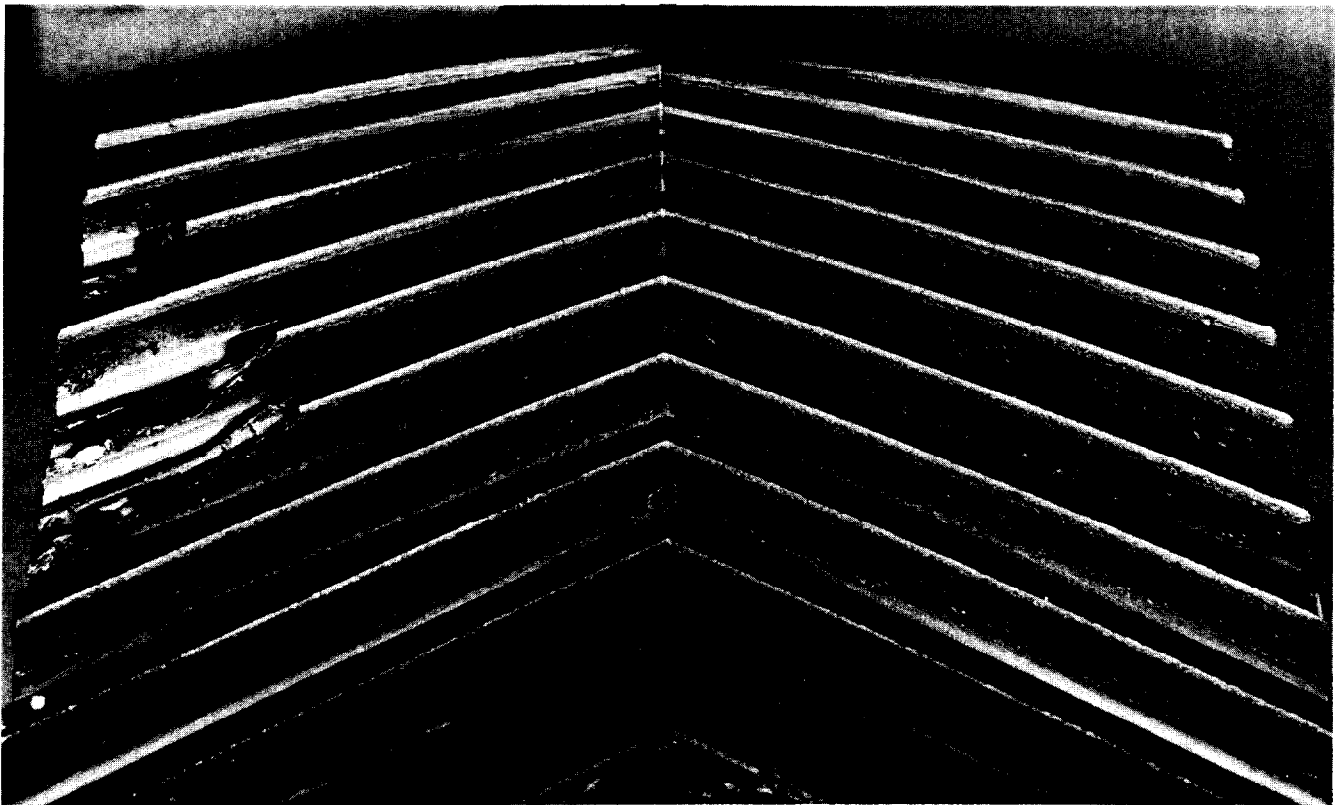
entire dedendum surface of the involute is badly undercut. And eventually, because of the bending loading on the teeth, some of the pits in the distressed area will initiate fatigue failures in the roots of the teeth. Figures 10 and 11 show the typical pitting, undercutting, and subsequent tooth breakage from metal fatigue. All of these factors are initiated by torque overload. Similarly, Figure 12 shows a pinion with tooth breakage in which the loading was with the "apex leading". The pinion illustrated in Figure 13 was loaded on the inside of the apex, "apex trailing"

Inspection of the fracture surfaces on Figures 10, 11, 12 and 13 shows that the failures are clearly from fatigue. Fatigue failure is a progressive type and takes considerable time from its start as a small crack to ultimate breakage of the part. As mentioned before, the characteristics of fatigue fracture are a satin like finish and a clam shell progression often being visible, while the final portion of the fracture is generally of a brittle nature and has a rough texture. In the illustration, the change from fatigue to brittle fracture can be clearly seen.

Fig. 10 Gear tooth pitting and breakage from torque overload.

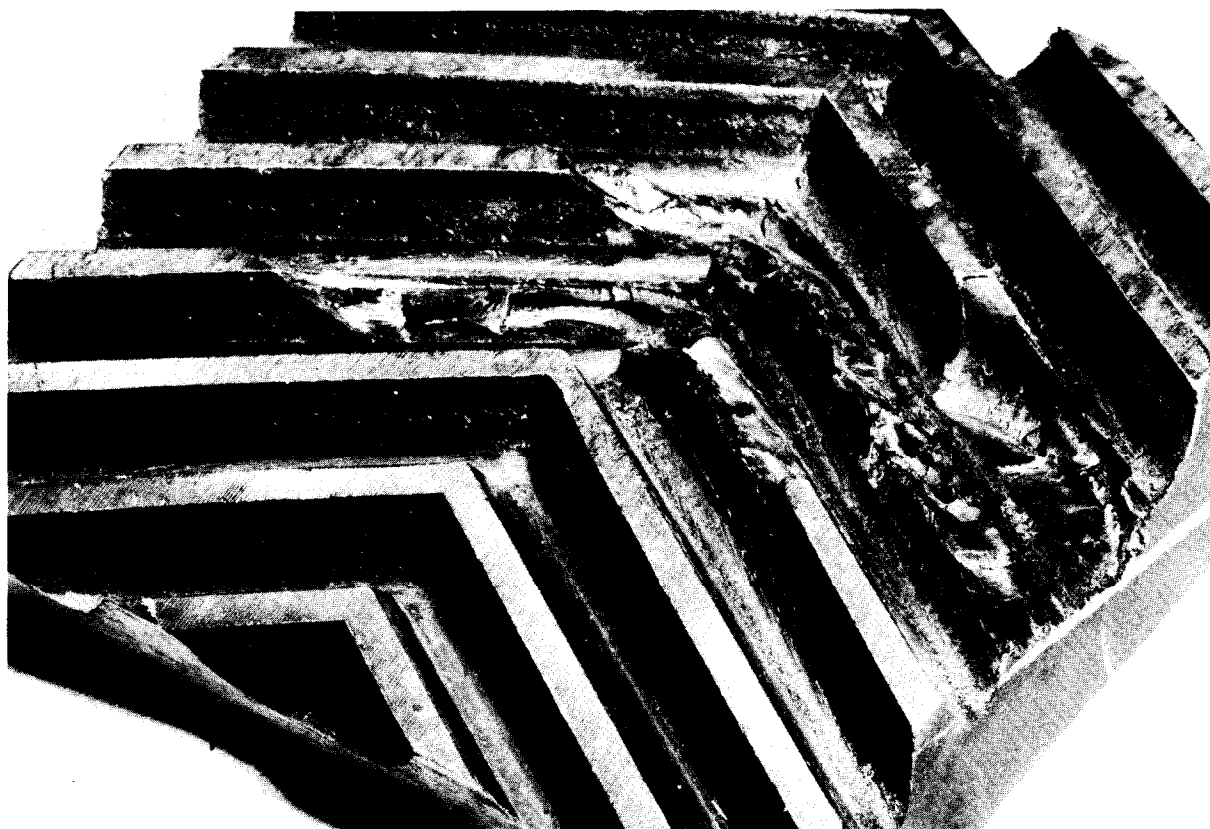
Fig. 11 Gear tooth pitting and breakage from torque overload.

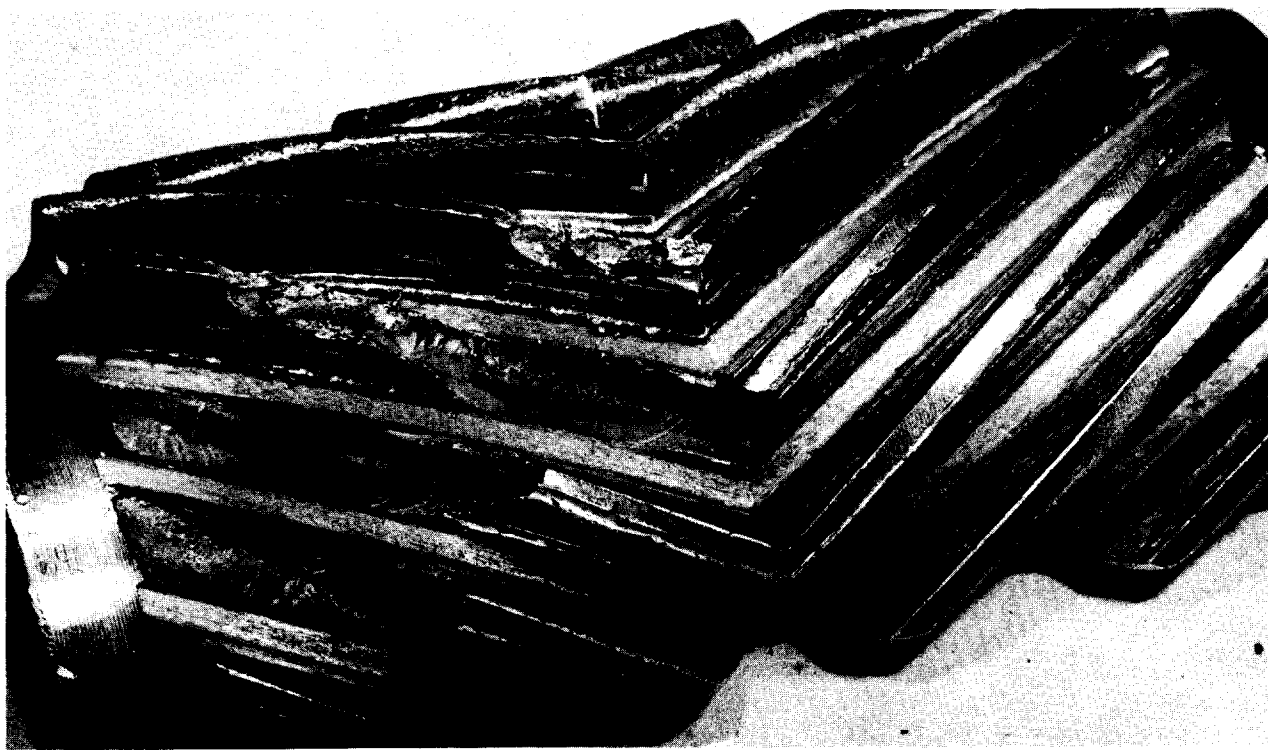
Fig. 12 Pinion tooth pitting and breakage from torque overload applied outside apex.

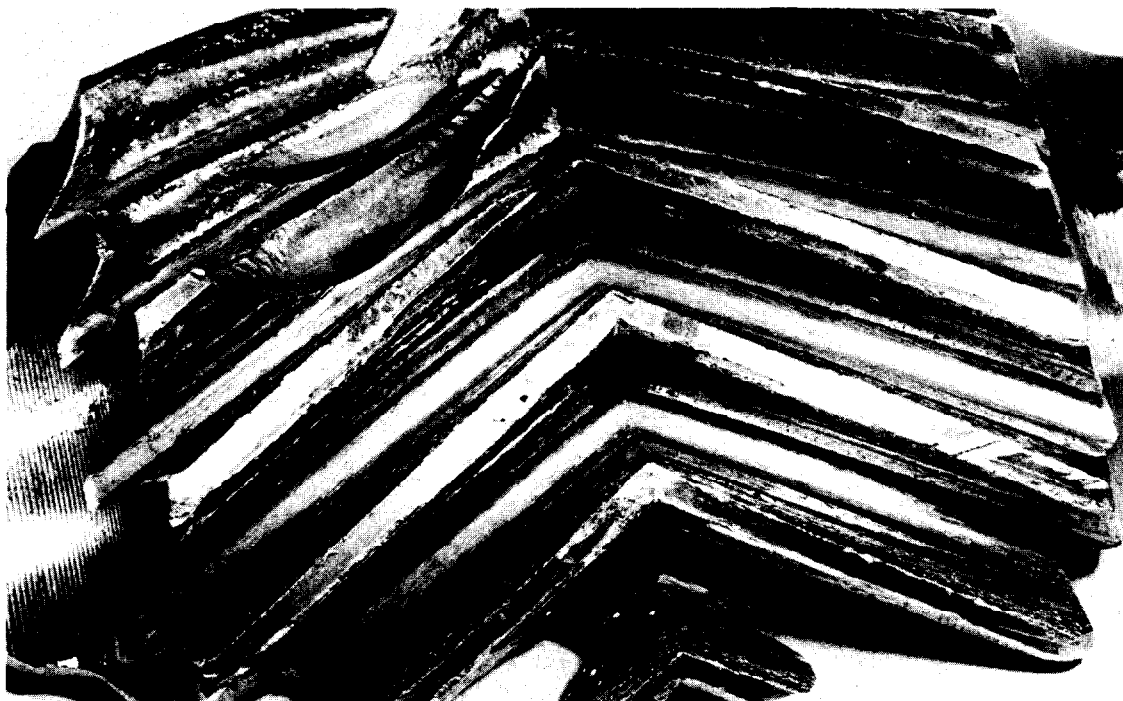
Fig. 13 Pinion tooth pitting and breakage from torque overload applied inside apex.

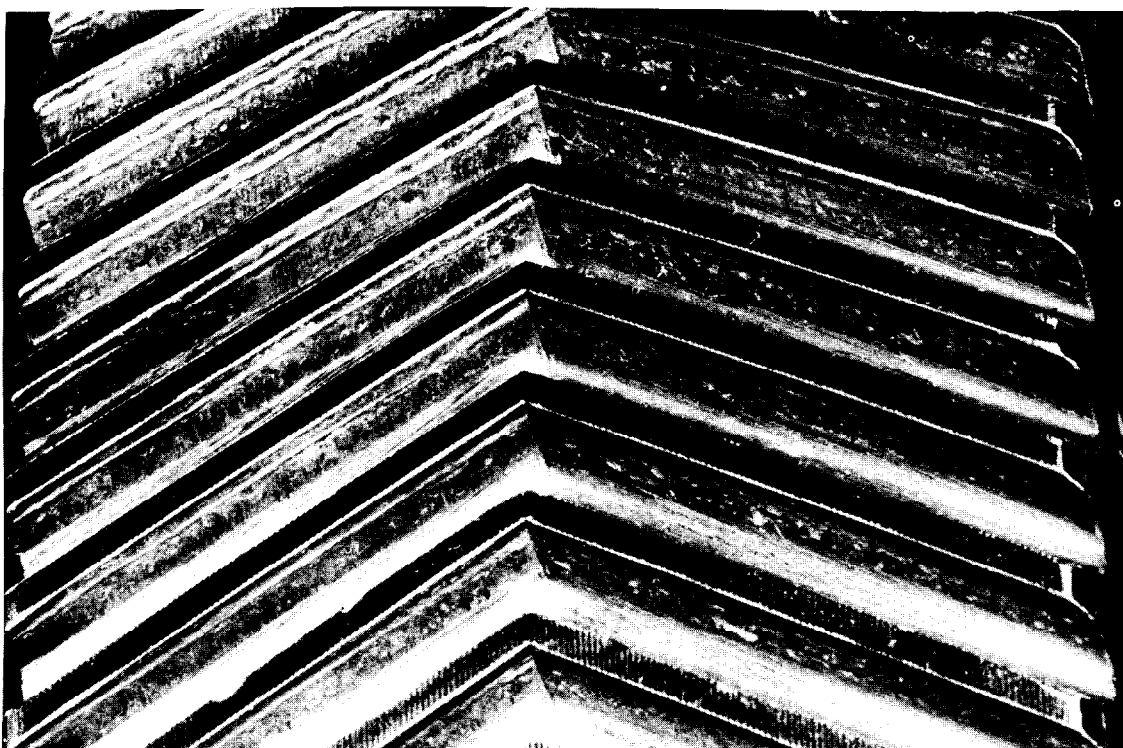
This new gear material is proving to have remarkable resistance to pitting. The character of pitting on nodular iron is different from pitting on steel. Figure 14 shows a nodular iron slow speed gear which had a torque overload. It is of interest that nodular iron has a "healing" property so that, even when pitting occurs, it does not progress as drastically as it does in steel.

Fig. 14 Gear tooth pitting, nodular iron, from torque overload.
