Drill String Fatigue in Short Radius Horizontal Applications

W.G. Storbeck, P.E.,

Storbeck Consulting, Inc. for Mobil E&P U.S.

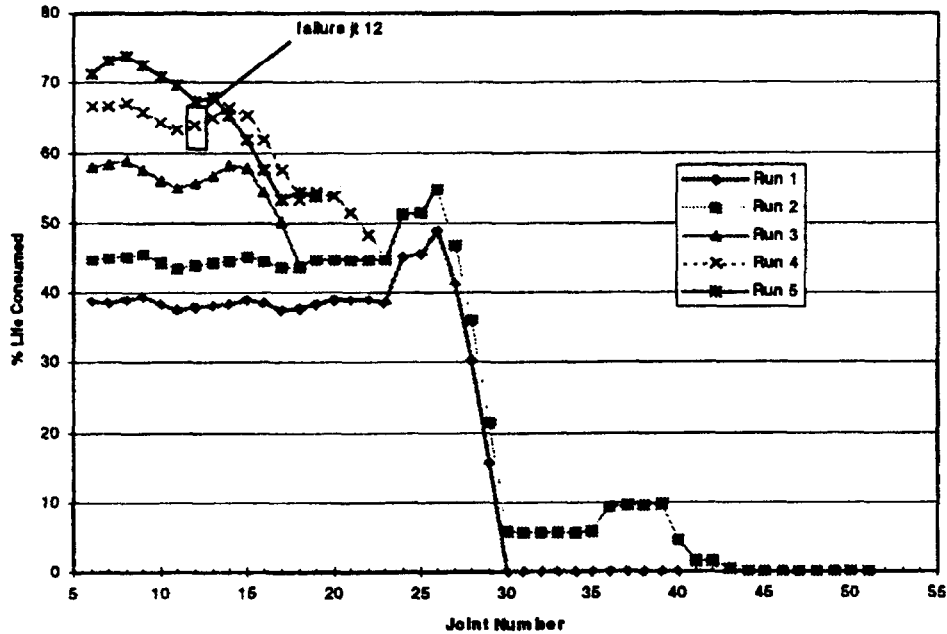
Figure 1 - East Mallet Drill String
% Current Life Consumed for Tubing

This tubing had a consumed life at the end of five runs of 73%. There was a failure during the fourth lateral. That joint had a consumed life of 64%. (Figure 1.)

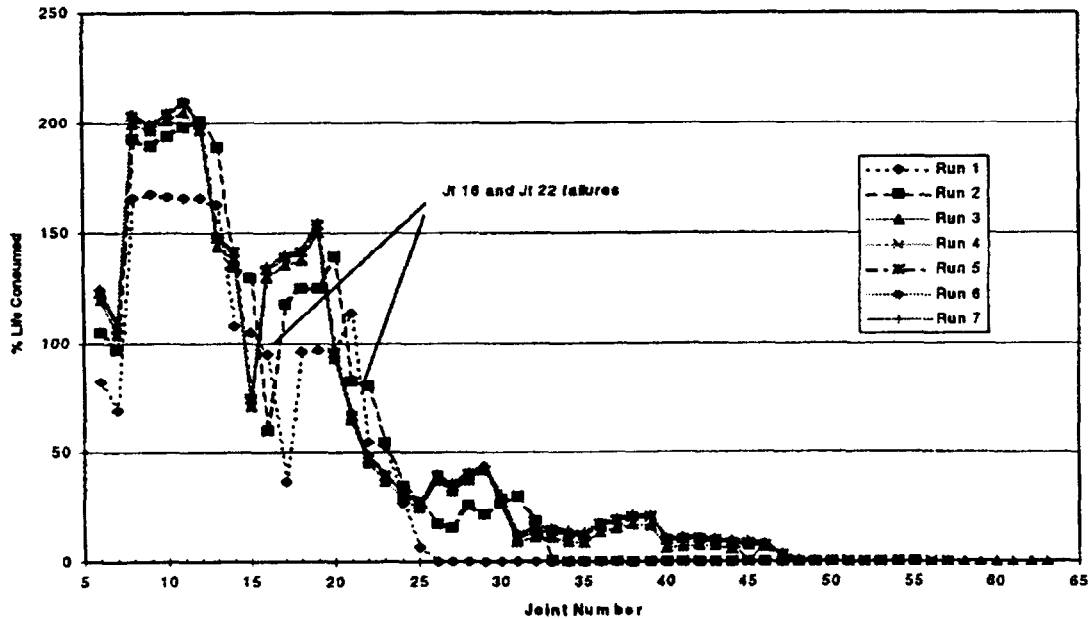
Figure 2 - String #1 at Rutherford
% Current Life Consumed for Tubing

This analysis was of the first seven laterals before being used in combination with the tubing from East Mallet. At the end of seven runs the tubing had a consumed life above or at 200% in some sections. There were two failures, one in the first run and one in the second. The consumed life of these joints was 95% and 81%, respectively. (Figure 2)

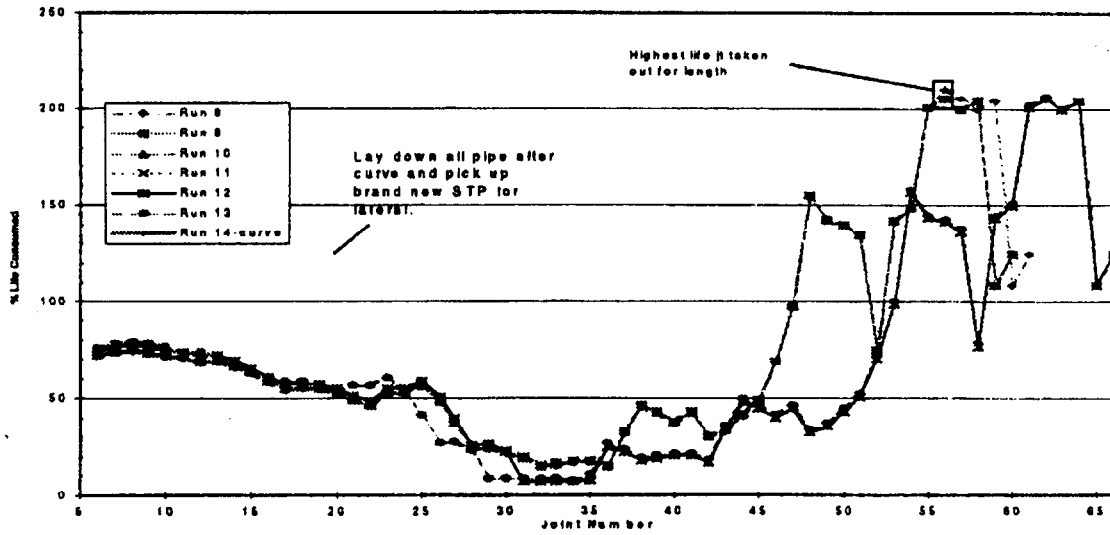
Figure 3 - String #1 at Rutherford
% Current Life Consumed for Tubing (reversed string order)

There were two failures, each during the drilling of the same lateral. These occurred during the twelfth run. The consumed life of these joints was 73.78% and 51.56%, respectively. During the fourteenth run, all of the tubing that had been used in the curve was laid down and sent for inspection along with all other tubing which had been used. Then brand new tubing was picked up to drill the lateral section to finish. This tubing was used to drill fourteen laterals, 21,351 feet, at a cost of \$3.41/ft. (Figure 3)

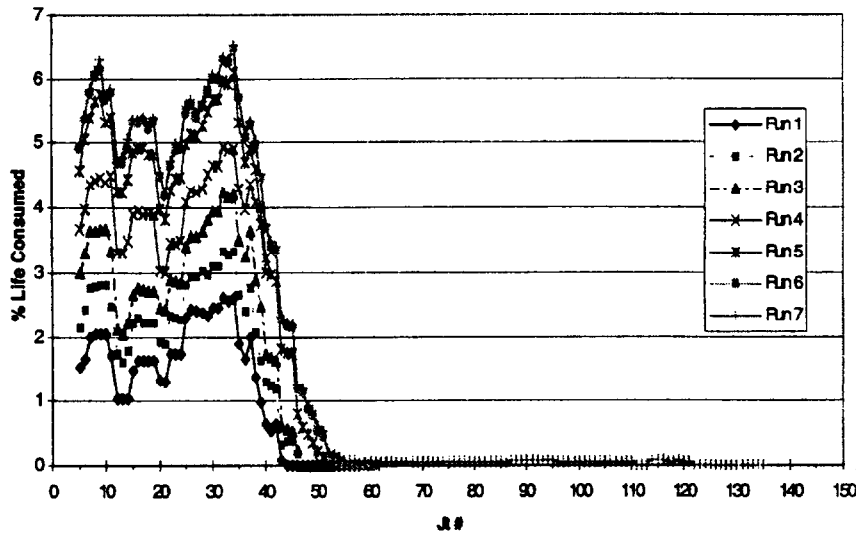
Figure 4 - String #2 at Rutherford
% Consumed Life of Tubing

Thus far the analysis includes the first seven runs for this tubing. This includes one medium radius lateral that was 3500 ft horizontal displacement. It can be seen in the attached graphs that the lower build rate curves drastically improve the percentage of tubing life spent. Although there were no failures, approximately 15 jts have been set aside mostly due to connection damage during make-up. (Figure 4)

After seven runs, the highest consumption of tubing life is approximately 6.5%.
