# COILED TUBING ROD STRINGS MAY EXTEND THE LIFE OF SPRABERRY WELLS (AND OTHERS) IN THE PERMIAN BASIN

Elton Smith, Pioneer Natural Resources USA, Inc.  
Jeff Harris, BJ Services Company, U.S.A.

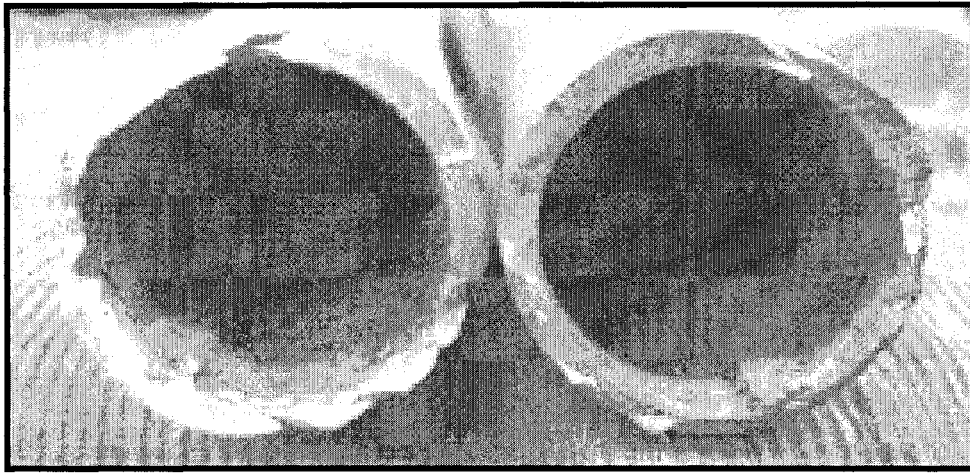
While the CTRS was being pulled, a crack was found in the coiled tubing at 180’ from surface. The crack was noticed when it opened as it passed over the gooseneck. The crack propagated through the entire tubing wall for approximately an inch around the perimeter of the pipe. To repair the crack, a welder was called to location. The failure would have to be cut out and the pipe welded back together in order to pull the rest of the system out of the well.

Both samples from the local lab and the manufacturer as well as two 5 foot sections from each end of the pipe between the cracks were sent to BJ Services' Coiled Tubing Research and Engineering facility in Calgary, Alberta, Canada. Again, different conclusions were found. Some conclusions about the top failure (figure 6) were:

Figure 6 - Top Crack After Opening Up Going Over Gooseneck

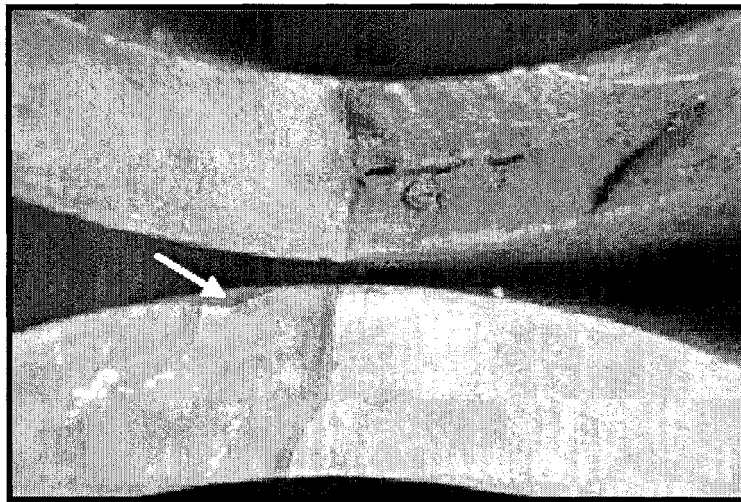
1. The CTRS failure occurred due to a corrosion fatigue rupture initiated from a relatively large external gouge defect (figure 7) while in an oxygenated chloride and sulfur aqueous environment.
2. The macro and micro hardness measurements indicated a wide spread in hardness of the ERW weld in the tubing. The Rockwell C method indicated HRC 19 and the micro hardness VHN 300g and Vickers 10kg methods indicated hardening up to HRC 27 at the center of the ERW weld (table 2).

Figure 7- Detail Of Fracture Surface and External Gouge at Initiation Point

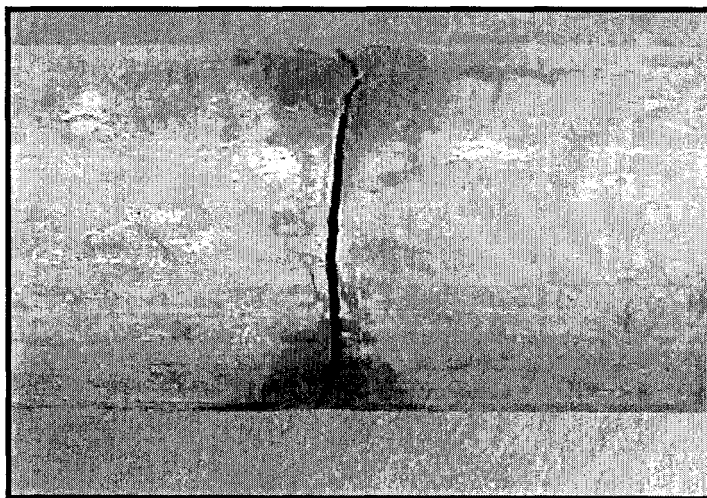
The local lab concluded that the bottom failure was caused by “hardness variations that produced uneven stresses resulting in a fatigue fracture”. This analysis noted that chemical testing for  $H_2S$  exposure was conducted and produced

The lower failure (figure 8) that had been analyzed by the local lab had similar conclusions:

Figure 8 - Lower Failure

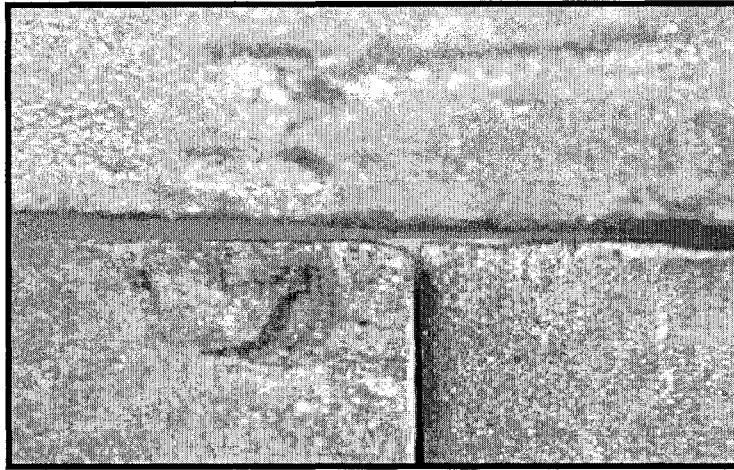
1. The CTRS failure occurred due to a corrosion fatigue rupture initiated from a large external stamp-like defect (figures 9 & 10) while in an oxygenated chloride and sulfur aqueous environment.
2. The pipe was degraded by a moderate external and internal general corrosion, which did not cause any localized or random pitting.

Figure 9 - Stamp-Like defect at fracture Initiation Point (OD view)

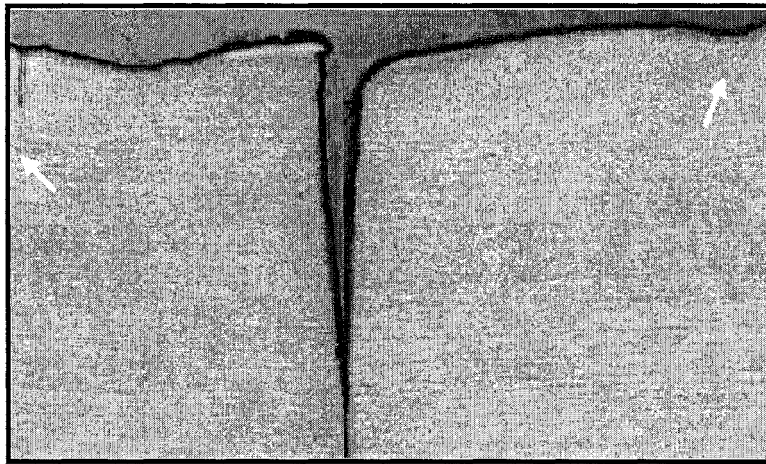
Figure 10 -Detail Of Fracture Initiation Showing Secondary Crack and External Defects

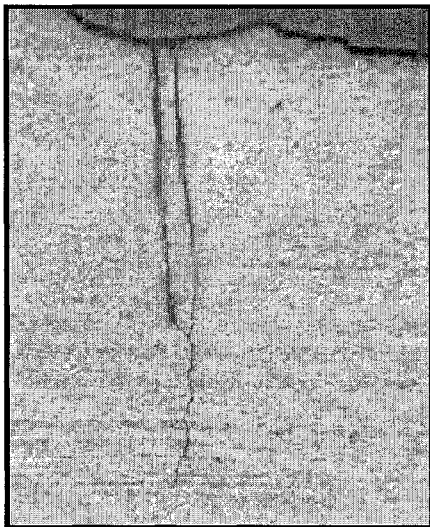
Secondary fatigue cracks were also found (figures 11 & 12) and to have originated at the deformation dished depression in the OD surface. The jagged profile of the secondary crack contained branching with a corrosion film, inferring that the fracture occurred due to a corrosion high fatigue mechanism.

Figure 11 - Detail of Secondary Cracks

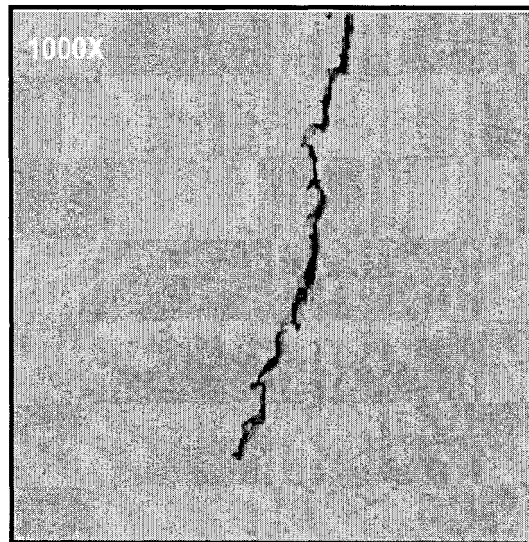
Figure 12 - Detail Showing Tight Fatigue Propagation w/ Corrosion Scale
