## CASING INSPECTION LOGS HELP PLAN WATERFLOOD RE-DEVELOPMENT

Robert T. McNaughton, Texaco Exploration and Production Inc.

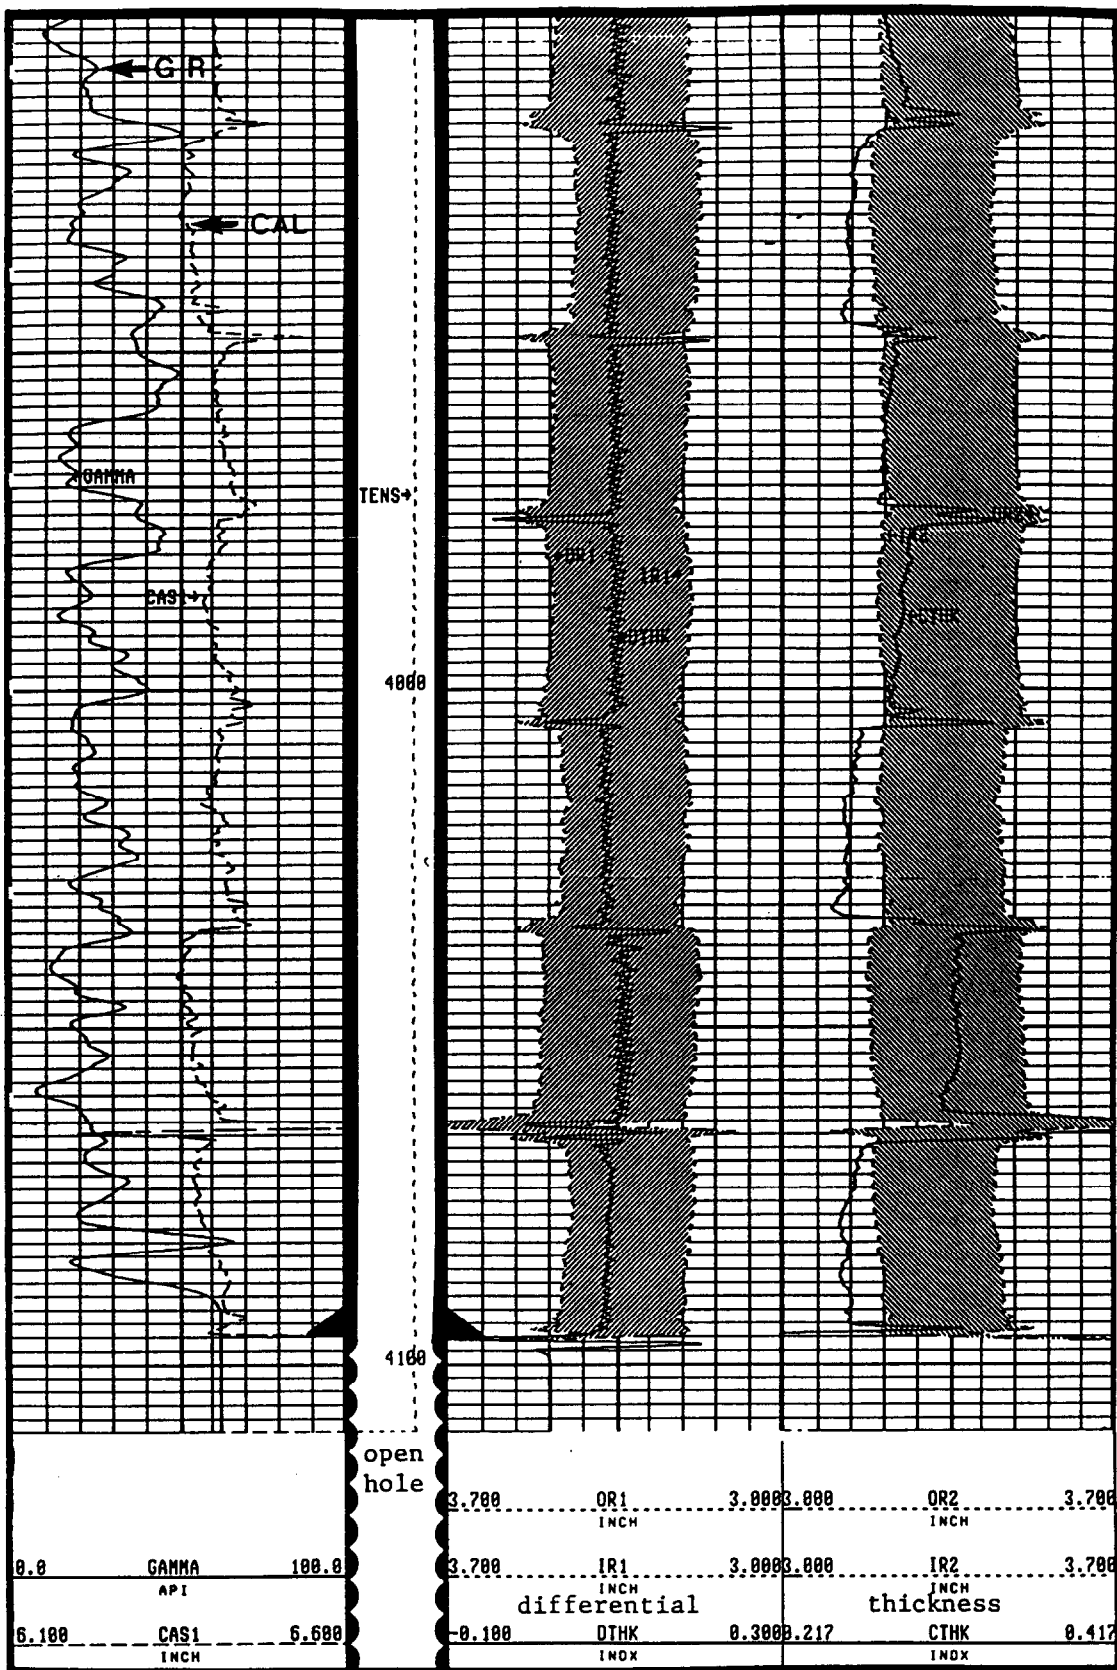
Figure 1- CVU No. 97 Ideal Casing Inspection Log

The inspection log in figure 1 shows the standard curves on a typical presentation. The gray shaded area simulates the casing as if it were cut in half. The differential thickness is a detail curve showing changes in casing thickness over a small interval. The thickness curve measures change in casing weight and the

caliper reads the internal casing diameter. This particular Vacuum Grayburg San Andres well was drilled in 1938 and has produced 2.4 MMBO and 3.2 MMBW. Despite being almost 60 years old and almost 19 years of waterflood exposure, the casing is in excellent condition. This log shows that casing conditions should not be inferred by just the age of a well. The operating environment has a much larger role in determining the service life of a well. The differential curve in track 2 reflects the expected roughness of the inner casing surface. Casing collars appear as sharp deflections to the right and then to the left (4005') and as double deflections to the right in track 3. Caliper and thickness curve shifts reflect changes in the casing weight of each joint. This is typical for much of the casing manufactured prior to adoption of API standards.

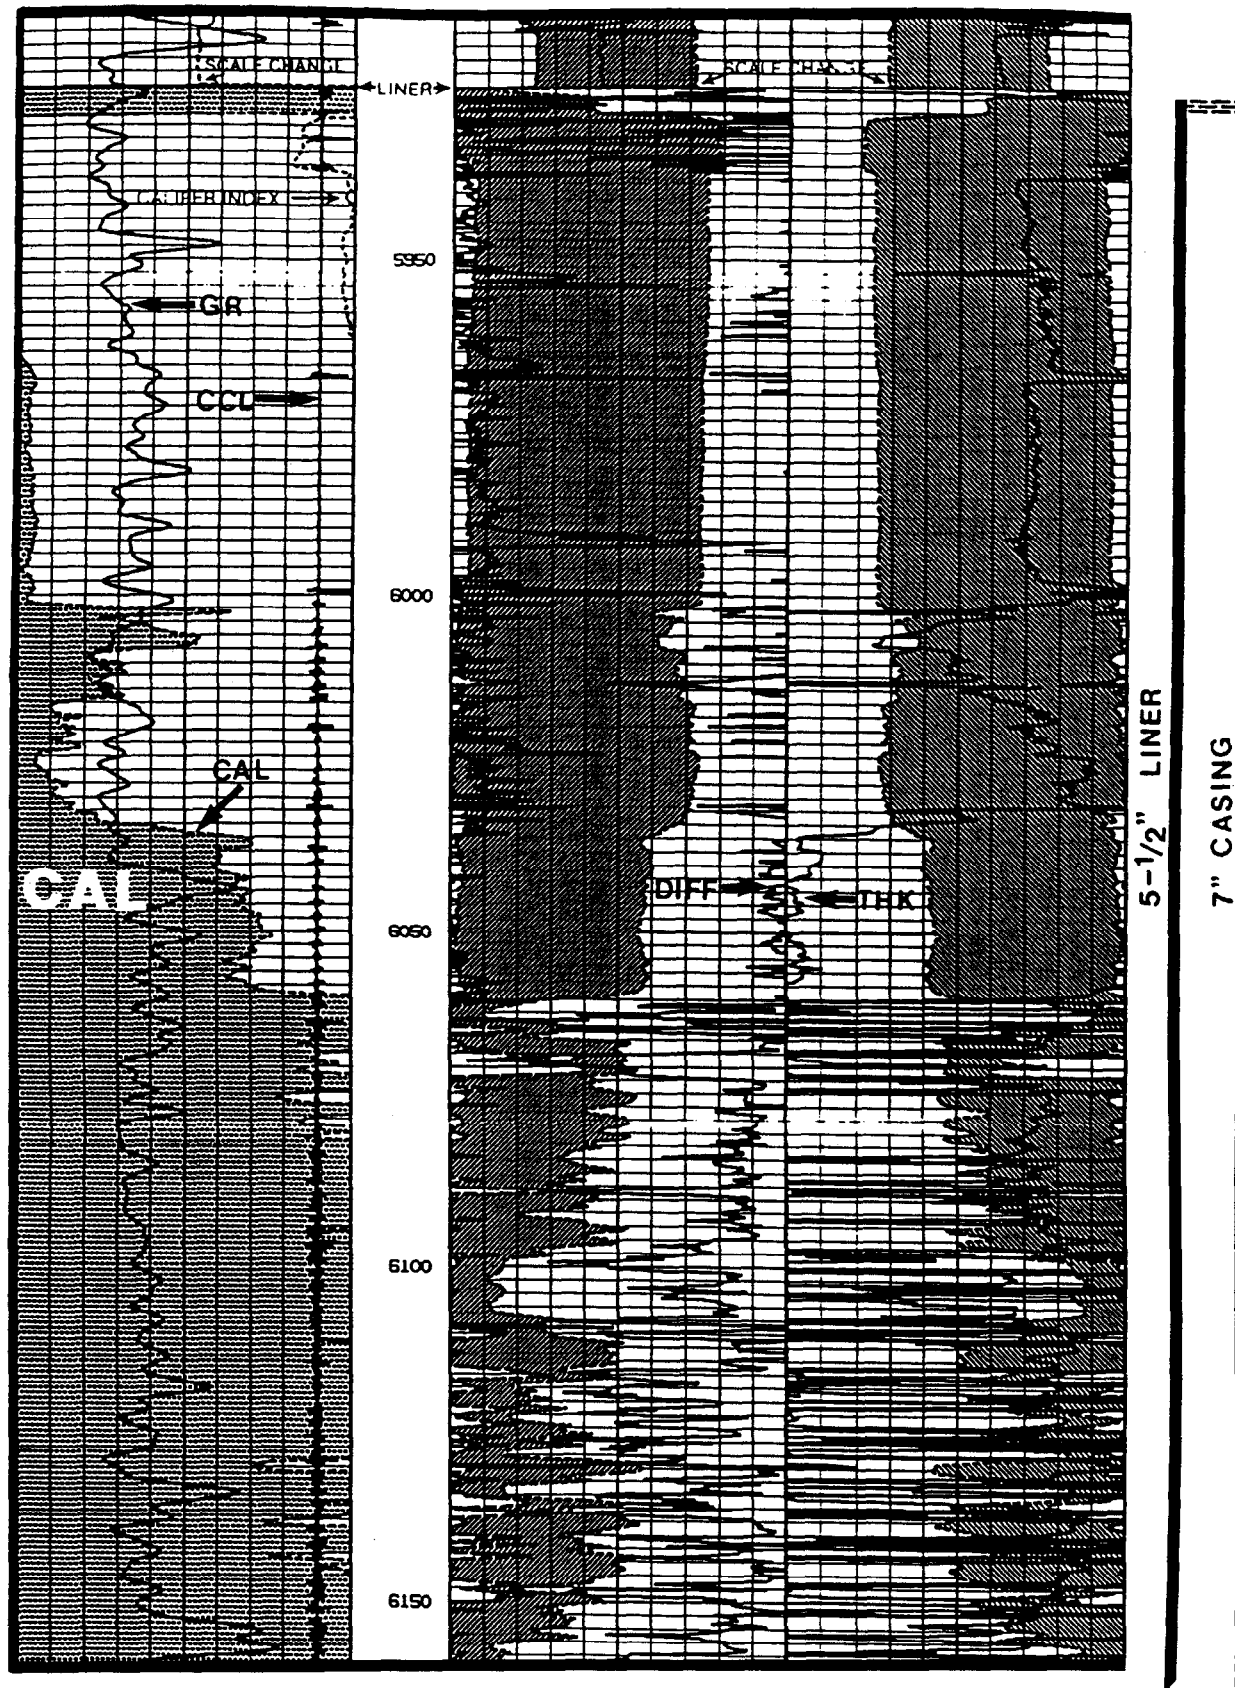
Figure 2 - WDDU No. 86: Casing Inspection Log Through Liner Top

The second example is an injection well in the Southeast corner of the WDDU unit. Well No. 86 was drilled in 1953 and completed as an open hole producer with 7" casing set at 6310'. A 5" liner was run in 1971 when the well was converted to water injection. The injection packer was set above the liner top at 5881'. The liner was cleaned out and reperforated in 1976. The packer was lowered to above the main Drinkard at 6350' but would not hold. It was reset inside the liner at 6050' and injection was resumed. In 1981, junk was milled out of the liner during a routine workover. A treating packer was set at 6217' but it failed during stimulation. The packer was reset at 6002' and injection resumed. In 1993, pressure developed on the annulus due to a tubing leak. The injection packer and tubing were pulled, and metal and heavy scale were milled out of the liner. A casing inspection log was run through the liner and casing. Figure 2 shows that the production casing, hanger and liner are in good shape down to 6002'. The liner shows progressively worse deterioration from the packer set point to about 6300'. Figure 3 shows the rest of the log; nothing remains of the liner except the collars. Several important observations can be made from this log:

1. Corrosion damage begins just below the last packer seat at 6002'.
2. In track 1, the light gray backup shading indicates the caliper (CAL) is reading beyond the outer diameter of the 5" liner. "Noise" on the collar log also picks up casing damage from the packer set point to where the liner ends.

3. In track two and three, the top 130' of liner appears to be exceptionally thick. This is because the magnetic field extends beyond the outside of the liner, and is influenced by the outer production casing. This interference continues down to 6310' where the production casing ends. The gray casing profile shading in these two tracks shows the gradual thinning of the liner wall. The wavy appearance is a good indication that the metal is deformed or crumbling.

4. At 6350', the shading disappears indicating the liner has no wall thickness and has effectively dissolved. The 7" production casing shoe is at 6310'. The log would have read true liner thickness, if any remained, from this point to the bottom. Also note that the noise on the collar log in track 1 ends. There is nothing metallic left to read between collars.

5. The log also found leaks in the production casing uphole, which were confirmed by packer tests.

The production team evaluated the well conditions with the New Mexico Oil & Gas Division. From past WDDU experience, the cost to squeeze the production casing leaks was estimated to be at least \$50,000. The estimated cost for removing the remains of the liner and restoring effective Drinkard injection was at least \$150,000. WDDU No. 86 supported one producer that would eventually be converted to injection if

an offset infill producer was drilled. The team decided to invest the money and effort on better opportunities so the well as plugged. In this case, the log quickly identified terminal casing damage where a traditional packer test would be extremely expensive.

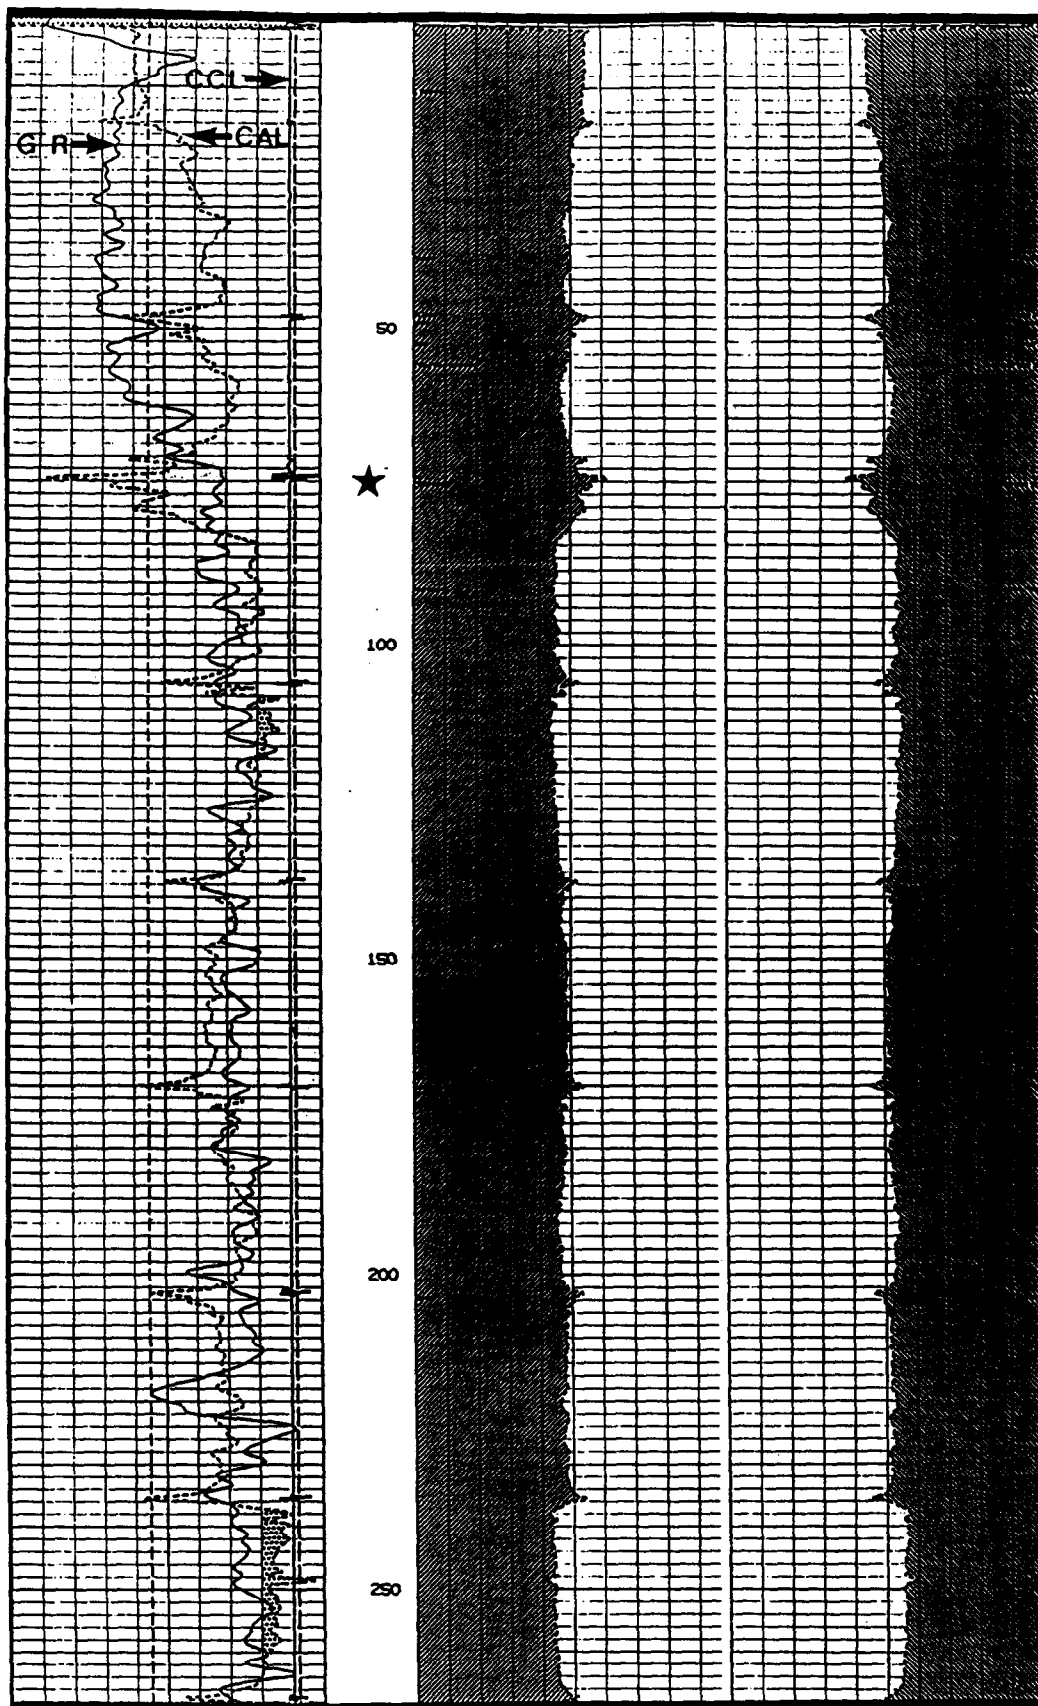
Figure 4 - WDDU No. 11: Casing Inspection Log Near Surface

Figure 4 shows where a casing inspection log identified a surface casing leak. WDDU No. 11 was drilled in 1956 as a cased hole producer, with 5-1/2" casing set at 6900'. The primary cement top (TOC) was at 3563', which is just above the Queen. The casing annulus was squeezed in 1980 as part of Getty's Drinkard isolation project. During a conversion workover in 1993, a small leak was found between 44' and 77'. The logging crew had spotted a caliper deflection while going in the hole. After logging the production casing up to the intermediate shoe, the crew ran a log section at the surface (figure 4). The log shows the following items.

1. The caliper (dashed line) shows reasonably smooth casing. The collars show up as spikes to the left and the large deflection at 74' is an apparent tight spot in the casing. Close observation of the collar locator curve at 73' reveals a second kick below the first. This sometimes indicates a casing split or hole adjacent to the collar. This is important because most inspection tools lack the resolution to see an actual collar leak.

2. The shaded casing wall portion of tracks 2 and 3 appears to be calibrated or scaled wrong. Actually, the surface casing string is influencing the magnetic field. Single frequency magnetic tools will not measure true wall thickness unless the outer casing is perfectly centered and has a sufficiently larger inner diameter.

The log indicated the leak was probably at the collar. Twenty sacks of fine grain cement were spotted in the casing. The cement was squeezed from the braden head at 600 psi. After drilling out, the collar leak was sealed and the conversion was completed with no other problems.

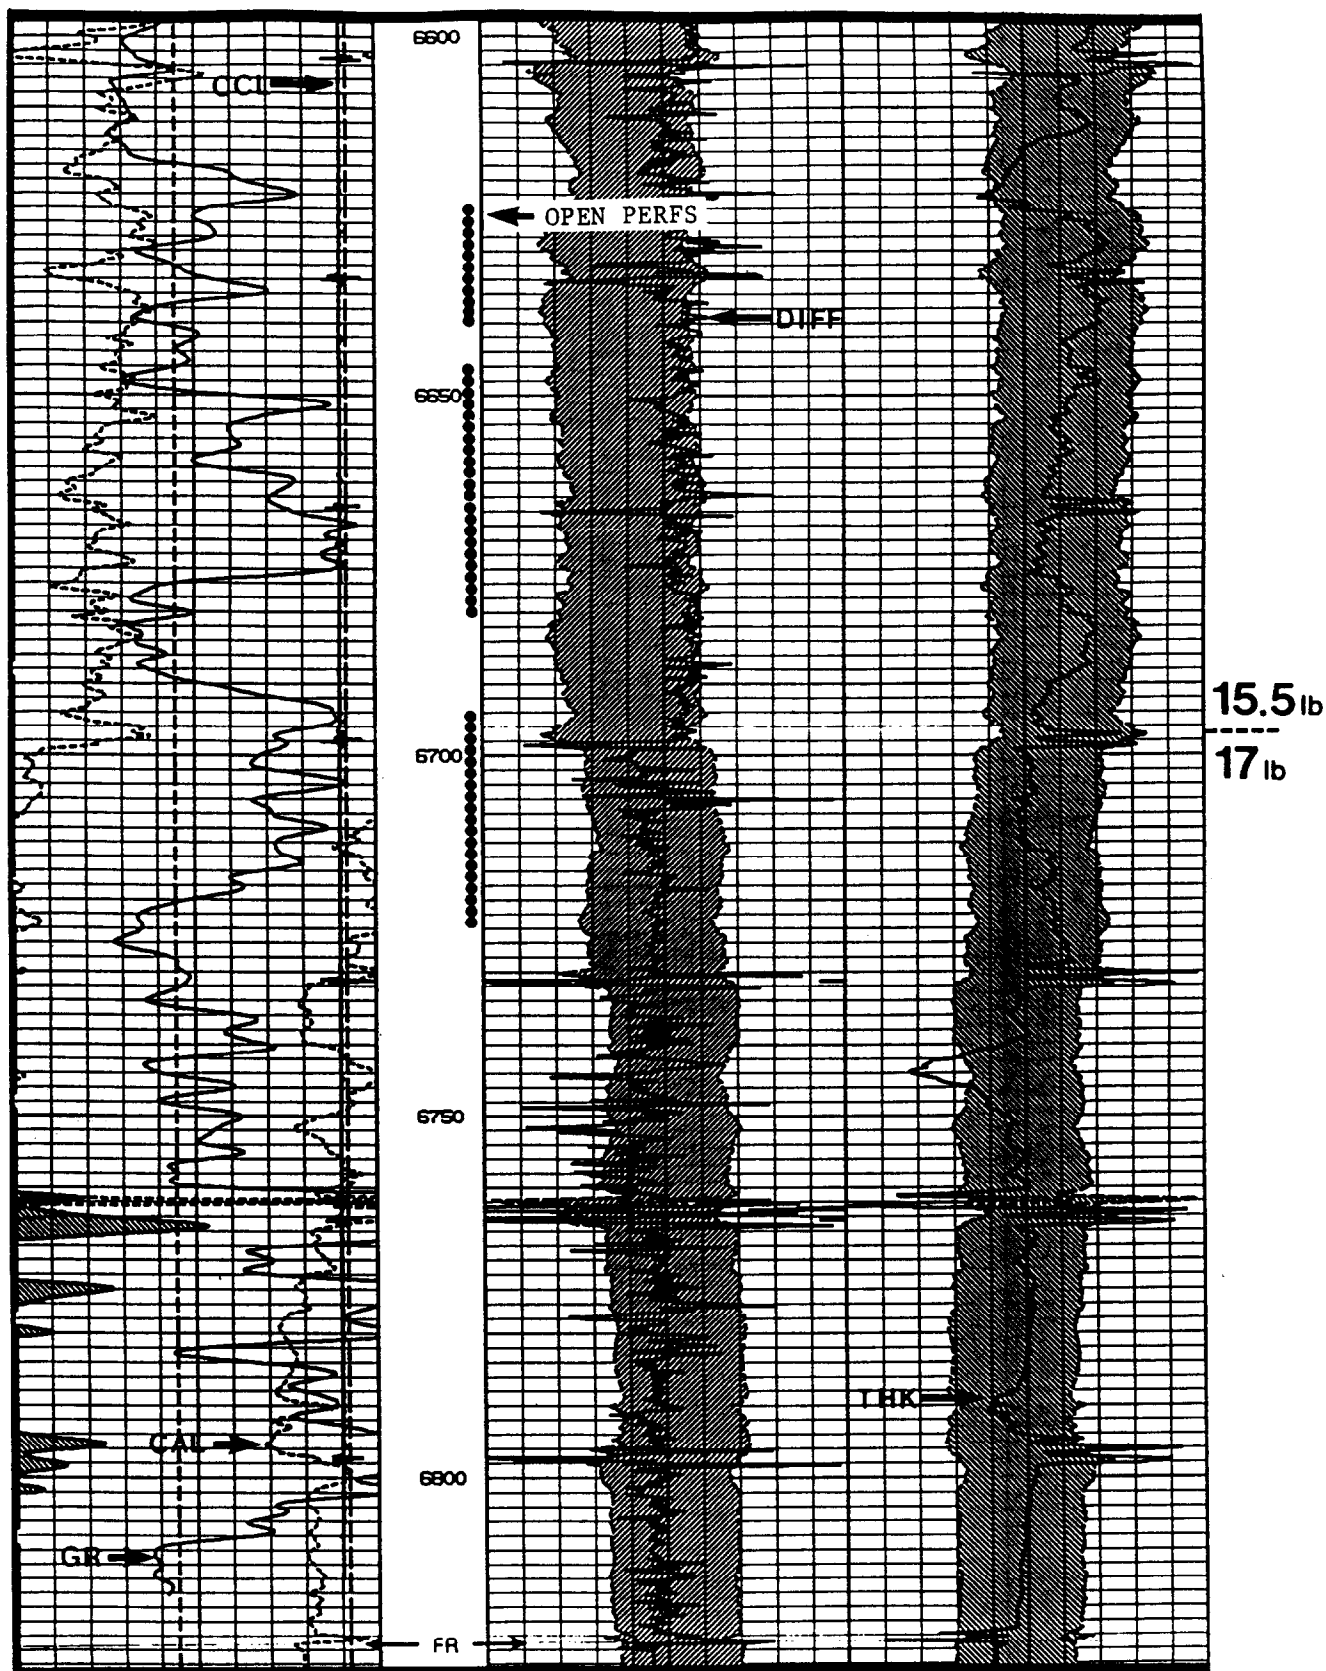
Figure 5 - WDDU No. 11 Casing Inspection Log Through Drinkard Section

3. The log section through the Drinkard and Abo (figure 5) shows some general wall loss due to corrosion. A change in casing weight at 6698' can be identified by the caliper change in track 1 and the shift in casing profile in track 2 and 3. Locating changes in inner casing diameter is important when selecting the size of the rubber elements for injection and treating packers. This information is sometimes lost over time and a log or caliper survey is the only way to reacquire this data.

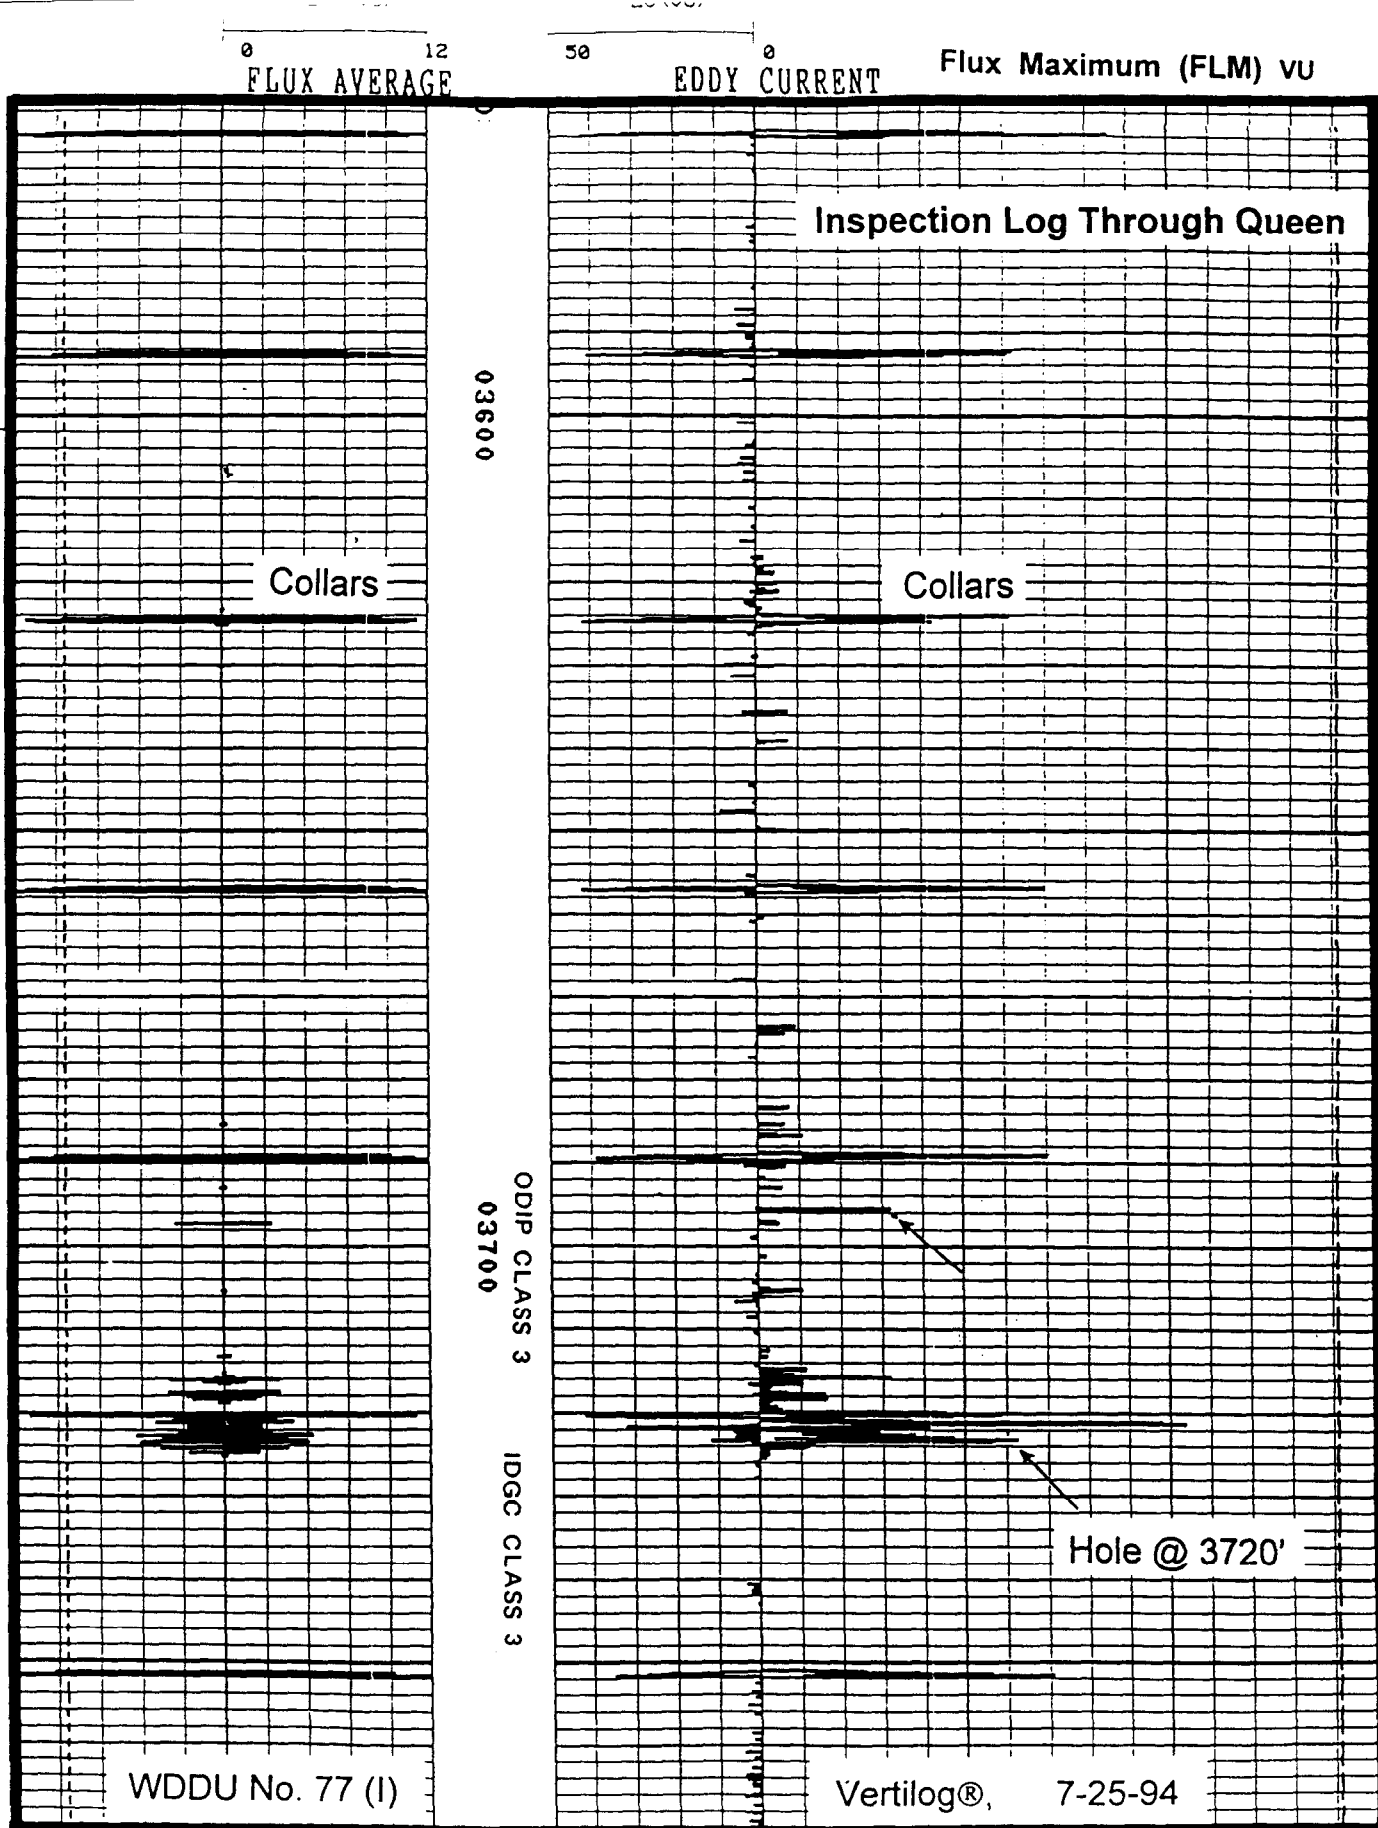
Figure 6

1. The flux maximum curve (FLM) through the Queen in figure 6 shows significantly larger defects than the eddy current track. This indicates the corrosion originated on the outside of the casing.
2. The flux average curve indicates the hole at 3720' covers less than one third of the casing circumference.
3. The recorded depth of the liner top was questioned after tagging up on a possible hanger at 5755'. After drilling junk out, the top of the liner appeared to be at 5893'. The production casing, liner and drill bit size are drawn on figure 7.
4. The caliper curve shows holes in the production casing and the profile confirms that a significant part of the total injection is being lost in the upper Tubb.
5. Noise on the collar locator curve also confirms the poor condition of the liner.

The liner was pressure tested but would not hold. Since there were casing holes in the Queen interval, the liner was not repairable and an offset well was available for conversion, this well was abandoned. In this example, an injection profile log was able to provide sufficient information for the team to make a decision on remedial options.

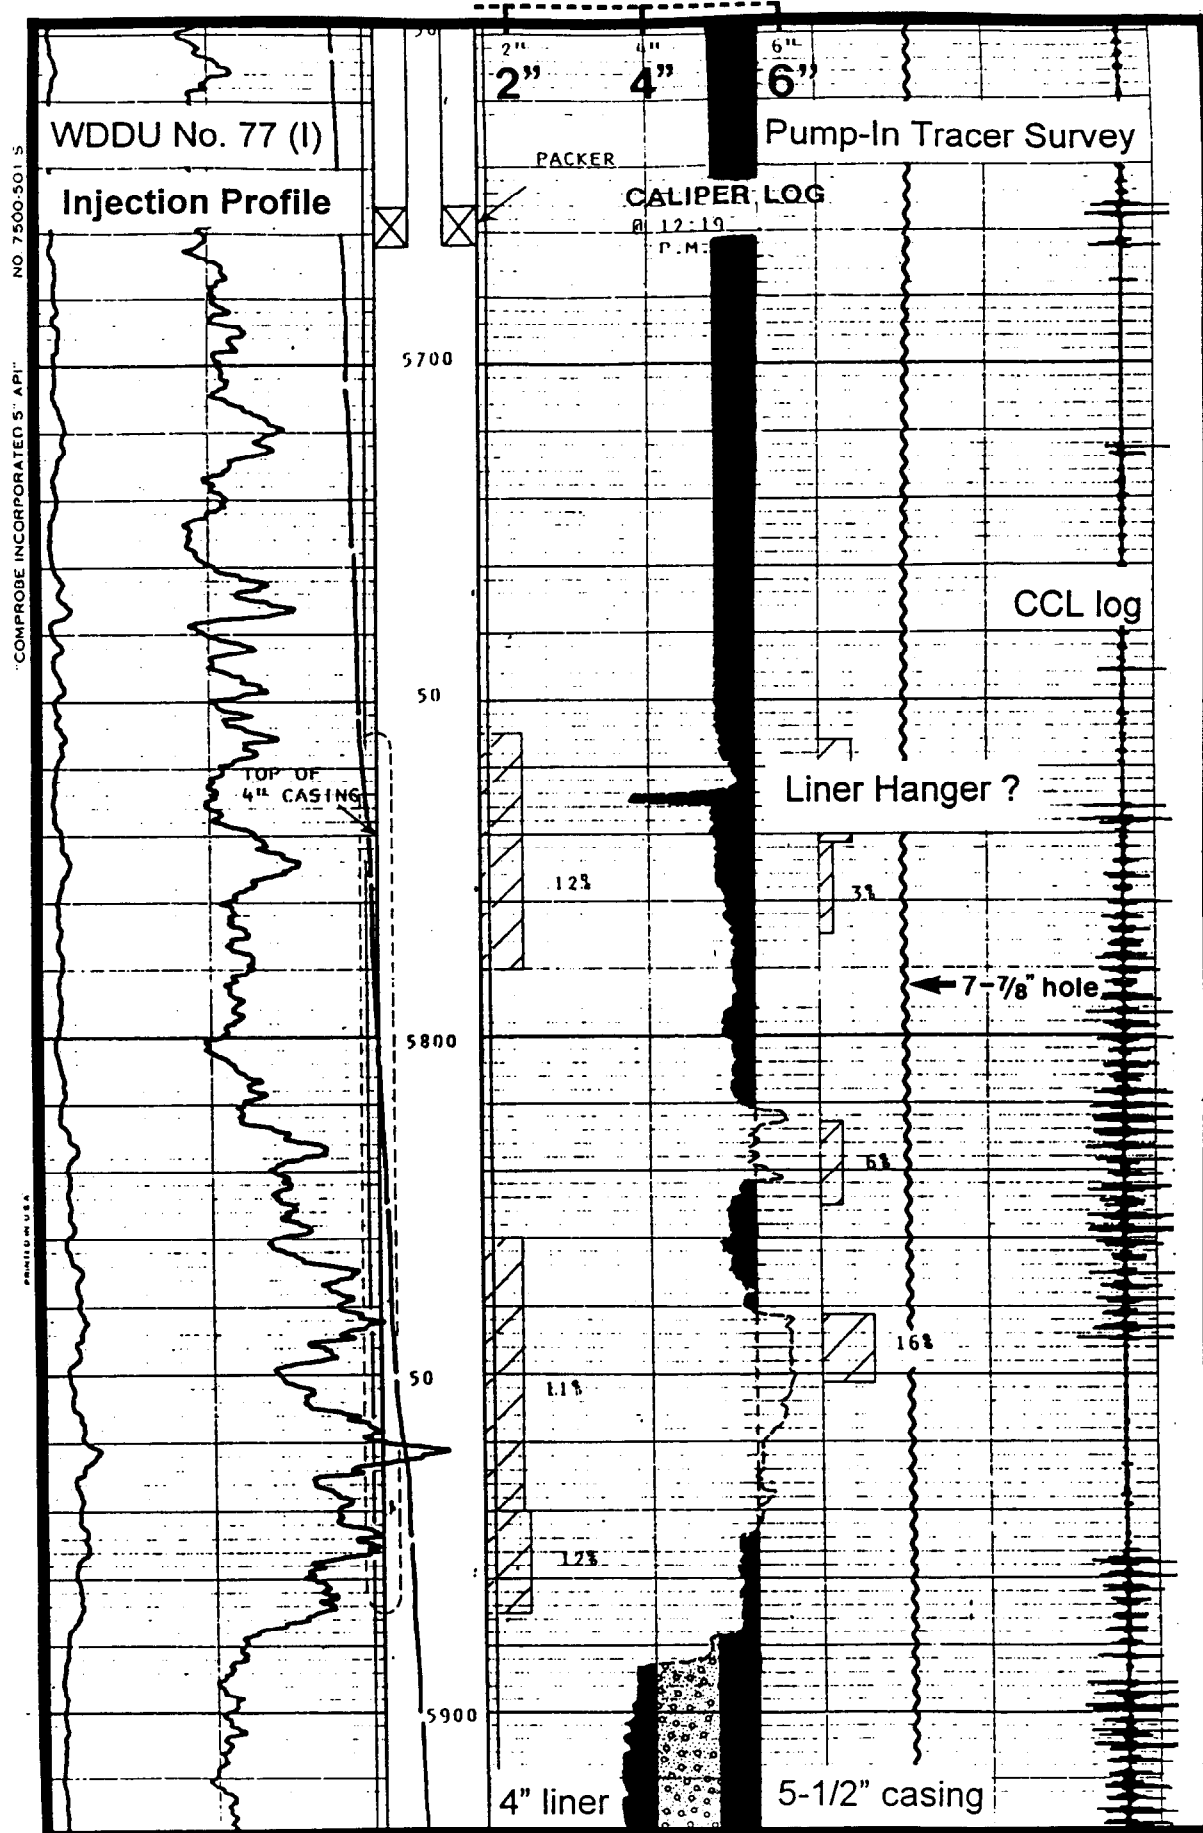
Figure 7

WDDU No. 77 was drilled in 1954 as an open hole producer with production casing set at 6480'. In 1969, it was converted to injection with a packer set at 5776' and injection into the Tubb, Drinkard and Abo. After channeling developed in the Tubb and Abo, a liner was run in 1971 from 5918' to 6879' and the Drinkard and Abo were perforated. In 1972, the Abo perms were abandoned and the packer was set in the liner at 6050'. In 1977, cement was circulated across the Queen to the surface and the packer was reset above the liner top. In 1993, the well was shut in after the seals failed in the injection packer. The packer, junk and heavy scale were drilled out of the liner to TD. A casing inspection log (figure 6) was run from the liner top to the surface. A few casing holes were located in the Queen interval. An inspection log was not run through the liner because of insufficient inside clearance. A new packer was set above the liner top and an injection profile was run (figure 7). Several important observations can be made from the injection profile and log.

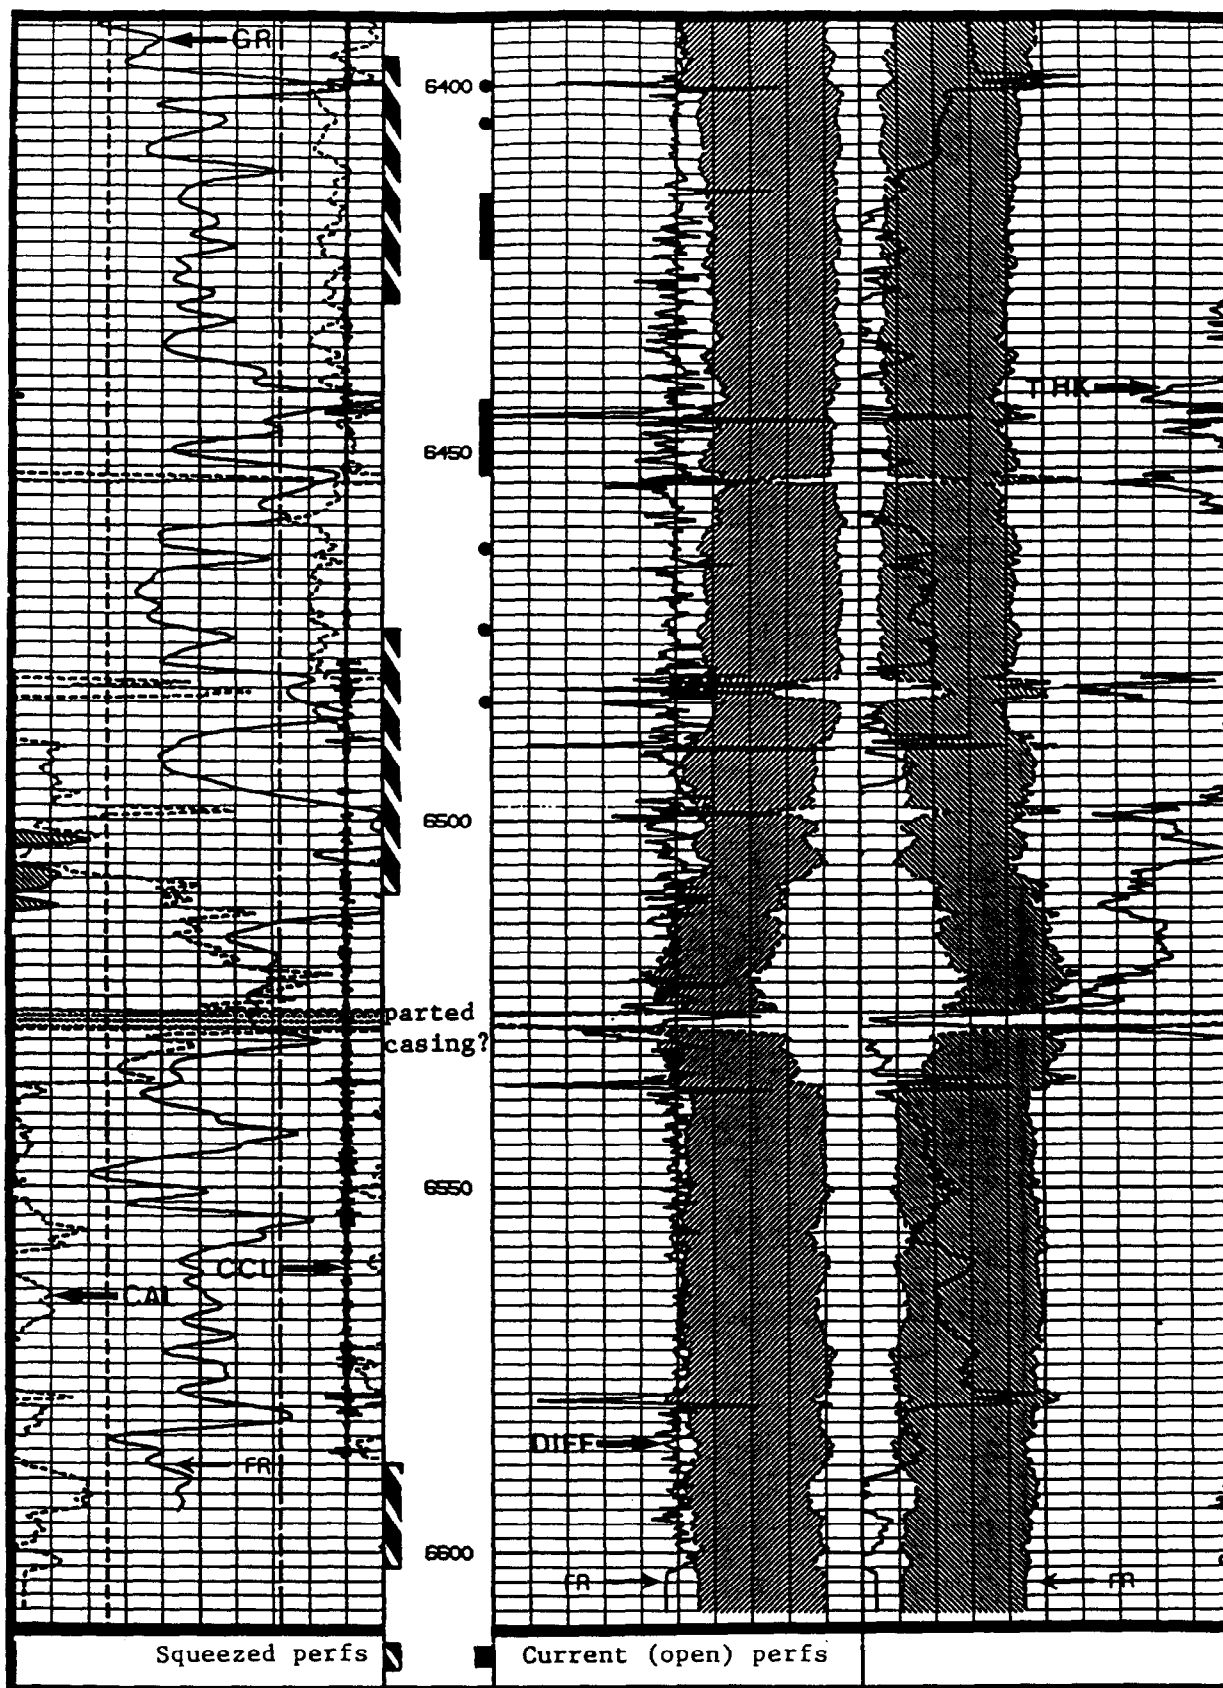
Figure 8 - WDDU No. 32: Casing Inspection Log Through Drinkard Section

1. The caliper backs up to the right in track 1 of figure 8 indicating holes through the casing. The dark gray shading below 6500' is a backup of the gamma ray curve. Natural radioactive scale (NORM) has accumulated where significant fluid production has occurred over time.
2. Tracks 2 and 3 show obvious thinning of the casing wall, especially around the parted casing at 6527'. The differential and thickness curves also confirm holes in the casing.
3. The above corrosion effects are all within the primary Drinkard injection zone. Except for injection losses through the parted casing, none of the casing defects should impair the injection conformance.
4. The log of the Queen section in figure 9 shows the same features as the Drinkard section. The gamma ray backup (GR) shows hot streaks from fluid movement behind pipe and the other curves indicate several holes.

The casing above the injection packer must pass a mechanical integrity test prior to starting injection. Between acid stimulating the Drinkard, setting the packer and circulating packer fluid, the casing was successfully tested four different times from 250 psi to 375 psi. The packer was reset and water injection commenced. Pressure developed on the annulus soon after and the injection packer and tubing were pulled.

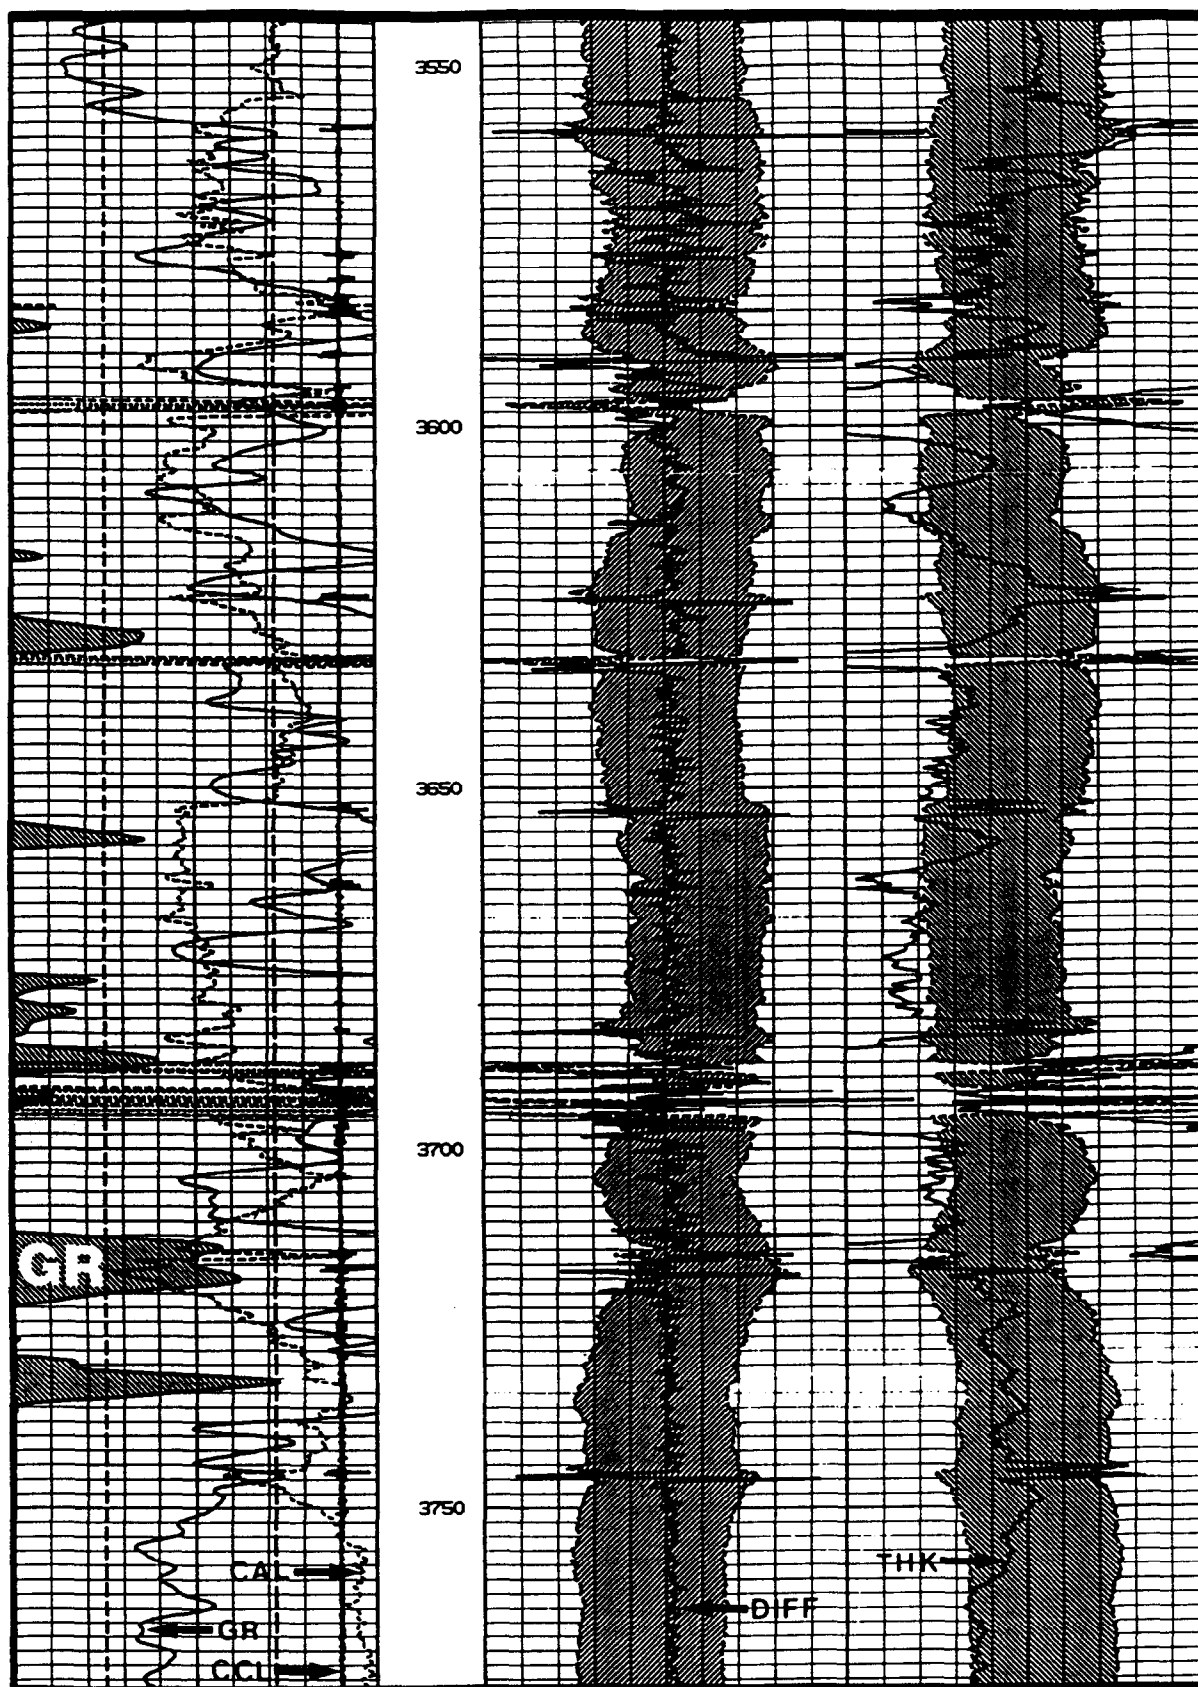
Figure 9 - WDDU No. 32: Casing Inspection Log Through Queen Section

WDDU No. 32 was drilled in 1953 as a cased hole producer with 5-1/2" casing set at 6959'. The primary cement top was below the Queen zone at 4030'. In 1974, the braden head was squeezed to stop an annular water flow. A Queen casing leak from 3636' to 3825' was squeezed twice with a total of 500 sacks of cement. During an injection conversion workover in 1993, a log was run from TD to the intermediate casing at 3131'. As expected, the casing in the Drinkard interval (figure 8) showed extensive internal and external corrosion and possible parted casing at 6527'. The log also identified several holes in the casing across the previously squeezed Queen interval (figure 9). The casing was also swaged out from 3703' to 3722'. From the two figures, the following observations should be noted.

A treating packer and retrievable bridge plug (RBP) were unable to hold a seal across and above the Queen from 3170' to 3740'. The log shows that the casing above 3520' appears to be in good condition. The differential and caliper curves do not indicate any pitting or holes. A retainer was set at 3170' and the

casing down to 3740' was squeezed with 200 sacks of class "C" cement. The cement was drilled out to 3670' and the subsequent casing test failed. A second retainer was set and the same interval was resqueezed with 200 sacks. The cement was drilled out to 3491' and the casing was successfully tested to 1000 psi. The log indicated that the casing above the Queen was in good condition and the packer test confirmed this. The previous test above 3491' may have failed due to damage to the rubber elements in the packer or RBP. The remaining cement was drilled out to 3616' and the second packer test failed. The squeezed cement does not appear to have reached the holes shown on the log from 3688' to 3696'. If the retainer had been set closer to the top of the Queen, the cement squeeze would have had a better chance of success. WDDU No. 32 would have supported just one offset well so the team plugged it. If the well is reentered in the future, the log will provide sufficient information to restore mechanical integrity to the casing.

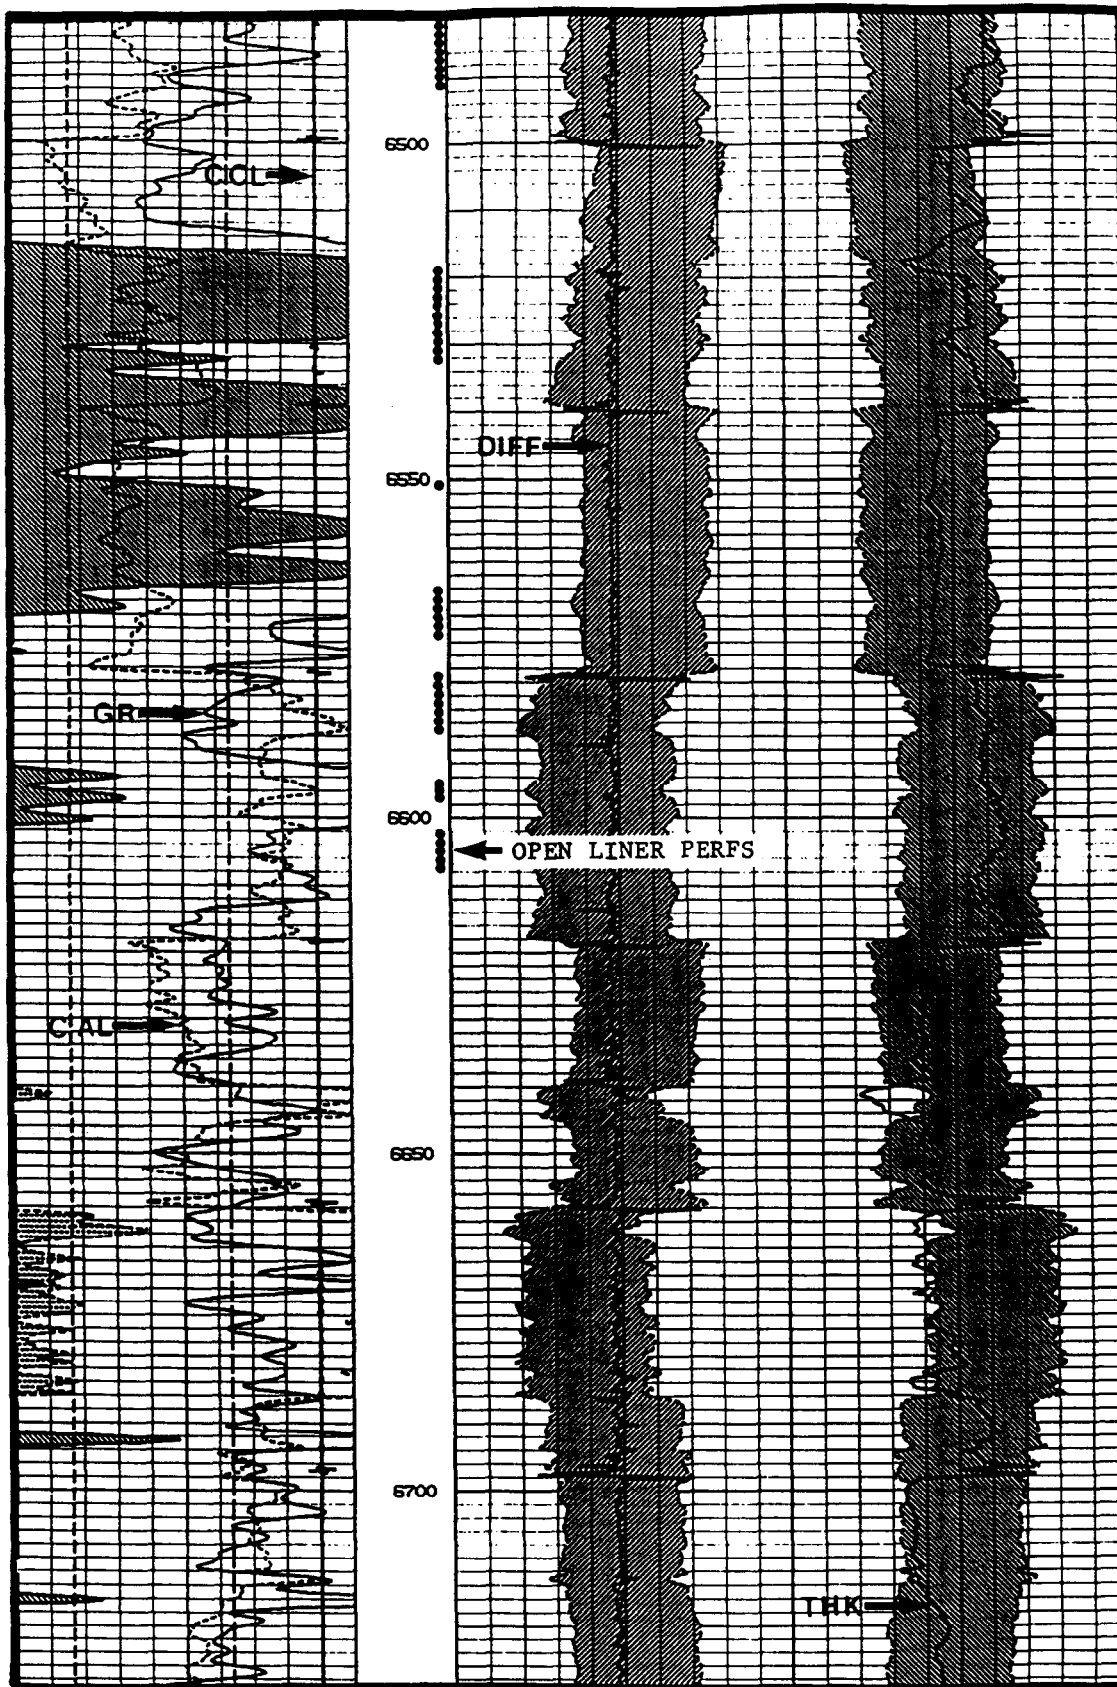
Figure 10 - WDDU No. 56: Casing Inspection Log Through Drinkard Interval

1. The liner below 6500' shows increasing internal and external corrosion. Distinct changes in the diameter of the liner joints are evident. This was seen on other logs and is not very unusual considering the time period. During the early 80s, casing and tubulars were often in short supply and non-API grades were used if available. The differences in weight are sometimes severe enough to prevent a good packer seal. This is important since a poor packer seal is often mistaken for a casing leak, resulting in unnecessary packer trips.

2. The differential and thickness curves are relatively smooth indicating a low corrosion environment. The gamma ray backup reflects water movement through the main Drinkard floodable pay zone.
