## CASING INSPECTION LOGS HELP PLAN WATERFLOOD RE-DEVELOPMENT

Robert T. McNaughton, Texaco Exploration and Production Inc.

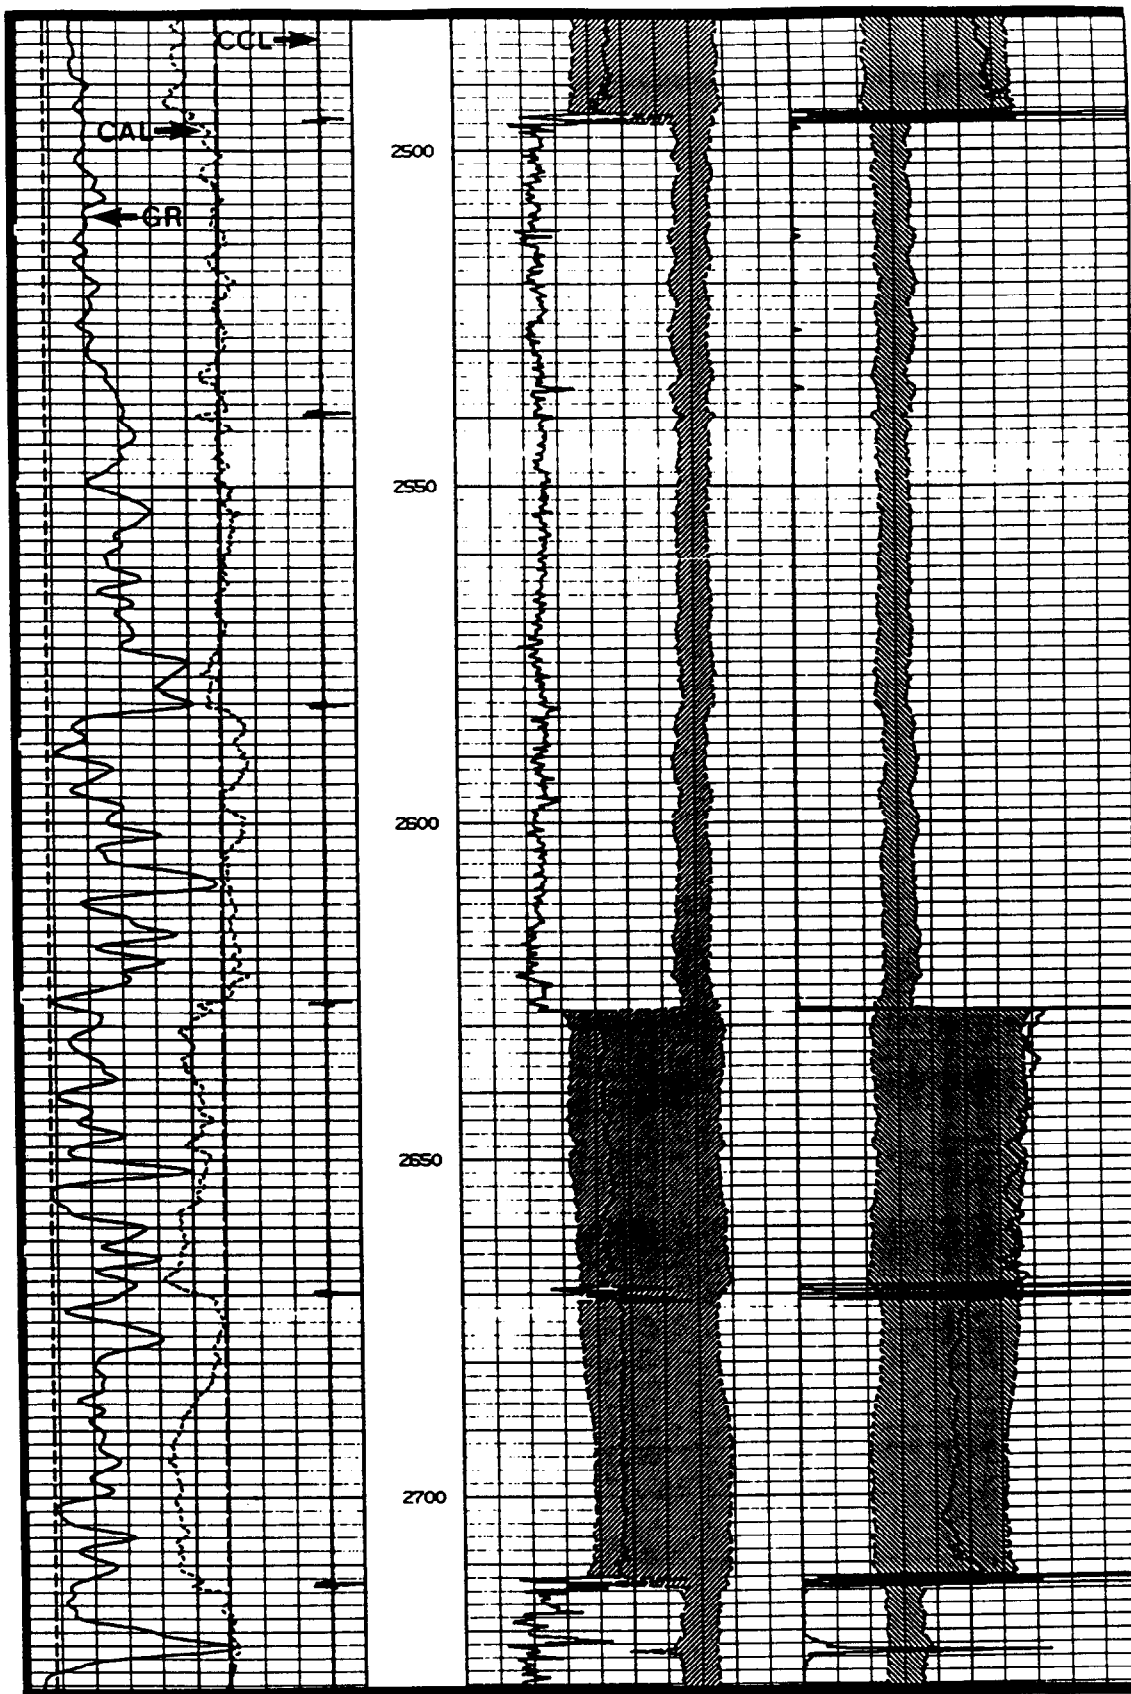
Figure 11 - WDDU No. Casing Inspection Log Through Salt Section

3. Figure 11 is a log section of the 7" uncemented casing across the salt section. The loggers interpreted this as evidence of severe external corrosion. Notice that most of the sharp reductions in wall thickness are adjacent to collars.

4. Sometimes the logs exhibit characteristics that are difficult or impossible to interpret. In this case, the service company engineers speculated that this extreme wall loss may be evidence of substandard casing construction. Overall, the differential, thickness and caliper curves are exceptionally smooth so the casing should pass a pressure test.

This example makes a good case for reliability engineering. No problems were encountered during the injection conversion and the casing will probably last for some time. However, external corrosion will continue until cement is circulated behind the casing. Comparison of the base log to a later log allows the operator to plan future remedial work. The cost of inspection logs is a minor part of a workover, especially when other logs will be run. Saving one well from premature abandonment will pay for a lot of data acquisition.

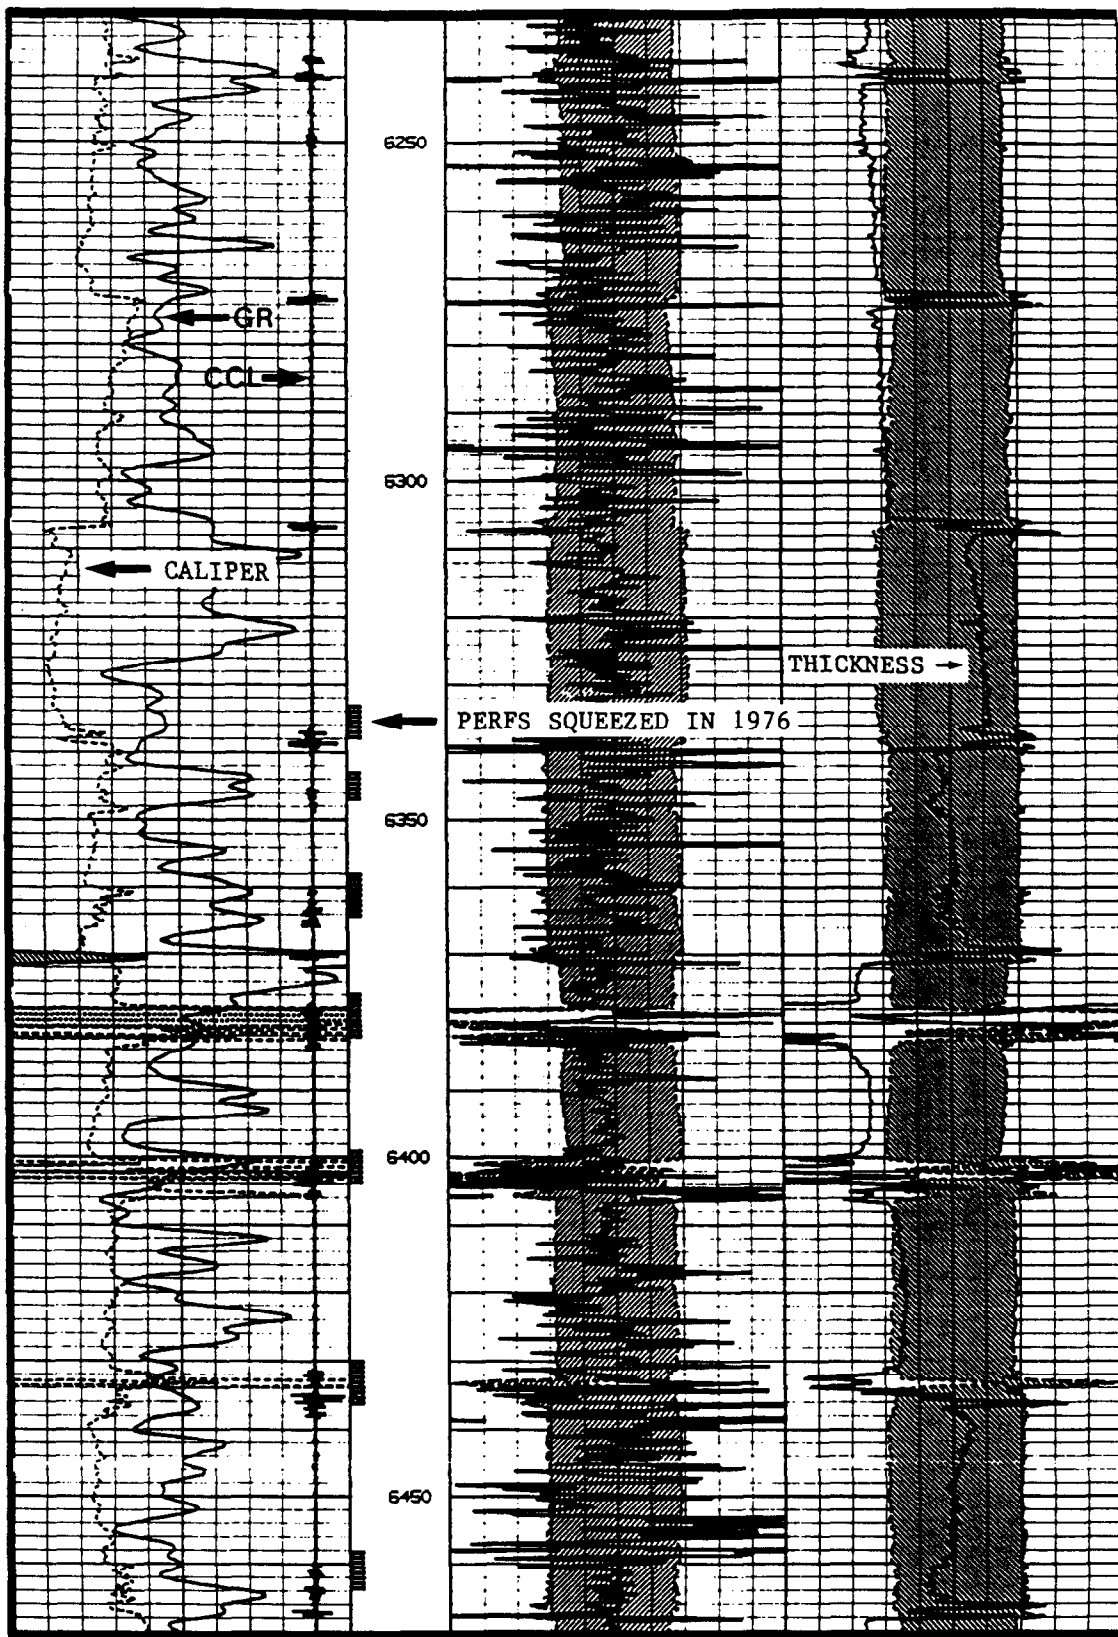
Figure 12 - WDDU No. 37: Casing Inspection Log Through Tubb Interval

1. The caliper in track 1 indicates several distinct holes in the Tubb casing and two major gaps in the Drinkard casing. The gamma ray backup accurately defines the main floodable Drinkard pay zone.

2. The holes in the Tubb were caused when the old squeezed perfs were washed out.
3. The constant width of the shaded casing profile in track 2 and 3 shows that overall casing condition through the Tubb is good. The differential curve in track two indicates that there are numerous small pits in the inner casing wall. The same curves through the Drinkard confirm that about 55' of casing has completely corroded away.

5. Packer tests confirm that the isolated Tubb holes were partially squeezed off. A treating packer set above the Drinkard held long enough for the acidizing. But injection water eventually leaked by the packers set above the Tubb and Drinkard.

The team decided that resuming injection with the packer set above the Tubb was the best option. Although the Tubb perfs will take some fluid, the pattern will still receive adequate pressure support. Comparison of the inspection log with future injection profiles should indicate when more remedial work is necessary. The analysis will help monitor terminal casing damage from corrosion, especially if a caliper is run with the profile.

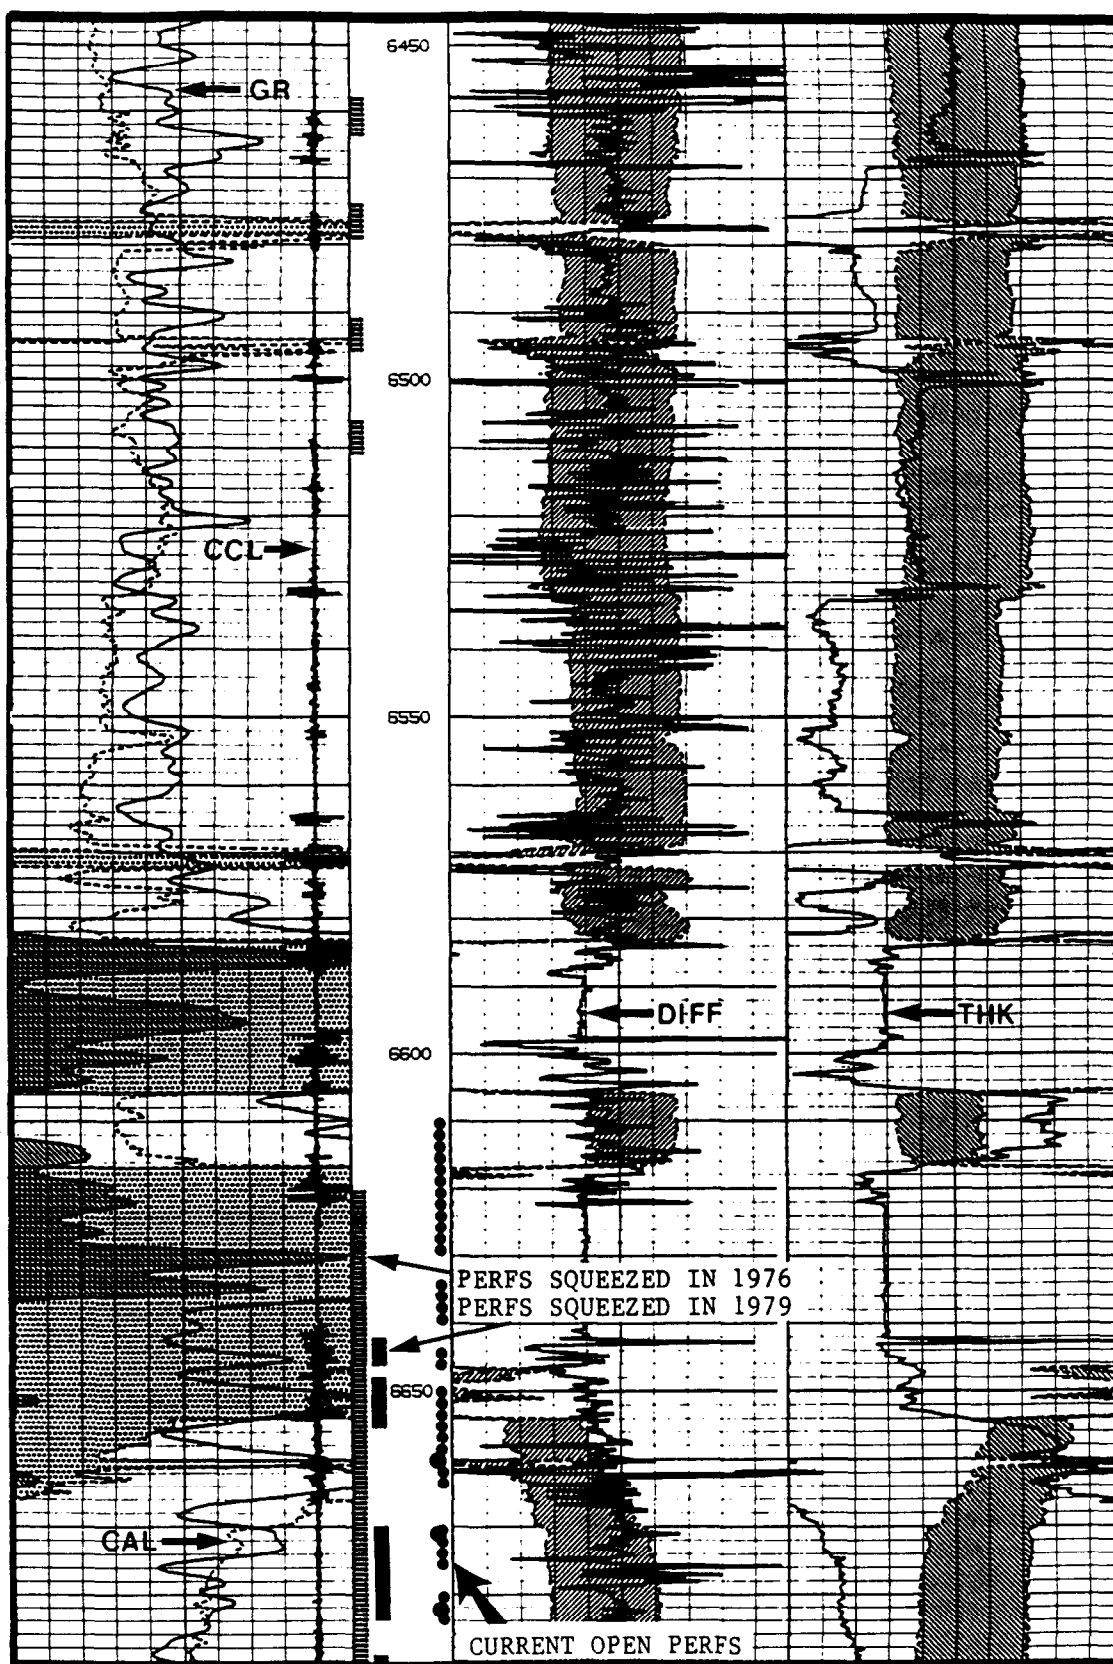
Figure 13 - WDDU No. 37: Casing Inspection Log Through Drinkard Interval

4. The lost casing is within the intended injection zone and should not affect conformance. Profile modification is not necessary and probably impossible without running a liner.
