USING POLYLINE TUBING IN A WEST TEXAS FIELD TO MITIGATE TUBING FAILURES, A CASE HISTORY

Kent Gantz
Schlumberger IPM

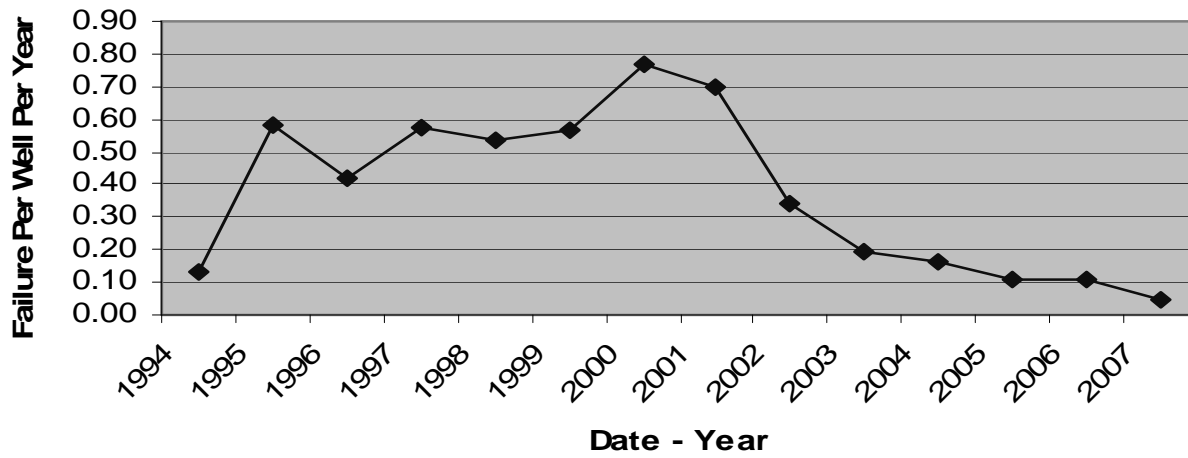
Graph 1 depicts the well failure rate for tubing failures for 37 wells, of which 33 are of the McKnight zone

(abbreviated McK). Beginning in 1994 and ending in 2007, all tubing failures experienced by these wells are depicted with a 1. When bare tubing was used, a failure was denoted by a "1". If polylined tubing was installed "1" depicts the failure. If polylined tubing were installed during a workover a "WO" is depicted. If a partial string of polylined tubing was installed a "1/2" is depicted, where a "1/2" is followed by another "1/2", then the partially lined tubing string failed (see Legend for Table 3). Some wells did not exist or were not producing early on, so the years that the well did not exist are grayed out. For each year the population of lined tubing strings are tallied and shown at the bottom of the Table. The failure per well per year statistics for each year are at the bottom of Table 3, and are depicted by Graph 1. Between 1994 and 2001 the average failure rate per well per year was 0.53, peaking at about 0.7 in the years after the price of oil fell, but improving year after year afterwards to a low of 0.05 failure per well. This graph demonstrates that the use of polylined tubing had a significant effect on the tubing failures of many wells equipped with it. It also identifies wells that have had some failures. In each case, however, the number of joints of failed tubing is small, usually due to external corrosion.
