METALLOID COATING TEST PROGRAM FOR SUCKER RODS IN CORROSIVE WELLS

Kent Gantz, Schlumberger IPM
Anthony Rallis, Aliron Tool Research

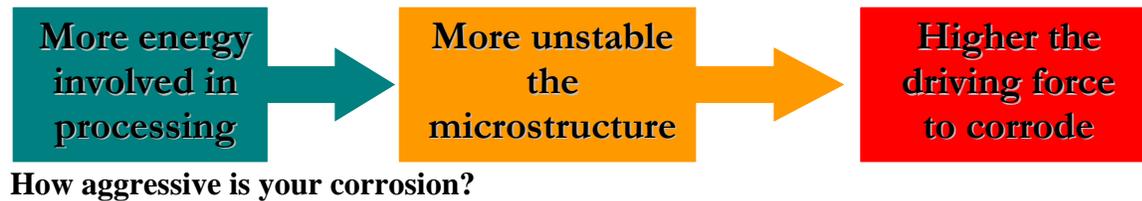
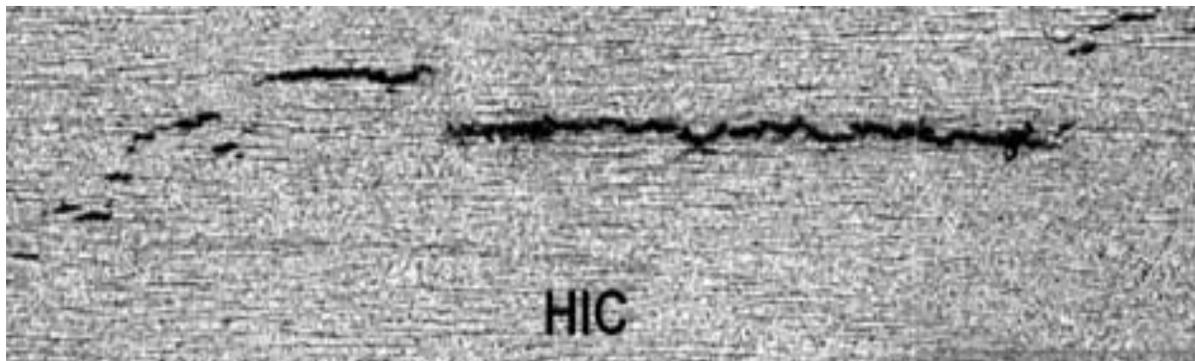
Figure 1- Photomicrograph of Hydrogen Induced Cracking [HIC] and stepwise cracking caused by hydrogen embrittlement [HE].

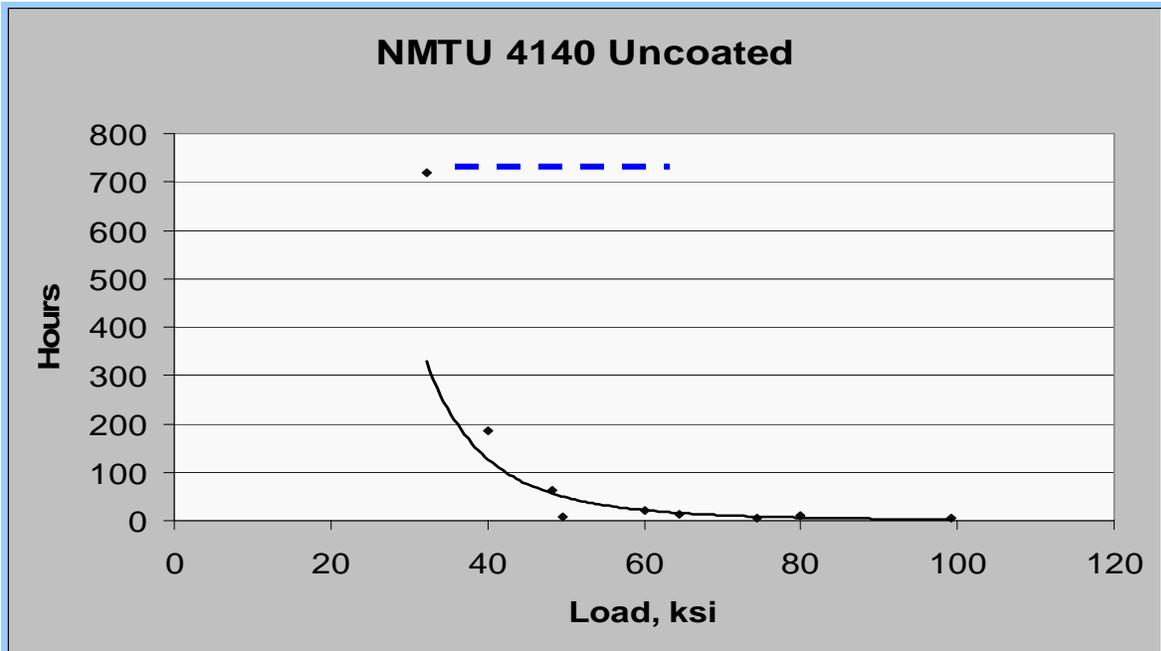
Graph 1 - NMTU TM01-77 Test Results: Test results for the 4140 samples show an immediate degradation of strength shortly after loading. No coated samples failed [blue dashed line].

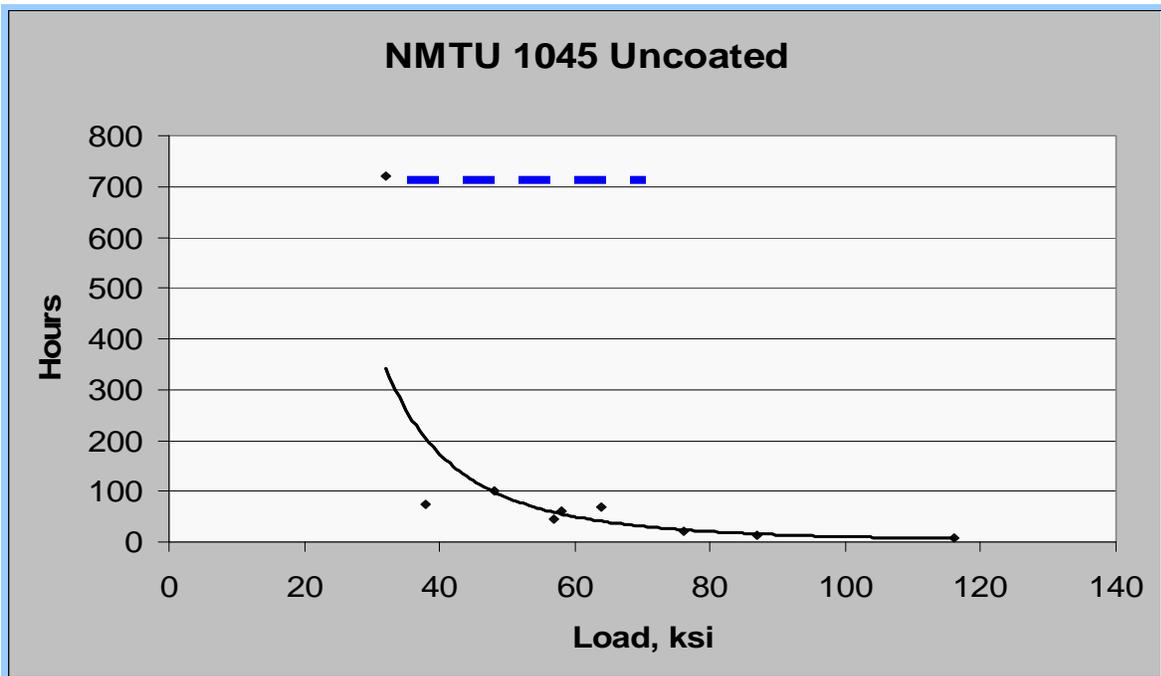
Graph 2 - NMTU TM01-77 Test Results: Test results for the 1045 samples show an immediate degradation of strength shortly after loading. No coated samples failed [blue dashed line].

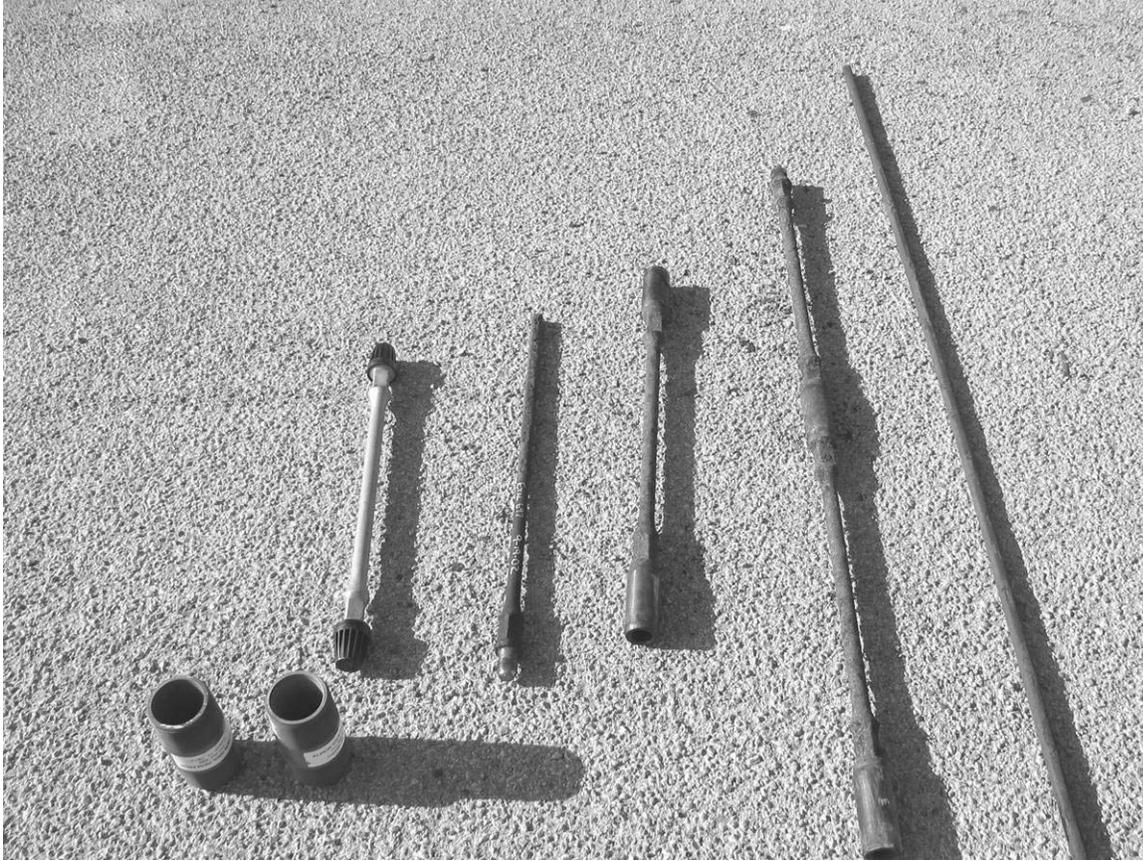
Figure 3 – Samples from field test. Beginning at lower left to right: 2 – 2 7/8" x 6" J-55 tubing nipples (not used), 7/8" x 2' UHS rod sub w/ new metalloid coating, 3/4" UHS rod sample removed from Well 697 9-19-2002, 7/8" x 2' UHS rod sub w/ metalloid coating after use in Well 697, 2 – 7/8" x 2' UHS rod subs, 3/4" UHS bare sucker rod sample.

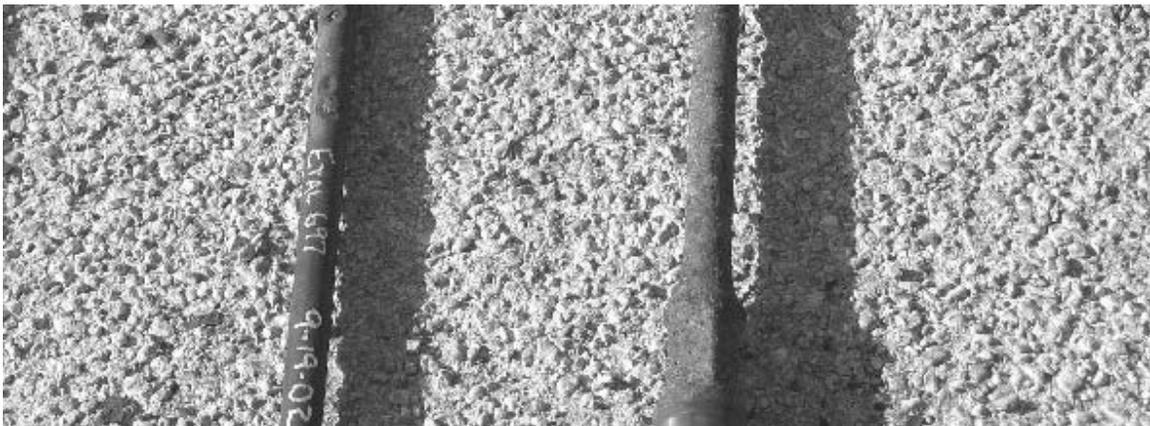
The pony rods were cleaned and found to be intact, no pitting. The bare rod had suffered from corrosion, and spalling. The spalling pattern was along a wear line, but main cause of metal loss was spalling of the hard outer layer. The outer layer of the ultra high strength sucker rod is heat treated by induction during manufacturing and this process hardens the outer surface to about 50 HRC whereas the core hardness is usually about 30 HRC. This process forms a compressive case about 0.050 in thick. Visual inspection of the surface shows rod failure caused by very heavy corrosion damage. It appears that corrosion activity caused hydrogen embrittlement of the hardened case and subsequently caused spalling, greatly compromising rod string integrity. See Photos 3, 4, and 5.

Figure 4 – Closeup view of 3/4" UHS bare rod sample from Well 697 removed 9-19-2002, showing heavy pitting along a wear pattern. Also, shown is coated 7/8" UHS rod sub, with oxidized FeS scale still intact, after removal on May 6, 2004.

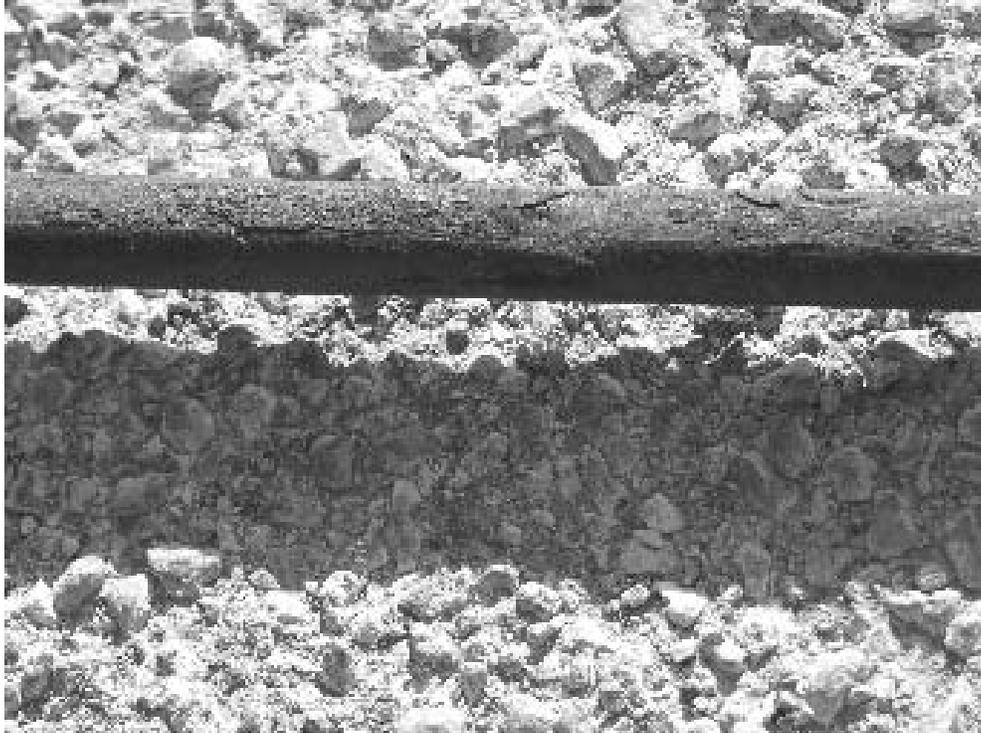
Figure 5 – Close up photo of $\frac{3}{4}$ " UHS bare sucker rod sample showing spalled metal flaking from rod body, along a wear pattern. Rod sample taken from Well 697 with the coated pony rods on May 6, 2004, after being in well about 5 months.

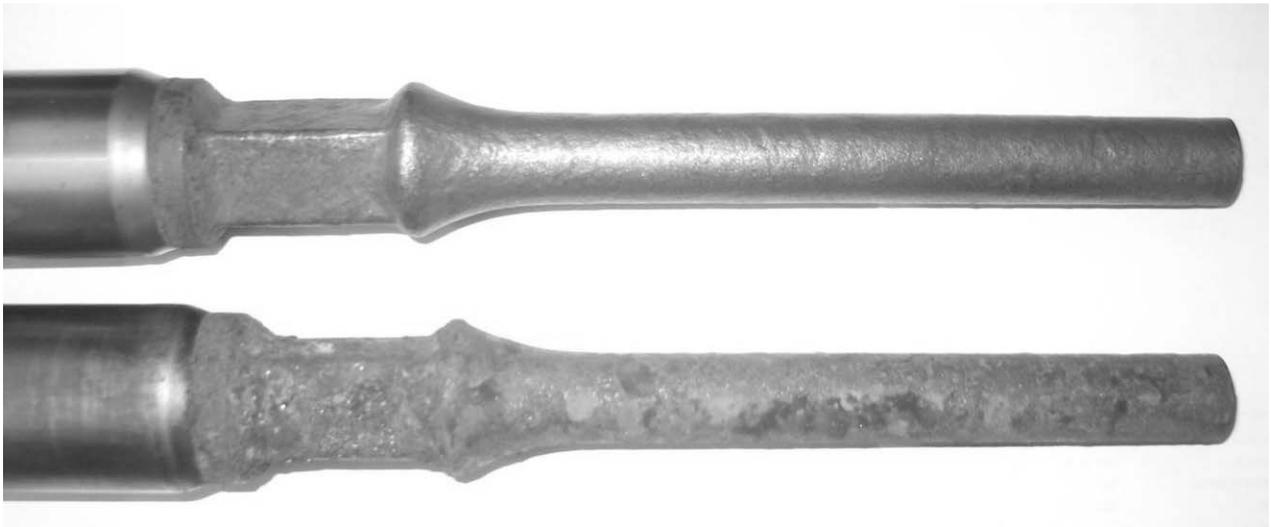
Two 3/4" pony rods were in the Clearfork well for over 1 year, and was removed during a pump job. That well did not have the corrosion anticipated, and later it was realized the well produced fluids have very little acid gas in them. A photo of one of rods, cut in half for the photo: one end showing oxidized FeS scale still on it, and one end "shot" peneered to expose the metalloid underlying the scale. Note the "silvery" gleam.

Figure 6 – $\frac{3}{4}$ " x 2 ft UHS pony rod, after being cut in half. The bottom half showing oxidized scale on it, and top half after "shot" peening. The pony rod ran for over 1 year. The majority of the metalloid coating appears in tact.
