# A WEB-BASED FAILURE DIAGNOSIS AND FREQUENCY REDUCTION SYSTEM, FEATURING IMAGING OF ROD-PUMPED PRODUCING WELLS

John Rogers and Simon Ward  
VisuWell

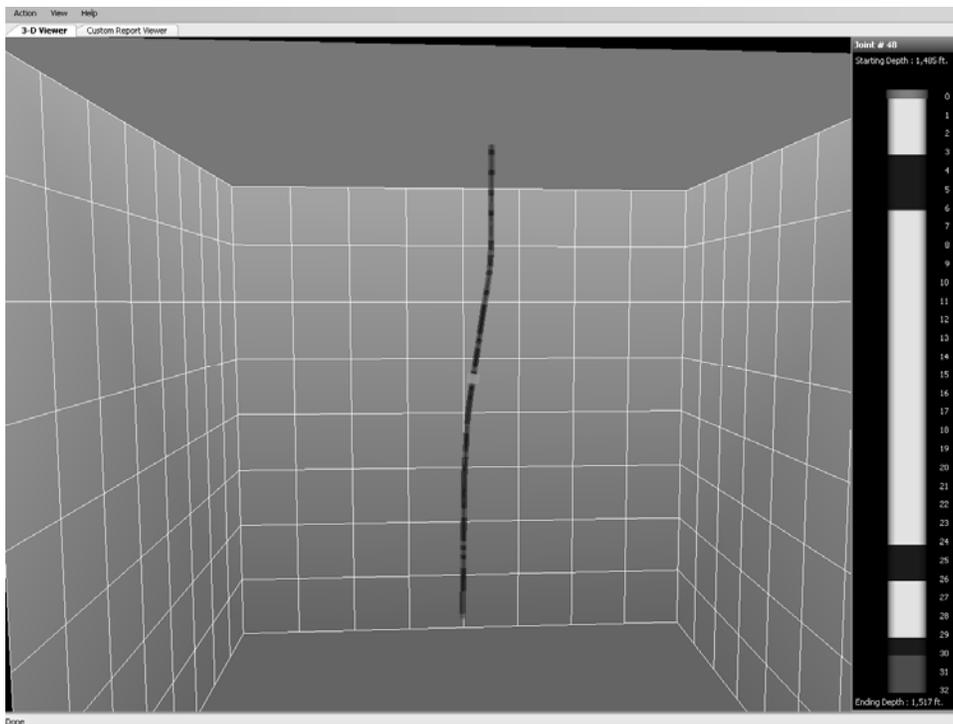
Many wells drilled as “straight holes” have doglegs that pose severe problems to production staff (Figures 2 & 3). This phenomenon can be worsened by the nature of the drilling contract as deviation often occurs as the drilling rate of penetration changes through differing formations. High dogleg severity wells can be difficult to produce with sucker rod pumps and may exhibit high failure frequencies, particularly with corrosion from H<sub>2</sub>S, CO<sub>2</sub> breakthrough or high water cuts<sup>12</sup>. In such conditions, dynamic loads can cause rapid wear-corrosion, abbreviated fatigue life and premature failure.

Figure 2 – Deviated Well with Worn Tubing at Top of Hole

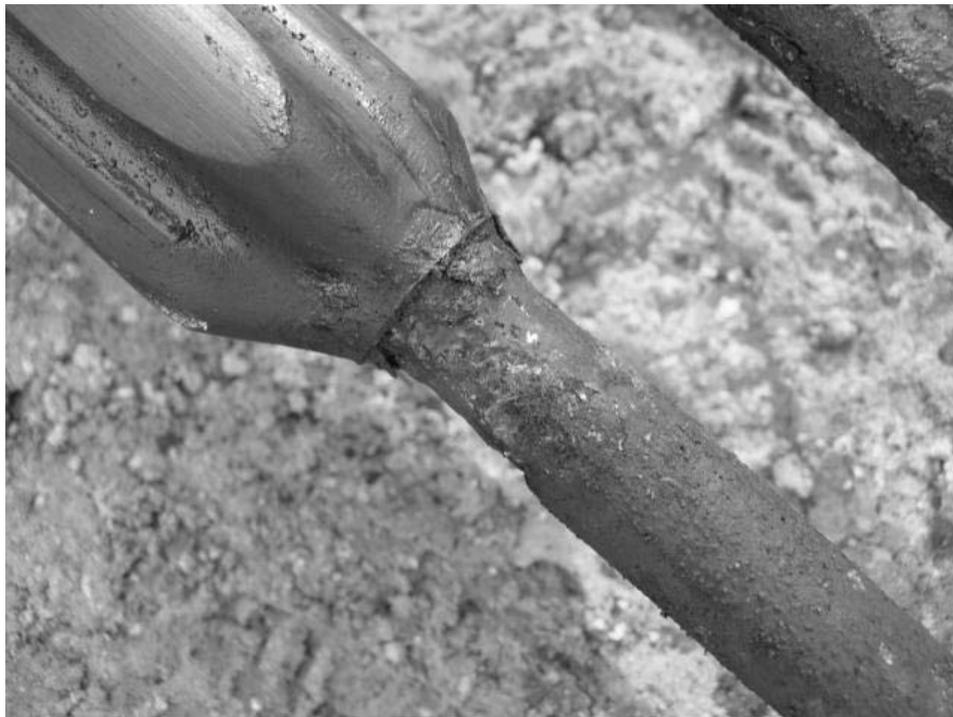
A Permian Basin well was completed in July 2007 in the Spraberry Trend. The TAC was set at 7,954 ft and the pump initially at 9,200 ft. By November of 2007, the well had experienced three hole-in-tubing failures for an aggregate FPWPY of over 9. All three failures had occurred between 7,700 and 8,000 feet MD. As a result of the two early failures, the operator moved the pump up to 8,042 ft, closer to the TAC. Thereafter the well failed a third time, again in the same zone. Upon performing a VisuWell analysis, it became clear that there were two distinct zones of high side load in the well, one from 6,369 ft to 6,420 ft and a second zone from 7,912 ft to 7,968 ft. (Figure 13). In order to prevent further tubing wear, the operator installed rod guides from 500 ft above the upper zone of high side load to immediately above the pump. Significant H<sub>2</sub>S corrosion was evident in the lower zone on both the rods and tubing, leading to an improved inhibitor program. Guide wear also indicated that the side load required increased guide spacing density (Figure 14).

Figure 14 – Rod Corrosion Detected in Spraberry Trend Well

Note: Wear On One Lobe Of Rod Guide

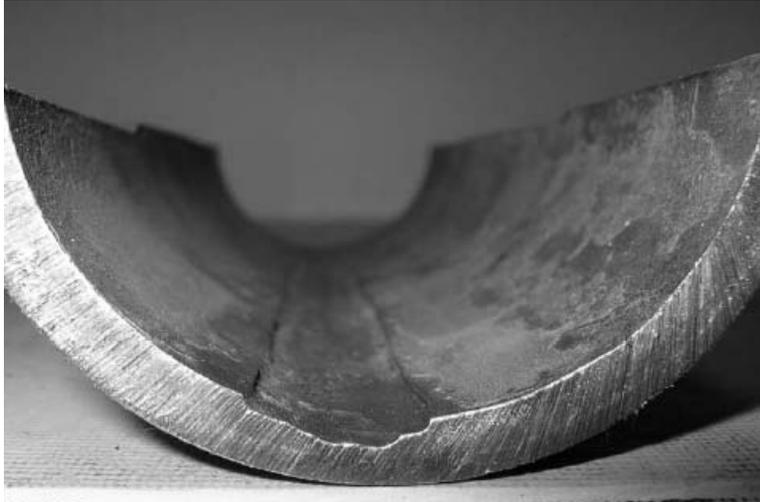
A Permian Basin well was producing from a pump depth of 6,726 ft. A conventional tubing scan had been performed. While running back in the hole, the operator observed significant pin end wear in tubing that had been classified as “Yellow Band” per A.P.I. RP5C1 (remaining wall thickness greater than 85% of nominal). A VisuWell systematic analysis was performed that revealed 13 joints of tubing with wall thickness less than 70% of nominal (“Green Band”) and 2 “Red Band” joints with wall thickness less than 50% of nominal. The joints were destructively analyzed to physically measure remaining wall thickness, corroborating the system wall thickness results within 9.9%. Much of this tubing clearly exhibited classic combination wear-corrosion in extended axial grooves, suggesting that the inhibitor batch treatment program be modified. (Figure 15)

Figure 15 - Typical Wear-Corrosion, Consistent with Inhibitor Wipe & Rod-On-Tubing Wear

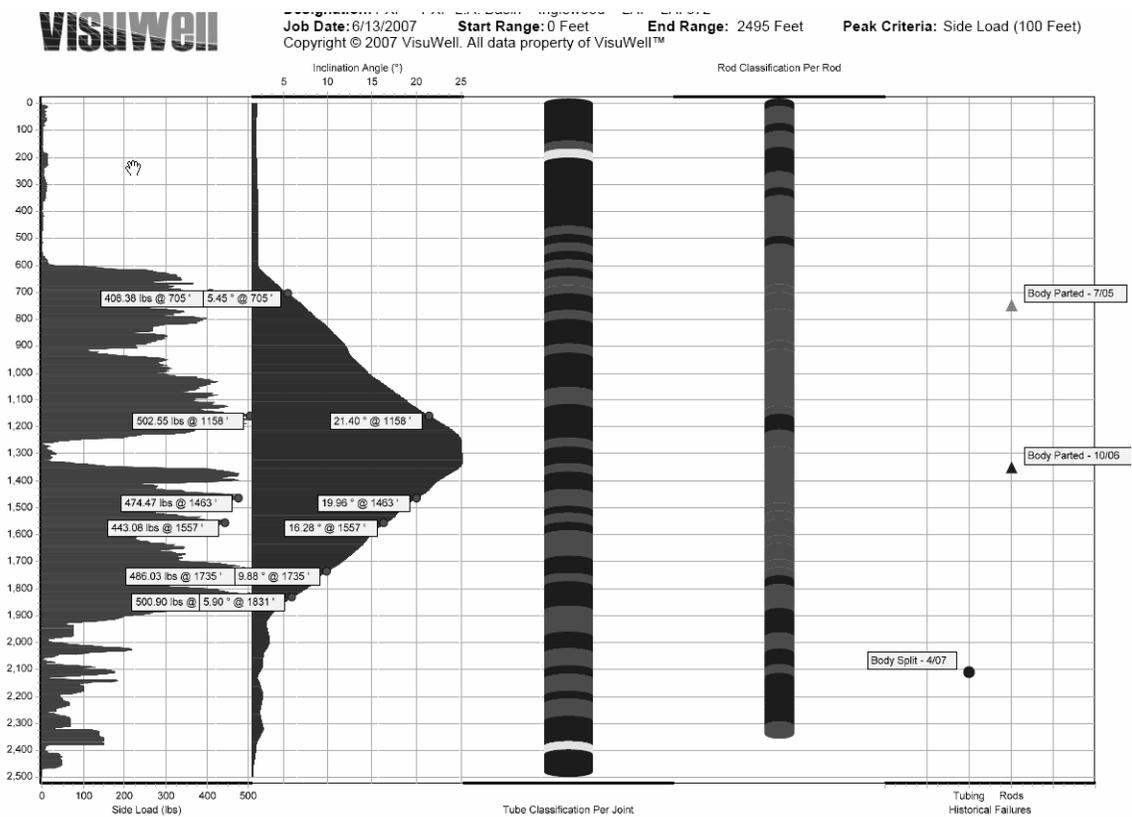
A 2,500 ft directional well in California exhibited two rod failures and a tubing failure, with average run times of 315 days. The failures had occurred at 754 ft, 1,354 ft and the hole in tubing at 2,108 ft. The system revealed that failures resulted from extreme rod body wear in two primary zones of side load over 300lbs from 630 ft to 1,227 ft and 1,330 ft to 1,885 ft. (Figure 16), that would benefit from the use of rod guides. Inclination peaked at 25.1° at 1,302 ft. A rod rotator was also added as a result of the high deviation and data showing that the rod body wear was contained within an 18 ft area spanning the center of the rods (Figure 17).

Figure 16 – Directional Well in California

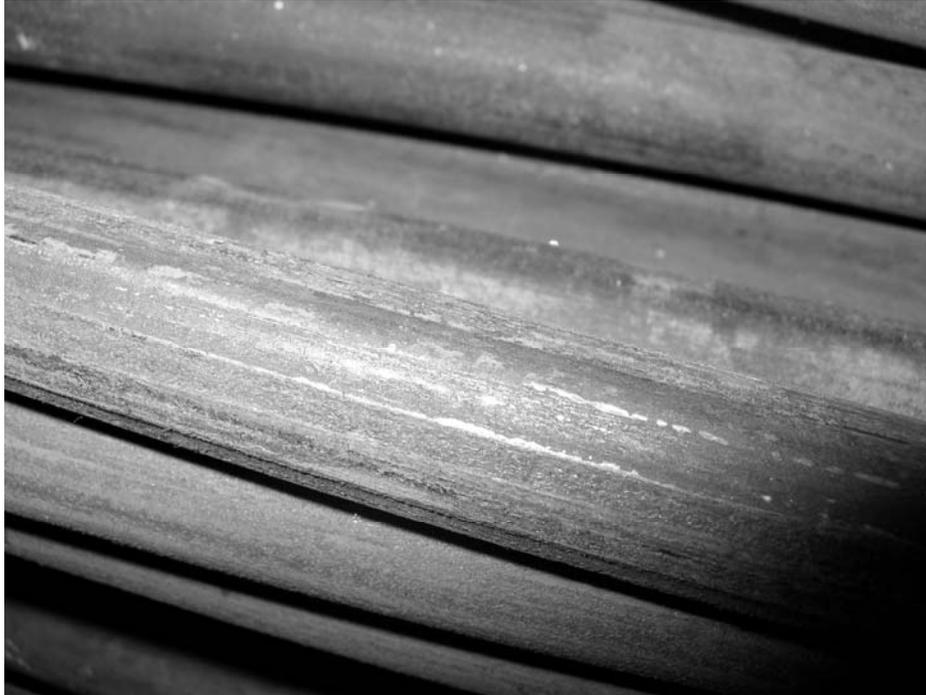
Figure 17 - Sucker Rod Body Wear

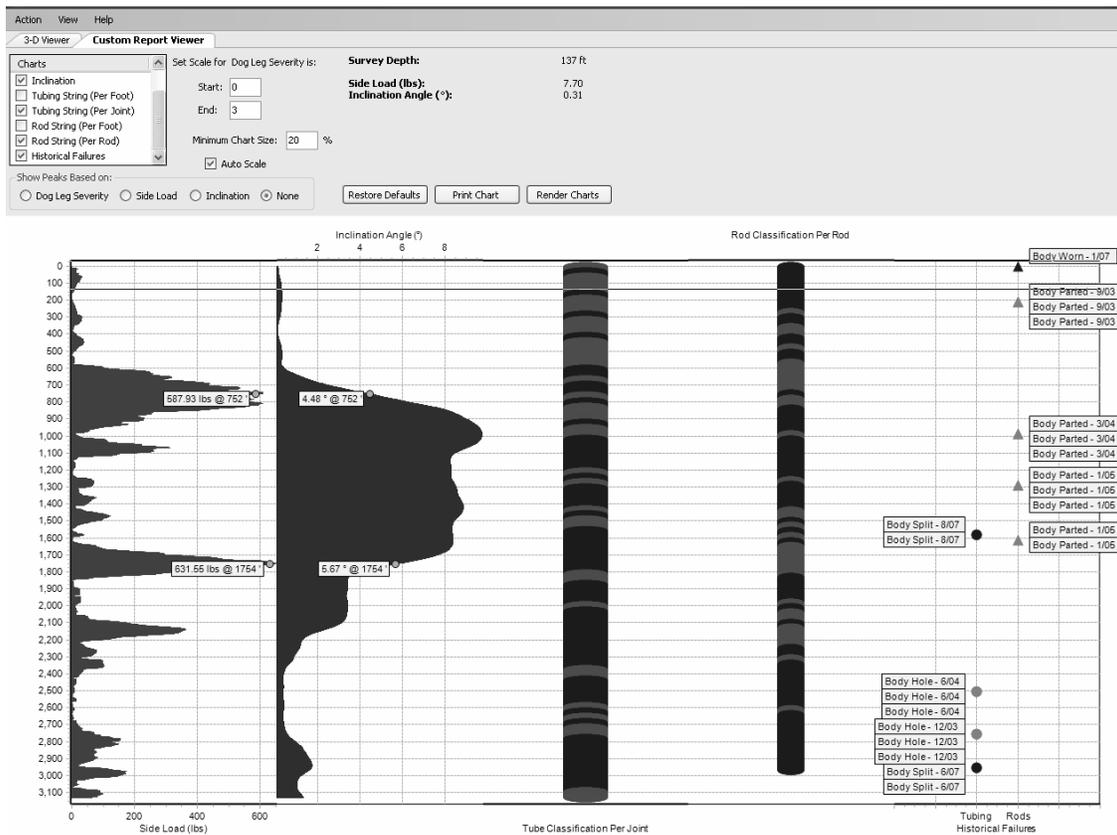
A Permian Basin well was producing from the Clearfork formation with the pump at 7,082 ft. The well had suffered numerous rod body failures at approximately 4,200 ft. A VisuWell analysis was undertaken in late June 2006 that identified inclination of nearly 14° and side load of over 150 lbs beginning at 2,823 ft to 5,552 ft. Maximum inclination was almost 13° at 3,950 ft. As a result, it was recommended that the rod string be guided from 3,000 ft to 6,025 ft.

Figure 18 –Rod Wear Correlating to Zones of Higher Side Load And Tubing Wear in Upper Zone From Rod Buckling

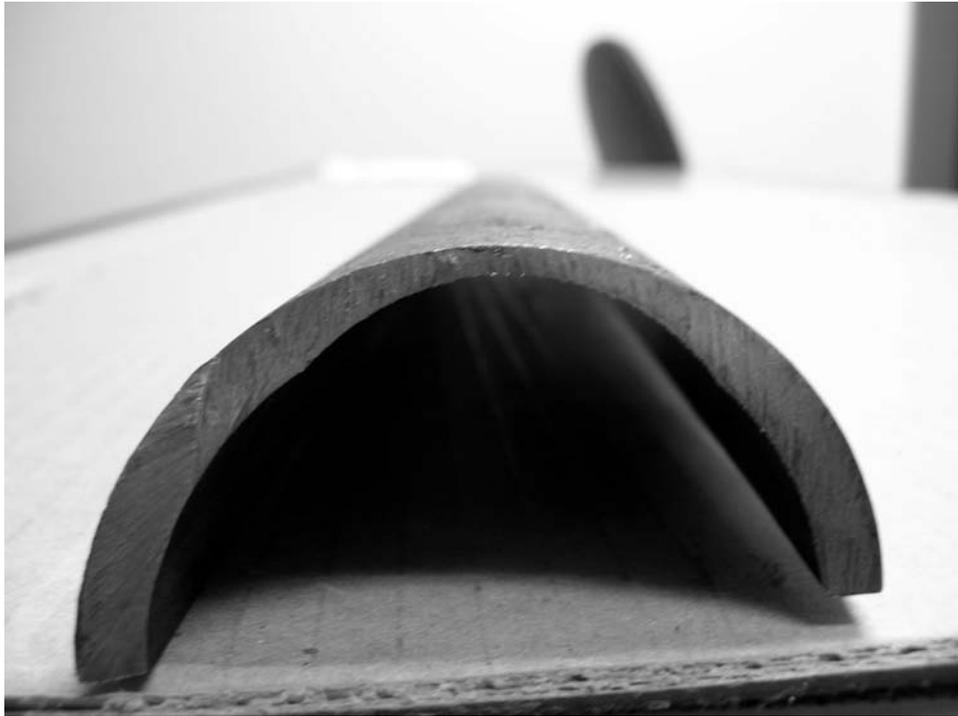
A California well, producing from the Repetto formation at 3,200 ft. had failed 9 times in approximately 52 months, for an aggregate failure frequency of over 2, substantially higher than the field average. In particular, the rod string had failed on three occasions in an interval between 1,000 and 1,600 ft. Tubing had also failed at approximately 1,600 ft. Following a VisuWell analysis, it became clear that there was inclination of greater than 8° from 840 ft to 1,690 ft. The current rod string exhibited wear in two zones from 600 ft to 960 ft and from 1,600 to 1,800 ft. This wear correlated to zones of high side loads exceeding 200 lbs. It can also be seen that wear in the current tubing string was centered around the upper zone of the well above 600 ft, suggesting that the rods were stacking out in compression (Figure 18). Tubing wear is shown in Figure 19 and the failure-causing split from excessive wear in Figure 20.

Figure 19 - Rod-on-Tubing Wear in a California Well

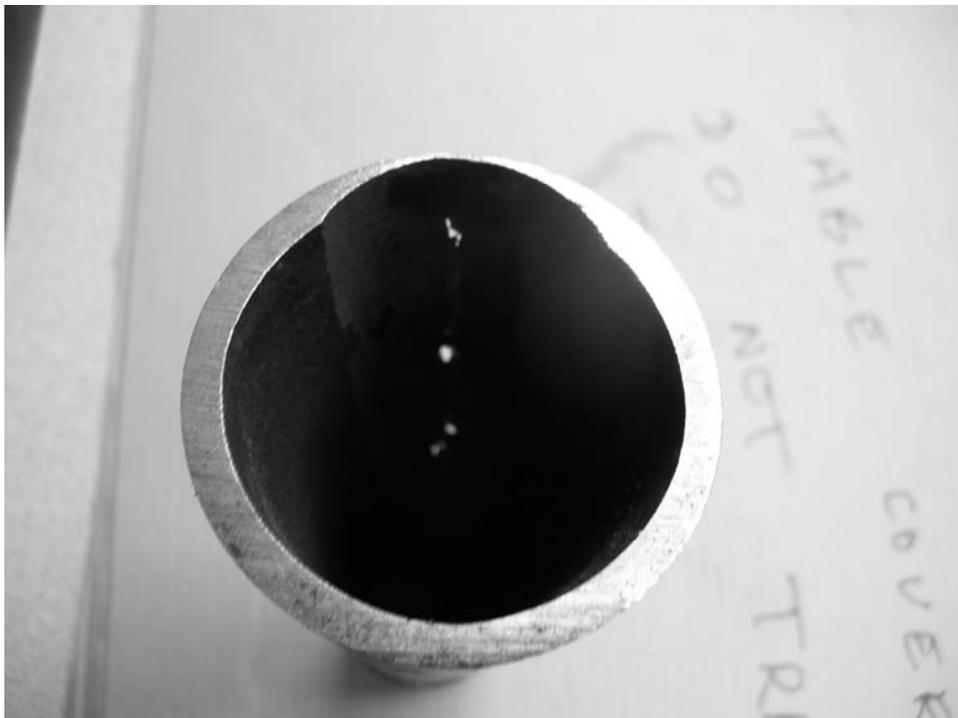
Figure 20 – Split Induced by Rod-on-Tubing Wear
