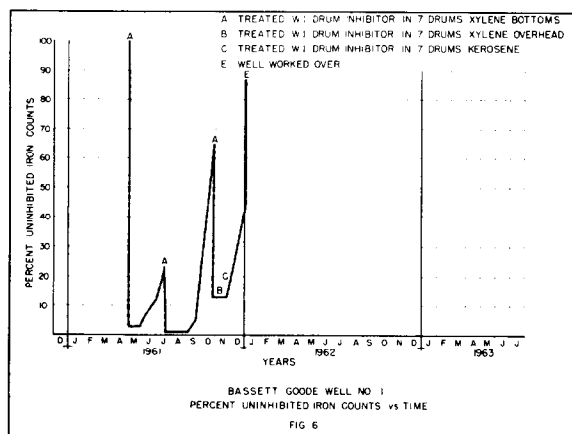
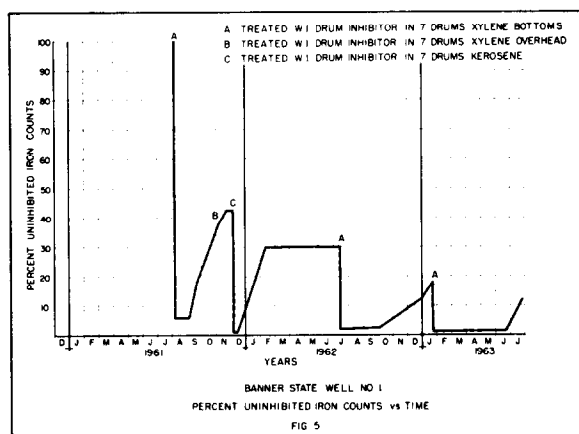
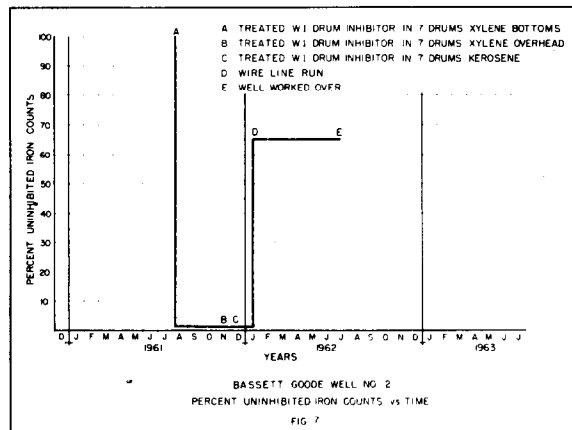
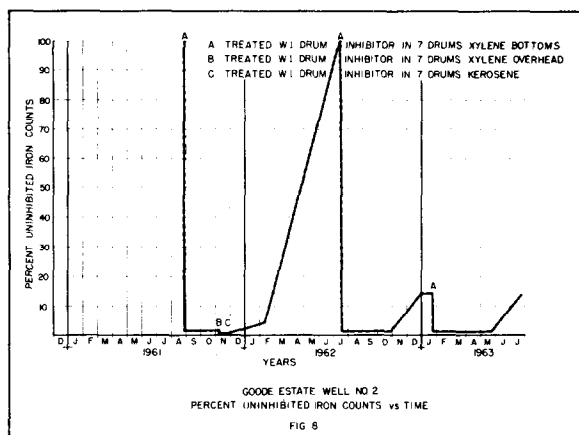
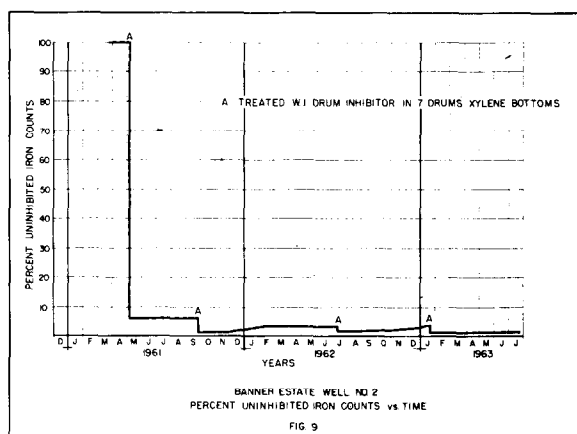
As can be seen from Figs. 5 through 9, excellent inhibition, in excess of 99% in some instances, has been attained. As a result tubing life for the existing coated 4140 tubing is conservatively estimated at 10 years. It was noted, however, that effectiveness of inhibition is a function of production rate. Although six months' inhibition, following treatment, has been the rule, periods of only one month were experienced for Bassett-Goode Well #1. This well produced 30 MMCFD through 3-1/2 in. OD tubing. From this it appears that velocity seriously modifies the effectiveness of inhibitors.
