## A 20 YEAR FIGHT AGAINST SUCKER ROD PIN FAILURES

Remigio Giacomet

Amoco Argentina Oil Company

This article covers the actions taken and results obtained in controlling sucker rod pin failures in the period 1963-1983 at the Cerro Dragon Area, Comodoro Rivadavia, southern Argentina.

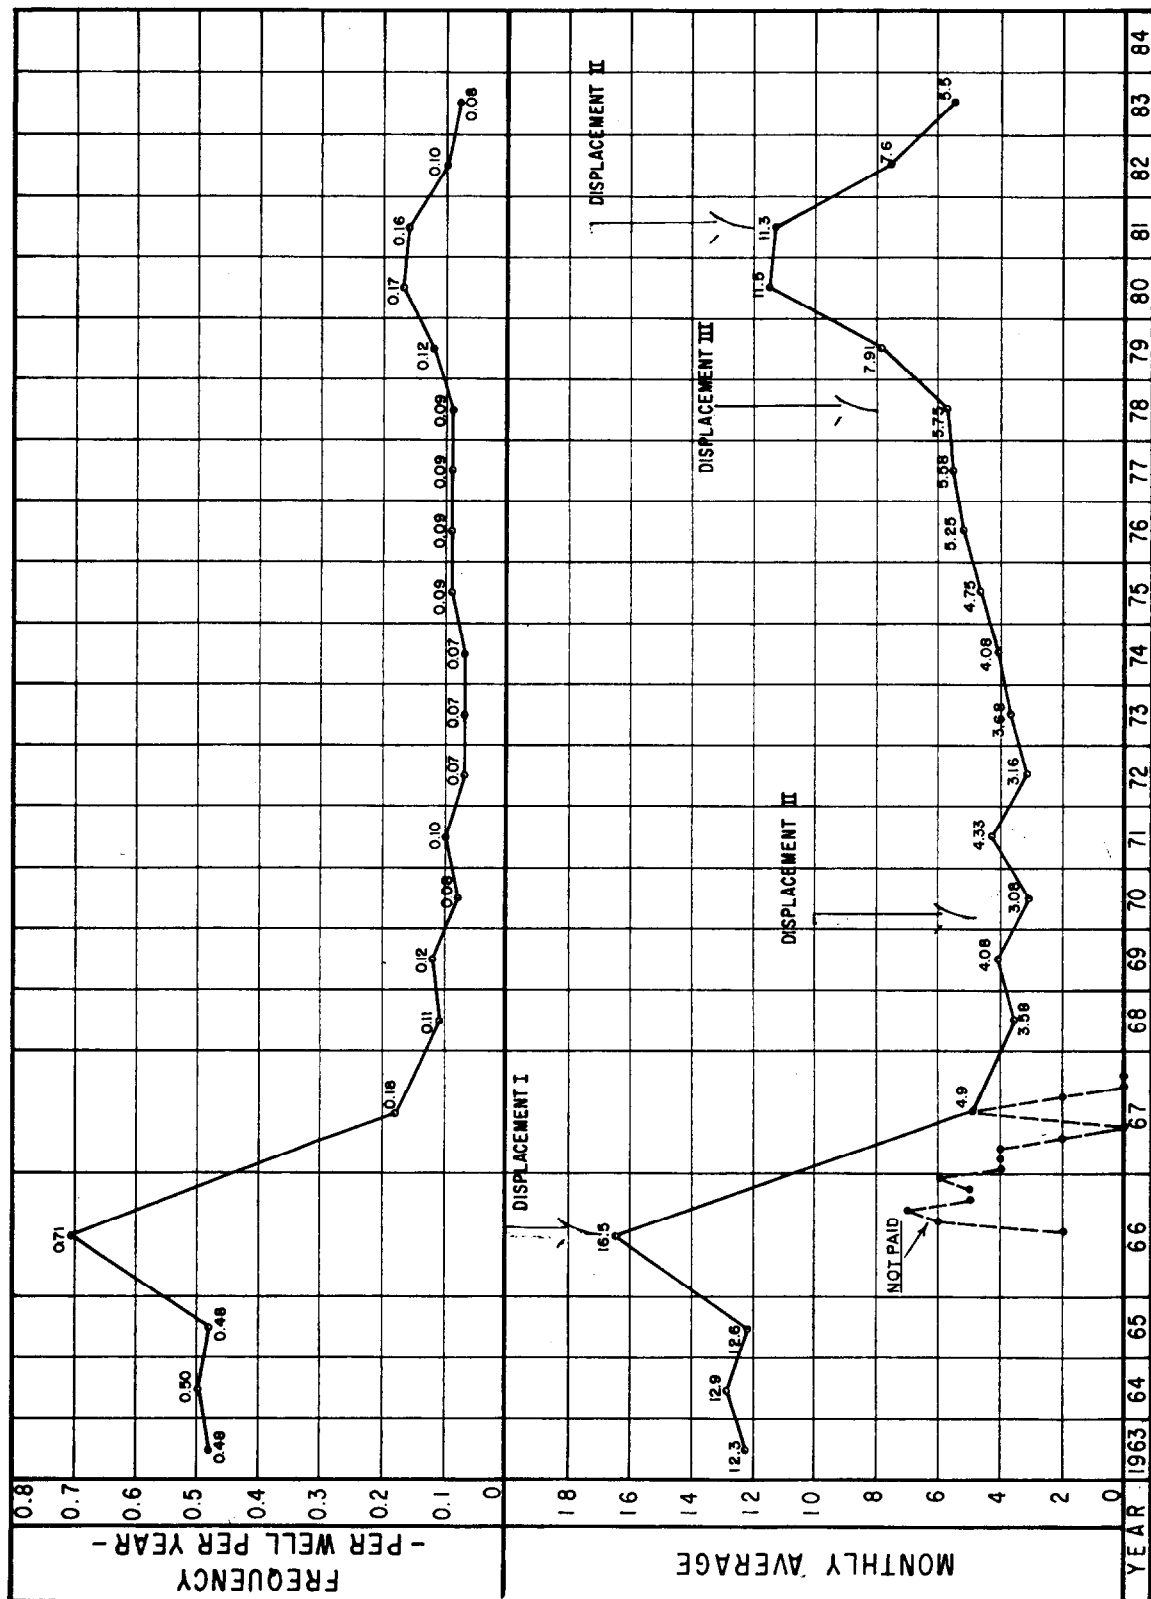
Figure 2 - Sucker rod pin jobs

During the period 1963-1965 the number of pin failures averaged 13 per month, or 50% of the total sucker rod failures. Despite the efforts made to control cleaning of joints and make-up torque, pin breaks kept increasing to a maximum of 25 in May 1966.

Results were dramatic. The "frozen" pin break occurrence stopped after 52 unpaid frozen pin breaks (13 months) and total pin failures decreased from 25 to an average of less than 5 per month in less than one year (Figure 2).

In 1978 and probably due to higher well loads, occurrence of wet rod connections started increasing, suggesting torque was too low. To prevent an increase in pin breaks, torque was increased on all rods to the displacement recommended by API for new rods (Displacement III, Figure 1). But pin failures increased instead of decreasing, so in 1981 the torque was reduced back to Displacement II with an immediate reduction in sucker rod pin failures.

With that finding in mind, the following procedure was implemented in 1966 for sucker rod make-up:

1. Make up the joints by hand, to the hand-tight position in order to detect damaged threads, and only then apply the correct make-up with hydraulic tongs.
2. Calibrate the hydraulic tongs by the displacement gauge method recommended by one sucker rod manufacturer (Displacement I, Figure 1).
3. Repair the damaged pin threads at the well head with chaser dies.
4. Last but not least, it was decided to put most of the responsibility on the shoulders of the pulling contractor by not paying for any future "frozen" pin break job.

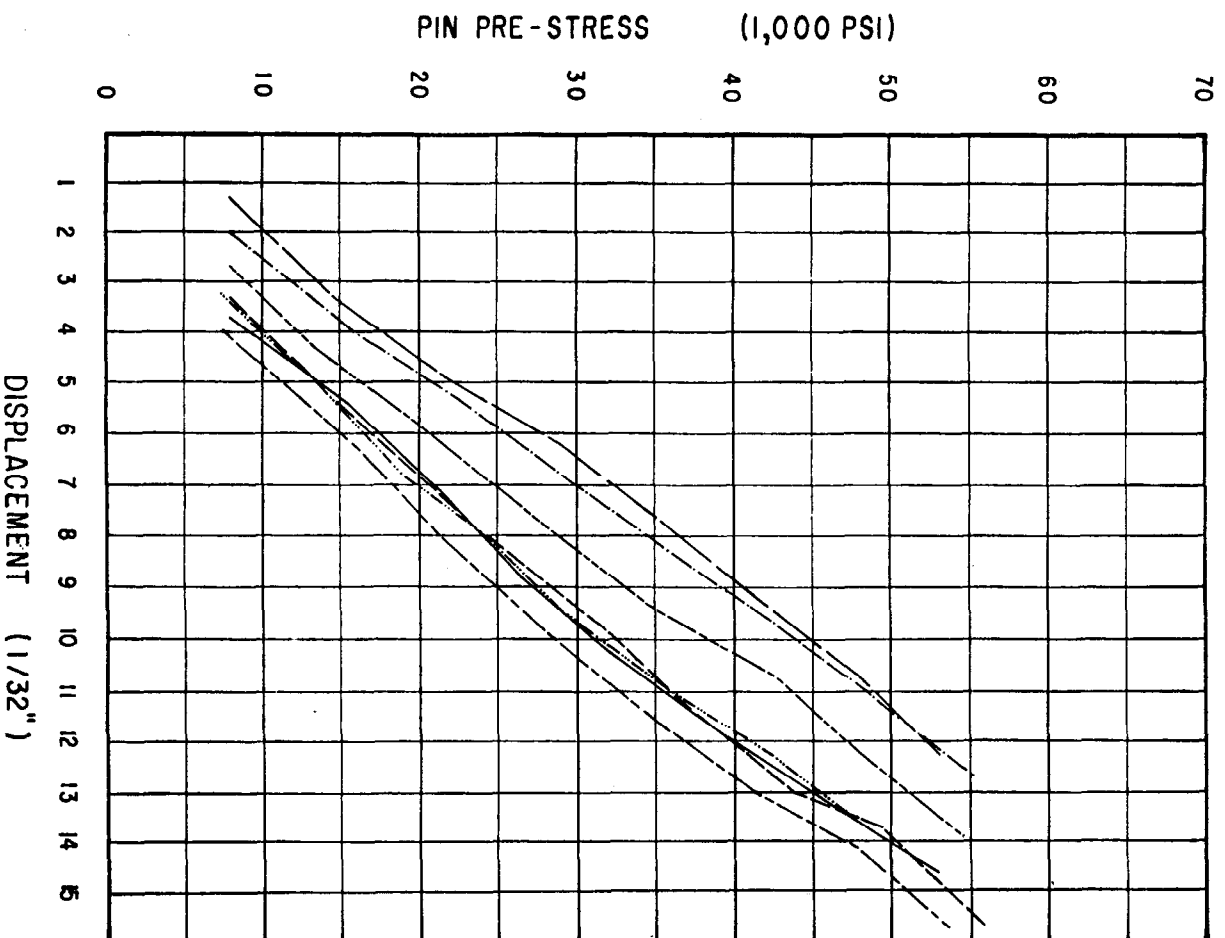
Figure 3 - Test with 7 coupling brands (1")

2. Sucker rod coupling shoulder geometry differs among manufacturers. As a consequence the same displacement make up could produce different pin pre-stress on different coupling brands. This was confirmed by lab tests performed on 7 different coupling brands by Avan S.A., an Argentina rod manufacturer (Figure 3). The subject should perhaps be analyzed further by the API.
