A NEW SUCKER ROD COUPLING MATERIAL: AN ECONOMICAL SOLUTION FOR DOWNHOLE WEAR IN DEVIATED UNCONVENTIONAL WELLS

Seth Silverman and Logan Stoner
Hess Corporation

William Nielsen and Diane Nielsen
Materion Corporation

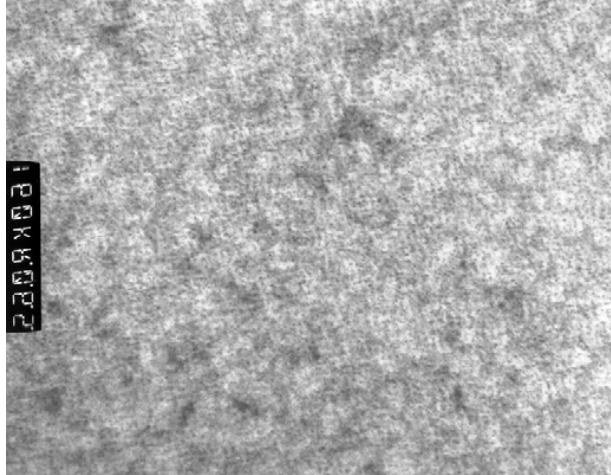
A project was initiated to manufacture 1 in. slimhole couplings. The new material was fabricated by a thermomechanical process. This resulted in a spinodal alloy structure made up of homogenous two-phase mixtures as shown in Figure 1. The spinodal hardening increased the yield strength of the base metal and added a high degree of uniformity of composition and microstructure. Table 1 details the mechanical properties of the alloy.

Figure 1 – High resolution electron micrograph ($>160,000\times$) of spinodal structure.

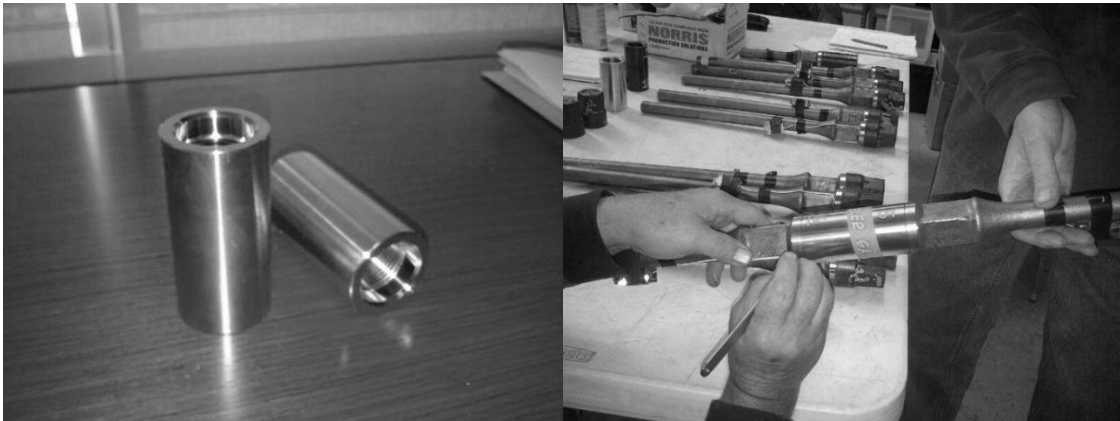
The operator machined prototype couplings following the standard API dimensions for 1 in. slimhole couplings with rolled threads. Controlled make and break tests with strain-gauged rods were conducted to assess whether the standard makeup resulted in the required pin pre-stress compared to a T-grade coupling. Figure 2 shows both the new prototype couplings and the controlled makeup/breakout test setup. The standard circumferential displacement card value supplied by the rod manufacturer for the 1 in. rod size was determined to be sufficient to deliver good pin pre-tension. The lower elastic modulus of this alloy does not affect the makeup characteristics of this coupling. Subsequent breaks and re-makes of the material demonstrated a return to proper pre-stress levels. The addition of copper plating on the threads and changing of the surface finish on the face of the coupling improved the overall makeup performance.

Figure 2 – Left: Prototype 1 in. slimhole couplings. Right: Strain gauged set up for make break tests.

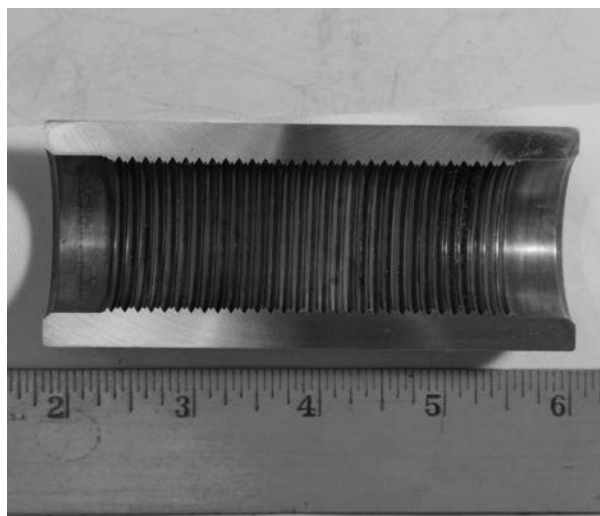
In June 2014, a tubing leak was discovered in Joint 295 and Joint 25 was found to be crimped. The *ToughMet* couplings were in excellent condition and were re-run. The operator removed one coupling for laboratory examination and it did not show any signs of wear. The original dimensions were all intact.

Figure 3 – Cross section of the used sucker rod coupling GO-Elvin Garfield from the June 30, 2014 pull (6 months service life).

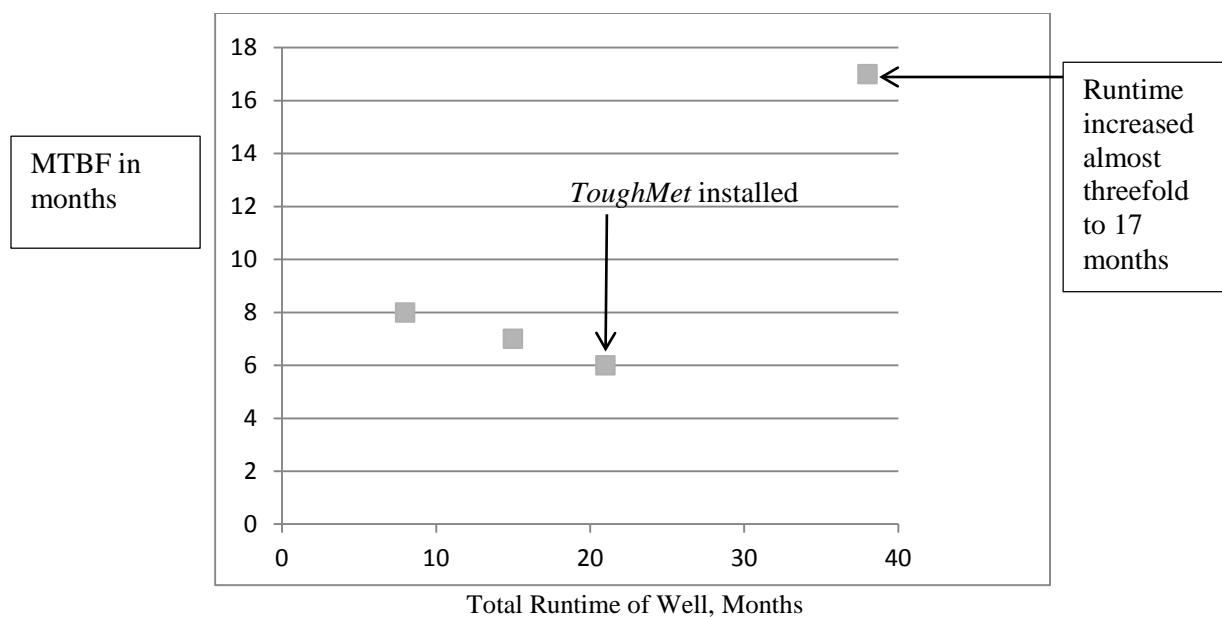
In August 2015, after 17 months of production (the longest run time to date on this well), another tubing leak was suspected. The plastic coated joint located just above the pump had a hole. Repairs were made and the well was put back on production. The operator reinstalled all the *ToughMet* couplings with the exception of two for dimensional analysis. Figure 3 shows a cross section of one these couplings. Figure 4 shows the mean time between failure versus total run time.

Figure 4 – GO Elvin Garfield well shows significant run time improvement with *ToughMet* couplings in the lower 600 ft of the 1 in. bottom rods.

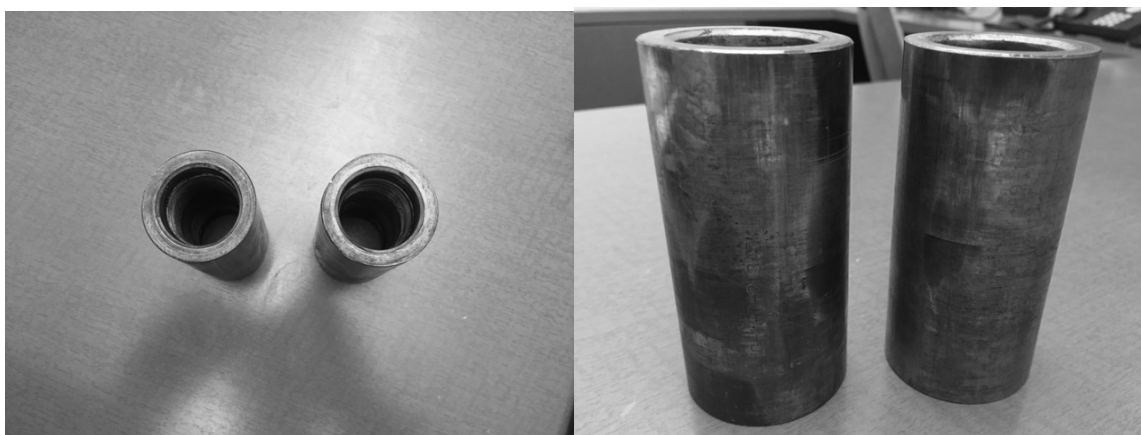
This well stopped producing in December 2015 because of a deep tubing leak above the pump (not in the vicinity of the *ToughMet* couplings). In this well, T couplings were alternated with *ToughMet* couplings at the bottom of 26 of the 1 in. guided sucker rods. The inspected tubing shows that there was no significant wear in the area covered by the 1 in. rod string. There was, however, more significant wear and corrosion above and below the area covered by the *ToughMet* couplings. Figure 5 shows the *ToughMet* couplings after 20 months of service with no noticeable wear on the OD. The serial numbers are still clearly visible, indicating the corrosion and abrasion resistance of the material. For comparison, the OD measurements were taken on a new *ToughMet* coupling and one of the *ToughMet* couplings retrieved from the well after 20 months service. The data shows that the change in OD was only 0.020 in. or 10 mils per side. This equates to a loss of only 0.5 mil per month. Figure 6 shows the couplings side by side. As expected, the T couplings had a corroded surface and were worn with flat spots. Figure 7 shows a cross section of one of the recovered *ToughMet* couplings.

Figure 5 – Photos of *ToughMet* couplings retrieved from Strahan well after 20 months of service.

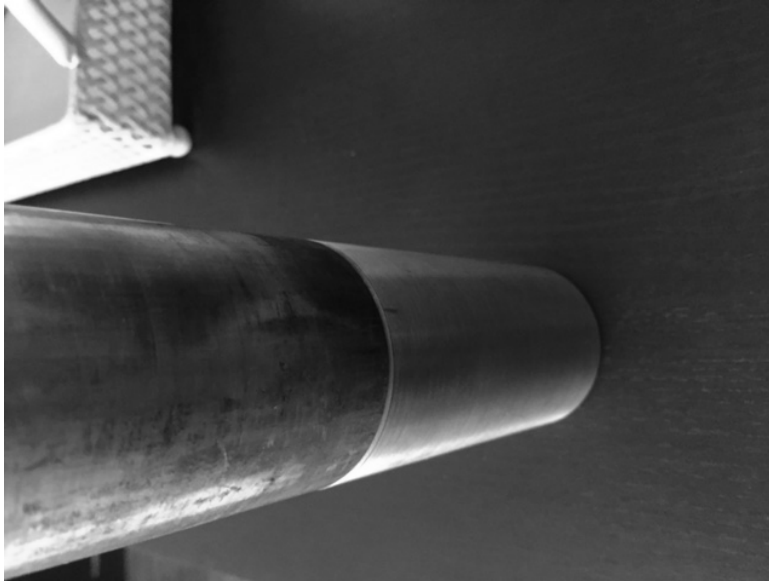
Figure 6 – New versus used *ToughMet* coupling from the Strahan well. The average OD of the new coupling is 1.998 versus and average OD of the used coupling of 1.978 for a diametric loss of 0.020 in. or surface loss of 10 mils over a 20 month period (0.5 mil per month).

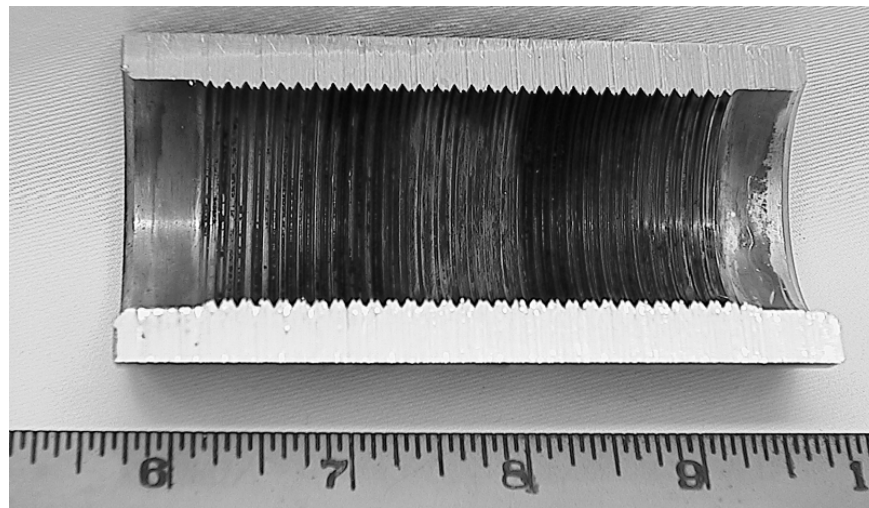
Figure 7 – Cross section of *ToughMet* coupling from the Strahan well after 20 months of service.

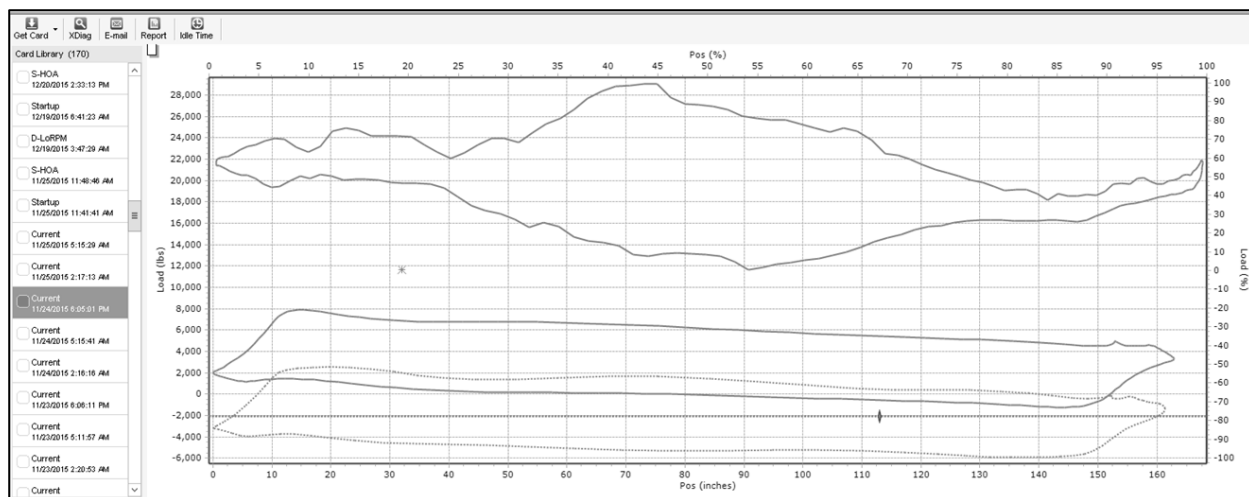
The EL Cvancara H3 well experienced tubing wear and pitting in 24 joints at the bottom of the well. There were 303 joints in this well above the tubing anchor catcher. Joint 300 experienced 99% wall loss. The operator installed 31 new 1 in. guided rods with 1 in. slimhole *ToughMet* couplings and 24 new ¾ in. guided rods with ¾ in. full size *ToughMet* couplings. The goal was to place the *ToughMet* couplings in the part of the well experiencing the greatest side loading. The pump was also worn and replaced. Figures 8 and 9 show the before and after pump cards and production data. Figure 10 shows additional production data. The well was restored to a production rate of 120 bopd from the pre-workover rate of ~50 bopd. This well has a history of frequent workovers in the 3 to 4 month average range. Success will be determined by the length of the extended run time between failures.

Figure 8 – Pump card of the Cvancara well before installation of the *ToughMet* couplings in the $\frac{3}{4}$ in. and 1 in. bottom section of the well. Note the erratic movement of the top load curve, indicating possible sticking of rods.

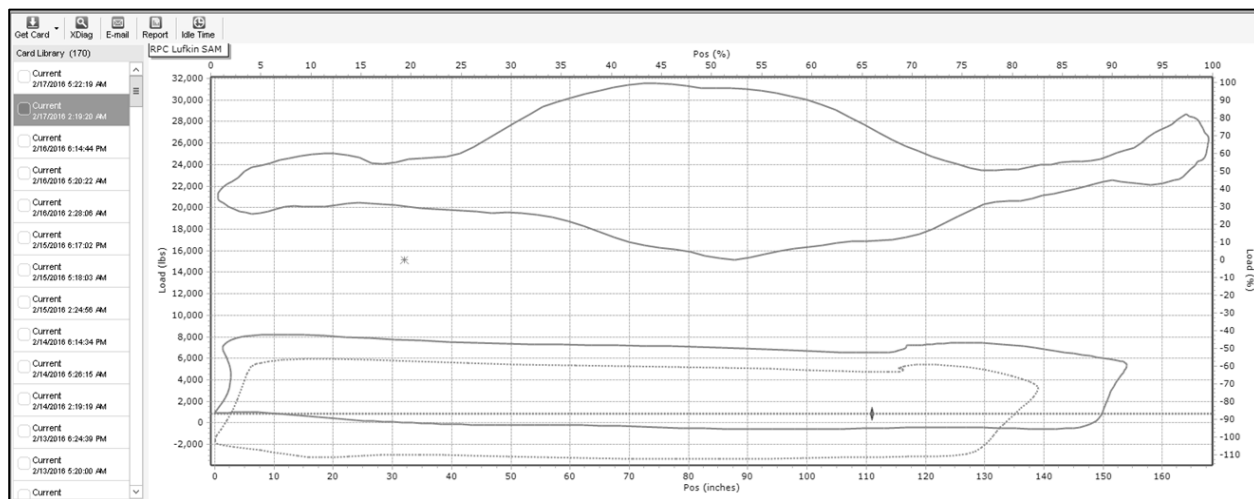
Figure 9 –After installing 24 of the $\frac{3}{4}$ in. full size *ToughMet* couplings and 31 of the 1 in. slimhole couplings, the pump curve is much smoother. This indicates a potentially lower friction force.

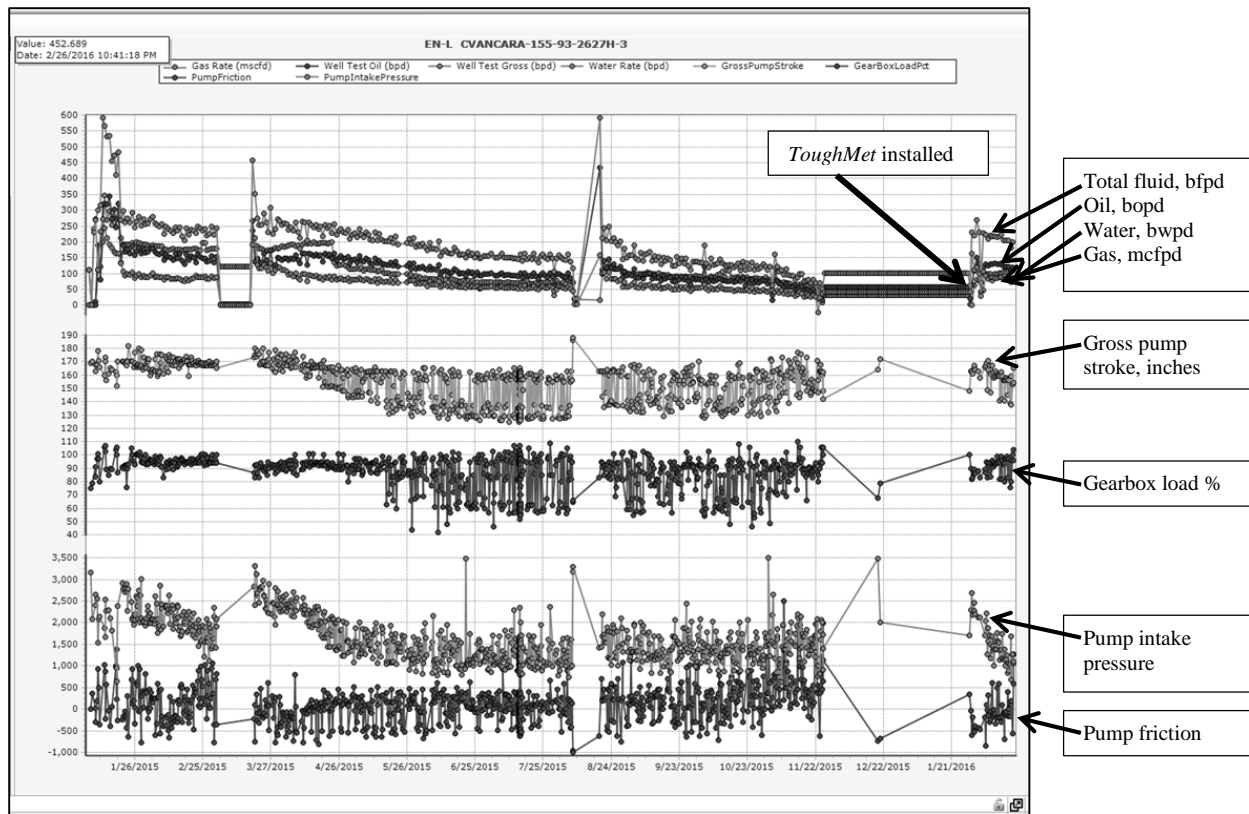
Figure 10 – A complete history of the Cvancara well production data from January 2015 to date.
