# REDUCING ARTIFICIAL LIFT FAILURE RATE THROUGH OPTIMIZED TUBING INSPECTION

Taylor Reeves, Anadarko Petroleum Corporation  
Alexander Restrepo, NOV Tuboscope

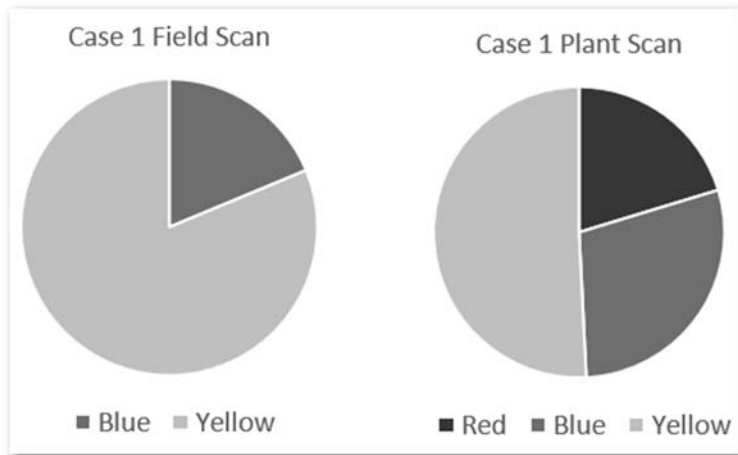
Figure C. Verde 34-153 1H Tubing Inspection Results

The Verde 34-153 1H was worked over for a suspected failed downhole insert pump. 315 joints of tubing were scanned on location with a non-contact EMI-only unit while tripping out of hole. The tubing was then transported and taken through an in-plant inspection facility. Major discrepancies between both data sets were found, as evident in Table 2, Figure C and outlined in the results section.

The results of the tubing scans in both case studies exhibited discrepancies between wellhead inspection and in-plant inspection. In Case Study #1, the plant and EMI wellhead scans only agreed for 70% of tubing joints inspected. The EMI wellhead scan missed 64 joints of red band tubing: 54 downgraded due to rod wear and 10 due to pin end damage. In Case Study #2, the plant and EMI wellhead scans agreed for 96% of tubing joints. The EMI wellhead scan missed 2 joints of green band tubing and 6 joints of red band tubing: 2 downgraded due to mechanical damage, 4 mashed and 2 to rod cut.

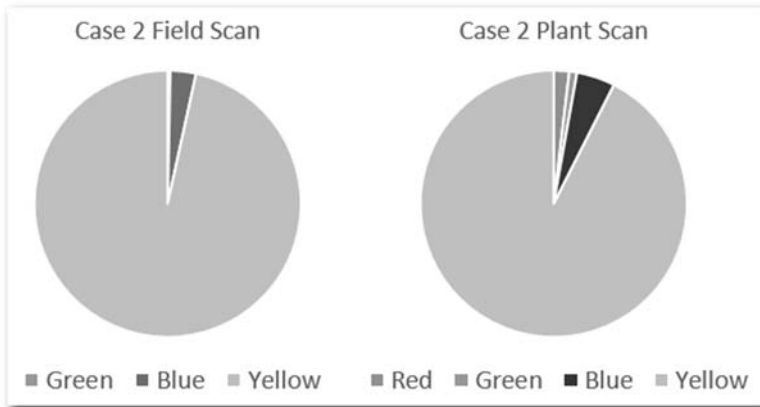
Figure D. Monroe 34-128 1H Tubing Inspection Results

The Monroe 34-158 1H was also worked over for a suspected failed downhole insert pump. 321 joints of tubing were scanned on location with a non-contact EMI-only unit while tripping out of hole. The tubing was then transported and taken through an in-plant inspection facility. Similar to Case Study #1, major discrepancies between both data sets were found, as evident in Table 3, Figure D and outlined in the following results section.

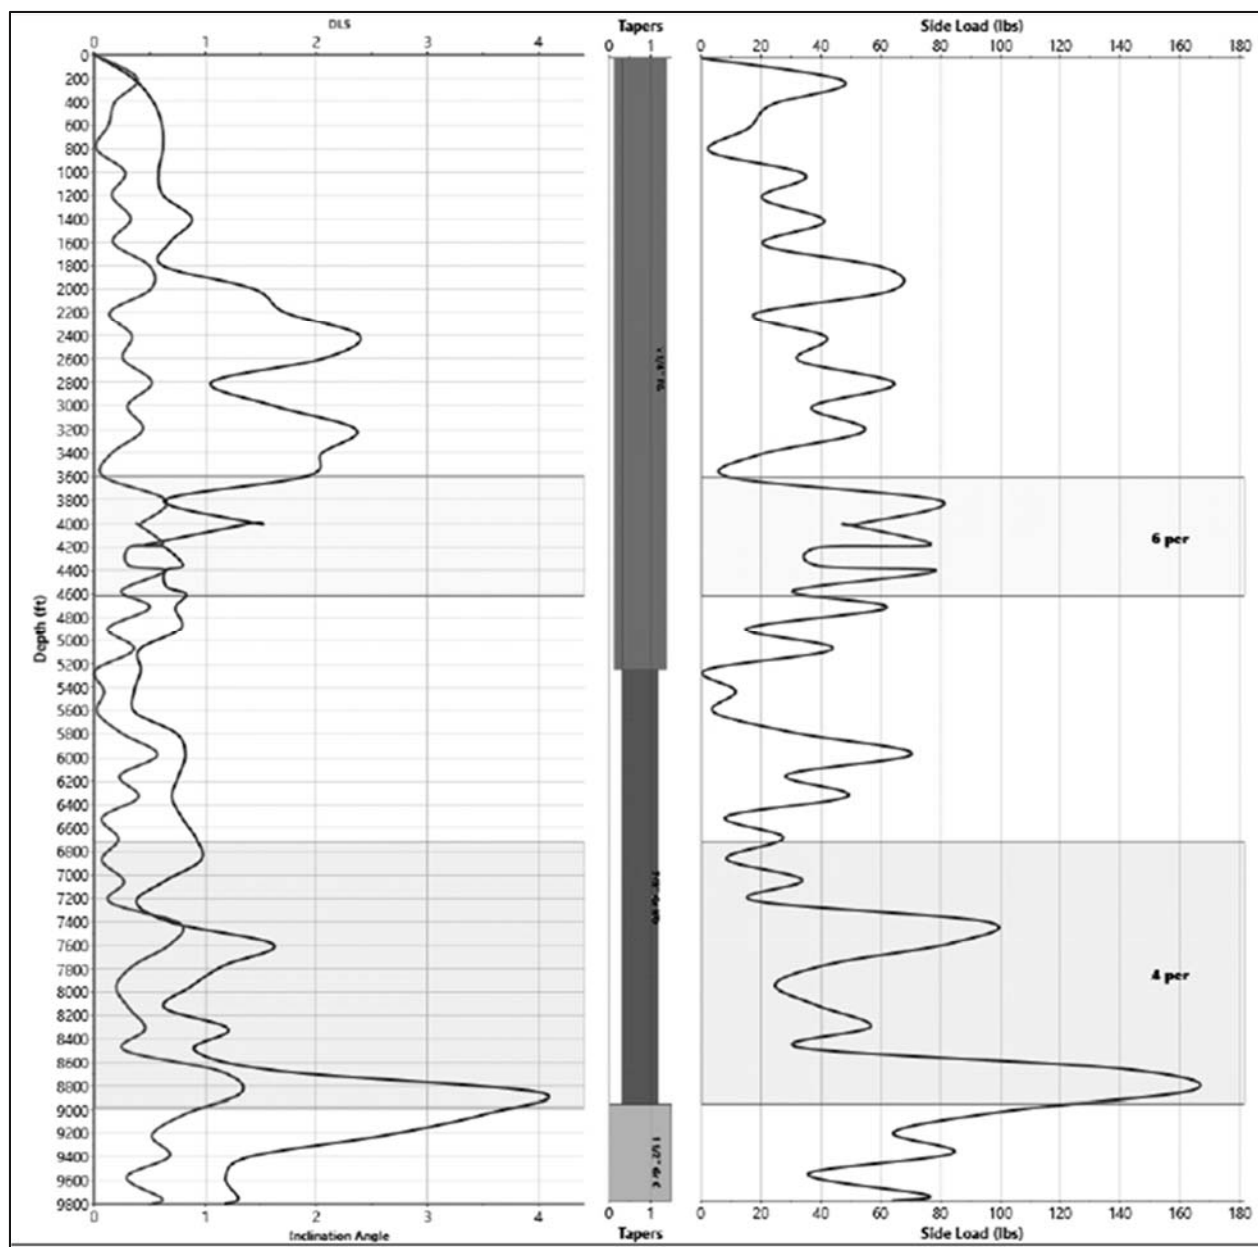
Figure G. RGAP Report for the Monroe 34-188 1H

Anadarko is working with Tuboscope to develop a process to correlate in-plant tubing inspection data with depth, enabling advanced design optimization and failure rate reduction. Figure E and F exemplify in-plant tubing inspection results for wells on two different types of artificial lift. The Super Duty 29-16 1H, a gas lift well, failed due to holes in tubing. When determining the root cause of failure, correlating the tubing inspection to depth was critical in understanding the location of corrosion and how to mitigate in the next design iteration. Consequently, Anadarko optimized the downhole design by running a full string of internally coated tubing and gas lift mandrels. The Monroe 34-188 1H, a rod pump well, failed due to parted rods. Utilizing a Rod Guide Advisory Program (RGAP) and correlating the tubing inspection to depth, Anadarko was able to determine the well's root cause of failure and optimize the rod string by adding guides (see Figure G). For both the Super Duty 29-16 1H and Monroe 34-188 1H, the tubing inspection report correlated to depth was imperative in order to advance the root cause of failure discussion and formulate recommendations for subsequent workovers.
