MAXIMIZING PRODUCTION EFFICIENCY IN BEAM PUMP WELLS USING ROD GUIDE DESIGN OPTIMIZATION

Brian Wagner & Clark Corser
NOV Tuboscope

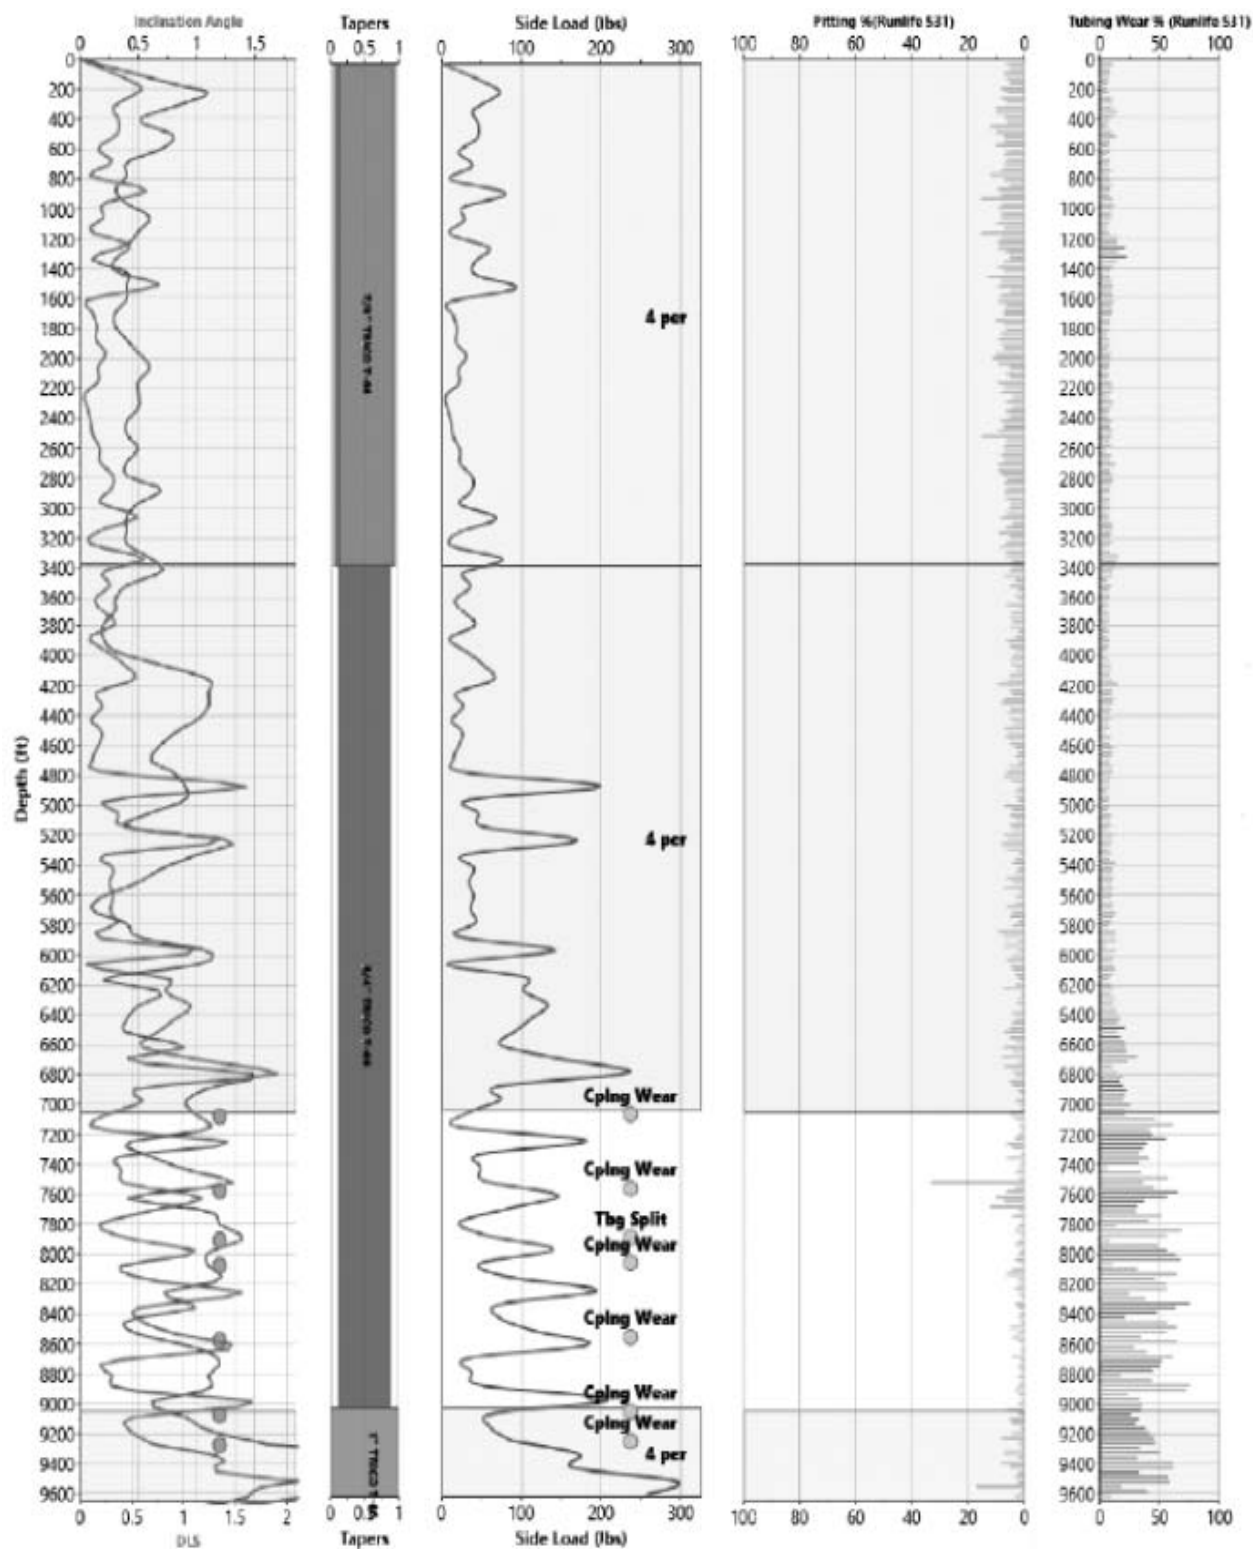
Figure 4 – Rod guide software well example (Well A)

The proprietary rod guide design software incorporates rules built on empirical data to help extend mean time between failures. Beginning in 2016, it became standard practice to scan tubing anytime it was pulled and use the software to help generate an optimized string design. The tubing scan is plotted alongside the dog-leg severity (DLS), inclination angle, side loading, failure history, and corresponding rod string design to recommend guide design, material, guides per rod, and depth placement based on a target run life (see Figure 4). It also became standard practice in 2016 to use this program to proactively design the rod string upon initial install to mitigate tubing wear based on the deviation and well conditions.

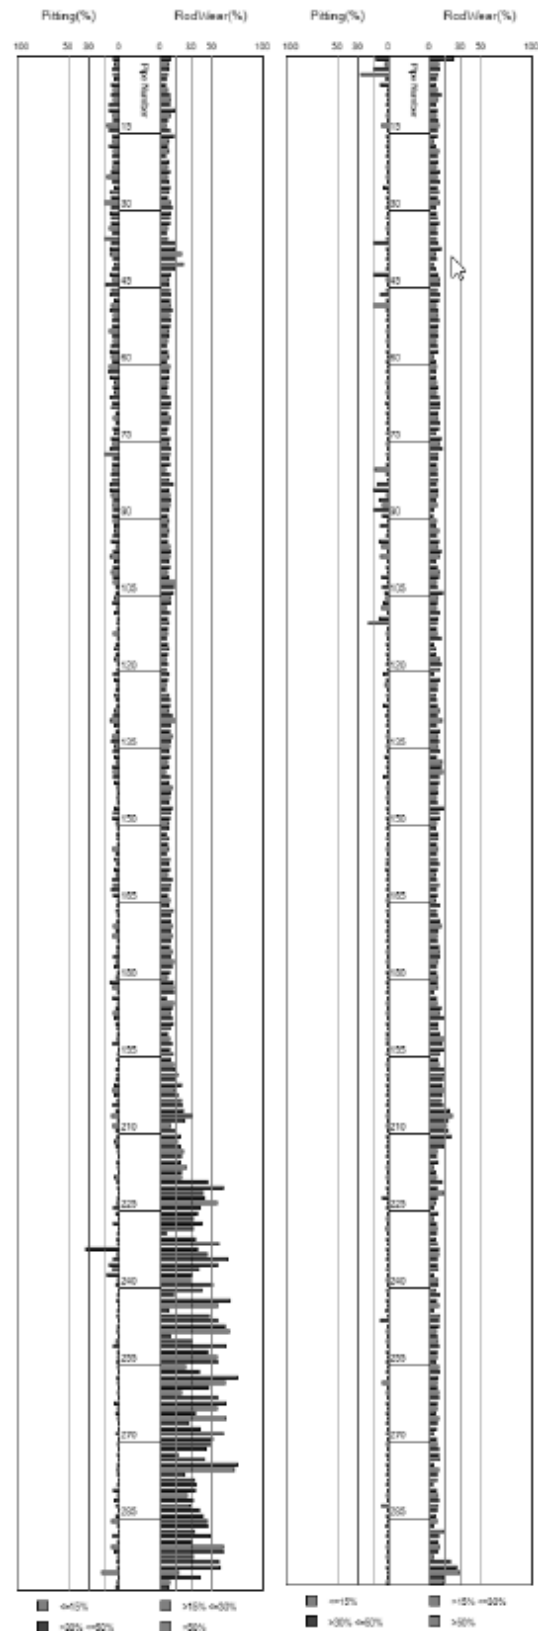
Figure 5 – Tubing scan comparison example (Well A)

second pull can be plotted side by side to visualize the impact design changes have made on the tubing condition (see Figure 5).

During this time frame, 50 wells have experienced at least a second tubing pull for consideration. The average tubing run time of these wells prior to the first pull was 529 days. Out of these 50 wells, half of them showed an improvement in tubing run time between pulls. The 25 wells that saw an increase in run time improved by an average of 78%. The other half of the wells that did not exceed the previous run time were pulled for a variety of reasons including pump failures, rod parts, tubing splits, and proactive pulls for offset frac activity. Only 10 of the 25 wells that didn't exceed previous run time were related to wear on the rods or tubing. All of these failures occurred in rods that were reran from the previous pull. It is likely that rods were not accurately identified during the previous pull and rod guides that were no longer offering wear protection were used. It is difficult to visually evaluate the remaining EWWV respective to the coupling size. This demonstrates the limitations to visually inspecting rods at the rig site while pulling but still offers an effective way to make real time decisions for optimization when compared to the tubing scan.

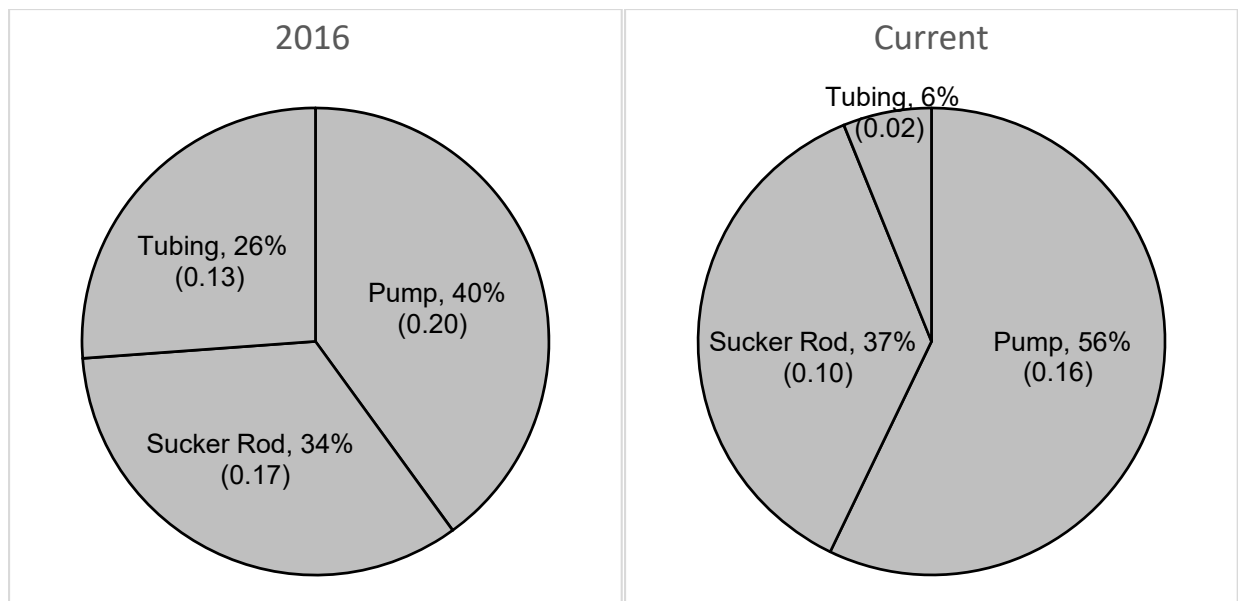
Figure 6 – Failure distribution by mechanism

The optimization strategy outlined above has lowered the failure rate across the field by 49% since it's induction. This is a direct result of reduced tubing failures and rod failures (see Figure 6). Coupling wear failures are the main cause of rod failures in this field and their decline can also be partially attributed to the rod guide strategy. During this time frame, tubing failures alone have dropped by nearly 90% because of proper guide material, design, and placement. Additionally, rod related failures have decreased by 40%. The reduction in failures across the asset has led to a 67% improvement in MTBF. This program has proven to be a critical piece in reducing failure frequency across key components of the rod system.
