# DOWNHOLE SUCKER ROD SENSOR

John MacKay, Paolo Santos, Stian Slotterøy, and Keith Fangmeier  
Well Innovation AS

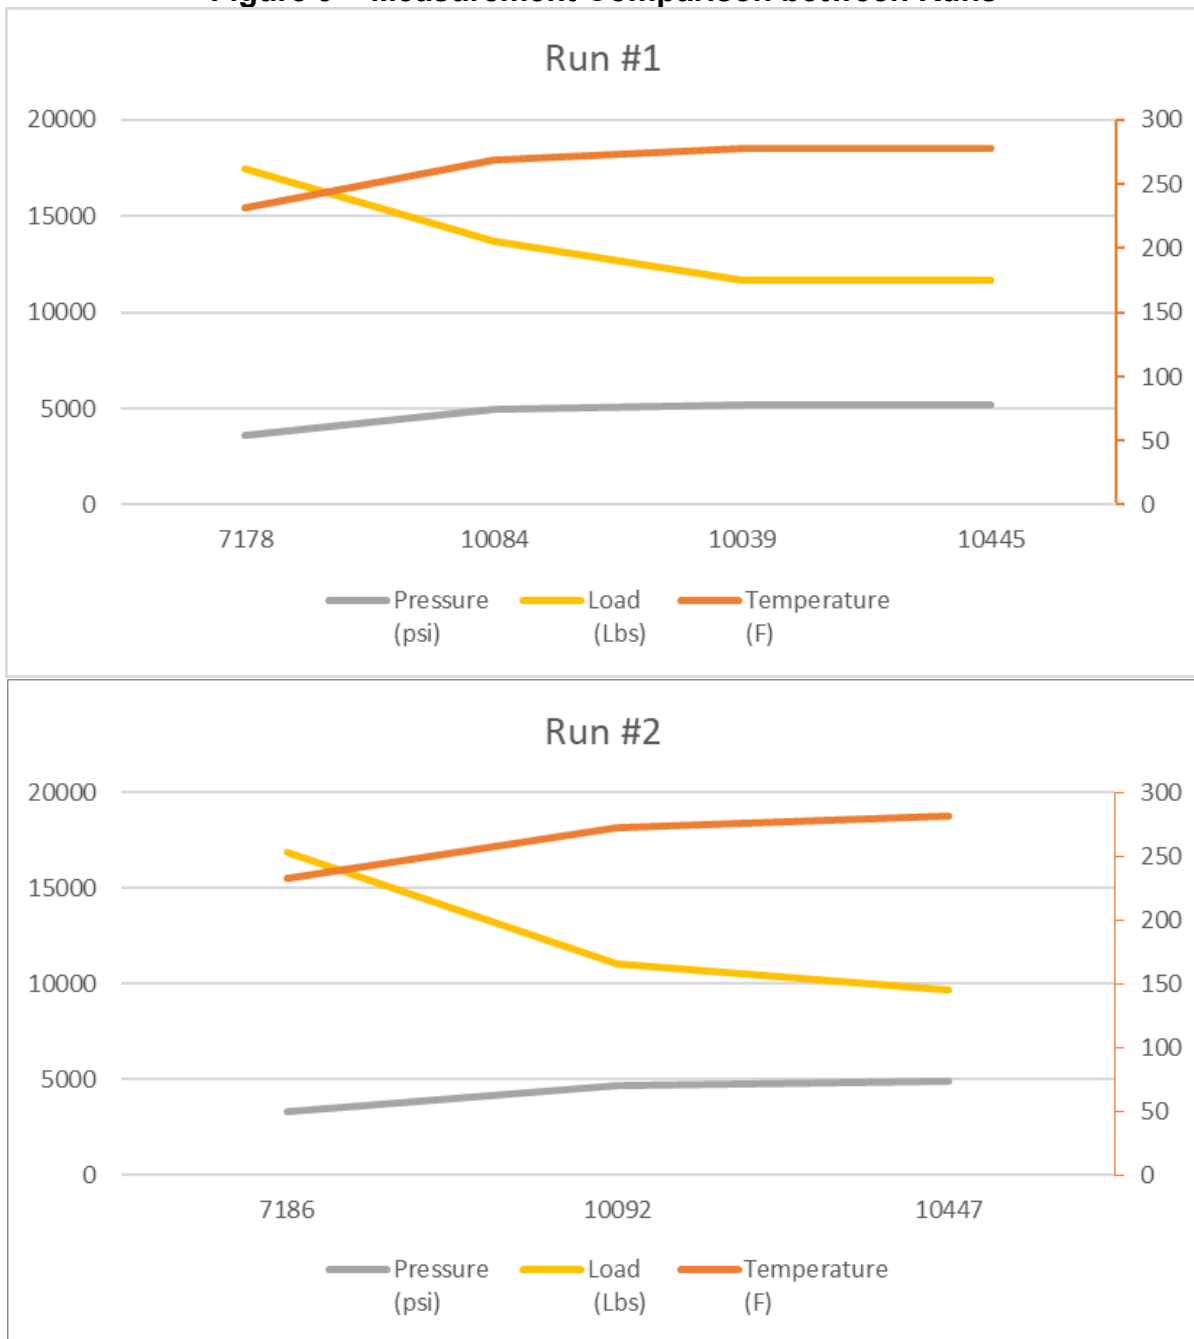
**Figure 9 – Measurement Comparison between Runs**

A closer look at the loads for Run #1 and #2 shows the effects of the guided rods in reducing the friction against the tubing. The bottom and middle tools are showing dynamic loads of 1500 lbs less *on run #2 when compared with run #1. The top tools, where there are no guides on either run are only 600 lbs less. Keep in mind that 300 lbs are due to run #2 being 300 lbs lighter than run #1. See Figure 9 – Measurement Comparison Between Runs.*

Dynamic Loads: Pressure and temperatures are consistent between runs but the loads for Run #2 are 1500lbs less over the guided section of rods even though the rodstring is only 300 lbs lighter.

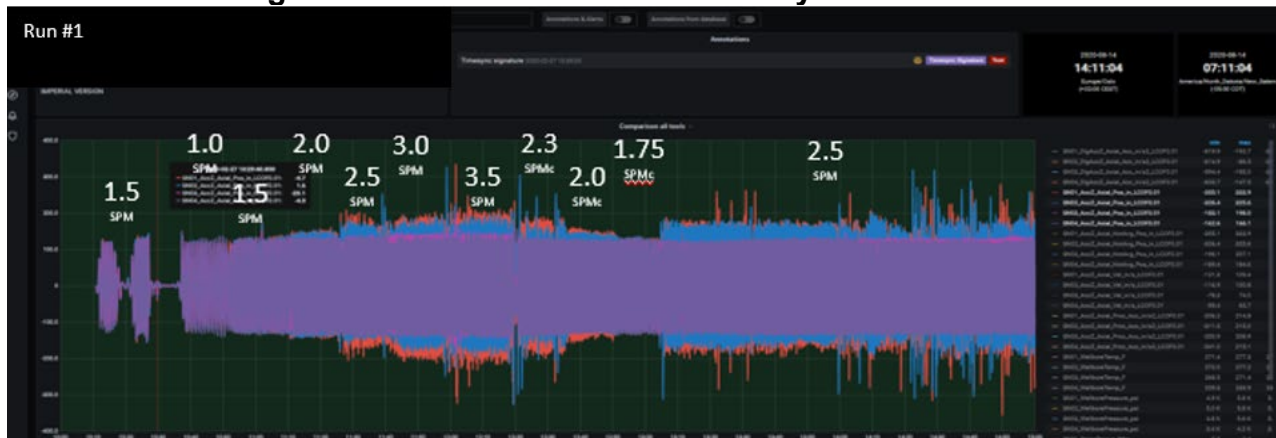
**Figure 10 – SPM and Position Overlay for each Tool**

The Middle and Top tools, 3 & 4 do not vary with changes in SPM. The Bottom two tools, 1 & 2 change due to increased friction/rubbing as the SPM increases above 2 SPM.

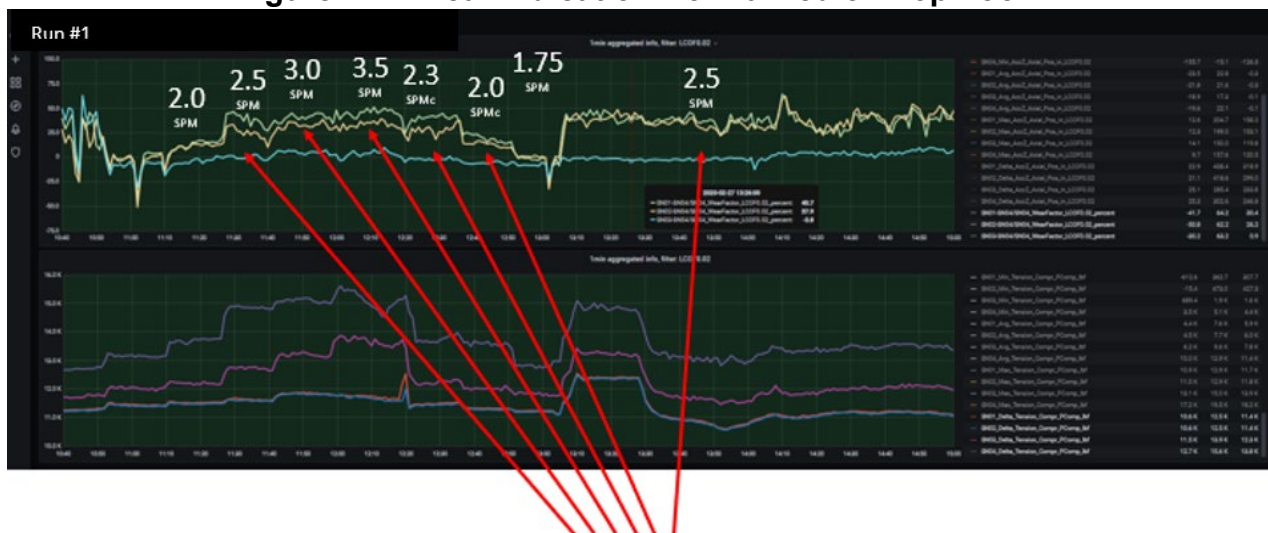
**Figure 11 – Wear indication Normalized on Top Tool**

On the first day of recording data, a series of speed tests were conducted by varying the surface SPM from 1 – 3.5 SPM in 5-minute intervals and the resulting rubbing/sticking effects were recorded and analyzed for each tool. One of the first observations was the increase in noise on the 3 axis accelerometers on the tools closest to the pump when surface SPM increased above 2 SPM. This increase in noise did not appear on the middle tool (360 feet above the pump) or the top tool (3270 feet above the pump) and this was the first indication of how critical the SPM is linked to wear in this well. *Figure 10 – SPM and Position Overlays*, shows the link to increasing SPM and how the position of the lower tools is affected as the SPM increase above 2.0 SPM. Further testing and possible hardware could reduce this effect, but for now the recommended speed to maximize this well's MTBF is less than 2 SPM. *Figure 11 – Wear indication Normalized on Top Tool.*

SPM of 2 SPM and greater results in higher Friction on Tools SN01 & SN02

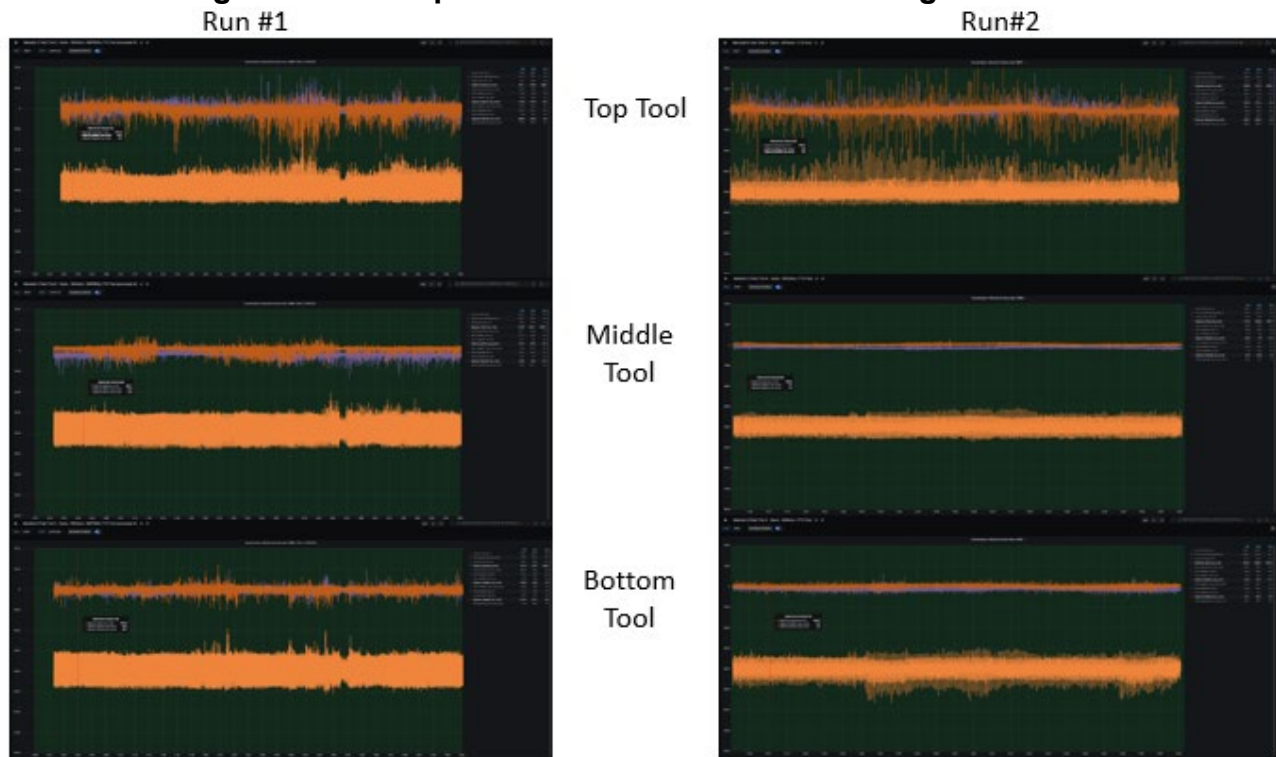
**Figure 12 – Comparison of the Effects of Running Guides**

Run #2 was pulled on January 25<sup>th</sup>, 2021 and Run #3 was deployed on Jan 30<sup>st</sup>, 2021. Running the combination of 1 inch and 3/4-inch guided rods reduced the side-to-side motion and improved the movement of the rodstring on all axes. This is clearly seen on the three-axis accelerometer's measurements when comparing the results from runs #1 and #2. Note here that the guided rods section ended between the middle and upper tools (1315 feet above pump) and there is still side to side motion on the upper tool. This is an area that we will continue to monitor. *Figure 12 – Comparison of the effects of Running Guides.*

Left set of graphs from Run #1, no guides on rods. Right set of graphs from Run #2, guides run with rods from bottom and end above Middle tool. Note that the graphs on the right are much smoother on all axis due to running guides but there is still side loading on the upper tool.

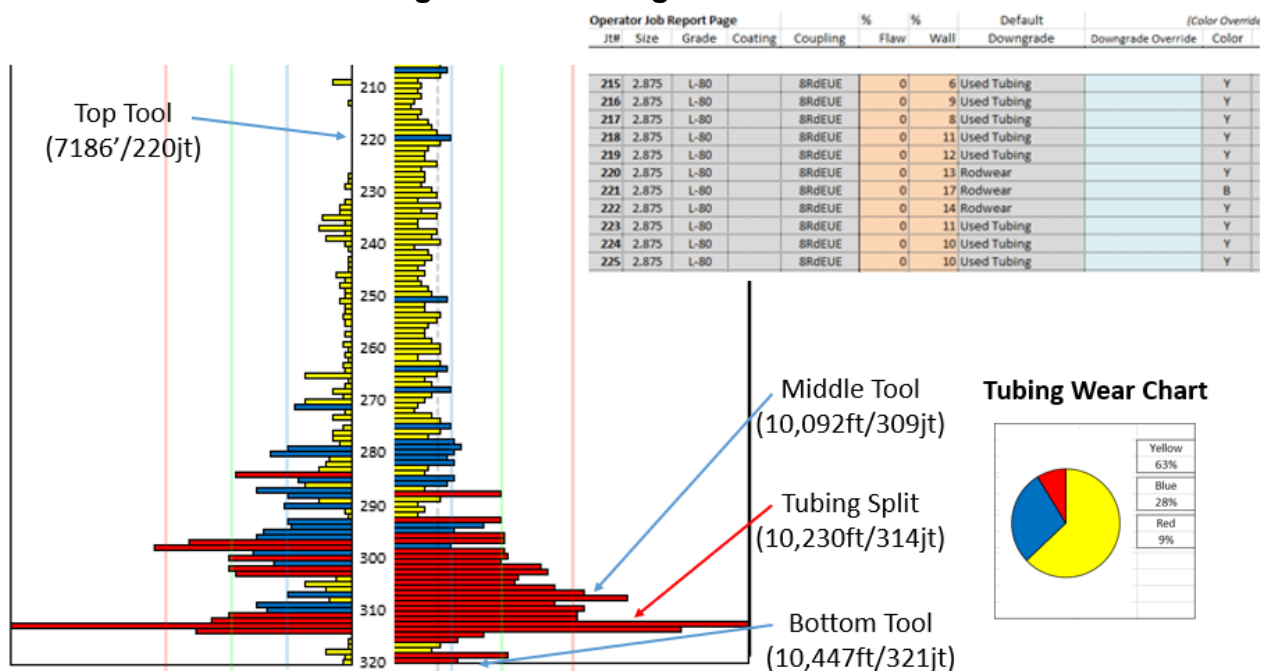
**Figure 13 – Tubing Scan Run #2**

The tubing was scanned while being pulled and the condensed results are shown in *Figure 13 – Tubing Scan Run #2*. The upper section of the tubing, where the top tool is located showed minimal rod wear. As expected, most of the rod wear was found in the lower 20 joints of tubing and the tubing split was located at tubing joint 314, between the bottom and middle tools.

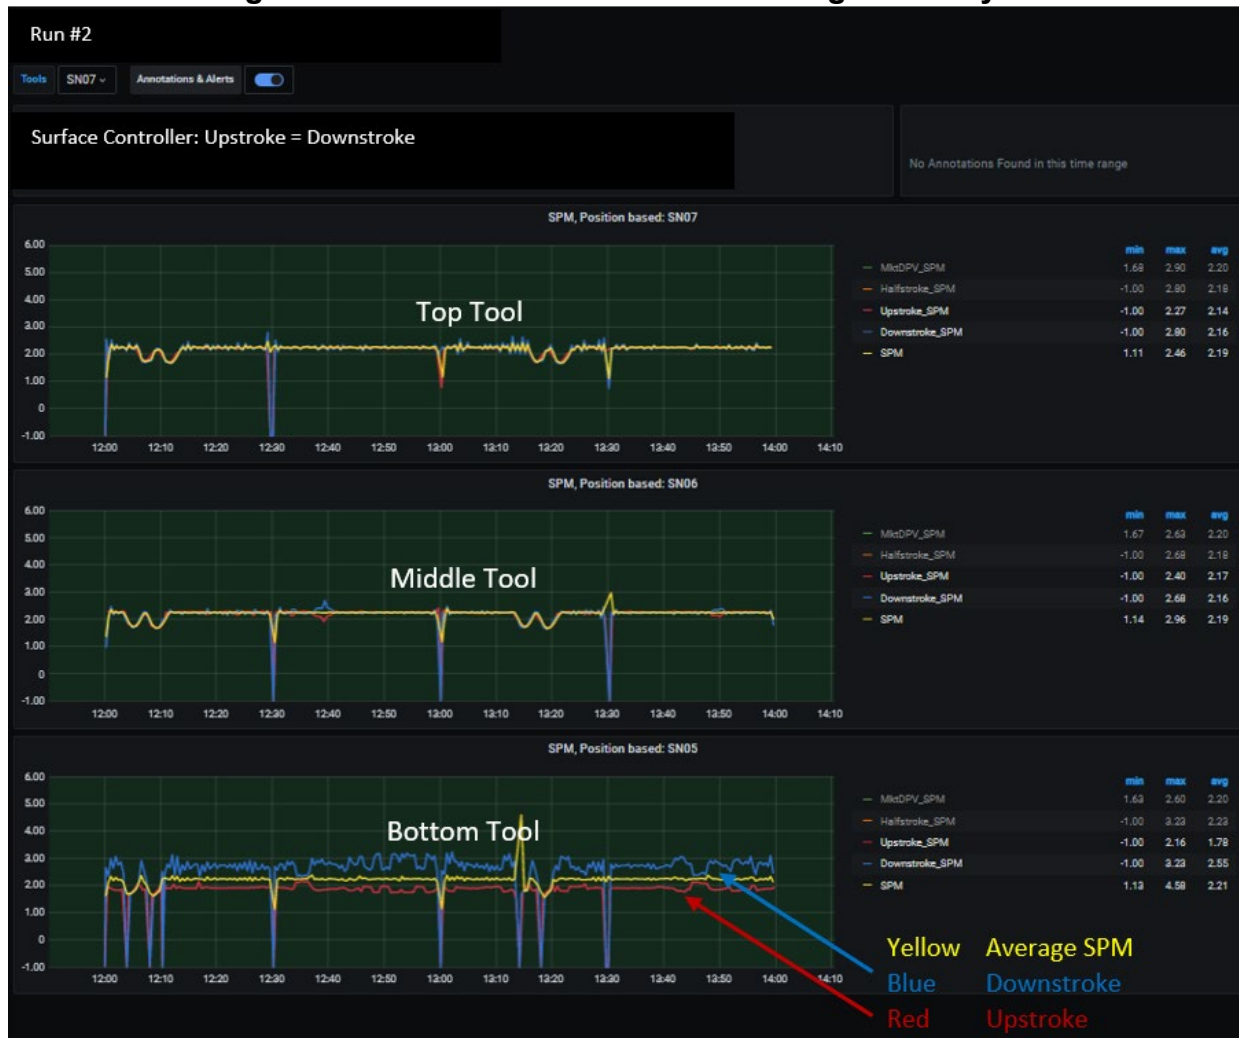
**Figure 14 – Run #2 – Bottom of Rodstring Out of Sync**

The Top and Middle tool are reflecting the surface controller set-up i.e. Upstroke = Downstroke. Notice that the Bottom tool is out of sync and the downstroke is faster than the upstroke due to rubbing.

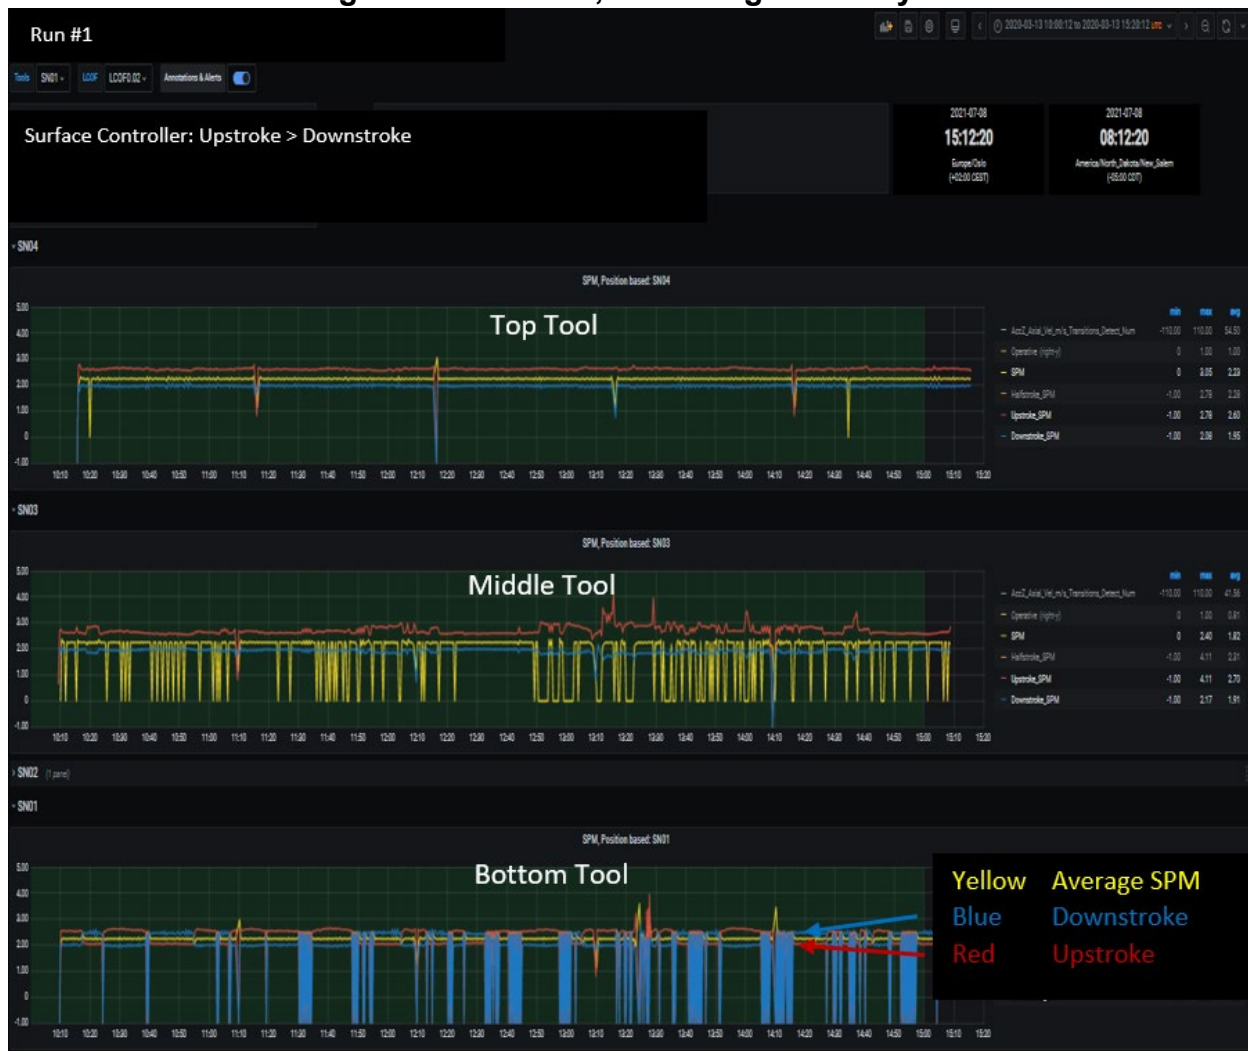
Figure 15 – Run #1, Rodstring Out of Sync

The Top and Middle tool are reflecting the surface controller set-up i.e. Upstroke > Downstroke. Notice that the Middle tool is erratic compared to Run #2 (Guided) and the bottom tool is reversing i.e. Downstroke is sometimes faster than upstroke. Keep in mind that the surface controller is set-up so that the Upstroke is faster than the Downstroke.

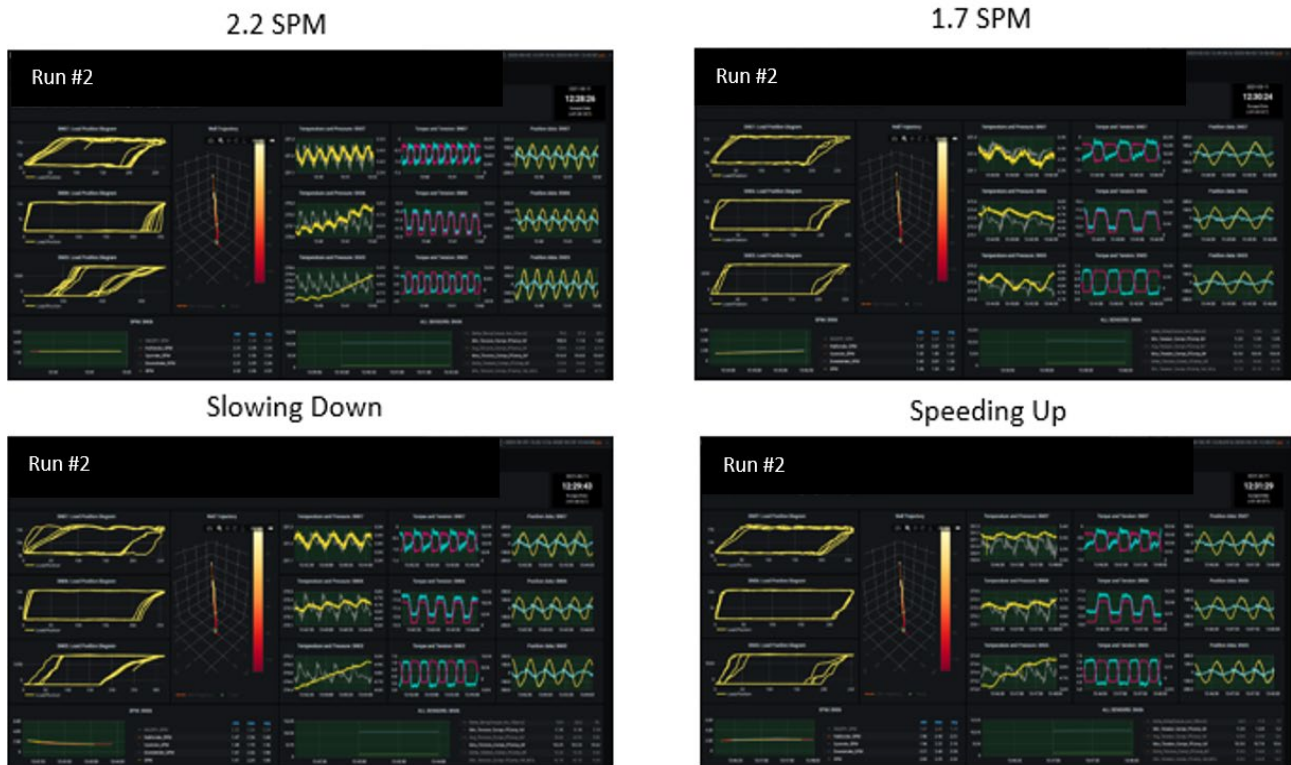
**Figure 16 – Measured Dynacards Plots**

Run #2, from Top Left system running at 2.2 SPM. Top and middle cards out of sync. Bottom Left, as the system slows down the shape of the top and bottom cards start to align. Upper right plot, the system is running at 1.7 SPM, all three cards are aligned. Bottom right, system is speeding up, cards show system beginning to have alignment issues.

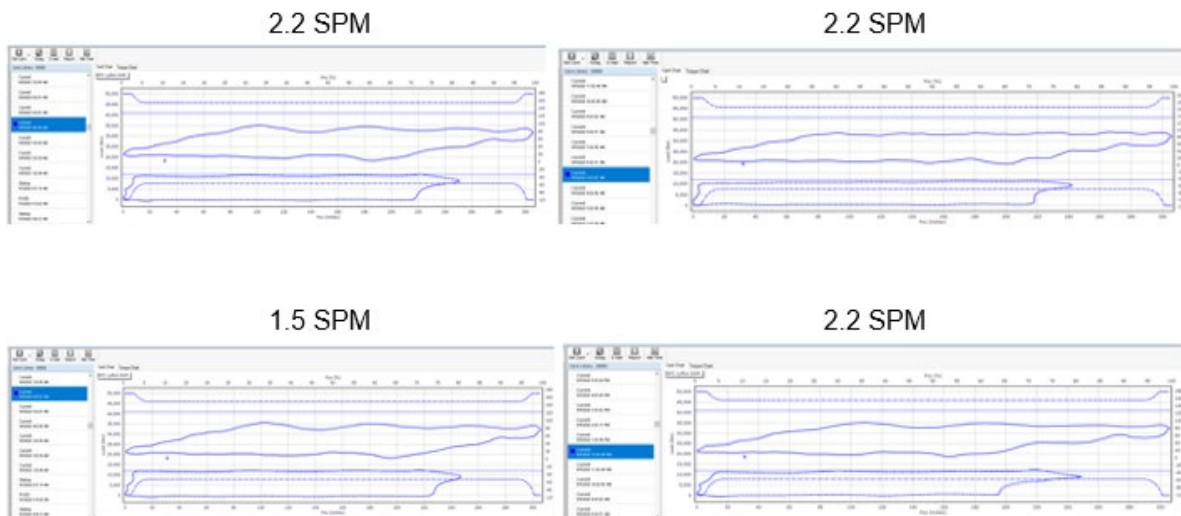
**Figure 17 – Predicted Dynacard Plots**

Predicted cards do not show string alignment issues with SPM changes.

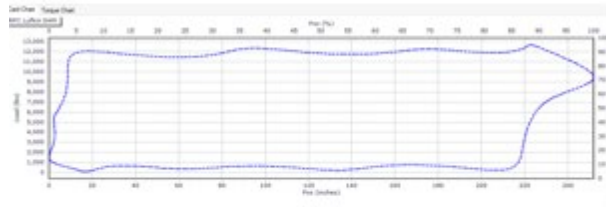
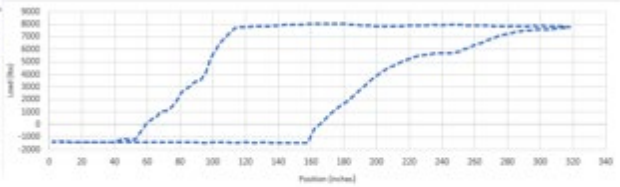
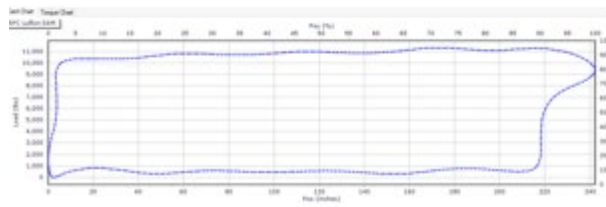
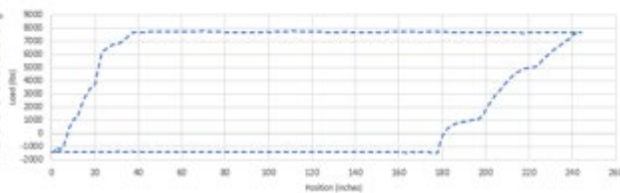
## Figure 18 – Predicted vs Measured Dynacards

Predicted cards on left-hand-side do not show a difference when the SPM decreases from 2.2 SPM in the upper left, to 1.5 SPM in the lower left. But when looking at the subtle speed reduction for the Measured cards (2.2 to 1.9 SPM) on the right, we see a significant difference. At Speeds of 2.2 SPM the measured card is seeing the effects of the increase in rod/tubing rubbing, which has led to several tubing leaks in the past few years.
