# MINIMIZING FAILURE FREQUENCIES IN THE MIDCON AREA BY ROOT CAUSE FAILURE ANALYSIS (RCFA) METHODS AND DESIGN OPTIMIZATIONS

Oscar E Martinez, Solutions Engineer  
Weatherford

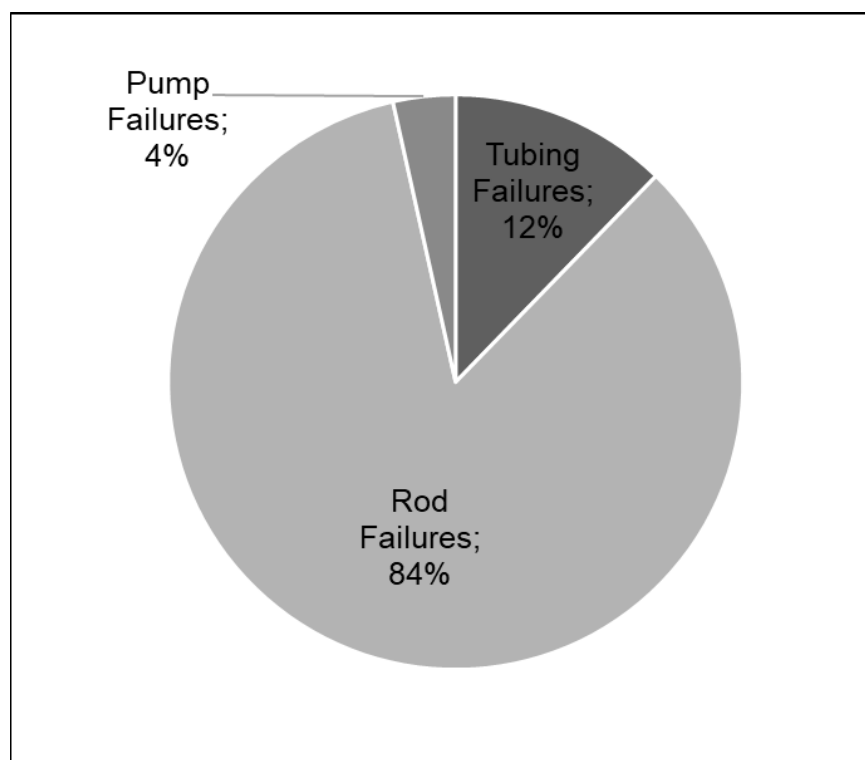
Figure 2 – Failure categories observed in the 1-year failure review.

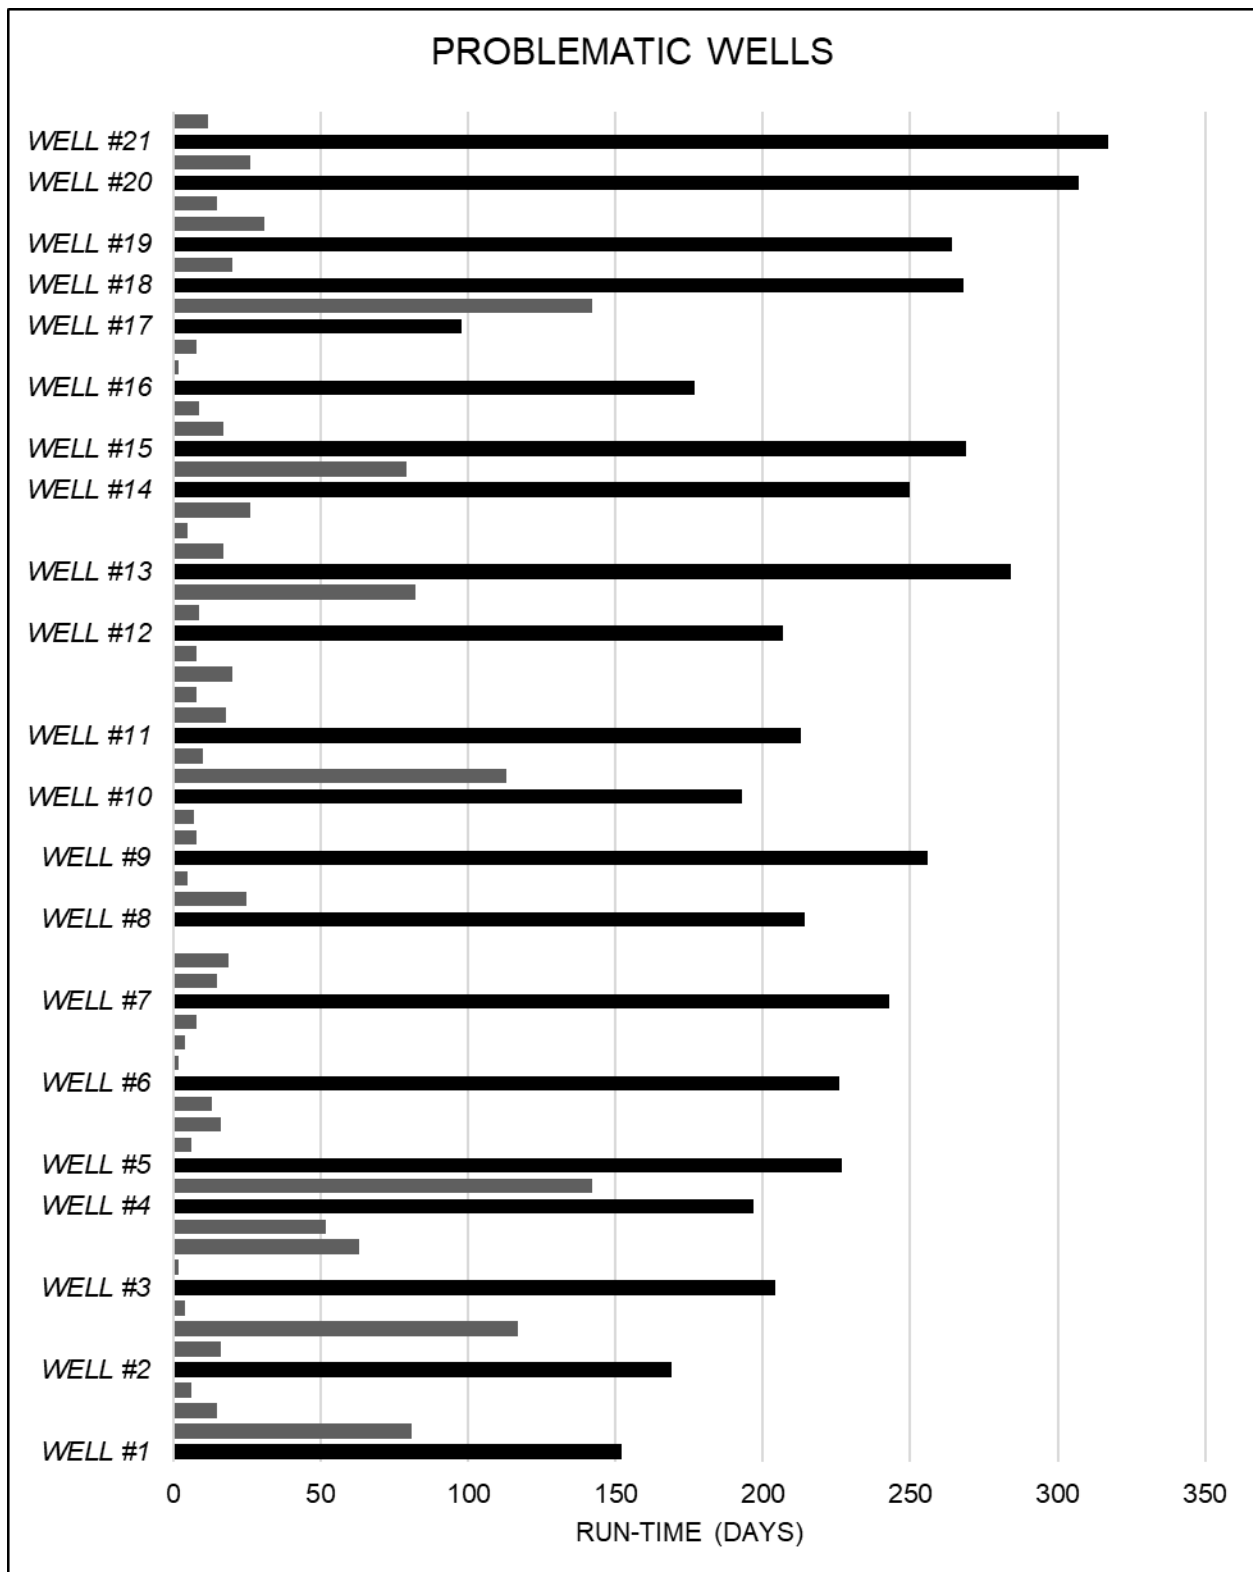
After 1 year of run-time and experiencing multiple failures, a complete root cause failure overview was performed. This overview focused on the failed components, failure locations in relation to the well depth, fracture surfaces and metallurgical failure report. A total of 21 wells were identified as problematic, having more than one repeated failure during this time frame. 57 total failures had occurred which were categorized as: pump failures (2), tubing failures (7), and sucker rod failures (48); see Figure 2. When the rod failures were matched with its respective well, it was noticed that approximately half of the rod failures were repeated failures, meaning not the 1<sup>st</sup> time the rod parts. The repeated failures averaged a run-time of 19 days whereas their 1<sup>st</sup> time run averaged 228 days; see Figures 3 – 5.

Figure 3 – Problematic wells identified with its 1<sup>st</sup> time run times (black) and repeated failures (gray).

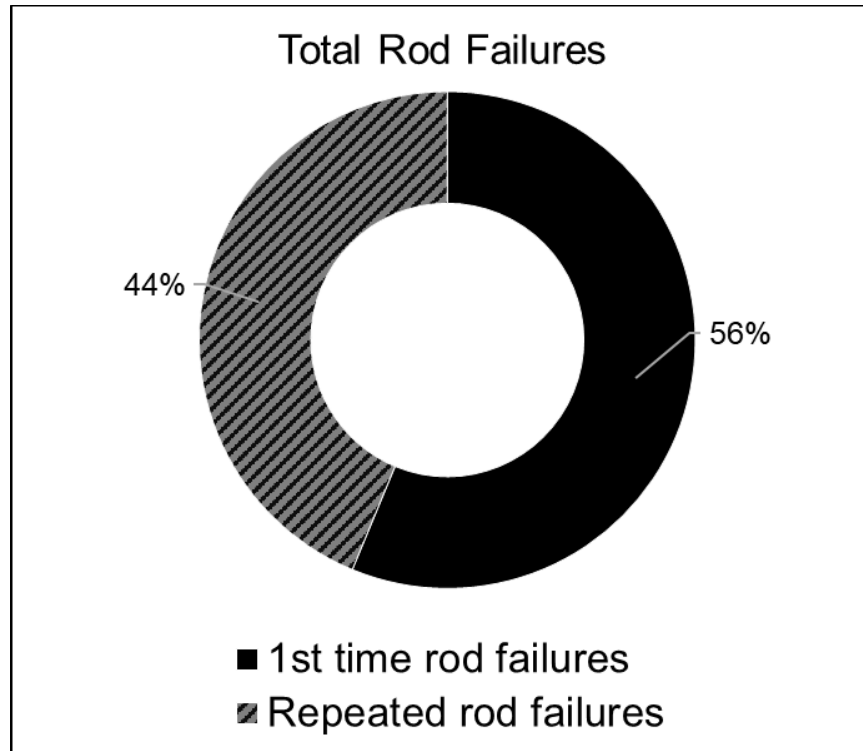
Figure 4 – Total rod failures showing the breakdown of repeated failures.

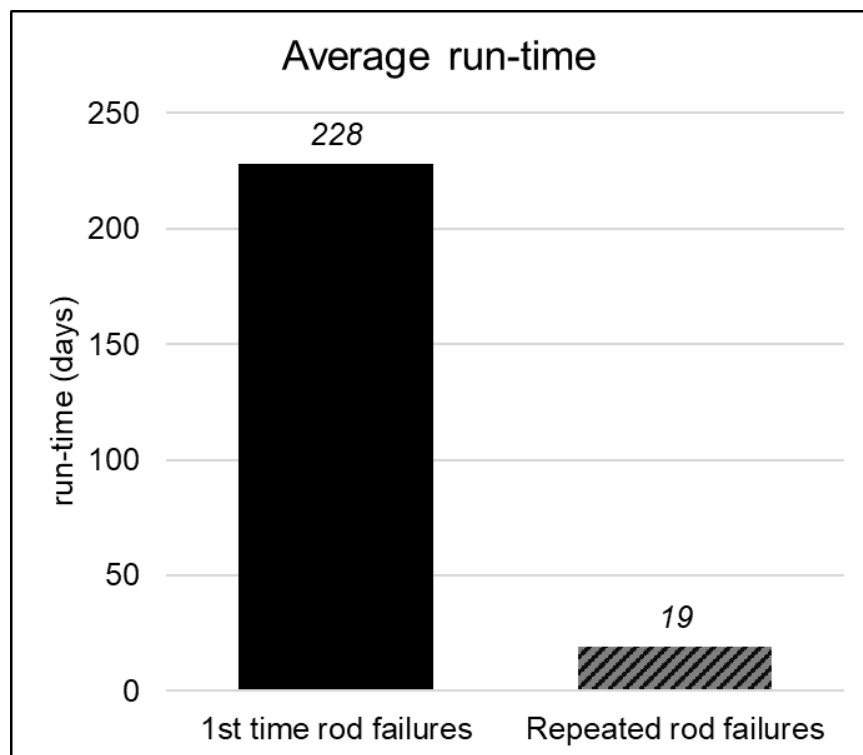
Figure 5 – Total rod failures showing the breakdown of repeated failures.

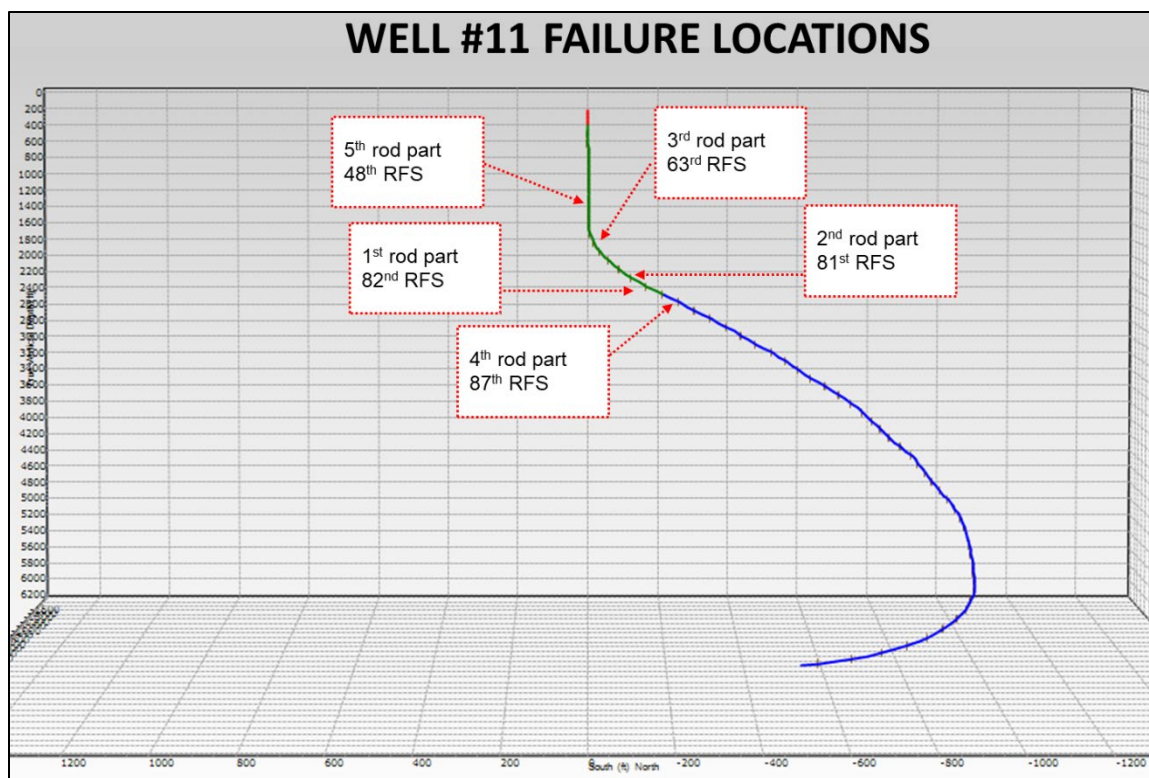
The failures were then plotted based on the rod location in the well. The intention was to determine if there was a failure pattern on higher stress areas; such as tangent sections, heavily guided areas, rod taper transitions or if it truly was random break locations. Based on the various plots completed, a definitive pattern was observed in most of the problematic wells, for example well #12 presented all of its five rod failures within 1,000' section located at the top tangent section; see Figure 6. Another example was well #5 with four of its failures all occurring along a 700' section underneath a heavily guided taper transition zone; see figure 7.

Figure 6 – Well #11 wellbore deviation with its five rod failure locations plotted.

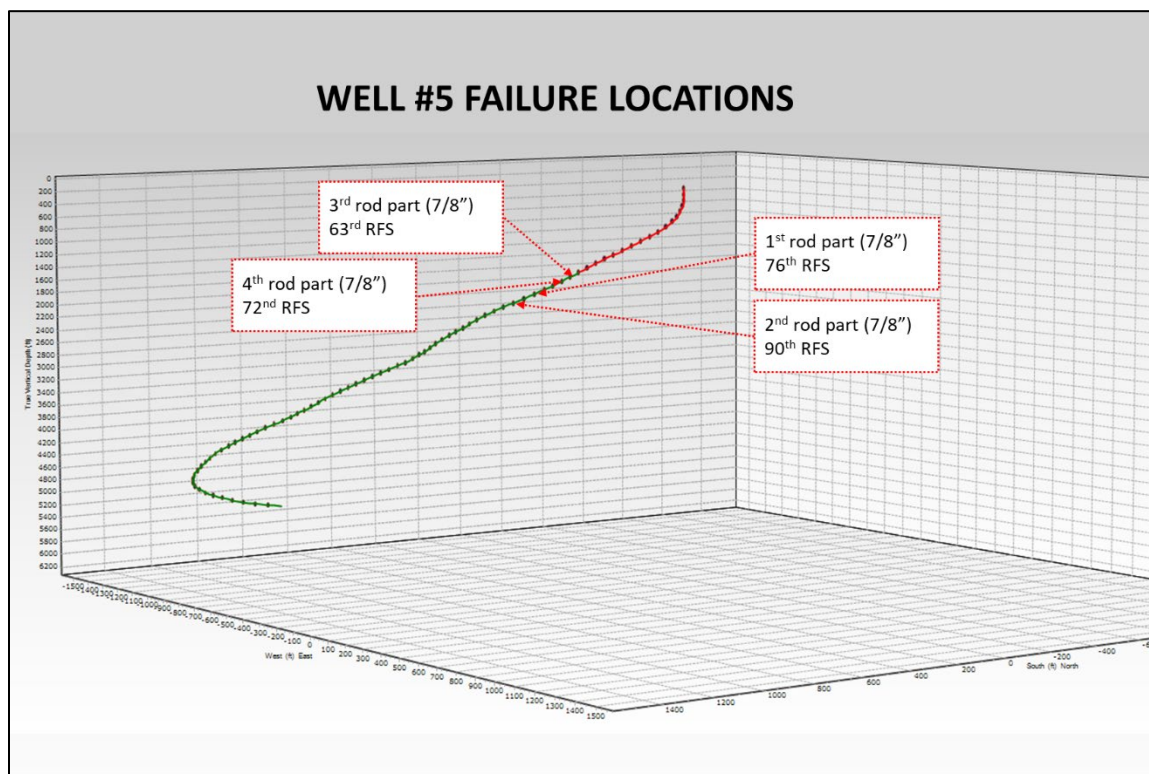
Figure 7 – Well #5 wellbore deviation with its four rod failure locations plotted.

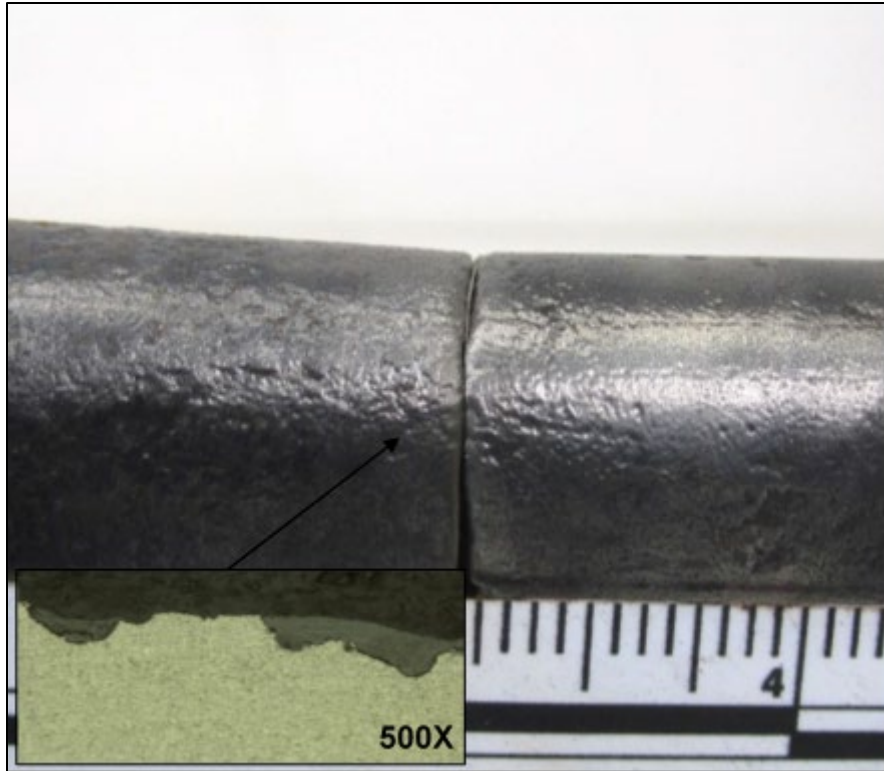
Along with the visual representation of each failure in relation to the wellbore, a metallurgical failure report was generated on various parted rods to better identify a root cause of failure. Based on the generated reports, it was concluded that most of the failures were corrosion-fatigue related with flexural loading conditions observed. Also observed was the fact that several of these failures were occurring at the end of a molded guide section. Although not necessarily failures, significant corrosion was observed on the T-couplings at the time of the analysis; see figures 8 – 11.

Figure 8 – Rod break presenting corrosion, metallurgical analysis confirming pitting (bottom left).

To prevent further corrosion, a batch chemical program has gradually been implemented on most of the reciprocating rod lift wells. Moving away from T-couplings and running spray metal instead has also been another corrective action taken. The rod of choice has been standardized to the KDP (mid-strength) due to its higher impact properties and added strength benefits as compared to the KD. Furthermore, the guide mold has been upgraded from 7" to 9" length low turbulence guide which is molded with a gradual taper at the ends to minimize the turbulent flow and prevent accelerated corrosion.

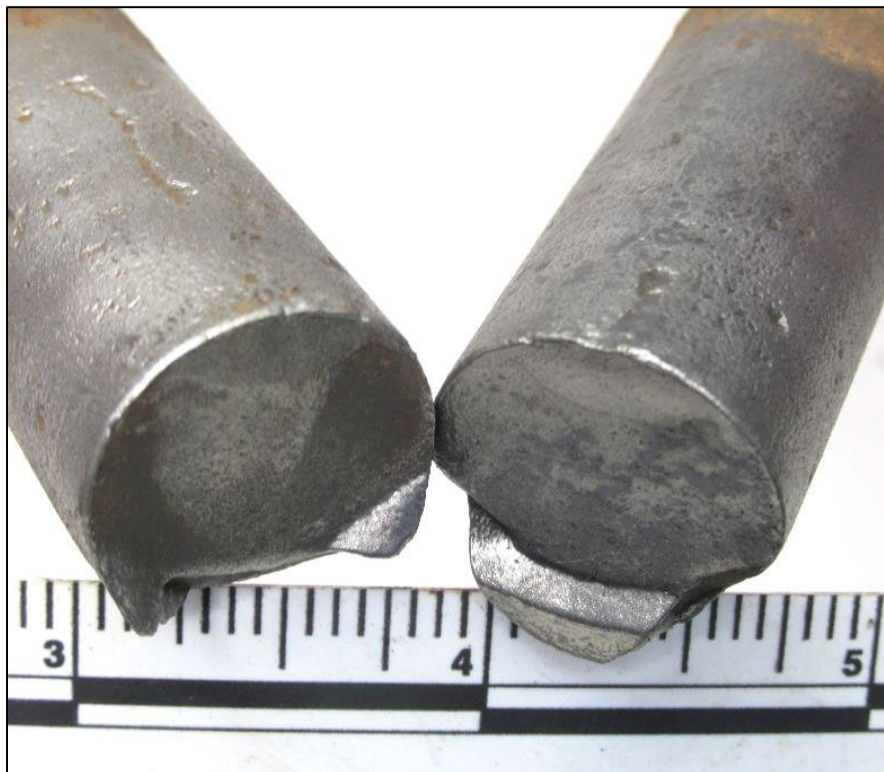
Figure 9 – Rod break presenting corrosion at initiation and flexural loading conditions (dual shear-lips).

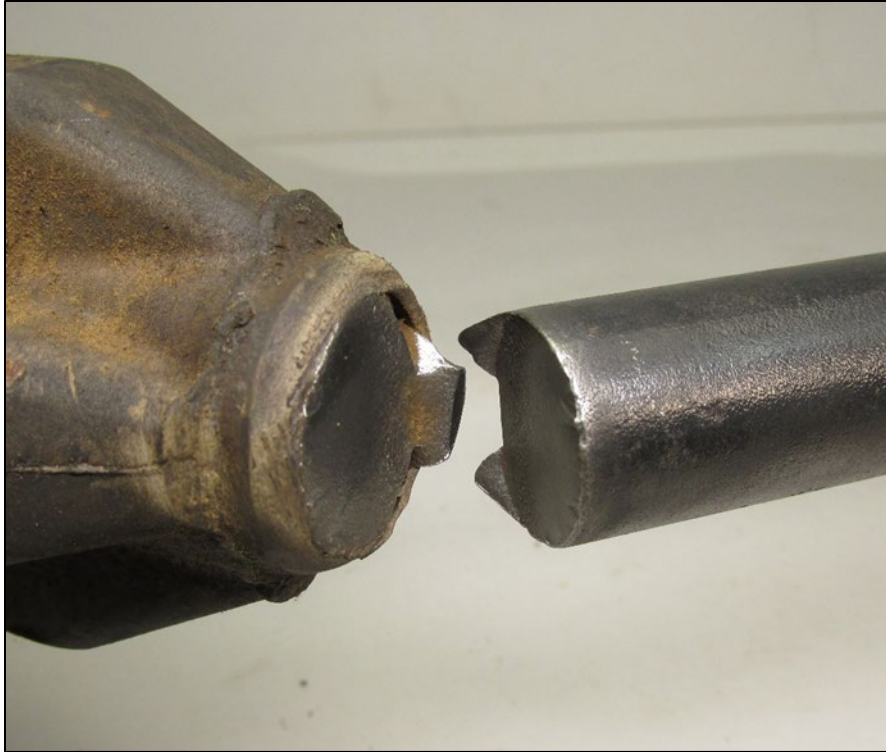
Figure 10 – Rod break occurring at end of molded guide section with flexural loading conditions.

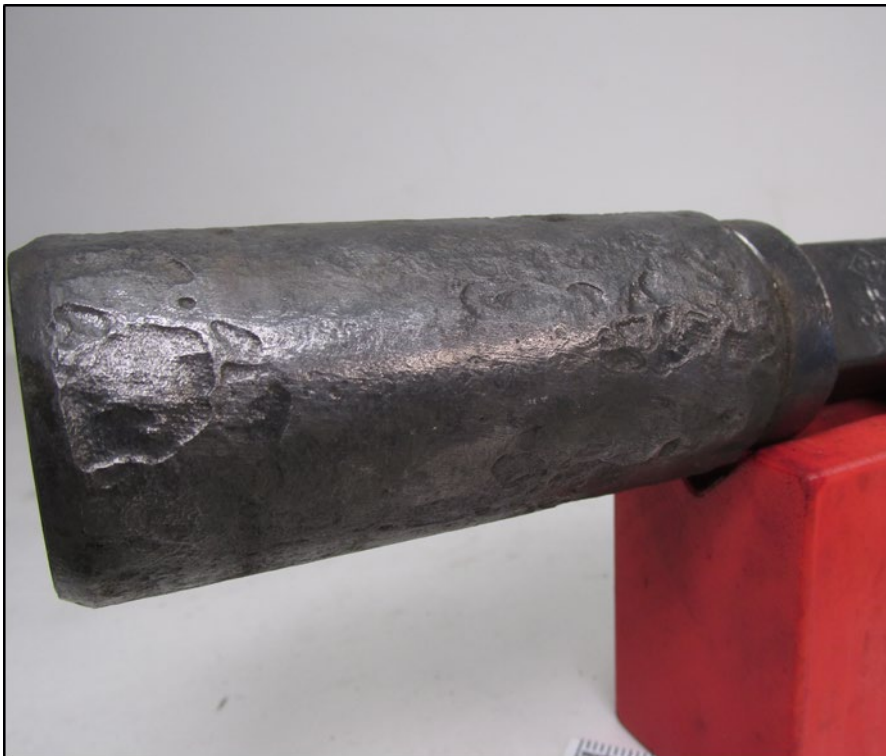
Figure 11 – Significant corrosion attack on T-coupling observed.

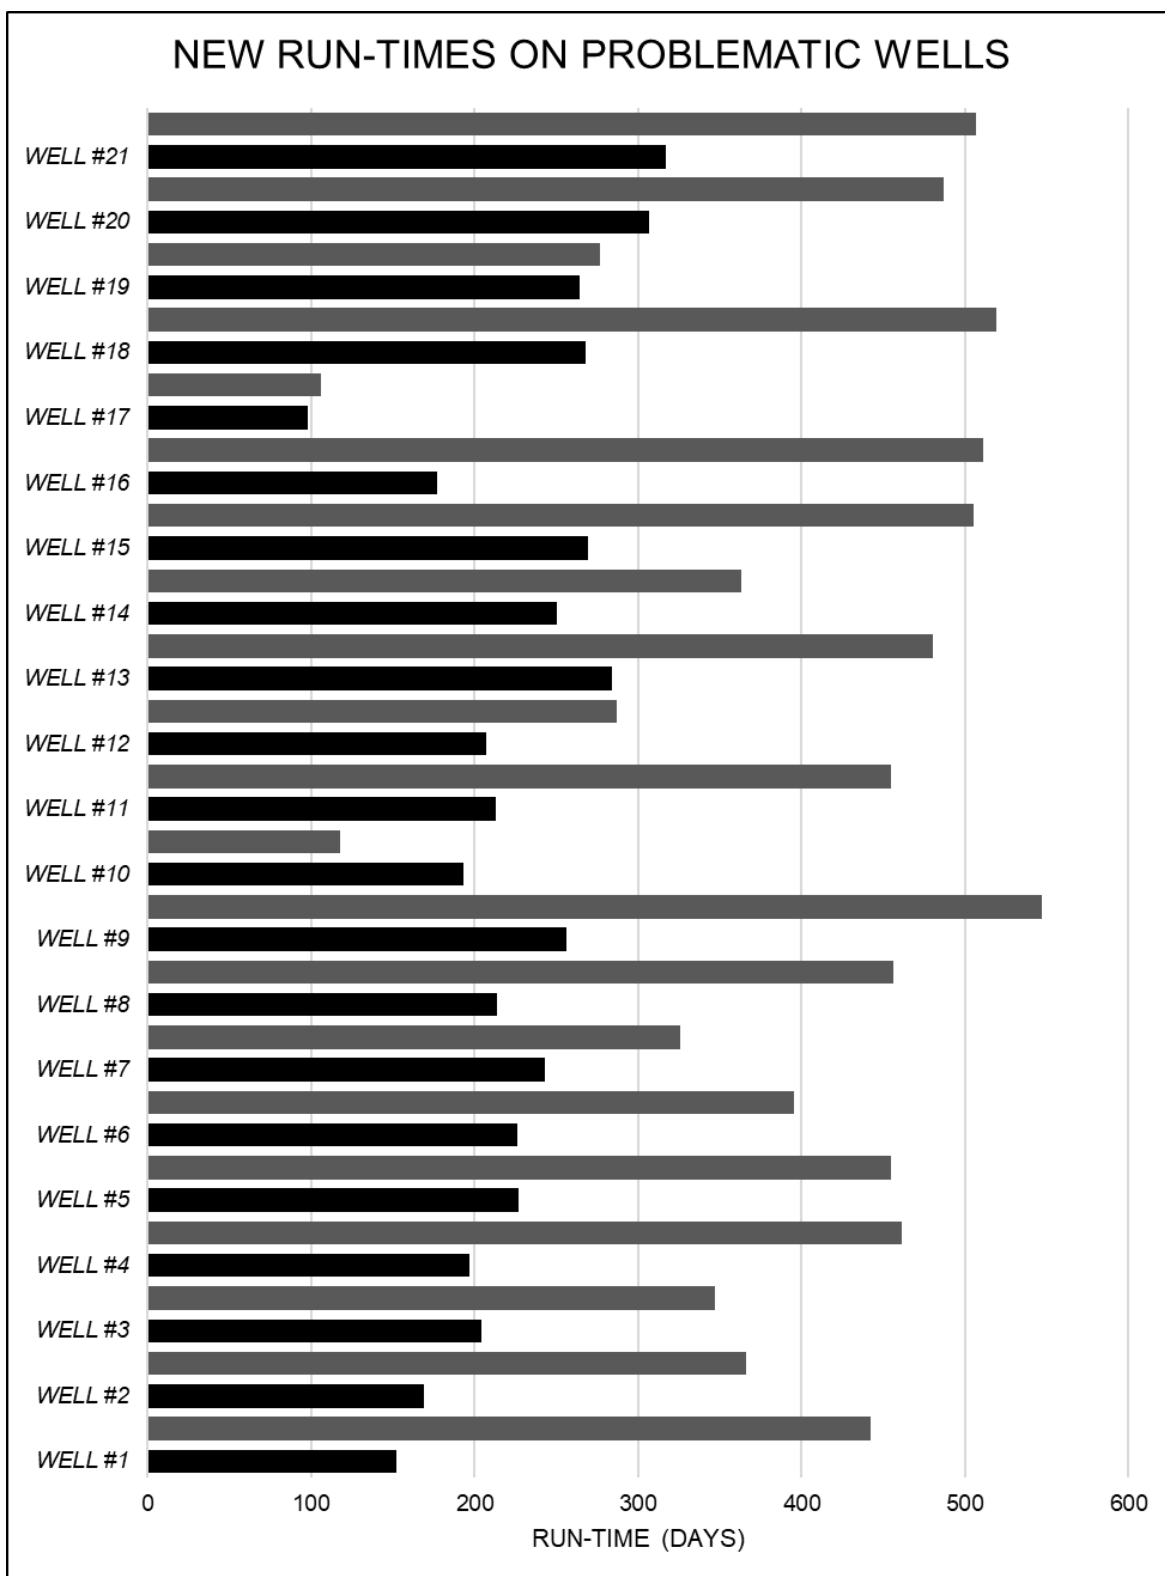
All these corrective actions have been implemented on new RRL conversions in 2020 – 2021. Though, on the current beam pumping systems, gradual implementation of these actions has been carried out. It is dependent on the well economics if a new string is installed but so far, the results have been positive as average run-time have increased from 228 to 400 days, see Figure 12.

Figure 12 –Post- corrective actions, wells identified with its 1<sup>st</sup> time run (black) and new run-times (gray).
