# **GAS LIFT TEAR DOWN DATA ANALYZATION & UTILIZATION OF DATA TO IMPROVE PRODUCTION**

Brett Fox  
Weatherford

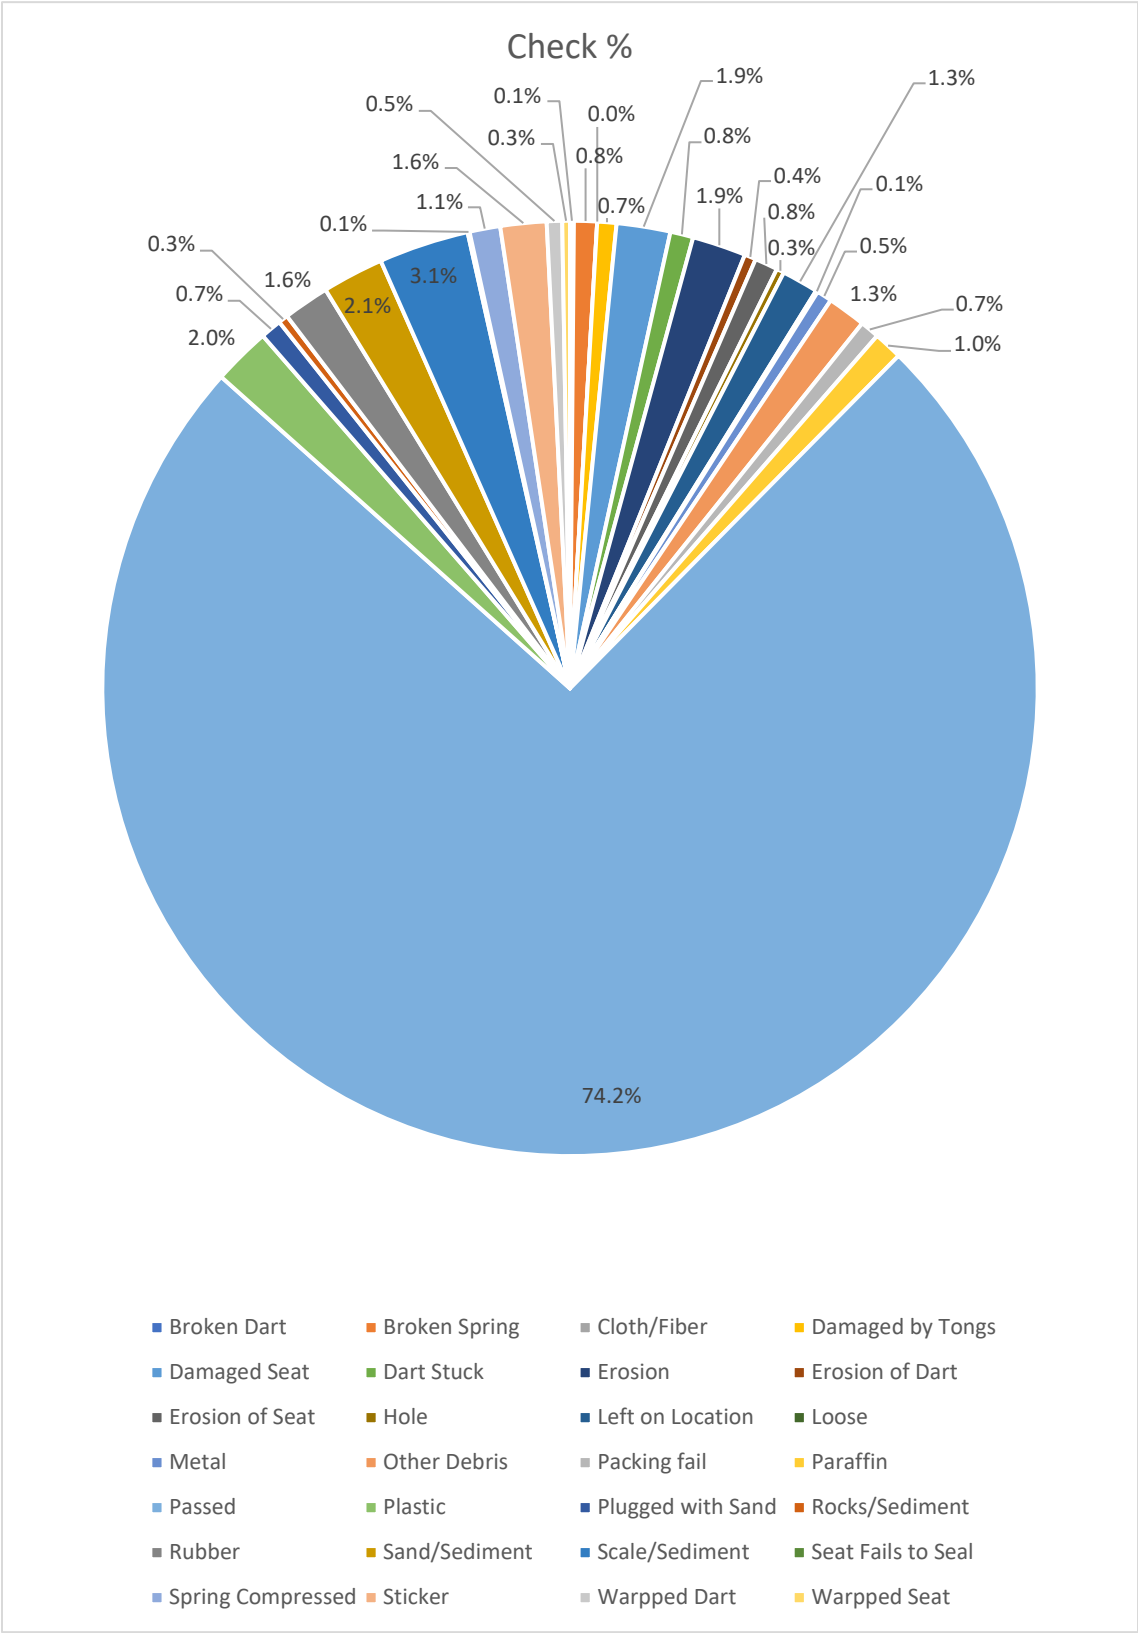
Figure 2:

Data from 2022 has shown the biggest contributors to valve malfunctions are sand, sediment, stem erosion, and scale (Figure 1). Scale, sand, sediment, and debris (Figure 2) are the largest contributors to check valve leaks. Holes in the mandrels, second only to mandrels being left on location (Figure 3), shows to be a large contributor to gas lift failure which has led to many Permian operators to increase the quality of mandrel coating and make metallurgy changes in mandrels themselves. Figures 4, 5, and 6 show the test results of the individual equipment that we started recording in 2022. The data from 2021 and 2022 have been compared to show trends in run life and equipment pass rate. This data should be considered new, but also important as trendlines can be established with as little as 2 years of data collection. Weatherford has already taken steps using this data to help reduce these issues by improving current procedures and equipment, developing new equipment, and conducting training classes to help educate the industry on why these issues occur.
