# IMPROVED WELL ANALYSIS FROM DEPTH-BASED TUBING INSPECTION PERFORMED IN A FACILITY

Brian Wagner, RTS

Courtney Richardson, OXY

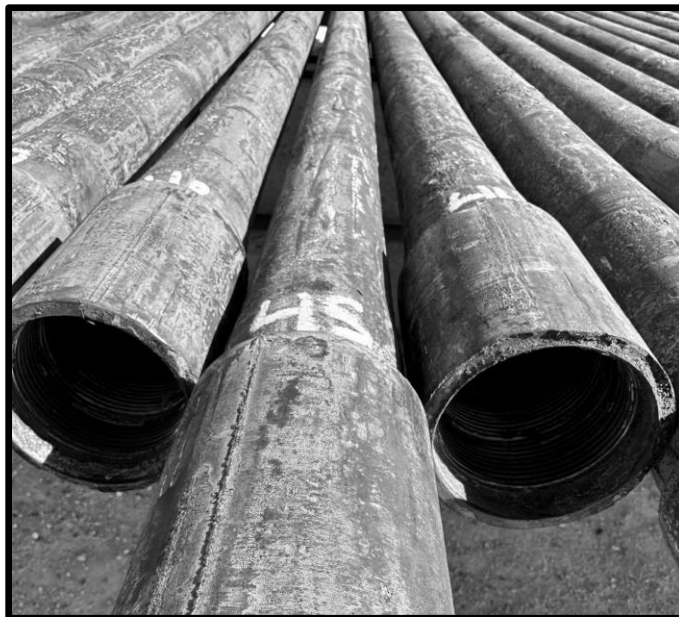
When tubing is pulled from the well it is racked out in sequence where it can be wiped clean of fluid and debris six to twelve inches from the collar. Each joint is labeled horizontally below the collar in order out of the well with a paint marker to ensure that the best data is captured once at the facility (see Figure 4). It is imperative that chalk is not used or labeling take place on the collar because it was discovered that these methods of identification yielded poor results following transport. These joint values are then captured at the facility as the asset is processed. Once the tubing has been inspected at the facility, the results of each joint are digitally rearranged according to the order they were pulled from the well. The result is a simulated depth-based inspection where the data is then used to create a well profile (see Figure 5). This useful graphical tool aids in downhole troubleshooting, failure analysis, and design optimization. All the inspection information is managed in a software database for streamlined access for all personnel involved in well operations. This platform serves as a historical archive where past data can be reviewed, allowing for side-by-side evaluation the next time the well goes down (see Figure 6). Through this process, in-facility inspections demonstrated that they could integrate some benefits traditionally exclusive to wellsite scanning. This development enhances the overall merits of in-facility inspections, establishing it as the preferred method.

Figure 4 – Proper placement of joint label.

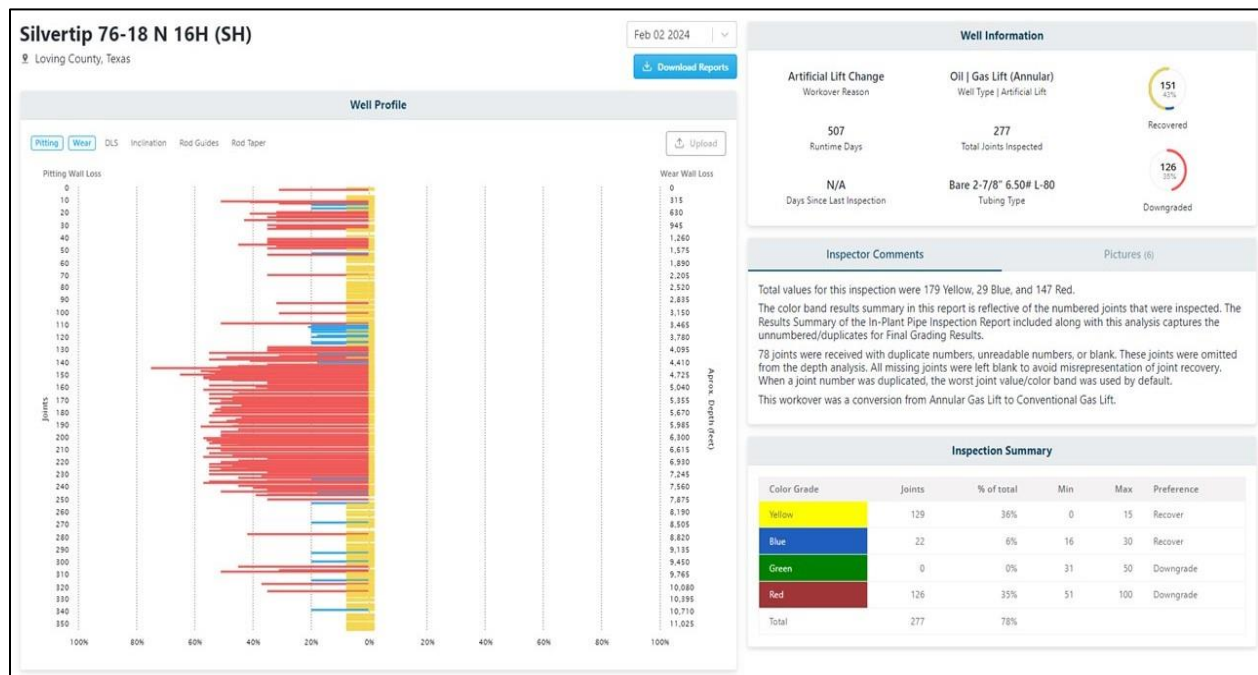
Figure 5 – Digitally generated well profile based on in-facility inspection.

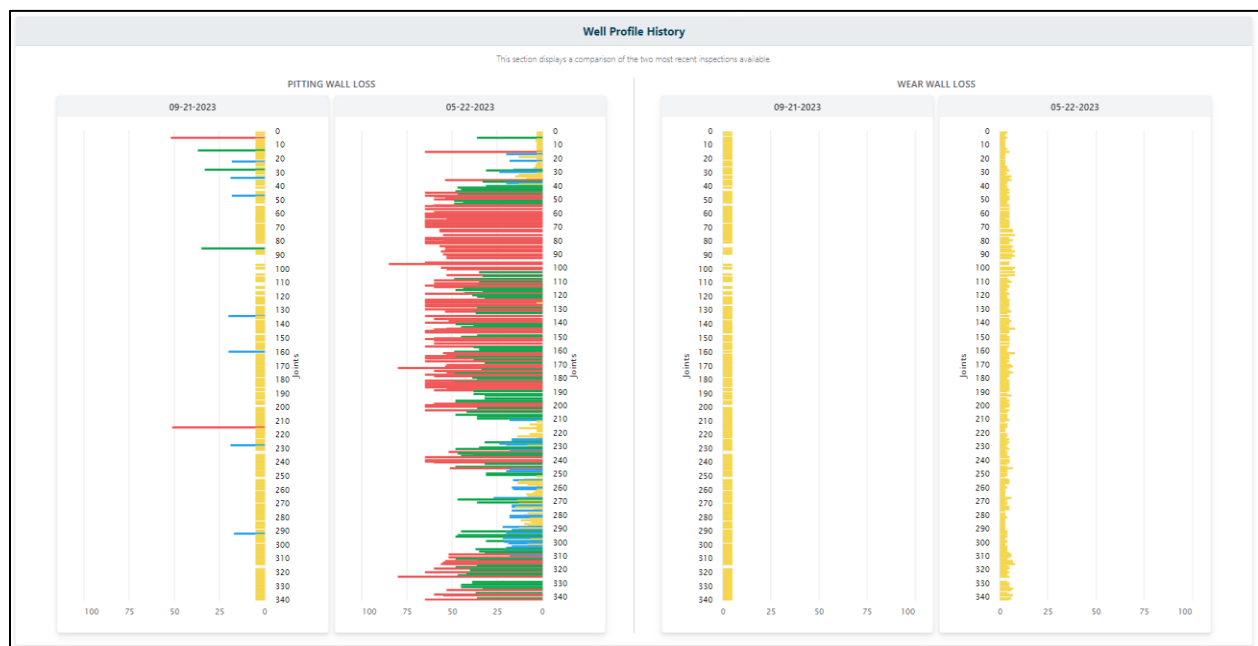
Figure 6 – Side-by-side inspection results for the same well taken at different points in time.

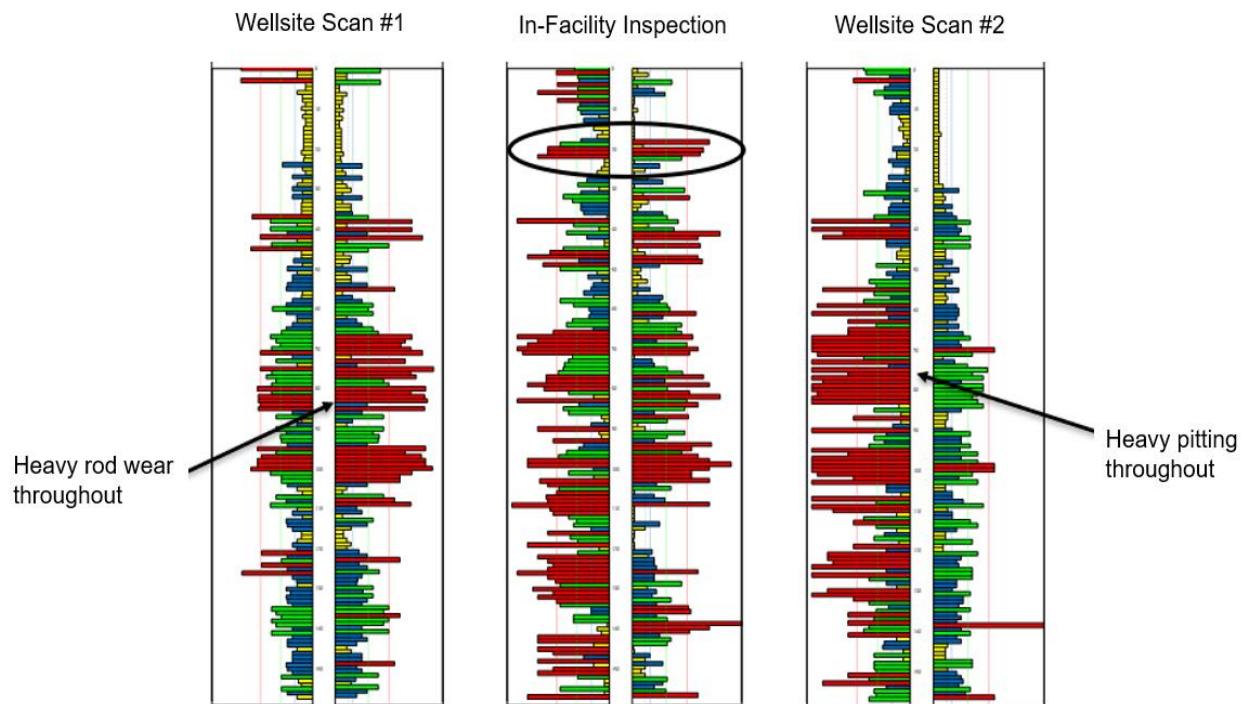
Through the conducted field trials comparing wellsite scanning to in-facility inspection, valuable information about specific conditions that significantly influence the outcome were discovered. The first well evaluated was a San Andres well approximately 5000 feet deep. It was chosen because it had a relatively short run time following a repair in December of 2020 where tubing was scanned prior to reinstallation. The subsequent failure was a tubing leak in April of 2021. When the tubing was scanned by both companies at the wellsite, neither piece of equipment was able to identify the hole but was visually located by the rig crew in the upset area during the second tubing pull. This validated the aforementioned limitation with wellsite scanning equipment and exposed the potential risk of putting this joint back down hole if it was not found visually. Any defect in the end area is restricted to visual inspection methods in less favorable conditions compared to facility-based inspection. It was also identified through this trial that iron sulfide could be interpreted by a wellsite scan as wall thickness. Both wellsite scans determined tubing joints 18-22 from surface to be either Yellow or Blue Band. Once this material was sent into the facility and cleaned properly, severe under deposit corrosion from iron sulfide was detected. It was determined that these wall thickness misinterpretations from iron sulfide deposits could give the impression that a joint was of good integrity. These same joints were downgraded to Red Band, greater than fifty percent wall loss, following the EMI in-facility (see Figure 7). Given the variance in tubing condition measured, it is likely that another diminished run time would have followed this well maintenance had the tubing been rerun following either wellsite scan. This well was returned to production with an entire string of Yellow Band tubing that had been previously inspected at a facility and ran for 762 days with minimal adjustment to the operating parameters, achieving four times that of the previous failure.

Figure 7 – Inspection results from both wellsite scanning systems failed to identify iron sulfide under deposit corrosion found in-facility.

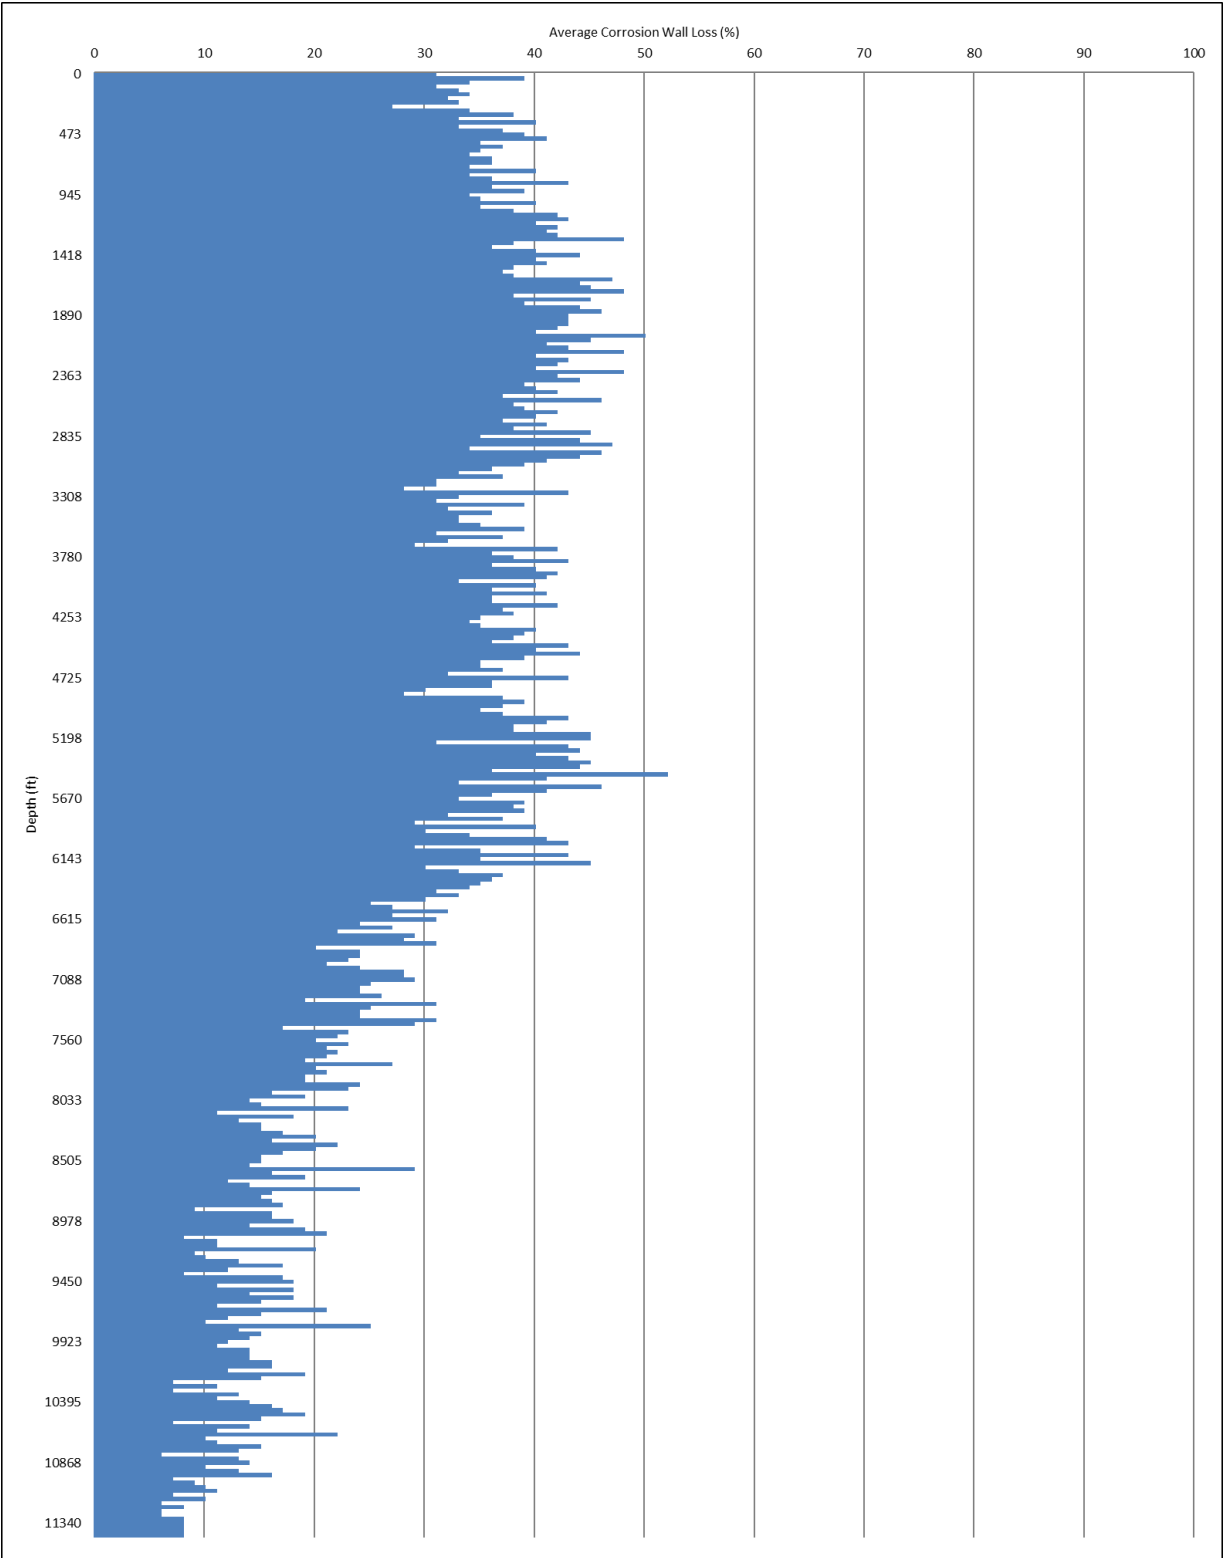
The ability to include depth correlation with in-facility inspection has provided a method to improve well designs using data trends in the entire well profile. This has provided valuable insight when optimizing sucker rod pumped wells showing significant tubing wear even though the high-resolution well survey may not have provided an indication of dog-leg severity in that area. The depth analysis capabilities of these inspections allow for improved run times between well failures when using the results to better design guide configurations in sucker rod pumped wells to mitigate wear. Not only has this adoption benefited wells operating on rod lift but it has also highlighted a recurring issue in annular flow gas lift wells. Through the thorough inspection process, consistent corrosion on the outer diameter of the tubing has been discovered due to high fluid velocities, erosion, and turbulent fluid dynamics (see Figure 8). This occurs predominantly in the areas where the capillary tubing for chemical treatment is clamped. Data modeling is easily comparable with field results when depth correlated inspections identify where lifting is taking place in the wellbore. A positive downward trend in tubing failures occurring within 90 days of a previous tubing failure was achieved through integration of this approach, resulting in more than a fifty percent decline year over year in wells failing in this time interval (see Figure 9). This is directly associated to the improved tubing integrity when installing assets back into a well.

Figure 8 – Inspection trend of annular gas lifted wells from corrosion-based wall loss compared to depth.

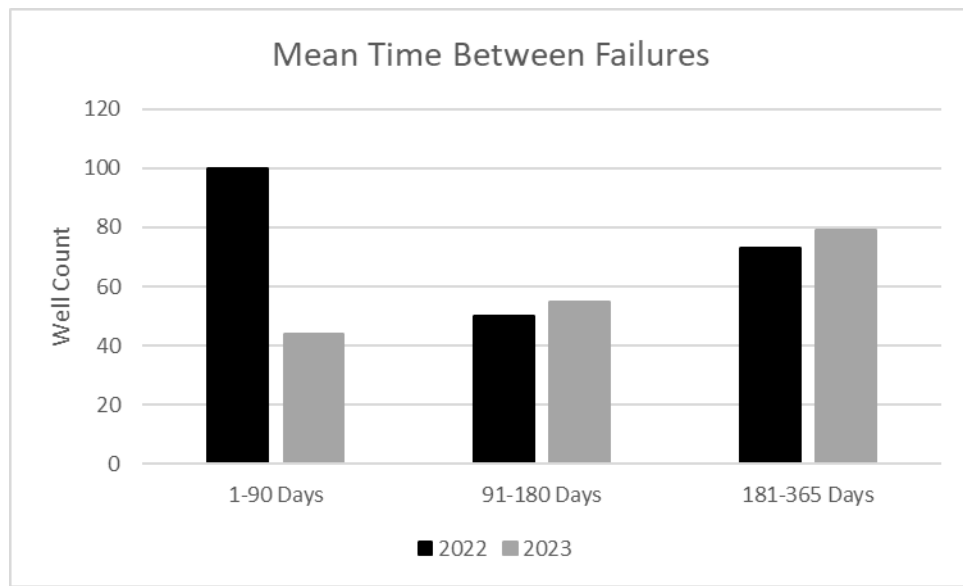
Figure 9 – Well performance measured by mean time between failures year over year.
