# **EMPLOYING THE LV-EMI™ UNIT IN THE GREATER ELK HILLS AREA**

Larry Aldrich, California Resources

Lightning Production Services

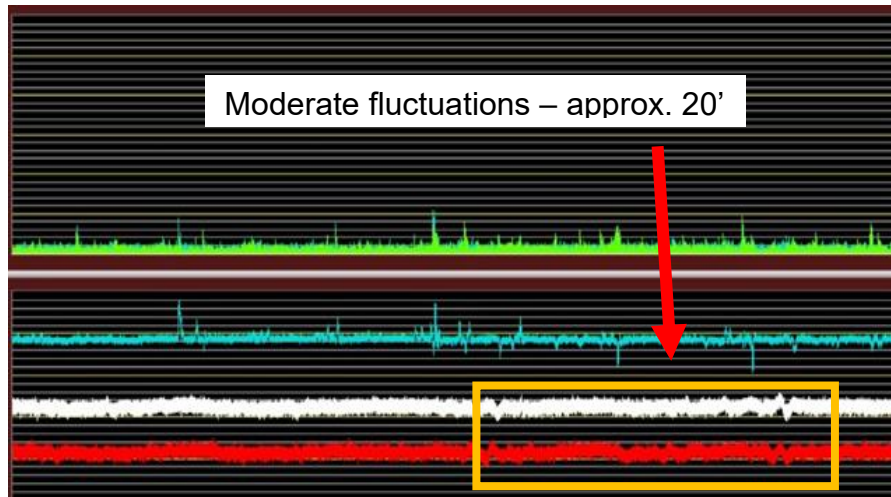
In addition to identifying wear and corrosion, the scanning process has also brought to light the occurrence of rod fatigue, shown in Figure 3. While initially uncertain on the nomenclature of this phenomenon, a pattern emerged: these fatigue indications were consistently present near areas where the rod string would part. This occurrence has now been identified as fatigue within the rod string. These types of indications in the rod string are termed as "MFD fluctuations".

These fluctuations are associated with hardness variations that alter the magnetic permeability properties of the rod string. This transformation is the result from the repetitive stretching and compression that the rod undergoes over time. These fluctuations can vary in magnitude depending on the frequency of strokes per minute and degree of deviation. Typically, the more cycles per day and the more severe the deviations, the EMI operator will observe a higher amplitude on the software. The density of the fluctuations and the length of the fluctuation section will determine how

Figure 3: Rod Fatigue

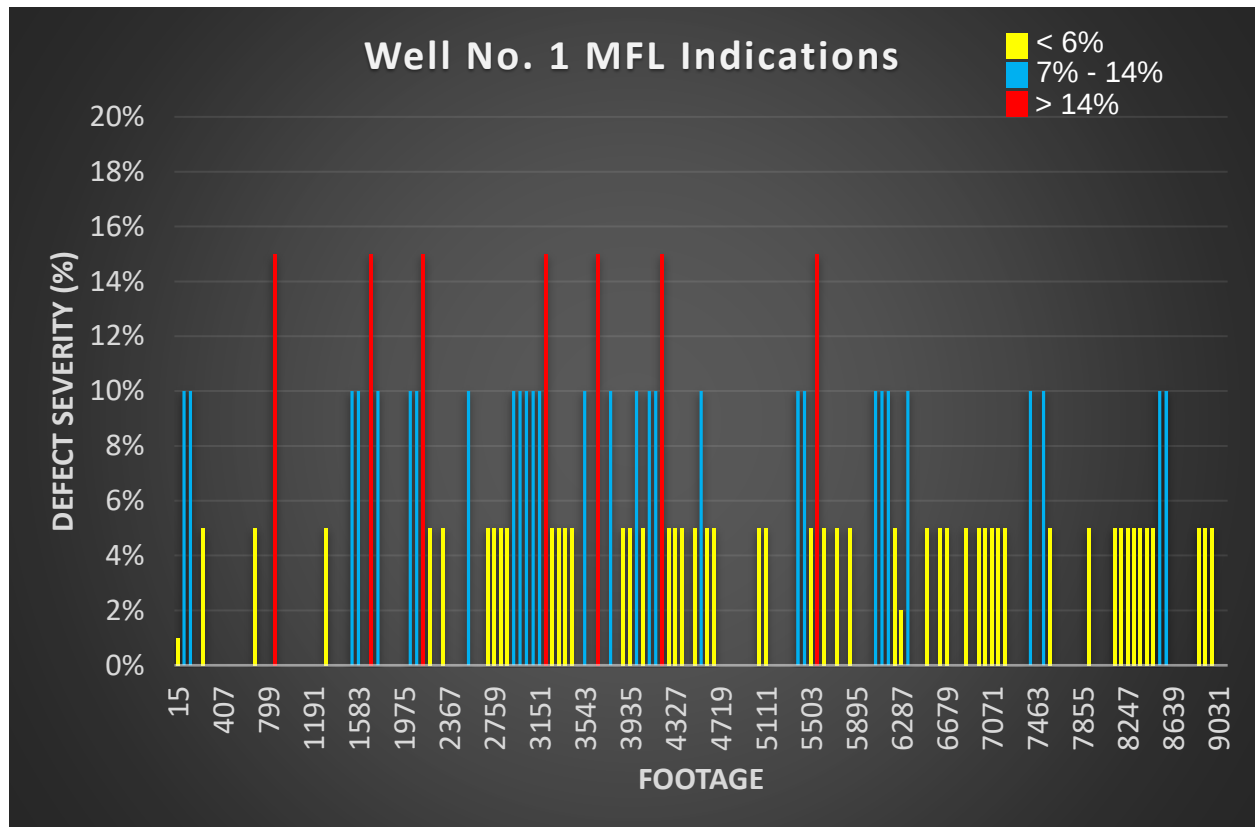
In January of 2022, the rod string was pulled due to pump failure. -At this time, CRC decided to scan the rod string using the LV-EMI™ unit. -The corresponding MFL and MFD indications for this rod string can be observed in Figures 4 and 5. -According to the EMI scan results, the entire rod string exhibited moderate to severe corrosion. -The rod string is graded from blue to red according to the scan. Images of the rod string with severe corrosion and moderate wear can be seen in Figures 6 and 7, marked based on the EMI readings. Based on this scan, CRC decided to retire the string and install a new rod string. It is noteworthy that CRC has not experienced a rod failure to date. Scanning this rod string with the EMI unit likely prevented a repeat rod failure.

Figure 4: Well No. 1 MFL Indications

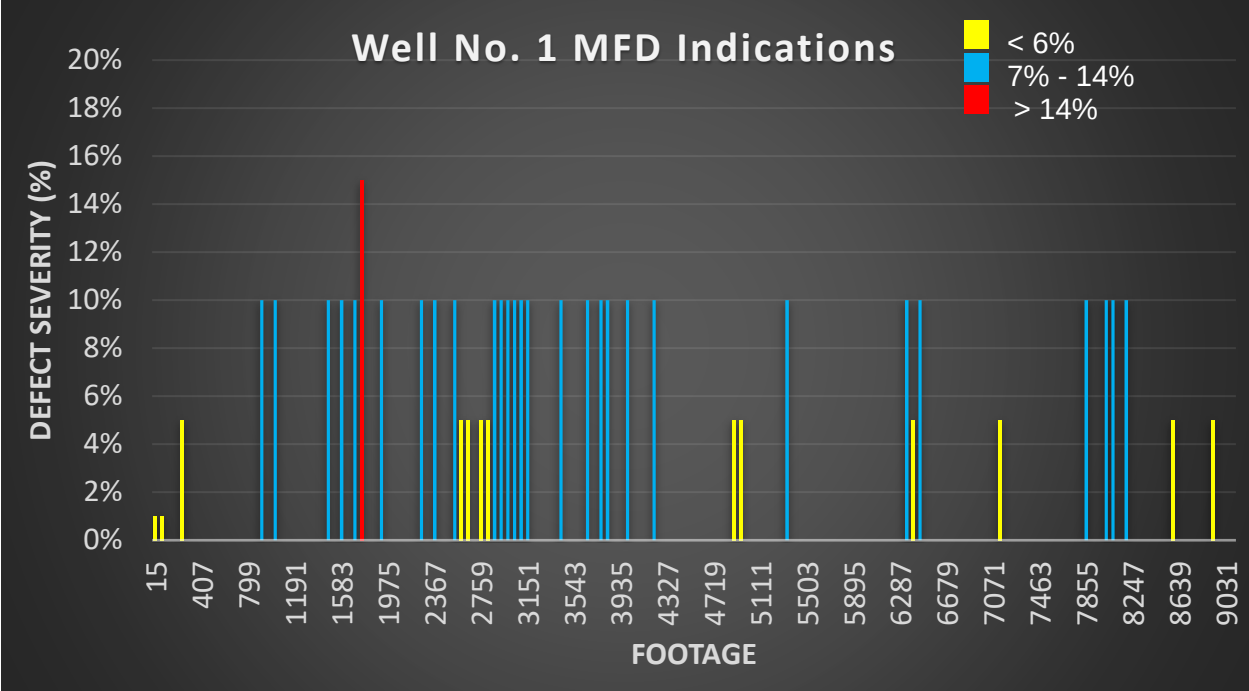
Figure 5: Well No. 1 MFD Indications

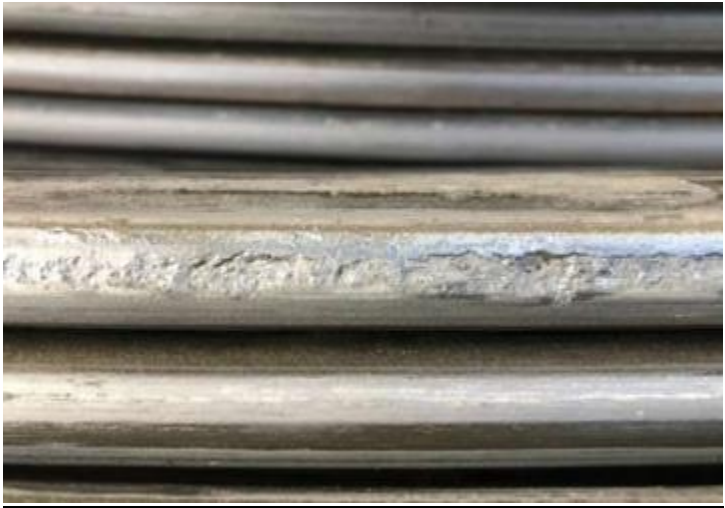
Figure 6: Well No. 1 - Moderate to Severe Pitting

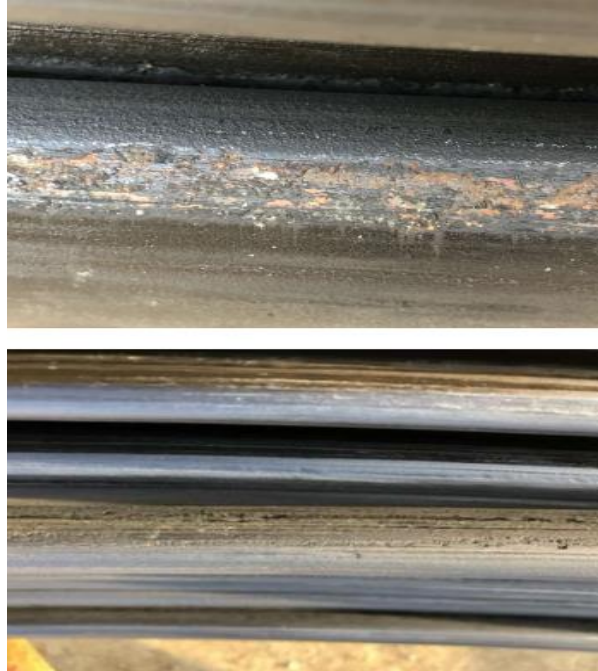
Figure 7: Well No.1 - Moderate Wear

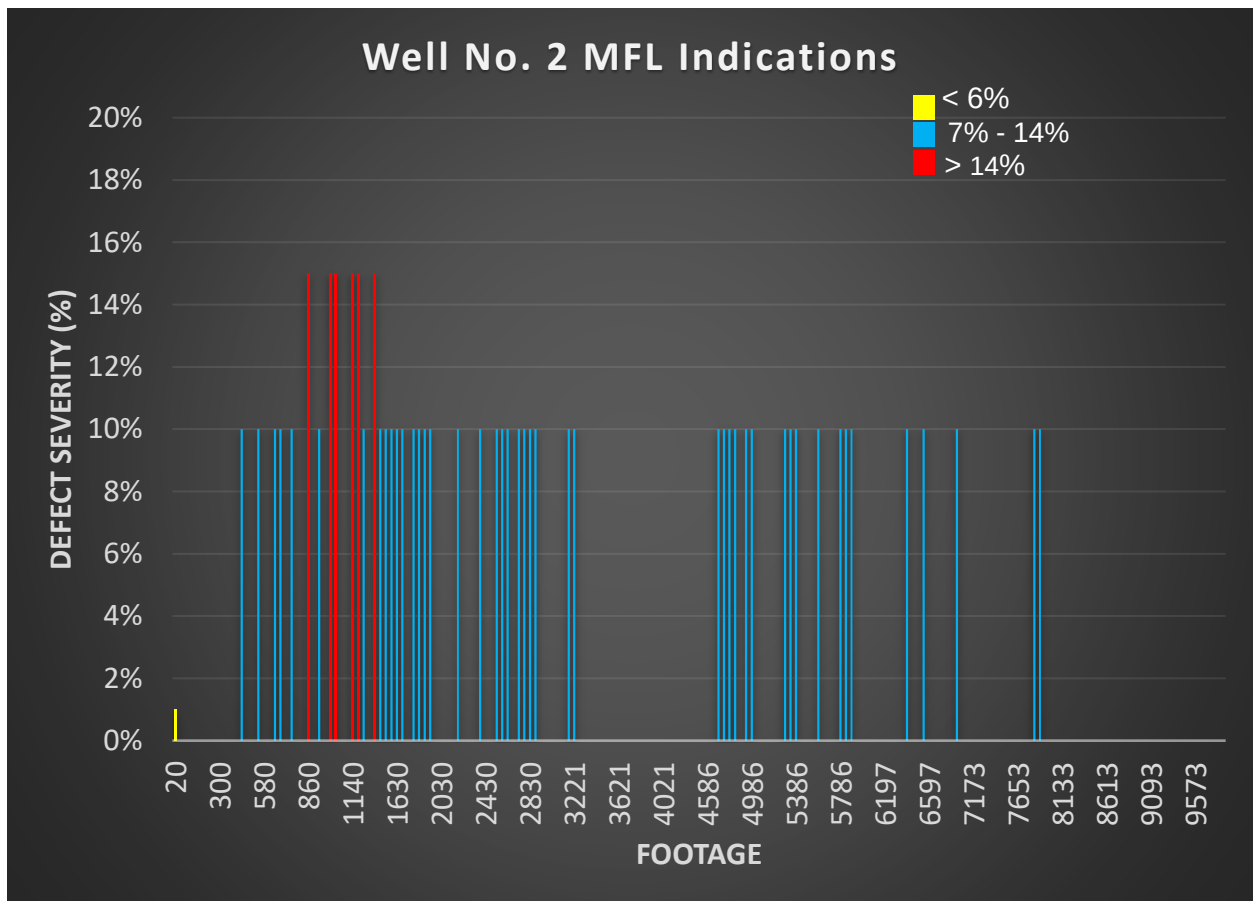
In August of 2022, the rod string was pulled due to a rod pump failure. -This prompted CRC to scan the rod string utilizing the EMI unit. The corresponding MFL and MFD indications for this rod string can be observed in Figures 8 and 9. According to the EMI scan, the top 1,500' of the rod string experienced stress cracking. Additionally, possible

Figure 8: Well No. 2 MFL Indications

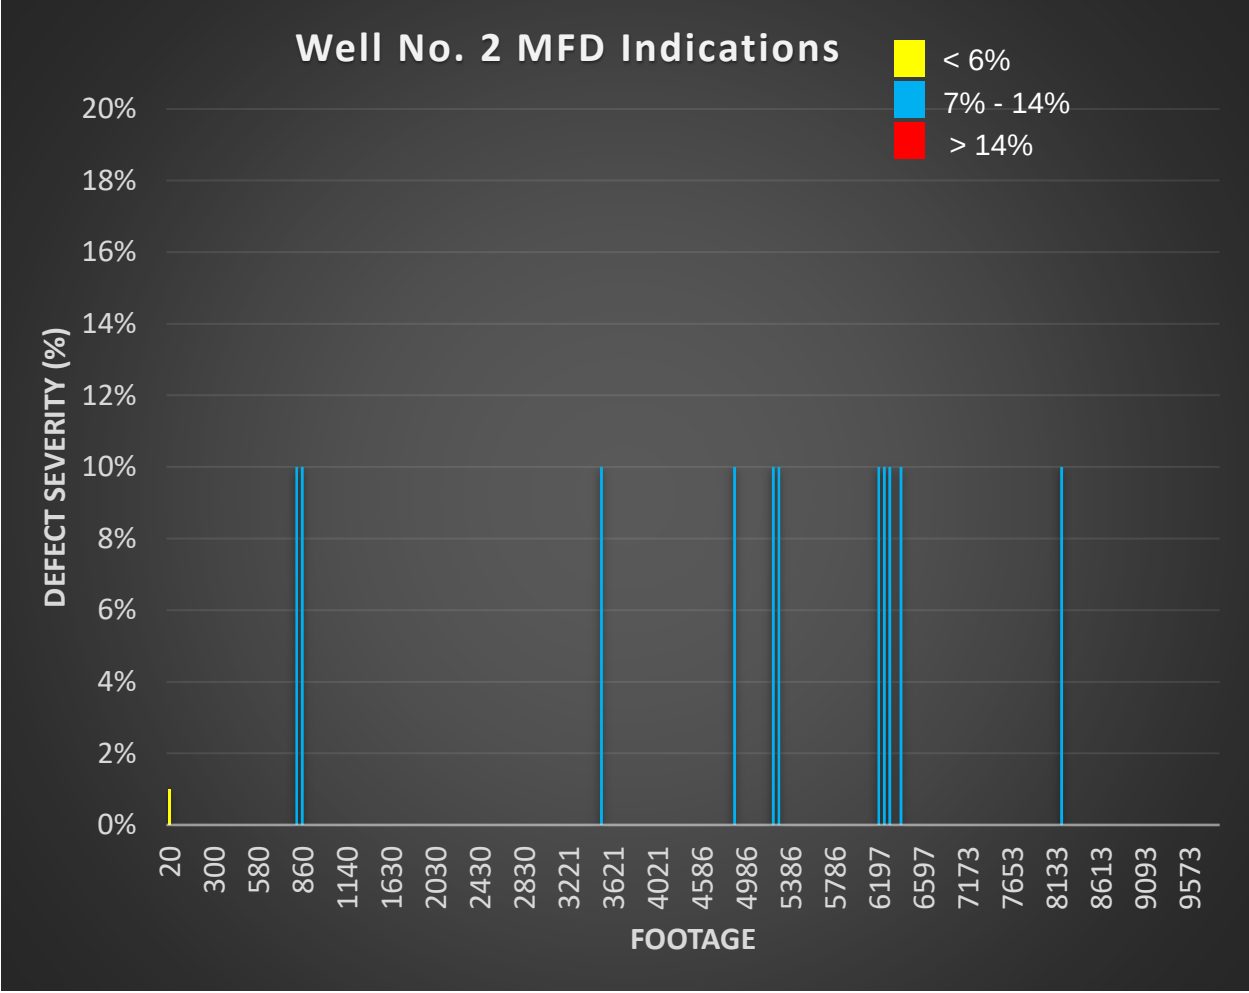
injector damage was detected throughout the entire rod string, with severe damage between 4,500' to 6,500'. MFD fluctuations were also observed from 4,500' to 5,500', indicating rod fatigue. Images of the rod string with stress cracking can be seen in Figure 10, marked based on the EMI readings. -Considering these findings, CRC decided to retire the string and run a new rod string in the well. CRC has not experienced a rod failure to date. Scanning the rod string instead of relying solely on a visual inspection likely prevented a repeat rod failure.

Figure 9: Well No. 2 MFD Indications

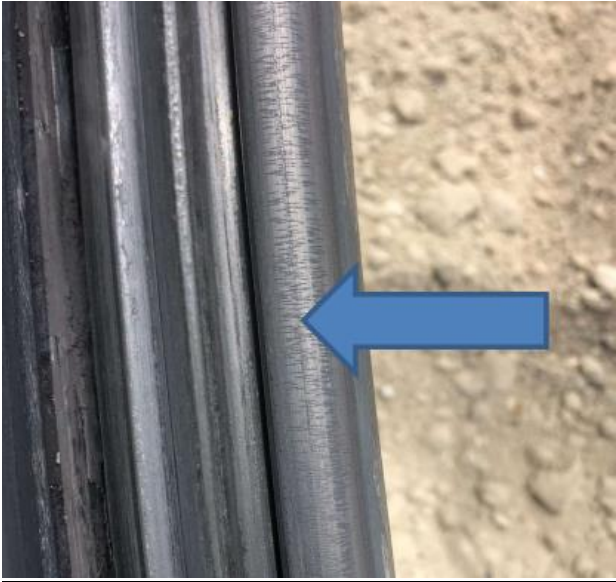
Figure 10: Well No. 2 - Stress Cracking

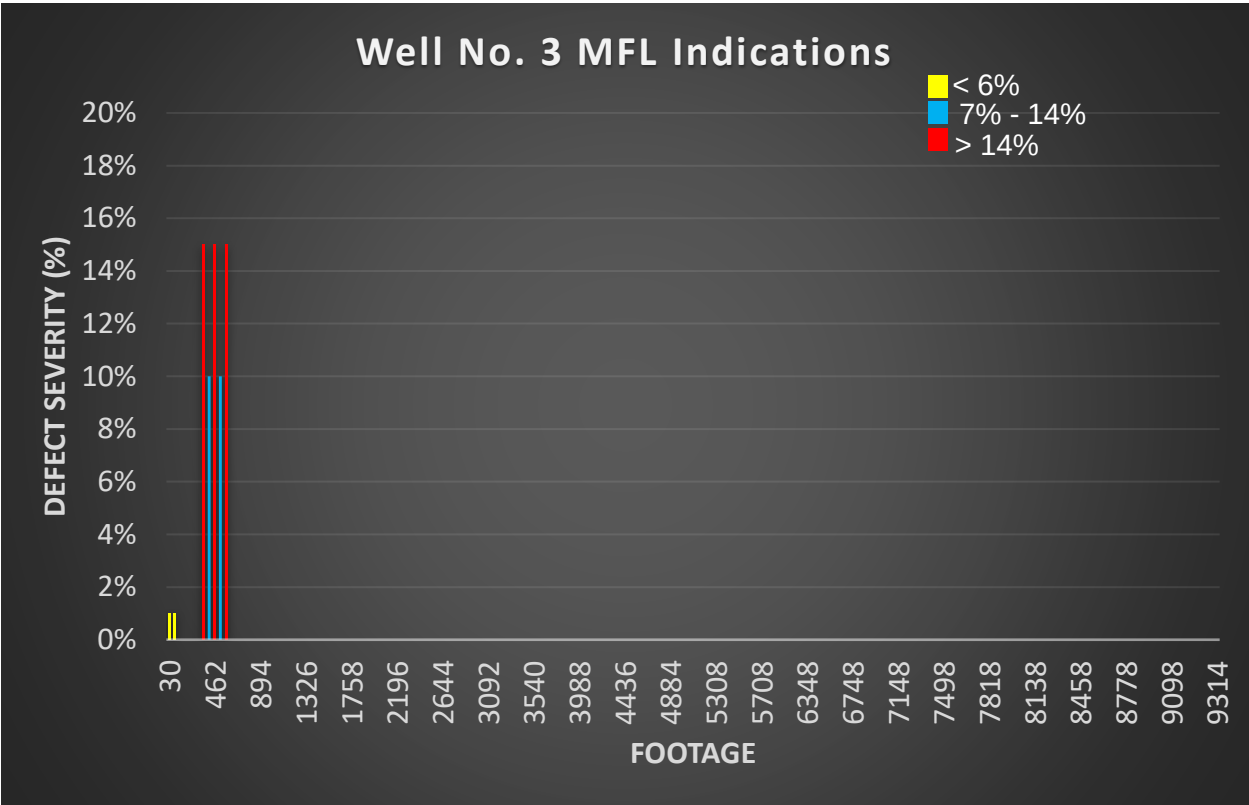
One week later, in November of 2023, the well failed due to a rod part. -This prompted CRC to scan the rod string utilizing the EMI unit. -The corresponding MFL and MFD indications for this rod string can be observed in Figures 11 and 12. According to the EMI scan, the top 650' of the rod string experienced severe pitting. Additionally, the bottom section of the rod string experienced moderate wear. Images of the rod string with severe pitting can be seen in Figure 13, marked based on the EMI readings. - In light of these findings, CRC decided to replace the top 650' of rod. By relying on visual inspection instead of an EMI scan, CRC could have prevented a failure.

Figure 11: Well No. 3 MFL Indications

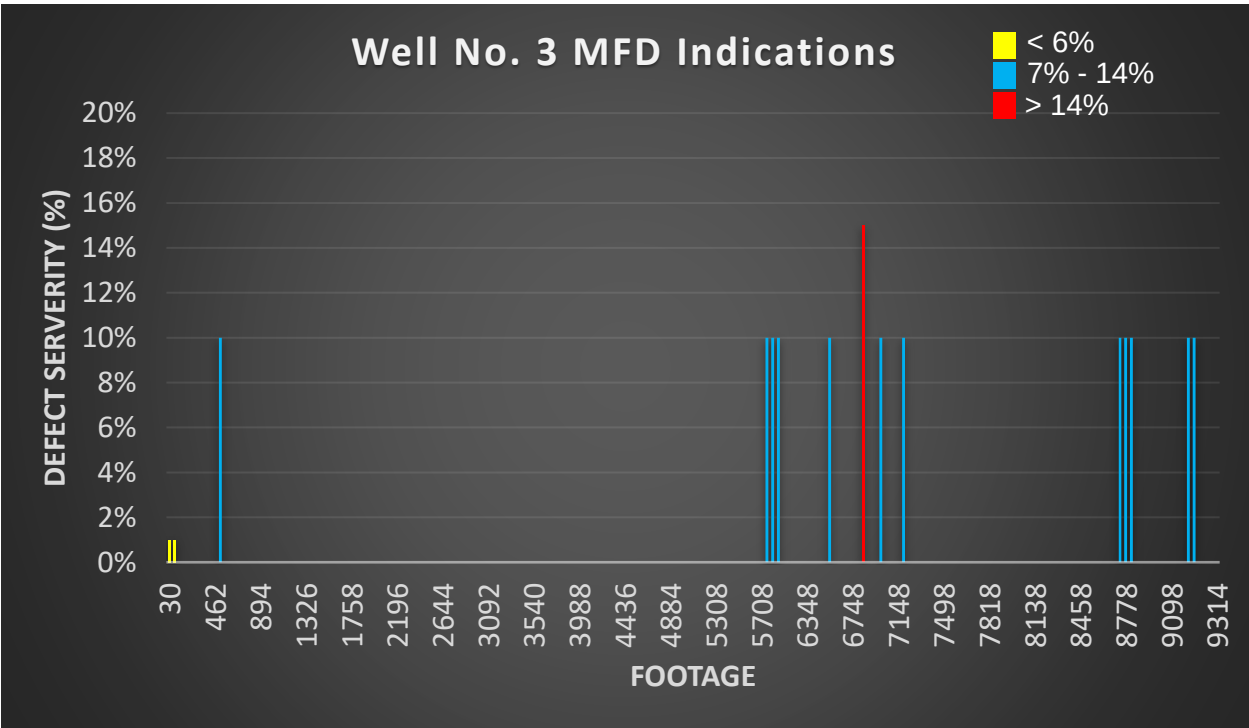
Figure 12: Well No. 3 MFD Indications

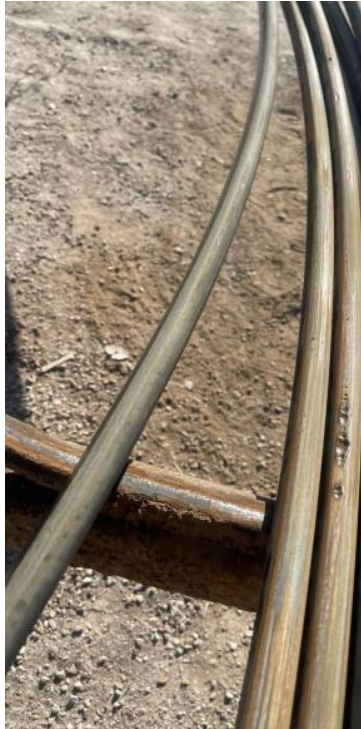
Figure 13: Well No.3 - Moderate to Severe Pitting

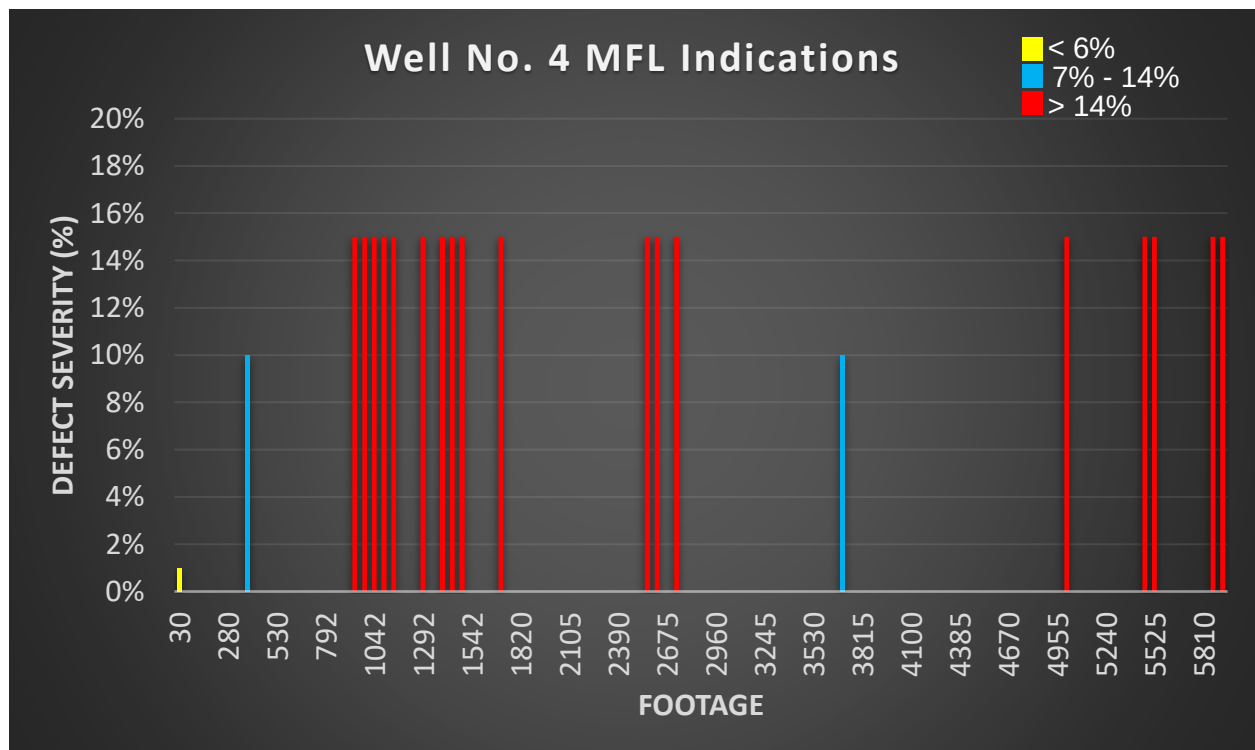
In October of 2023, the well failed again due to a rod part. -This prompted CRC to scan the rod string utilizing the EMI unit. The corresponding MFL and MFD indications for this rod string can be observed in Figures 14 and 15. - The failure occurred in the transition weld between the SE#6 and SE#7 taper, but per the EMI scan results, the rod string was highly compromised, with evidence of pitting and wear dedicated along its entire length. Images of the rod string with moderate to severe scale and wear on the minor side can be seen in Figures 16 and 17, marked based on the EMI readings. Considering these findings, CRC decided to retire the string and run a new rod string in the well. By relying on visual inspection during the first rod part instead of an EMI scan, CRC could have prevented a repeat failure.

Figure 14: Well No. 4 MFL Indications

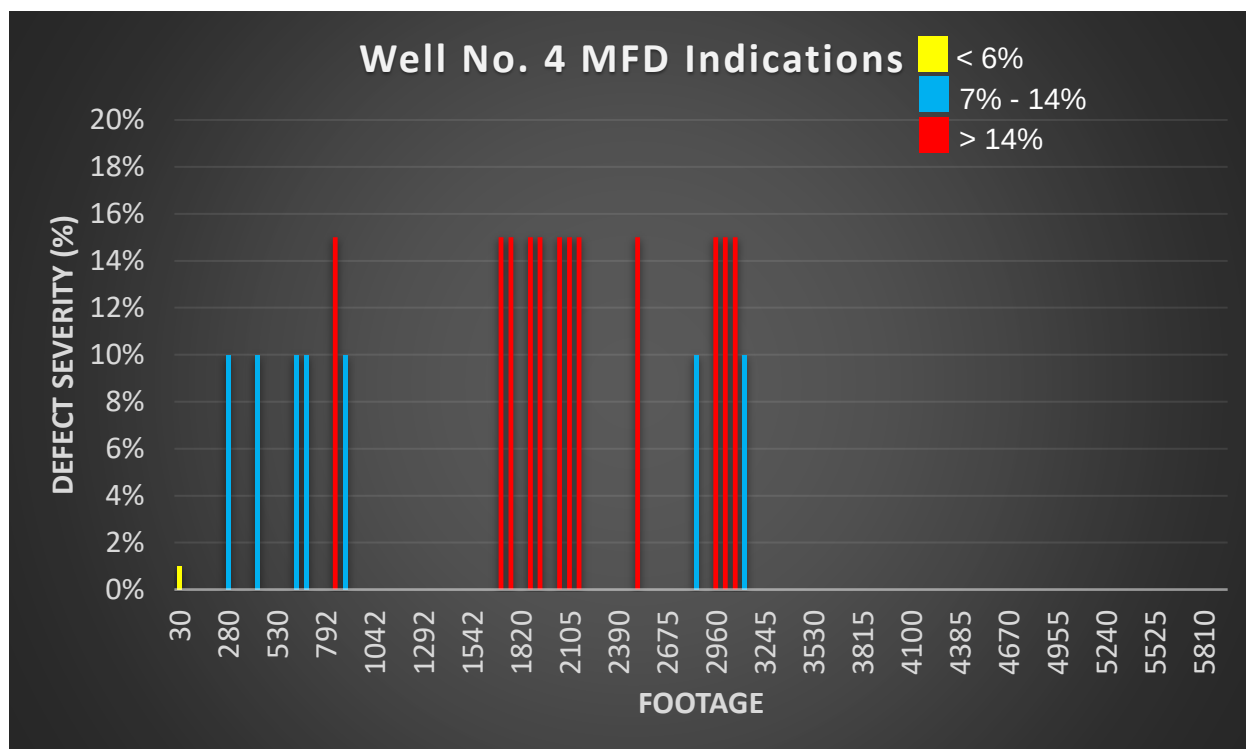
Figure 15: Well No. 4 MFD Indications

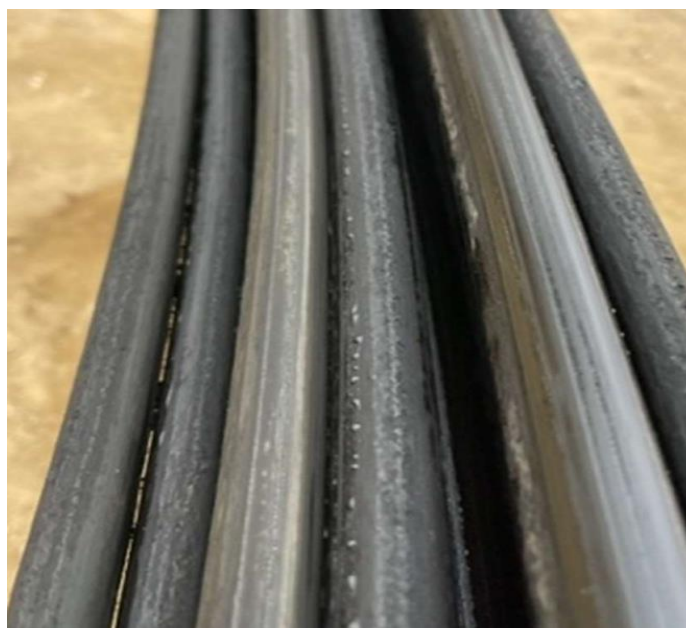
Figure 16: Well No. 4 - Moderate to Severe Scale Pitting

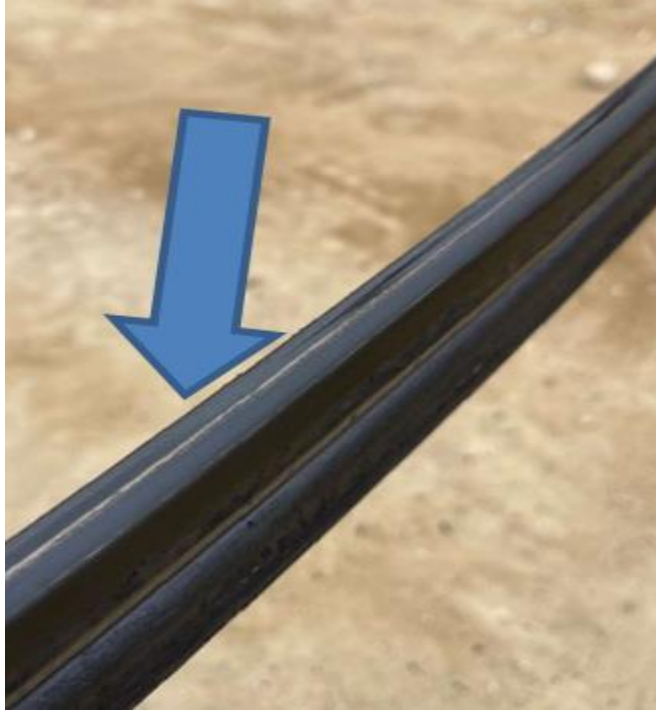
Figure 17: Well No. 4 - Wear on Minor

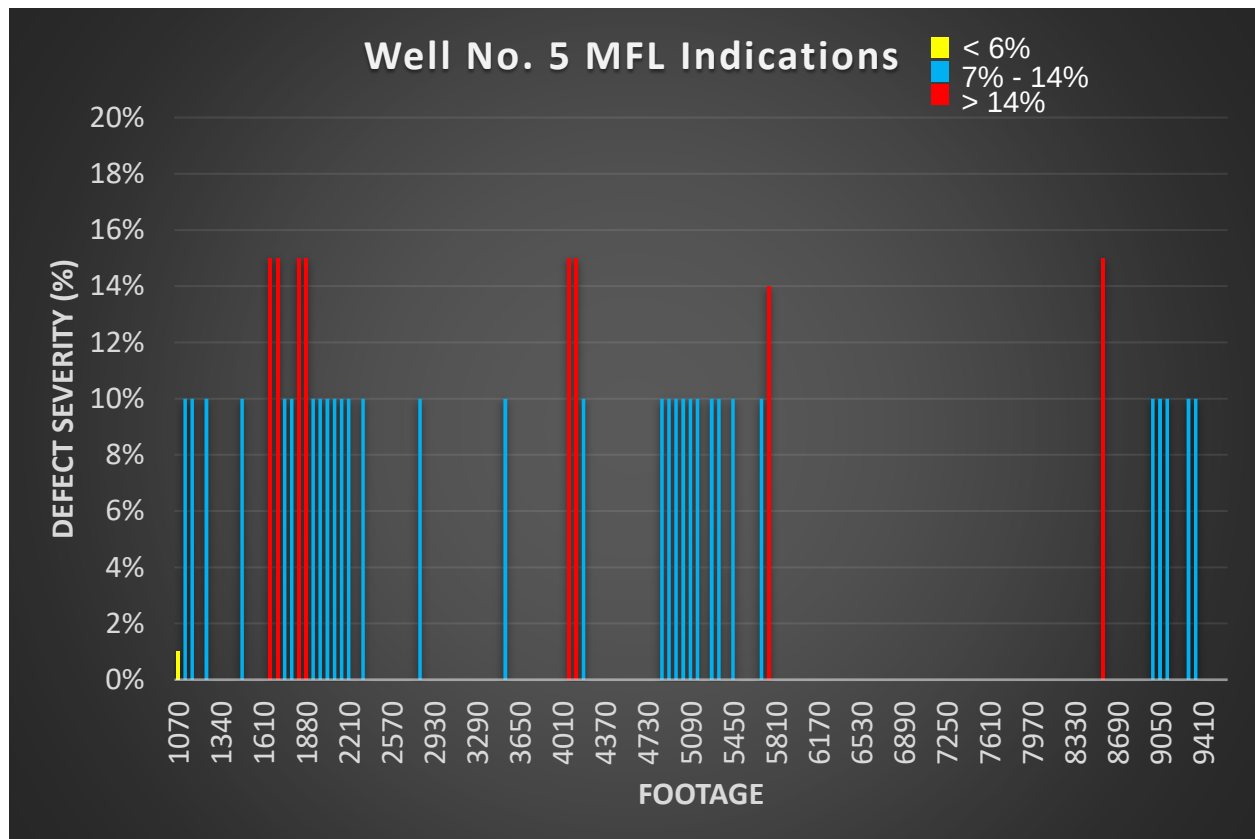
Ten months later, in December of 2022, the well failed due to a rod part. -This prompted CRC to scan the rod string utilizing the EMI unit. The corresponding MFL and MFD indications for this rod string can be observed in Figures 18 and 19. -The rod failed at a depth of 1017' in the SE #7 taper. According to the EMI scan, there are several sections of the rod string that experienced significant corrosion and wear. -Additionally, the EMI scan detected mechanical damage on the rod string. -Images of the rod string with moderate scale can be seen in Figure 20, marked based on the EMI readings. -In light of these findings, CRC decided to retire this string and install a new rod string. -CRC has not experienced a rod failure to date.

Figure 18: Well No. 5 MFL Indications

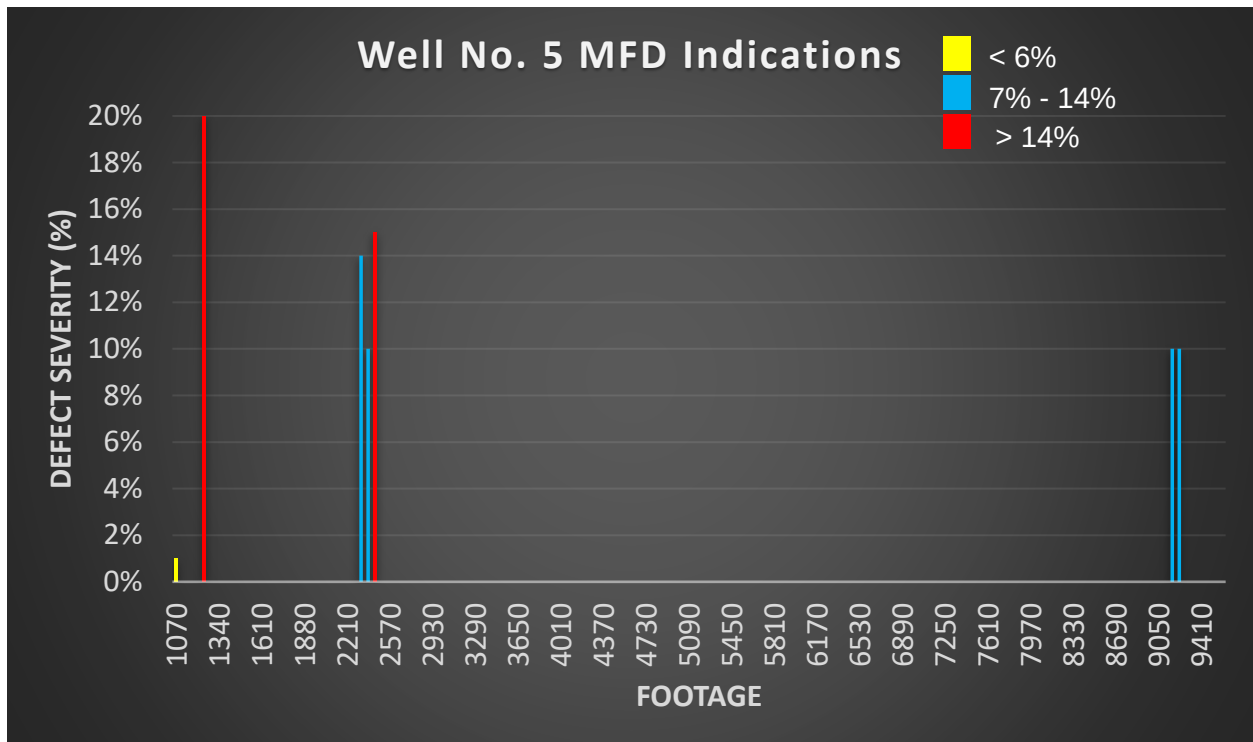
Figure 19: Well No. 5 MFD Indications

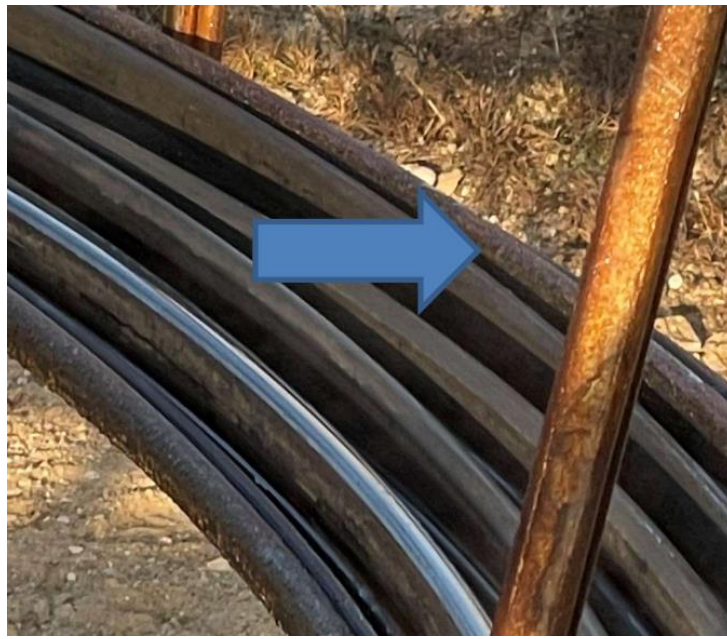
Figure 20: Moderate Scale
