ROD GUIDE STRATEGY FOR SUCKER ROD PUMPED WELLS IN THE EAGLE FORD SHALE

Leslie Malone
Murphy Exploration and Production Company

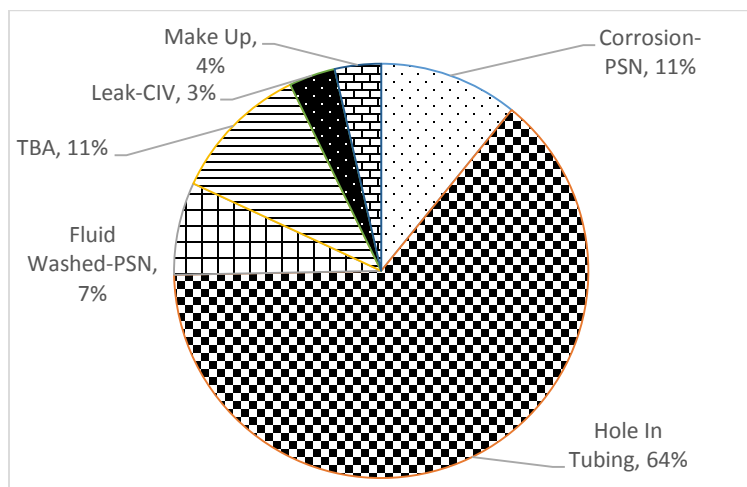
The tubing system includes the tubing, pump seating nipple and chemical injection mandrel for cap strings. Holes in the tubing comprise 64% of the total tubing failures. (Fig. 1) The holes in the tubing occurred in 9.4 % of the operating wells.

Figure 1 - Tubing System Failures 2012-2015

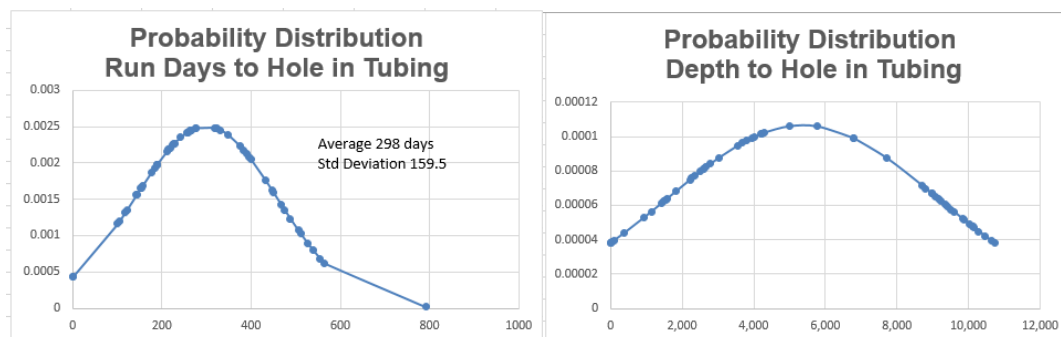
A probability distribution of the run days to hole in the tubing was plotted for the wells with a hole in the tubing. The average hole in tubing occurred in 298 days. A probability distribution of the depth to hole in the tubing was plotted for the same wells. There is no correlation to the depths of the holes in the tubing. (Fig. 2)

Figure 2 - Probability Distribution of Holes in the Tubing

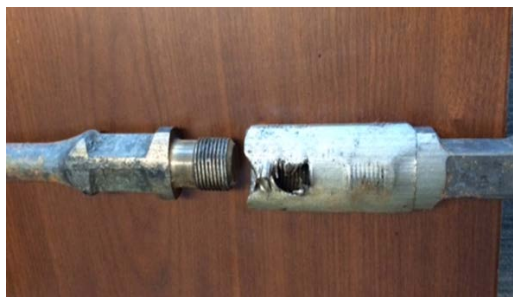
The two items which fail when sucker rod couplings contact tubing are the coupling and the tubing. The coupling will fail because of metal loss. The coupling wall becomes so thin that the pin will pull out of the coupling and the coupling will part. (Fig. 3)

Figure 3 - Rod pin pulled out of worn coupling

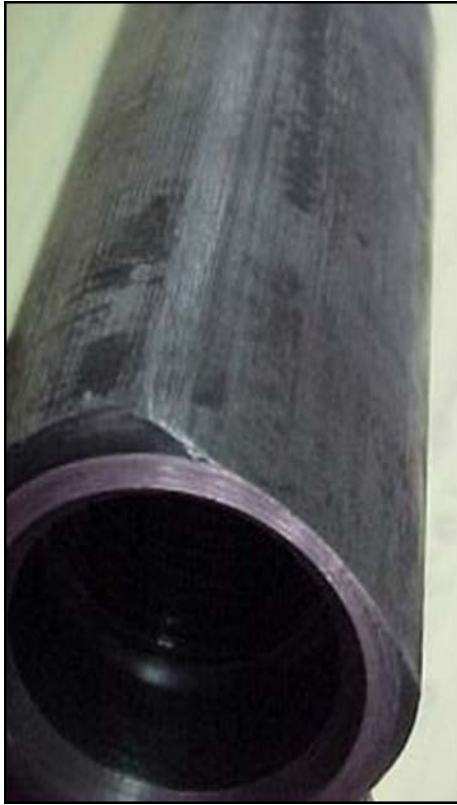
The sucker rod coupling can become worn flat on one side. (Fig. 4) When the coupling wear is severe then wear is seen on the shoulder of the rod. (Fig. 5). Wall loss in the tubing is expected when the sucker rod couplings and rod shoulders contact the tubing. Murphy does install rod rotators on all of the SRP wells. The rotation of the rods distributes the wear around the rod guides or sucker rod couplings in slick rod strings.

Figure 4 - Flat coupling

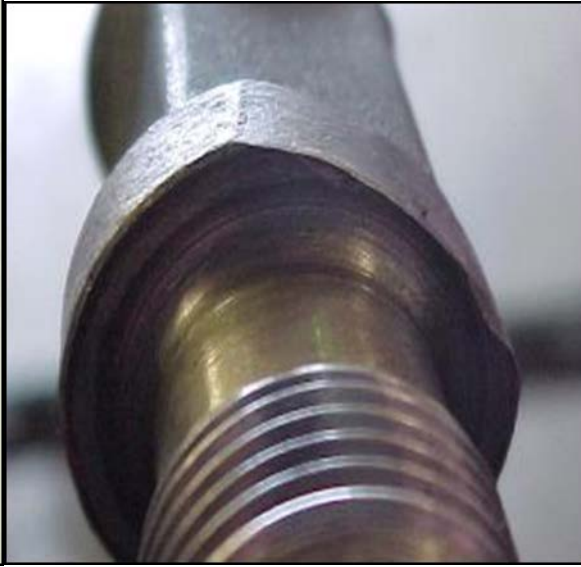
Figure 5 - Worn rod shoulder

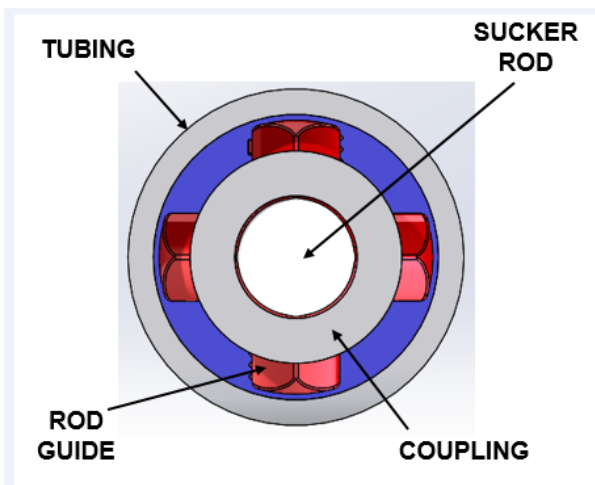
Erodible wear volume is the amount of guide material available to wear before the coupling comes into contact with the tubing. The larger the rod the less erodible wear volume is available because of the stand-off between the larger sucker rod coupling and tubing. One inch rods require more guides per rod to prevent coupling contact with the tubing. (Fig. 6)

Figure 6 - Erodible wear volume of rod guides in tubing

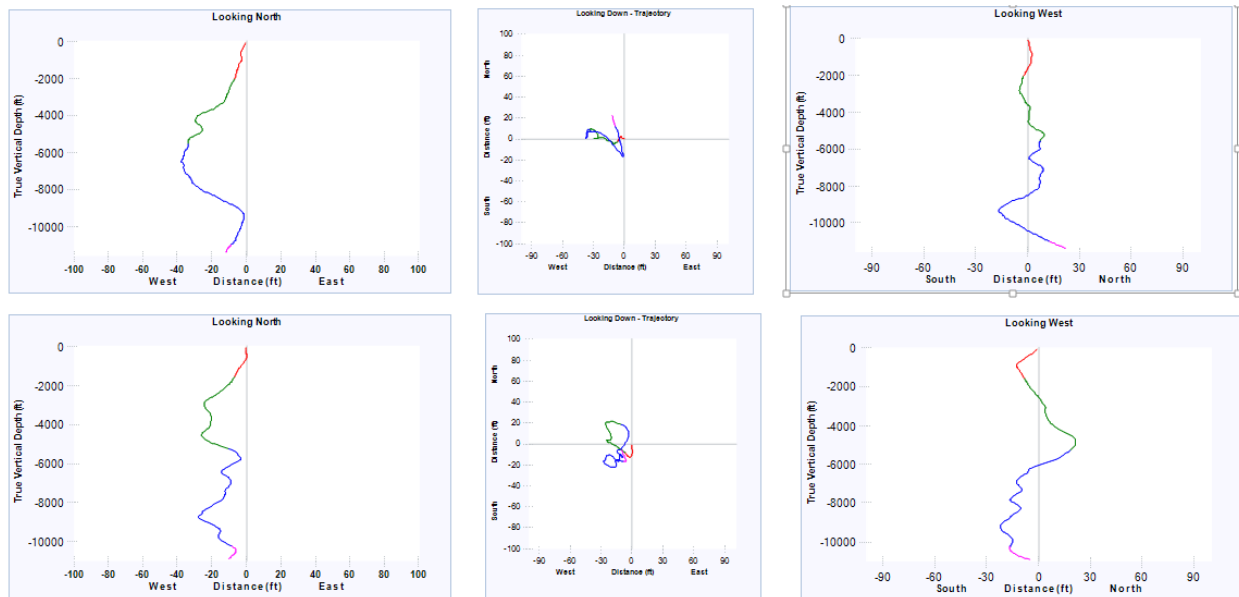
The drilling process includes deviation surveys. This survey documents the path of the wellbore from the surface to the producing horizon. Rod pump design programs use deviation surveys to graph the distance the well deviates from true vertical in the east – west and north – south direction. The looking down trajectory graphs the well path if viewed from the surface. Well trajectory for two typical Murphy wells shows the vertical sections are deviated. In one of the wells the wellbore deviates from vertical by 40 ft. to the east. (Fig. 7)

Figure 7- Representative wellbore geometry in vertical section

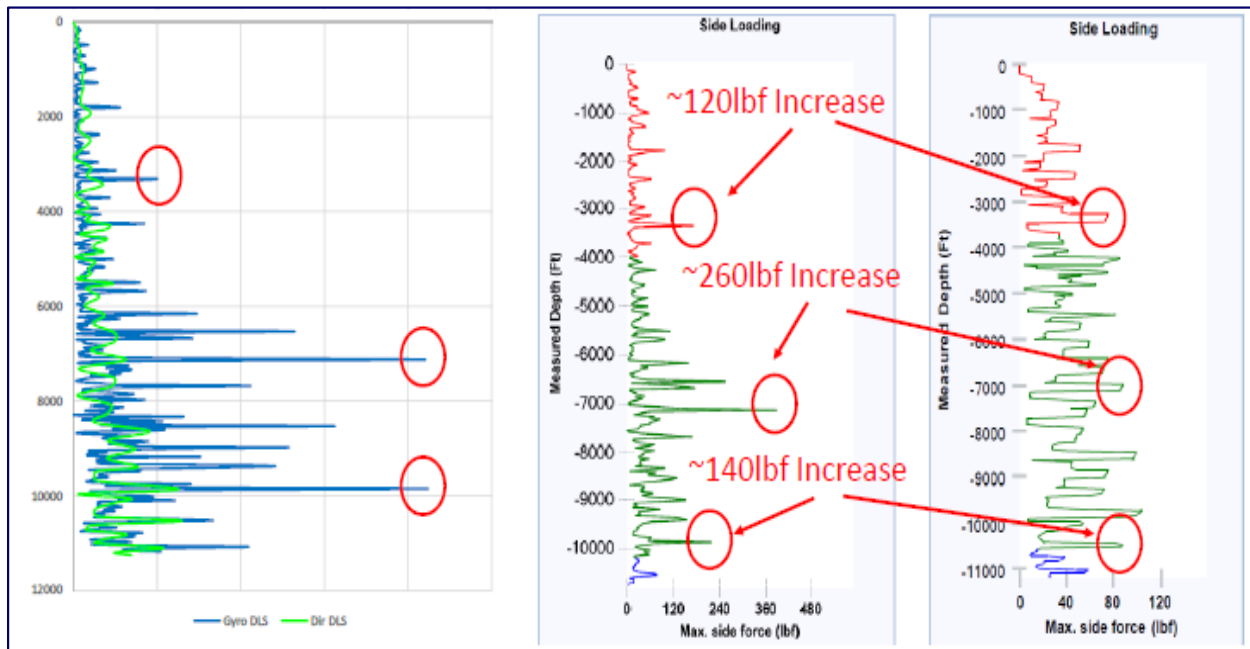
A comparison of DLS and side loading predictions made using a gyro survey versus an as drilled survey showed interesting differences. A Murphy example well shows the difference in the calculated DLS and side loading. The dogleg spikes are higher when the gyro survey data is used in the calculation. The result of higher DLS is larger side loading force. The side loading difference is higher by 260 lbf in one area of the example well. (Fig. 8)

Figure 8 - Comparison of Dogleg severity and side loading calculated from as drilled deviation survey and gyro deviation survey

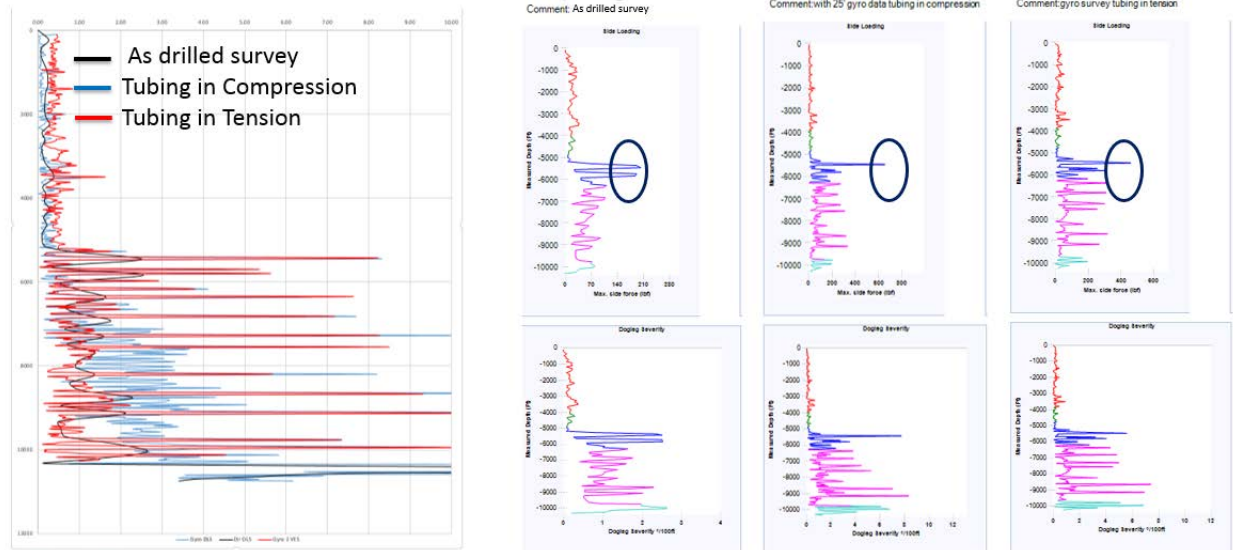
Murphy conducted a trial to evaluate the differences between a gyro survey run in tubing set in compression, tubing set in tension and in casing versus the as drilled survey. There are slight differences in the surveys. The doglegs seen in the gyro surveys are still present whether run in the tubing or the casing. Casing and tubing in the well did not smooth out or reduce the severity of the doglegs. (Fig. 9)

Figure 9 - Comparison of tubing in compression versus tubing in tension with gyro survey

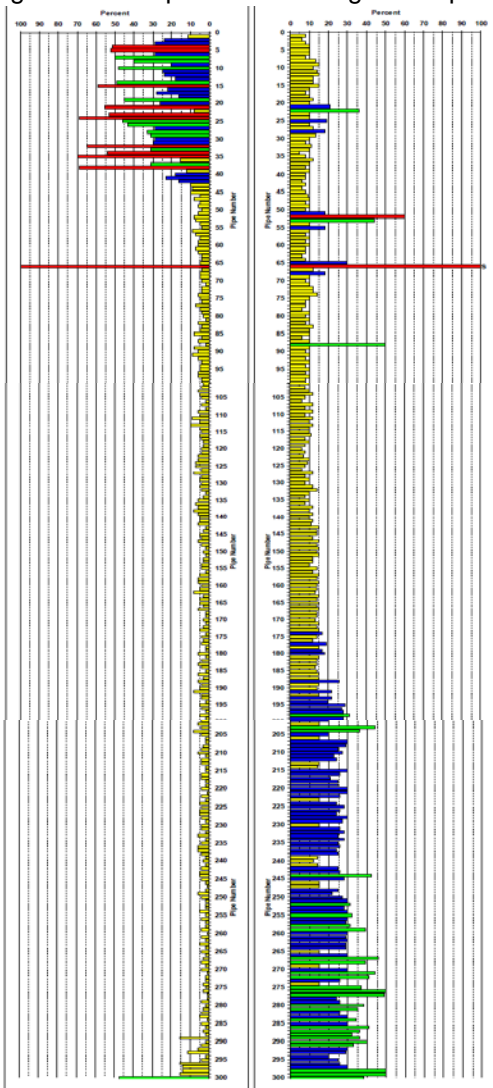
A tubing scan from a Murphy well shows pitting on the left side of the log track. Rod wear is displayed on the right side of the log track. Pitting is detected at the top of the tubing string in this example. Wall loss because of coupling contact with the tubing is seen at several depths. (Fig. 10)

Figure 10- Example of tubing scan

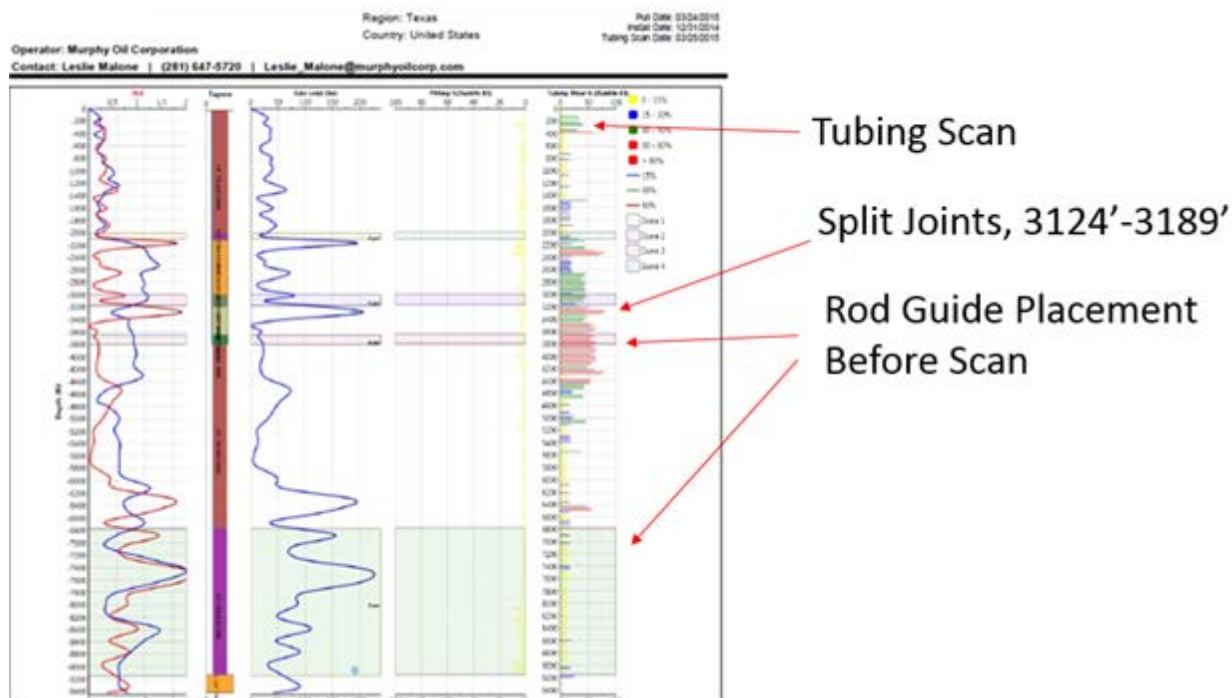
A review of the as run data from a Murphy well showed the guided rods were not placed in the areas of high side loading. The tubing scan detected wall loss at depths where the side loading was less than 50 lbf. (Fig. 11) This could indicate the presences of micro doglegs not captured in the as drilled deviation survey.

The result is sucker rod coupling contact in an unguided portion of the rod string. The wall loss in this area could be the guided rods forcing the unguided rods into the tubing wall. A workover on the example well discovered split tubing joints at a depth of 3,124 to 3,189 ft.

Figure 11- Rod guide placement before tubing scan

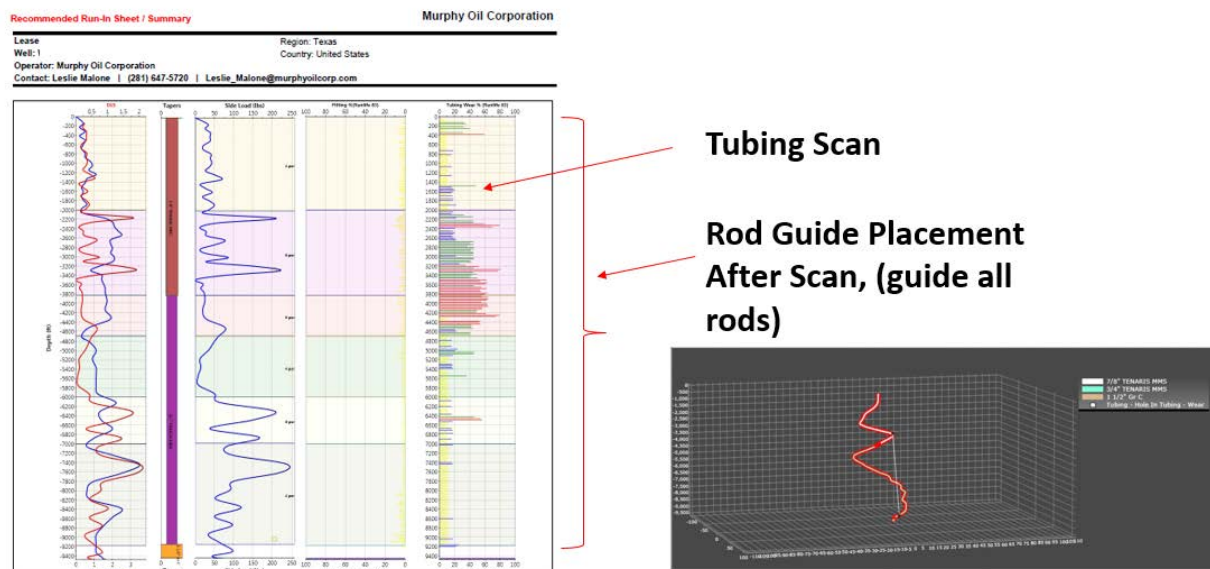
Figure 12 - Rod guide placement based on tubing scan and rod guide placement software

The rod guide software recommended the installation of a fully guided rod string. The software details the number of guides per rod in the recommendation. (Fig. 12)

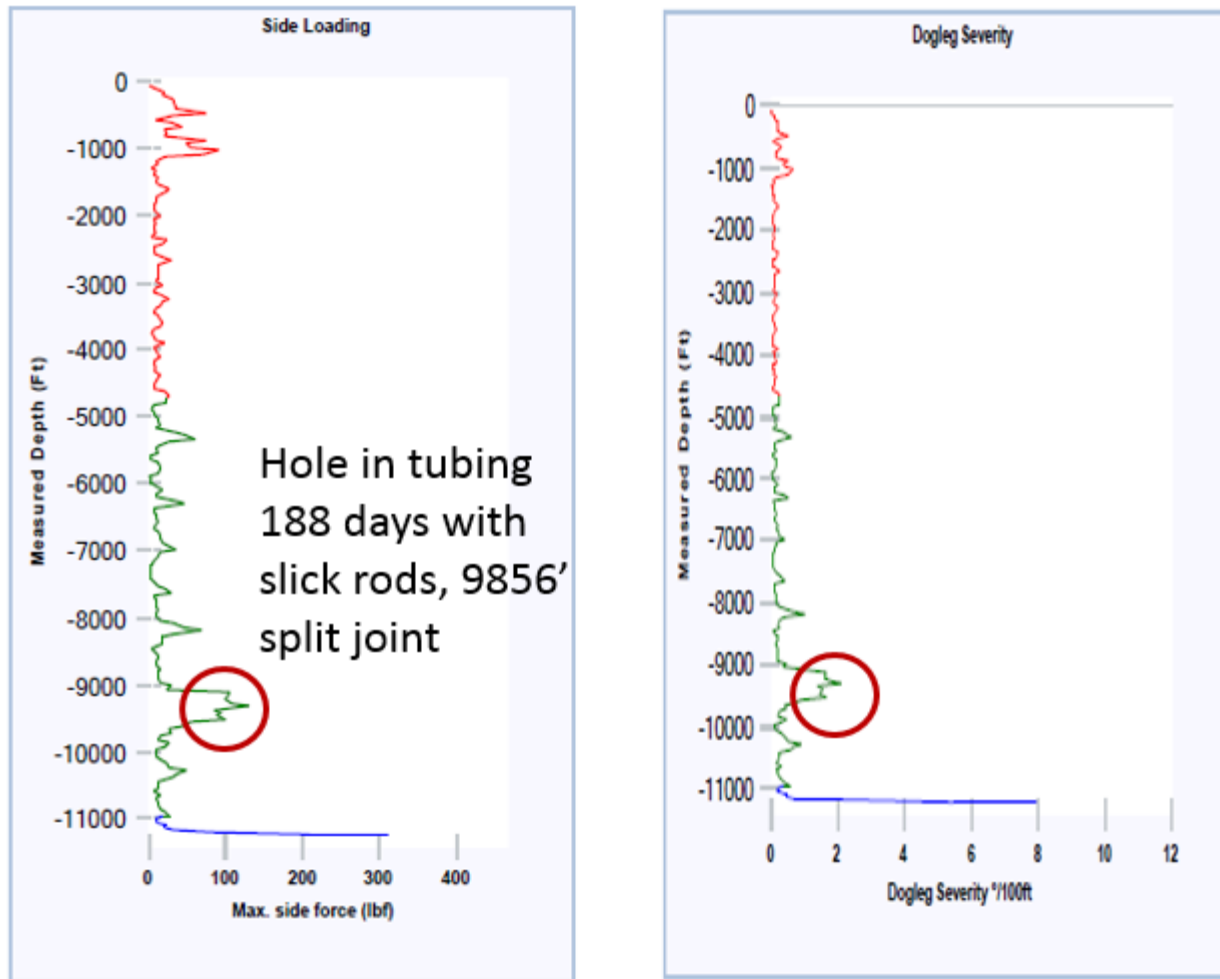
A case study was conducted on a Murphy well with a history of tubing failures. A slick rod string was installed in the well during 2012. The as drilled deviation survey was used in the rod design program. The design program output shows an area of side loading over 100 lbf at 9000 to 9500 ft. A DLS of 2°/100 ft. exists at the same depth. (Fig.14) The well developed a hole in the tubing after 188 days of run time. A split tubing joint was found in the well at a depth of 9,856 ft. during the repair work. (Fig. 13)

Figure 13 - Case Study DLS and side loading

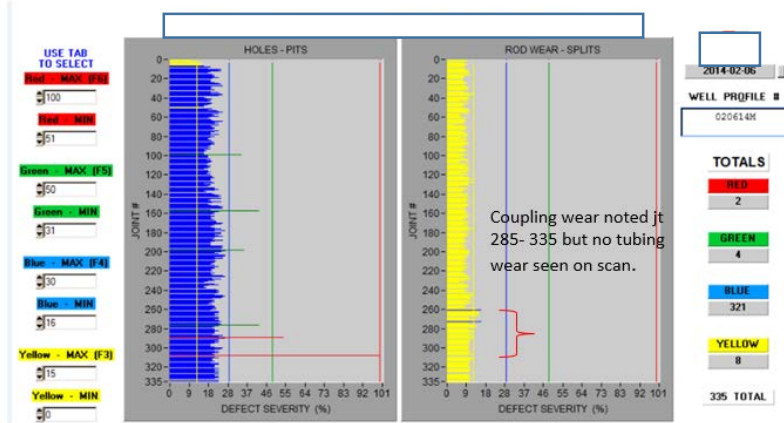
The tubing scan was performed with the type of tool that measures circumference and not longitudinal wall loss. The tubing scan did not detect the expected wall loss. There was no correlation between the tubing scan results and the visual inspection of the worn sucker rod couplings and rod guides. (Fig. 14) During the tubing repair job, 1,000 ft. of guided rods were installed from 9,030 to 10,030 ft.

Figure 14 – Case Study first tubing scan

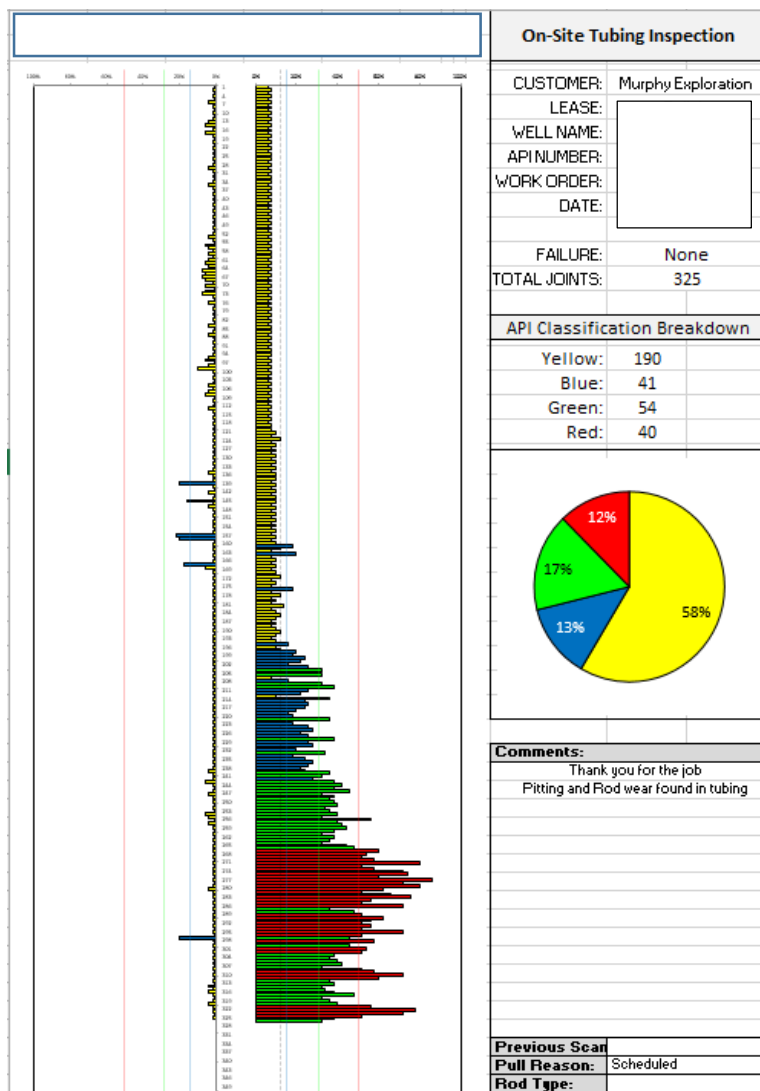
The case study well operated 467 days before the next tubing failure. During this repair job, a split joint of tubing was found at 10,269 ft. Rod guides were missing from some of the 3/4" rods. The tubing was scanned with different scanning equipment. A total of 107 joints of tubing were removed from the well because of wall loss. (Fig.15)

Figure 15 – Case Study second tubing scan

The well is currently operating with a fully guided rod string based on the recommendation of the rod guiding software. The guiding software output displays a summary of the rods pulled out of the well. A recommended run – in design is displayed in the output. The software documents the locations of tubing splits and sucker rod coupling wear. (Fig. 16) The mean time between failures (MTBF) for this well is 232 days. The current operating period has not surpassed the MTBF.
