# **USING HIGH PERFORMANCE INTERNAL PLASTIC COATINGS TO PREVENT CORROSION IN GAS LIFT WELLS**

Reza Fard  
NOV Tuboscope

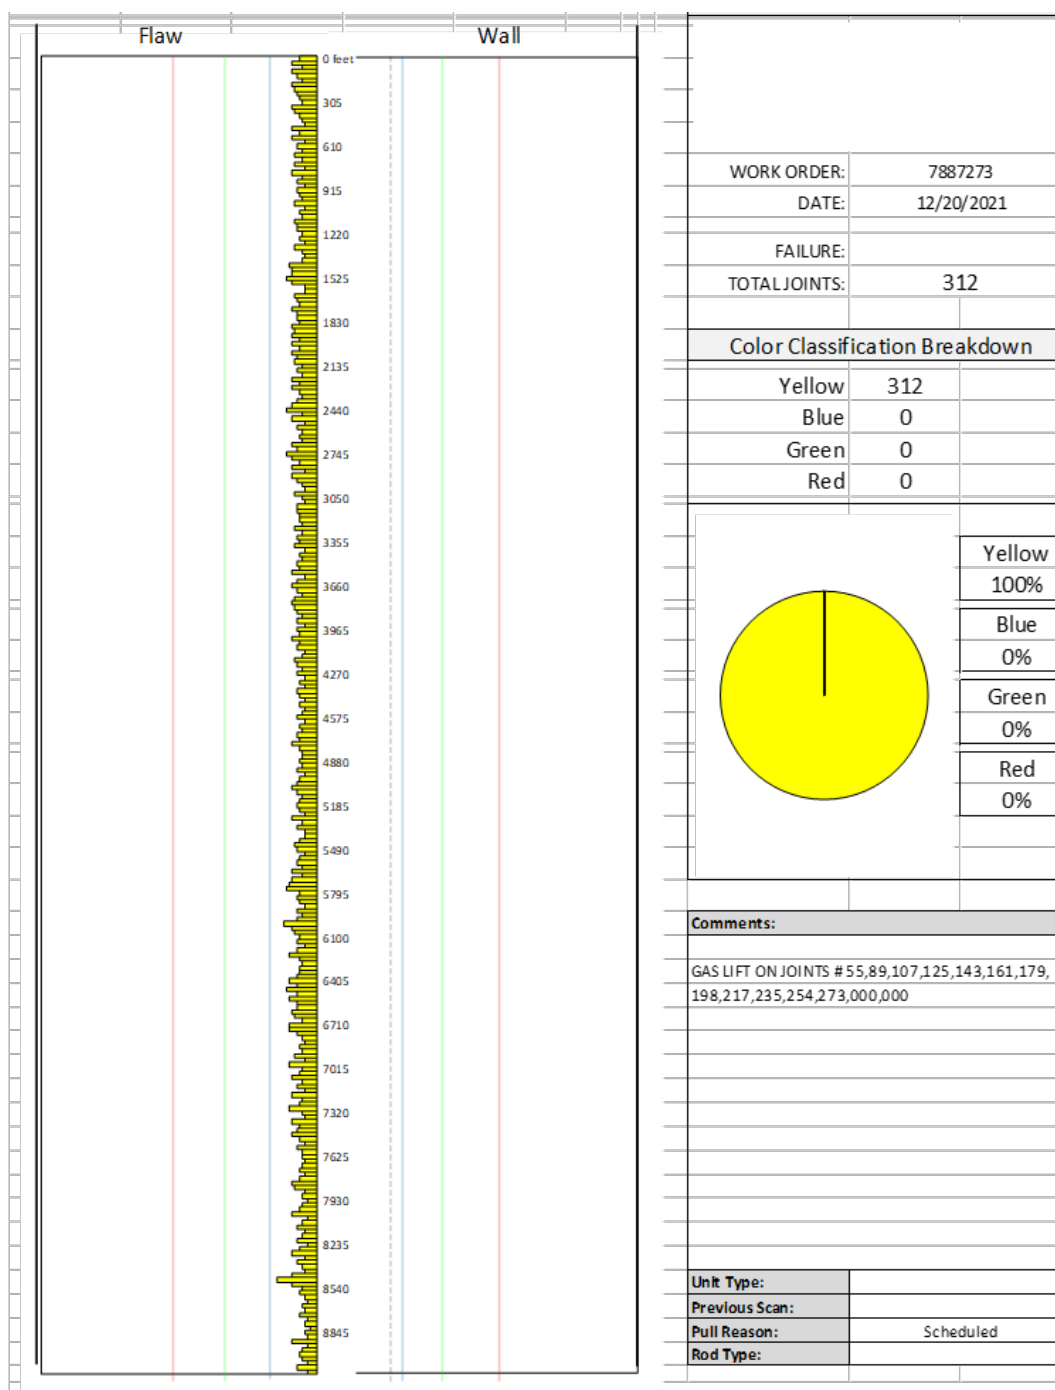
### Figure 2: Tubing Scan Results

The tubing scan chart for this gas lift well shows pitting on the left side of the log while Rod wear or erosion is displayed on the right side of the log. All 10,000 ft of tubing pulled scanned yellow band and no pitting was detected throughout the tubing string in this example as seen in Figure 2. Two joints, at 3,000 ft and 9,000 ft were set aside for further coating investigation at NOV Tuboscope's R&D laboratory in Houston, TX. The remaining tubing was run back downhole.

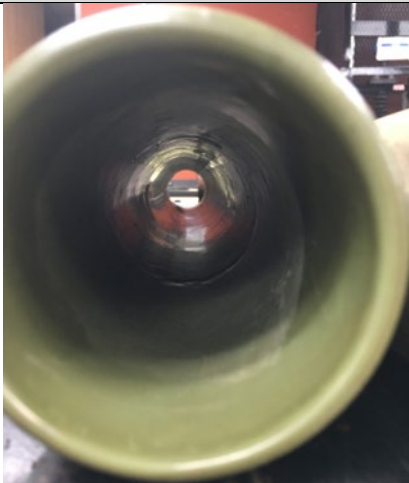
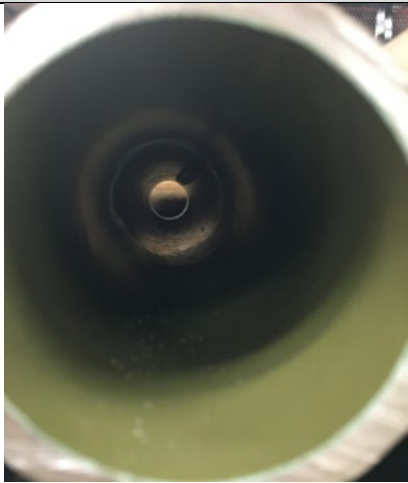
| 3,000 ft | | | |

The two joints returned to the lab were sectioned off into pin, center, box and visually examined. A visual evaluation was performed looking for blistering characterized (size, density) as per ASTM D714, swelling, discoloration and chemical attack. No visual signs

of blistering, swelling, discoloration or chemical attack were observed. Sample photos in Table 2 also show no scale deposit buildup on the ID of the coating before the samples were cleaned.

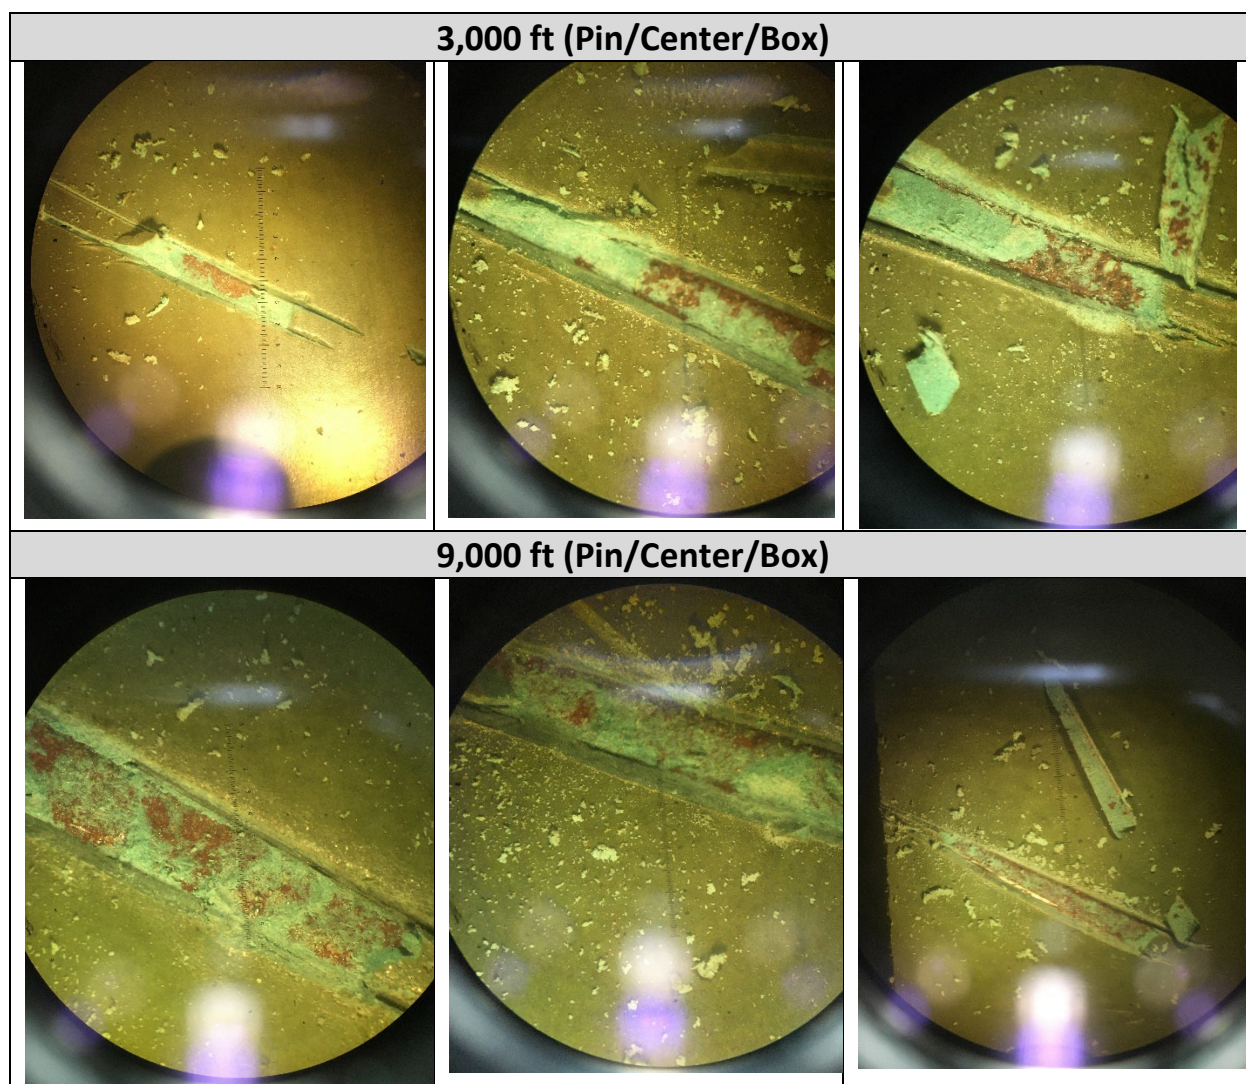
**Table 3: Knife Adhesion Test Images**

All samples tested for the 3,000ft and 9,000ft joints showed very good to excellent adhesion to the steel, receiving an “A” grade. This indicates that the coating has formed and maintained a strong and durable bond with the steel. The images in Table 3 provide visual evidence of the coating's exceptional adhesion. The red phenolic primer, which serves as the foundation for the topcoat, remains unaffected and intact beneath the surface, demonstrating the coating's ability to adhere without compromising the underlying layers. Furthermore, the adhesion test revealed no signs of softening or weakening of the coating during the downhole trial, confirming its resilience to the harsh conditions encountered in the well environment.
