# REVOLUTIONARY TECHNOLOGY TRANSFORMS CONTINUOUS ROD INSPECTION

Brian Wagner and LJ Guillotte Lightning Production Services

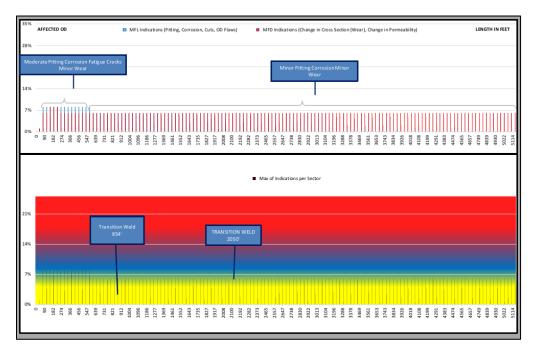
Figure 5. The LV-EMI<sup>™</sup> well profile summary depicts defects found in the first 600', with the remaining rod string falling below the threshold for downgrade.

Depending upon the condition of the rod string, certain sections of the string may be replaced during the current workover in order to prevent premature failure when running compromised material. With the ability to cut and replace specific portions of the string, the rod that is fit for service is maximized, and the propensity for rod failure is greatly reduced. Figure 5 highlights an example well where the upper section of the rod string needs to be replaced but the remainder is still viable for redeployment.

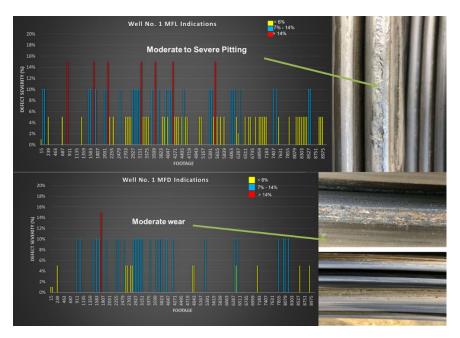
This well contains a semi-elliptical continuous rod taper installed in December 2019 that experienced a rod part at 869' in August of 2021. During this workover, the rod string underwent visual inspection by the rig crew, who observed mild pitting and rod wear, leading them to conclude that the rod string was in acceptable condition for reinstallation. This well was pulled 5 months later due to a pump failure and was inspected at this time. The corresponding MFL and MFD indications for this rod string can be seen in Figure 6.

Figure 6. MFL and MFD measurements by depth, along with example images of defects found.

There were several instances of moderate to severe pitting as well as moderate wear throughout the rod string. Based on these results, it was determined that the string should be laid down for a new string replacement. This well is still producing without failure, and it is unlikely that the existing string could have achieved this run time.

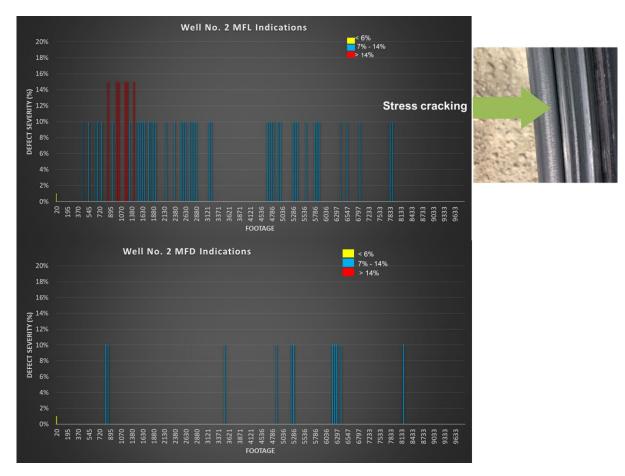
This semi-elliptical continuous rod string was originally installed in January 2020. After nearly two years of operation, the rod string parted in January 2022 at the transition between the tapers at a depth of 7,252'. During this workover, the rod string underwent a visual inspection by the rig crew, who concluded that the rod string was in acceptable condition for redeployment. In August 2022, the rod string was pulled due to a pump failure, prompting the string to be scanned with the LV-EMI<sup>™</sup> unit. Upon inspection, stress cracking was found in the top 1,500' of the rod string, with minor indications of rod wear, as depicted in Figure 7.

Figure 7. MFL and MFD measurements by depth, along with images of stress cracking discovered.

Although some portions of the string could have been salvaged, it was determined that it would be best to retire the string and replace it with new material. Given the nature of the defects, it is likely that a repeat rod failure was avoided.

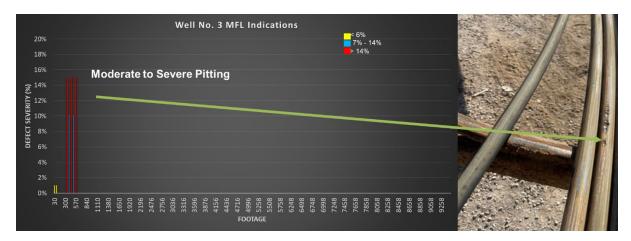
Again, this well contains a semi-elliptical continuous rod taper originally installed in May 2019. In November 2023, the rod string was pulled for elective well work. During this workover, the rod string underwent a visual inspection by the rig crew, who concluded that the rod string had light pitting and wear but was in acceptable condition for redeployment. After running for only one week following this workover, a rod failure occurred, prompting a scan. Severe pitting was found in the top 650' of the rod string, as shown in Figure 8.

Figure 8. MFL traces indicating severe pitting found in the upper section of the well.

Provided the MFD portion of the evaluation showed minimal indications, only the top 650' of the rod string was replaced, allowing the majority of the rod string to be reinstalled. No additional rod failures have occurred to date, validating that an LV-EMI<sup>™</sup> inspection could have prevented a rod failure had it been implemented at the time of the first failure.
