BORIDED TUBING SCANNING UTILIZING LASER TECHNOLOGY

Bryan Weaver, ConocoPhillips

Brandon McGinn, Stress Engineering Services

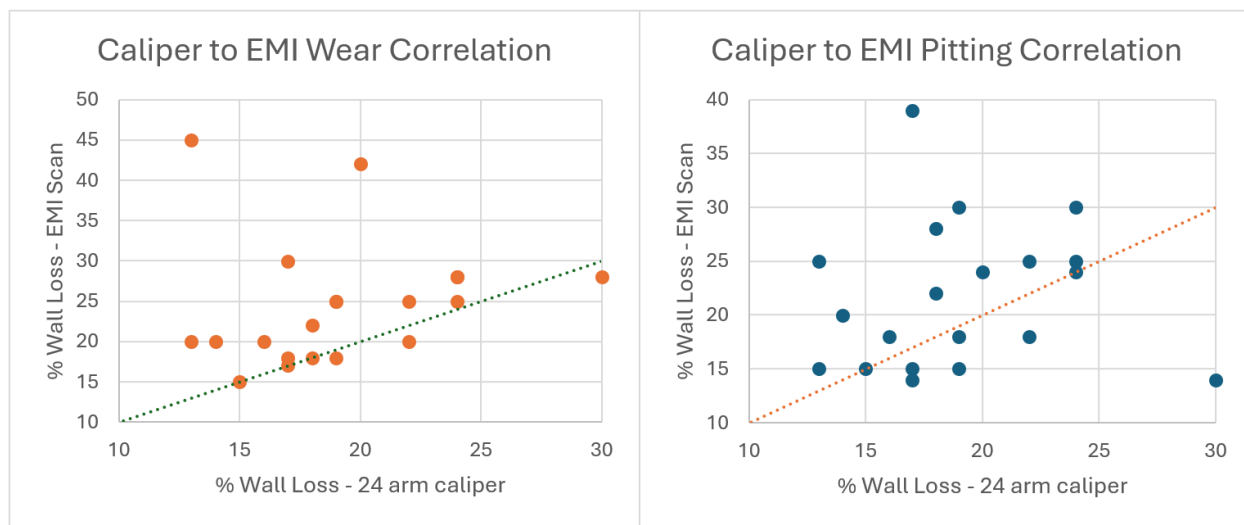
Initial pursuit of this project came from discovery work done in collaboration with Bluewater Thermal Solutions and Marathon Oil where caliper logs were conducted on borided tubing in a rod pump well. The results of the caliper logs were measured against traditional EMI wellhead scanning and determined that EMI scanning consistently measured higher wall loss readings. Ranges of the wall loss measurement discrepancies are shown in figure 3. Limitations of magnetic flux leakage testing on borided pipe are well known. The data obtained in this caliper study confirms that to determine the quality and integrity of borided pipe other means of measurement are required.

Figure 3. Measurement discrepancies- values above the trendline indicate higher wall loss readings on EMI scanning relative to measurement acquired by caliper log. Data obtained by study conducted by Bluewater Thermal Solutions and heritage Marathon.

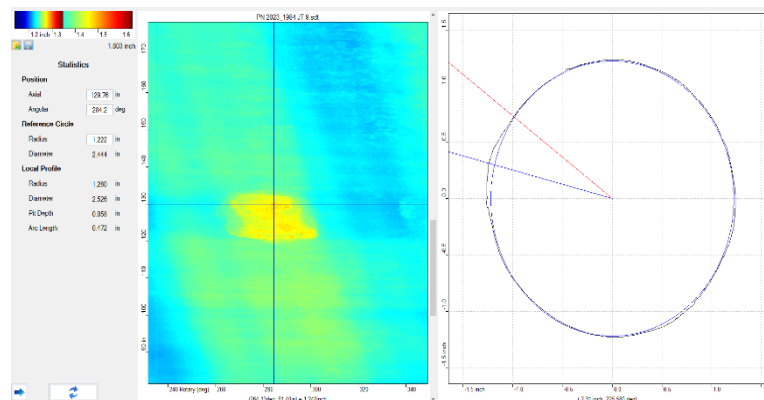
Figure 5. Rod wear sample generated by image processing from laser scanning clearly showing rod wear at 9 o'clock position.

On samples where pits and wear were observed, the most common wear was identified in the middle of the pipe or near the upset, primarily manifesting as single channels of wear. The ovality arises from calibrating the tool to the nominal internal diameter of the pipe. Despite this calibration, it was readily determined from the rendered images whether the identified defects were related to the nominal differences.

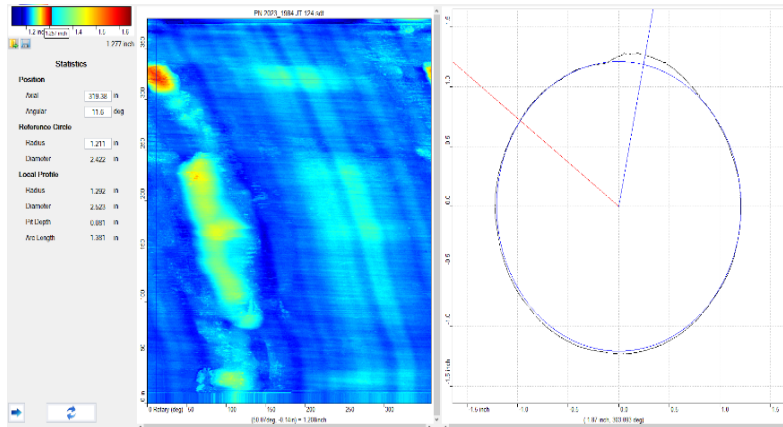
Figure 6. Similar example of image generated by scanning tool showing more pronounced rod wear at 12 o'clock position.

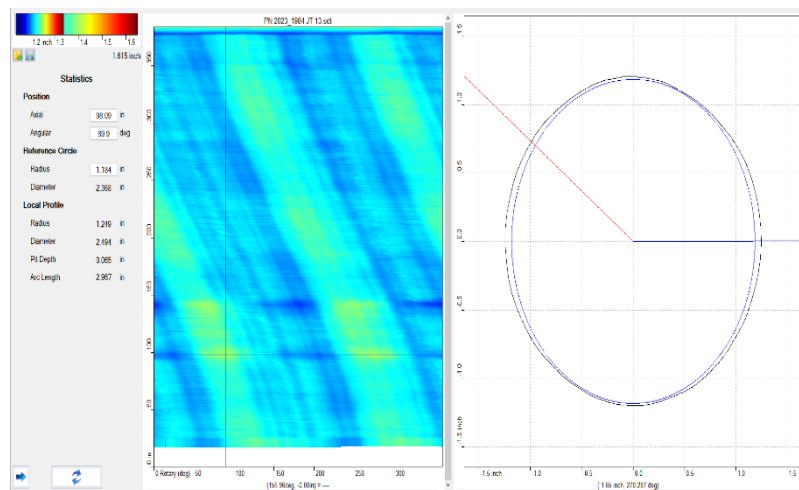
Figure 7. Image from scanning tool demonstrating challenges in discerning ovality from wall loss.

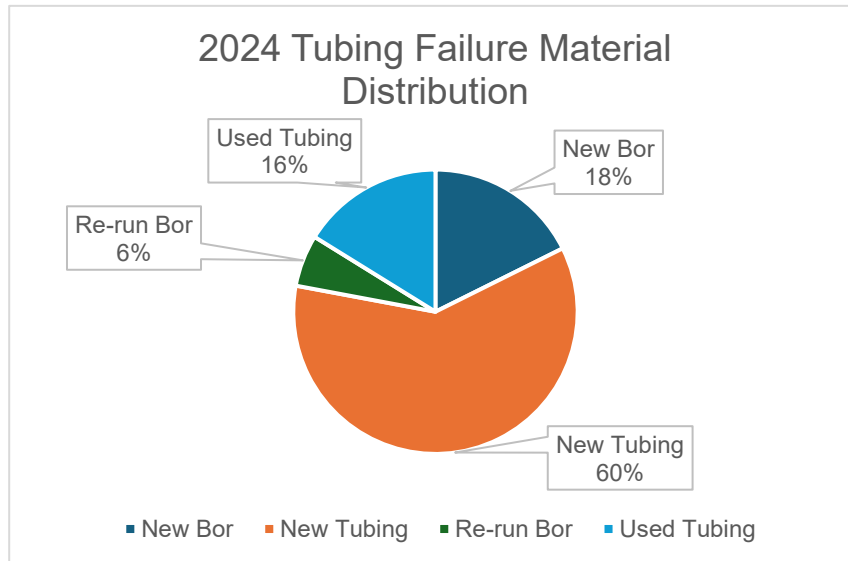
Figure 10. Review of failed tubing components from 2024- note that new borided tubing is a more frequent failed component than newer tubing- emphasizing the challenging conditions of pipe joints withing 200-400' of pump seat nipple.
