The Effect Of An Atomic Blast On Electric Facilities

By *ARLIE C. HUDSON*
Southwestern Public Service Co.
Lubbock, Texas

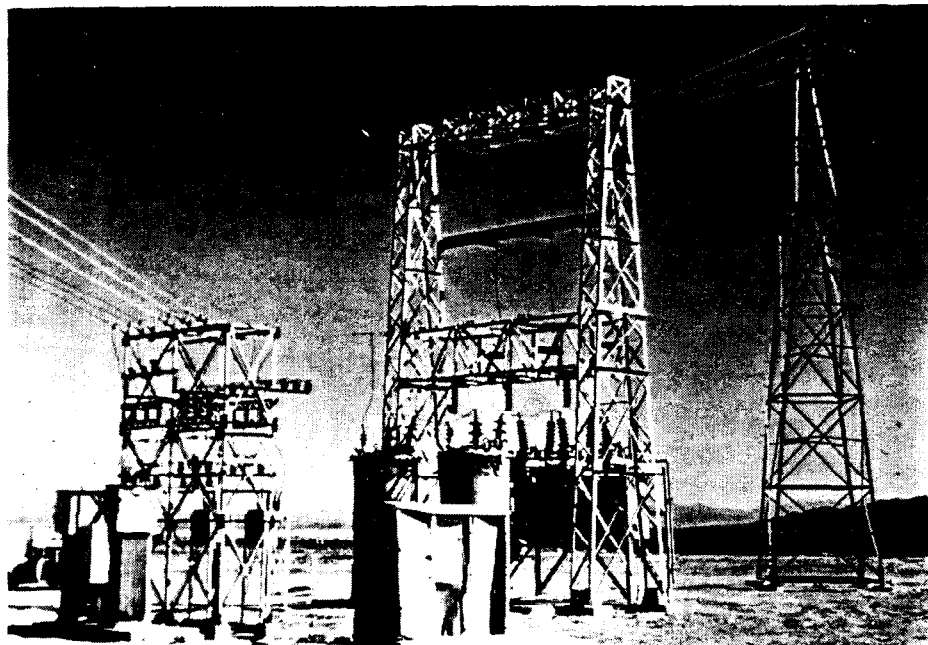
The substation survived the blast with nominal damage to the essential components (See Fig. 6). The metal cubical itself, housing the meters and relays, was heavily damaged. The substation was in sufficiently sound condition to permit re-energizing on a non-automatic basis with only a small amount of work by maintenance crews. The two 1500-kva single-phase oil filled transformers were undamaged, and were un-moved on the foundation pad. They withstood a 30-kv high potential test to ground and they meggered the same as pre-shot values. The paint on the transformer tank on the side facing the blast was slightly blistered. The cylindrical oil level gauges were undamaged. The glass on the regulator temperature gauge was broken.

The two 4-kv, 200-amp induction regulators were shifted on the foundation pad sufficiently to break electrical connections to the bus. In addition, the square flat-surfaced housing at the top of one regulator was dished-in on all four faces. The dial-type temperature gauge glass was broken. The cy-

Fig. 6 View of the substation at 4700-foot area after the blast. Note the damaged instrument cubicle.

lindrical oil-level gauge was not broken. The regulators were tested and found to be electrically operative.

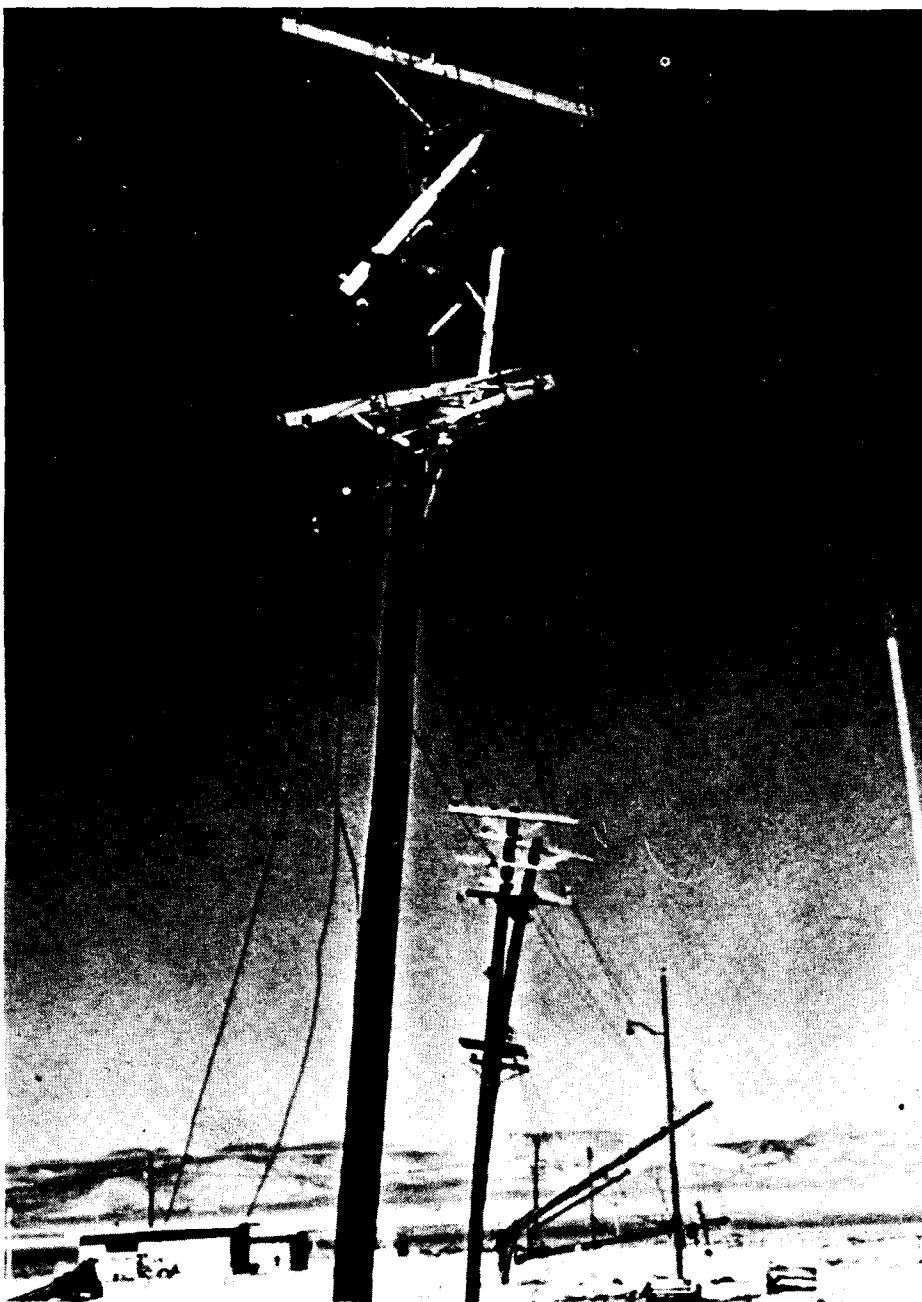
Fig. 8 View of distribution line located perpendicular to the blast line. The downed poles can be seen in the background.

The distribution system suffered light to moderate damage. (See Fig. 8) It was of the type that could be repaired in a reasonably short time with materials normally carried in stock by electric utility companies. Out of 14 pole positions, five received no damage, three received very slight damage to the extent of broken insulator pins (on the 4-kv only) or insulators, two extensive damage, and four were down. The four downed poles were consecutive poles in a section perpendicular to the blast line. Three of those carried the 3-conductor, No. 2/0 aerial cable in addition to the primary and secondary circuits.

Metal pins supporting the 11-kv insulators all held up. Except for broken poles and four missing insulators, the 11-kv circuit could have been re-energized. There was slight scorching of poles and crossarms. All primary conductors, including the aerial cable, were unbroken. The outer insulation surface of the aerial cable conductor was slightly scorched and charred. All tie wires held and all pole anchors and guys remained intact but were slacked off. Two 10-kva transformers installed on a line crossarm on pole No. 4 were not displaced. Two pot-heat installations were unharmed. All arresters and fused cutouts were undamaged and firmly in place where crossarms were not broken.

All steel and concrete street light standards were undamaged; however, the luminaires were all broken off and were lying on the ground underneath. The two modern pole-mounted mast-arm type units were undamaged except for a moderate bending of the mast arm. The streamlined elliptical luminaires on these fixtures were in place and undamaged. A steel street light standard is shown on the right.

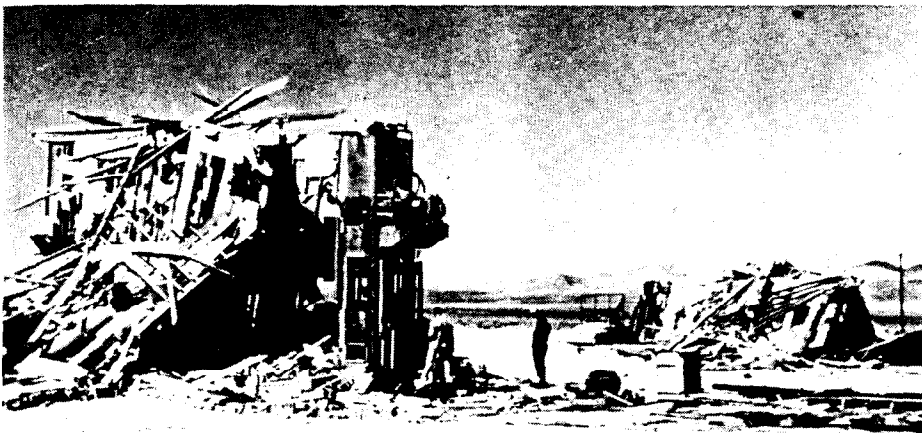
Fig. 9 The brick house and the wood frame house as they appeared after the blast. Compare with Figures 4 and 5.

In the general area, damage to structures that would normally be served by power facilities was also experienced. While an official evaluation of this damage has not been published, Fig. 9 shows the typical urban brick and wood frame house after the blast. Compare the "after" appearance of these houses with that shown in Figs. 4 and 5 taken before the blast.
