# **SUCKER ROD CONNECTION FAILURES – WHY THEY OCCUR & WHAT TO DO ABOUT THEM**

Norman W. Hein, Jr., P.E.

NPS - Norris/AOT

## **ABSTRACT**

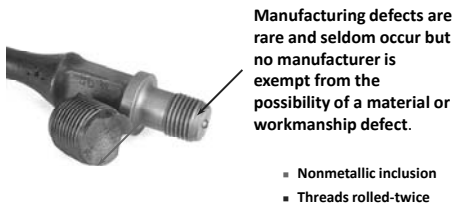
Figure 1 - Manufacturing Discontinuities or Defects

Connection failures due to manufacturing discontinuities or possibly defects normally do not occur unless there is something inherently wrong with the original steel. While surface discontinuities should be caught at the manufacturer's facilities, near subsurface or deeper in the thickness of the rod or coupling may be very difficult to detect until these imperfections contribute to a failure. A variety of example manufacturing discontinuities or defects is shown in Figures 1 and 2.

- Most failures related to manufacturing discontinuities or defects originate below the outer surface.
  - Rolling seam turned transverse turning forging
  - Forging cold shut
  - Forging crack

There may be little that can be done to prevent these unless increased visual inspection or even volumetric inspection of the steel is conducted. However, routinely conducting these increased inspections may add to the time and cost of manufacture which ultimately will be passed on to the end user.
