CASING PLUNGER RESTORES PRODUCTION AFTER FAILED CASING LEAK REPAIR IN OKLAHOMA PANHANDLE GAS WELL

Robert L. Moore, P.A.A.L., LLC
Windel O. Mayfield, Lone Star Rubber

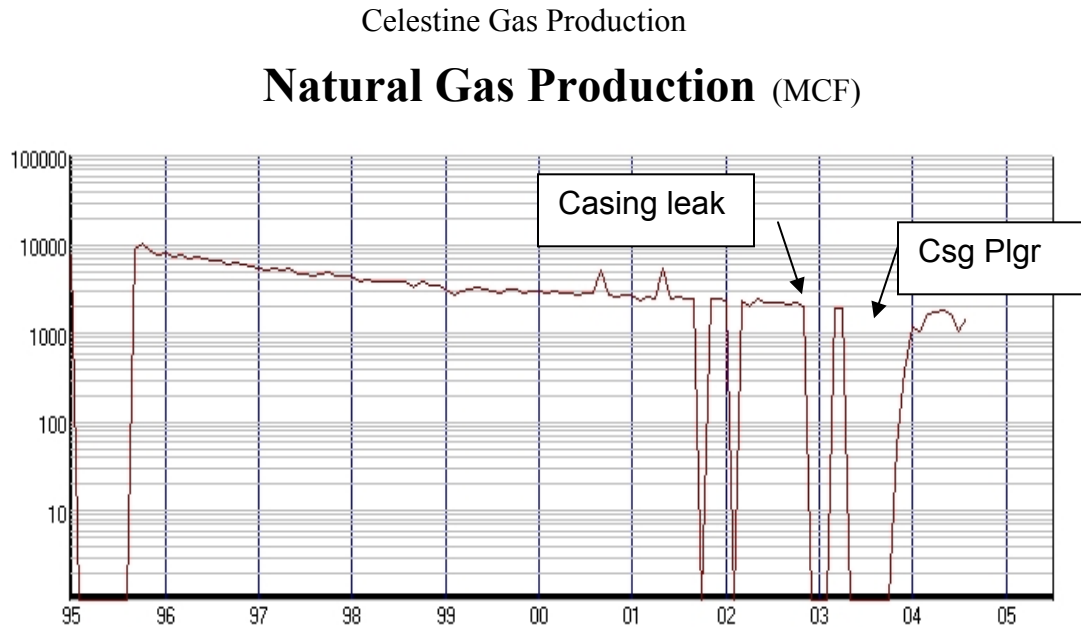
Figure 1 - Well production shows typical decline and steady production until casing leak in 2nd quarter of 2003. Casing repairs initiated and not totally successful.

Subsequent attempts for 2nd squeeze were deemed inappropriate. Alternative solutions were pump jack and rod pump or casing plunger. Casing plunger installed in November 2003. Production, after several modifications to typical casing plunger application, was restored to comparable sales volumes prior to casing leak. Gas sales continue 18 months after casing leak "repaired".

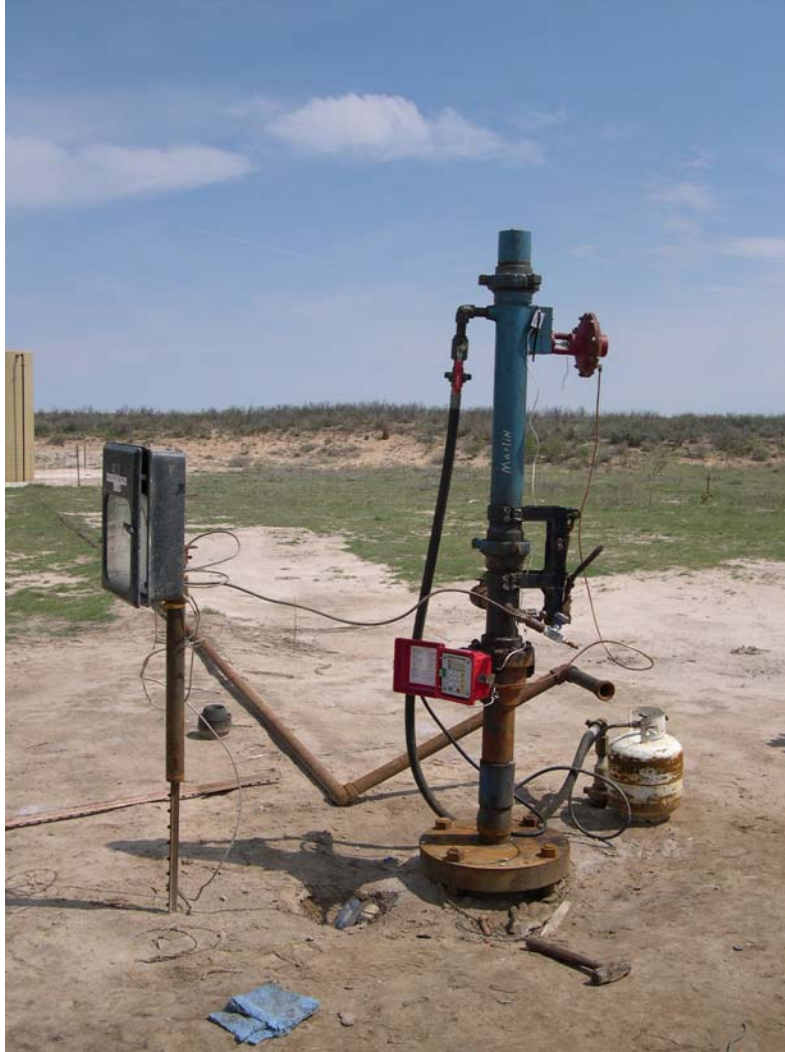
Figure 2 - Well head has been modified from typical 3000 # flange well head to 8 rd thread with full port ball valve installed as required for casing plunger application. Bottle gas can be used for clean, dry supply gas for controller timer. Surplus chart recorders can be used to record plunger cycles and trip times.

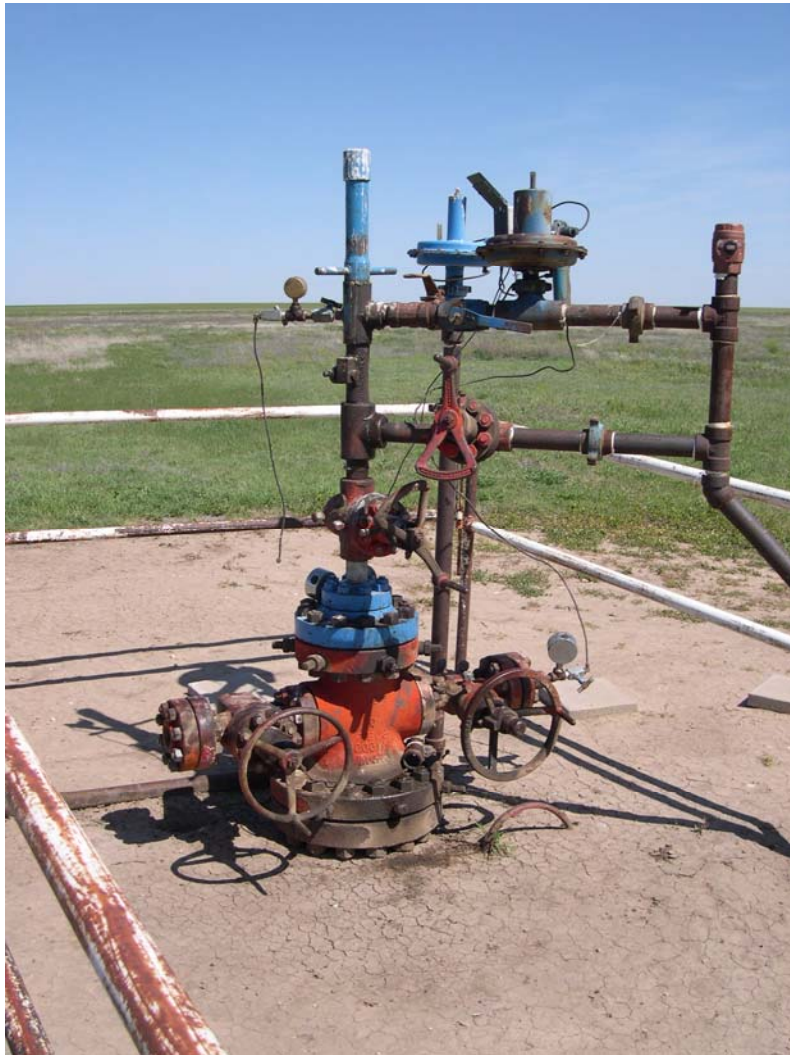
Figure 3 - Typical Flange Wellhead with Tubing Plunger Installation
Prior to Modification for Casing Plunger Application

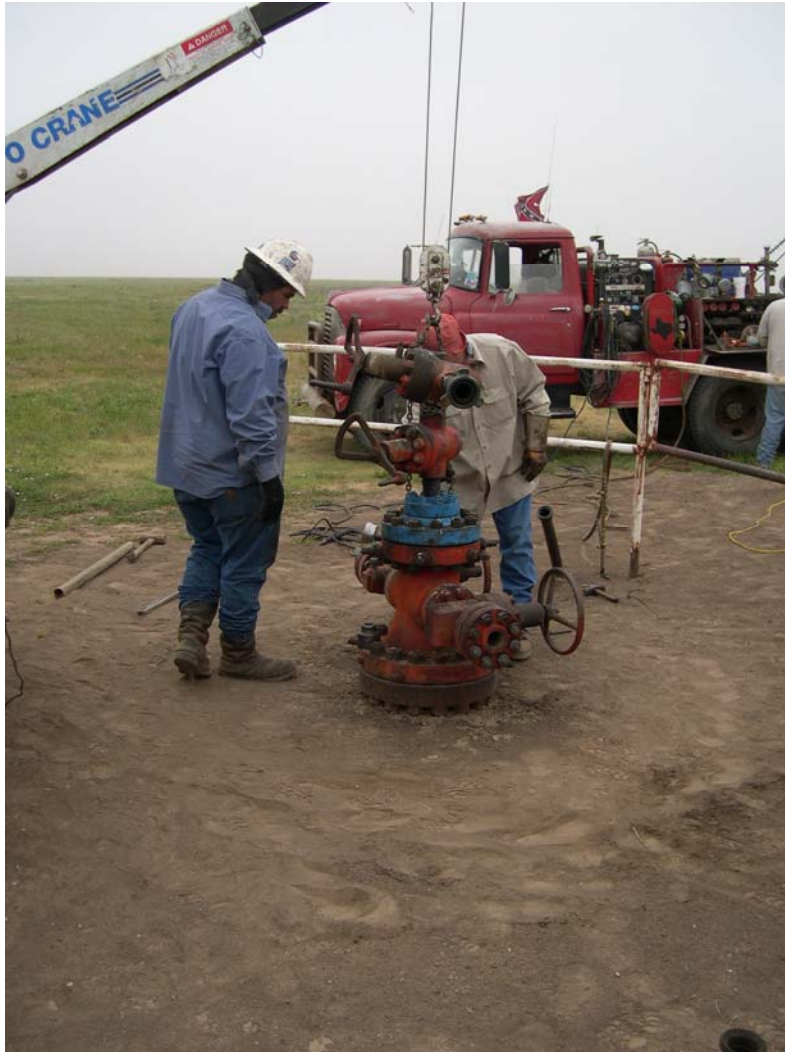
Figure 4 - Typical Flange Wellhead "B" Section Being Removed to Expose Top of Casing for Welding of Bell Nipple with 8 rd Threads Looking Up

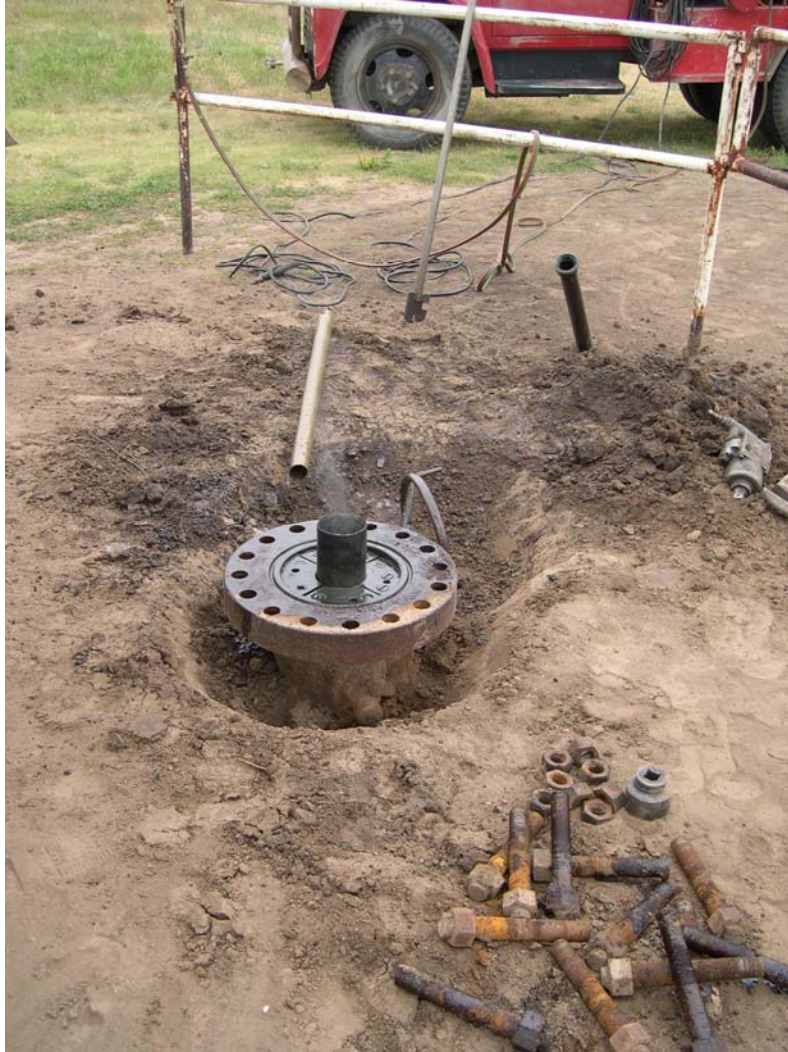
Figure 5 - Top of Casing Prepared to Weld 8 rd Thread Bell Nipple for Full Port Ball Valve Required for Casing Plunger

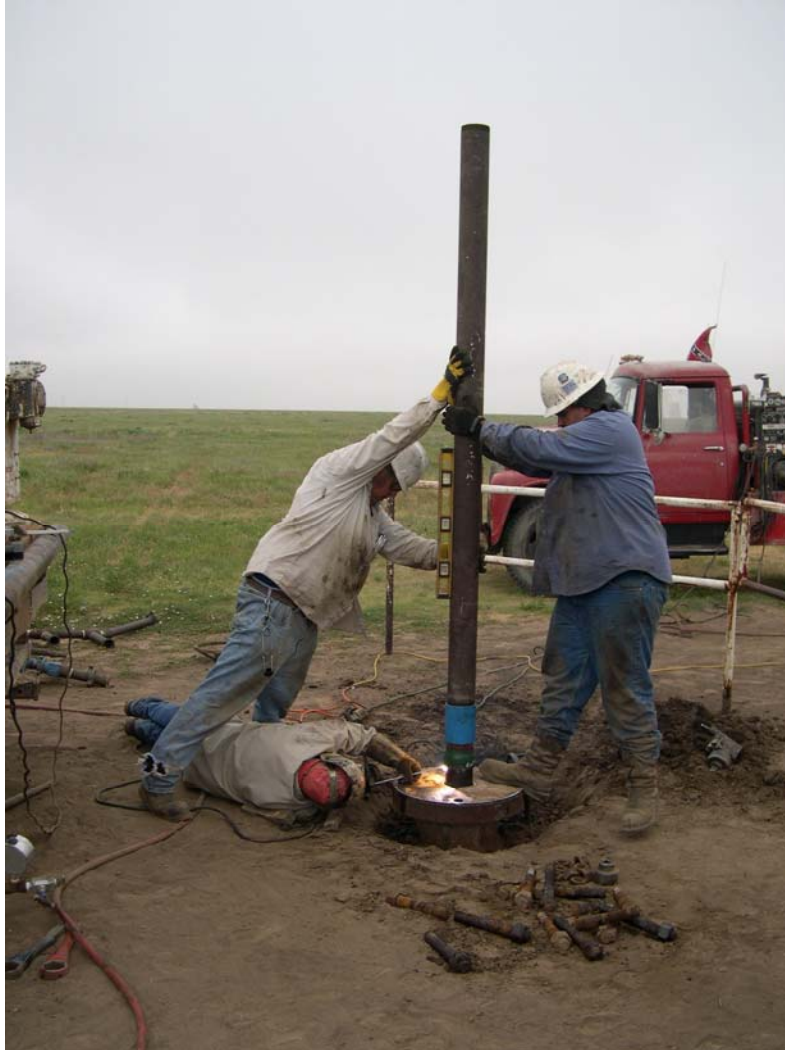
Figure 6 - Bell Nipple with 8 rd Threads Welded Onto Top of Casing
Use of vent stack allows gas flow to be safely diverted
away from weld site. Alternative flange adapters are
available when company policy prohibits use of welding on
well site.

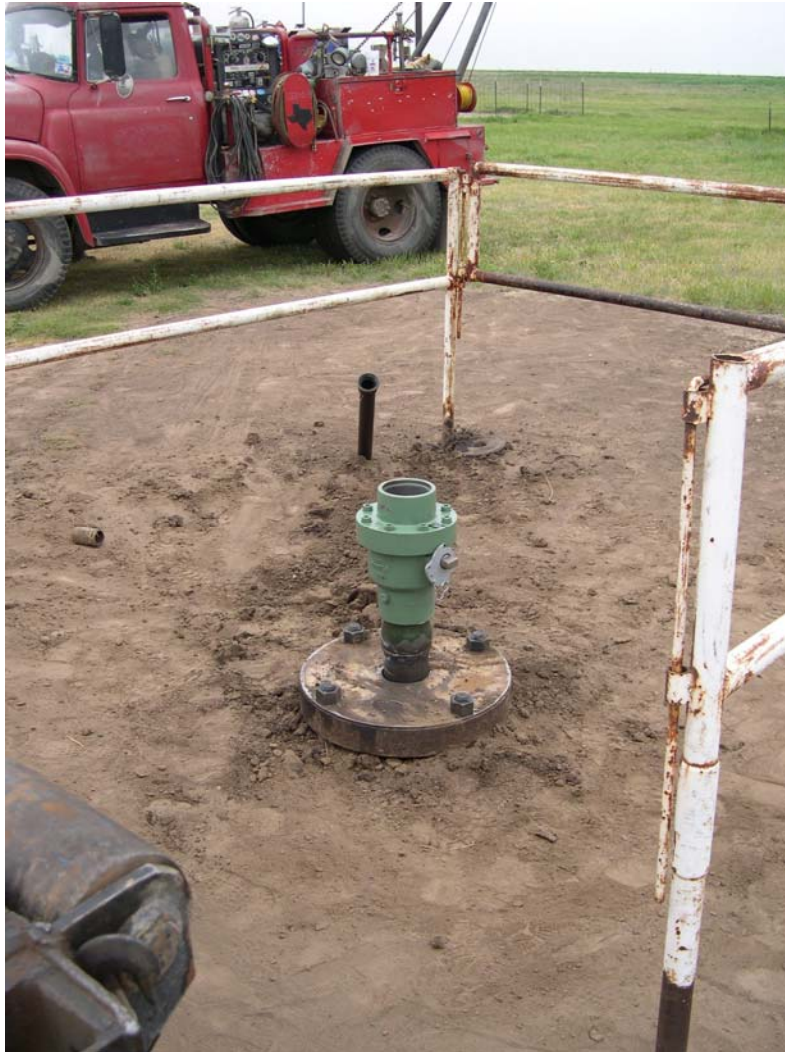
Figure 7 - Casing has been modified for full port ball valve and ready for installation of casing plunger. Should the need arise, the ball valve can be removed and a standard threaded casing/tubing head installed for conventional casing-tubing production applications.

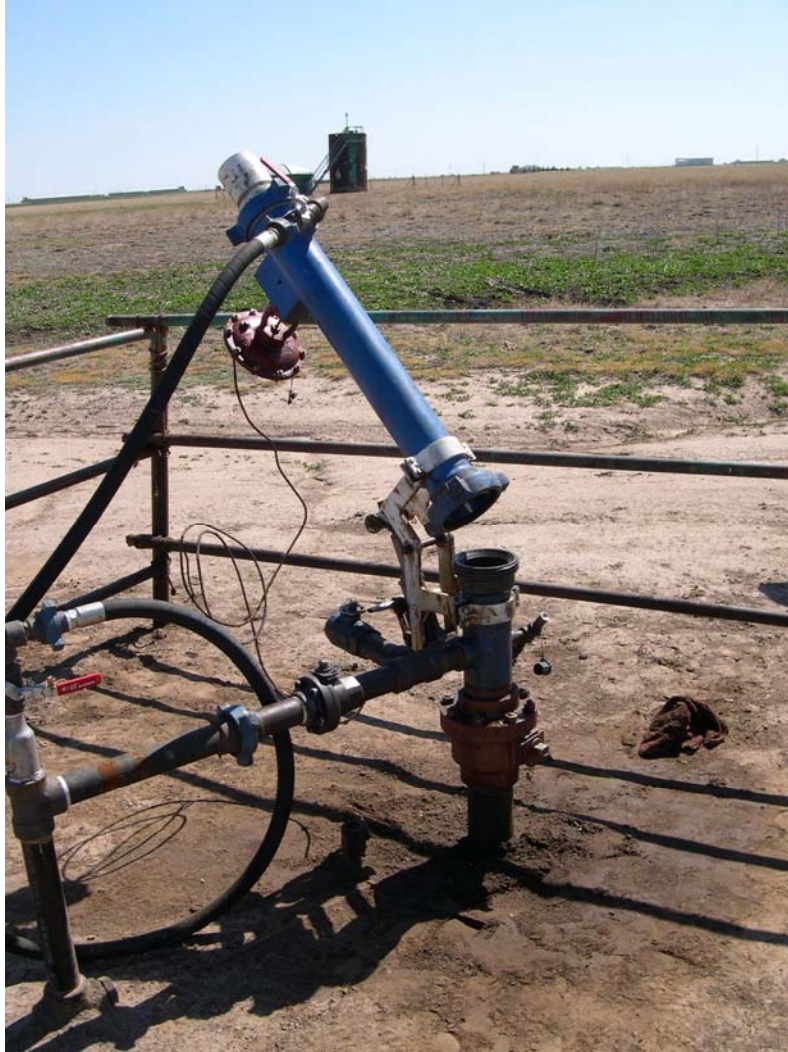
Figure 8 - Fully Assembled Casing Plunger Lubricator
Power assisted lift (Pat. Pend.) is helpful on 4 ½ inch casing plungers and essential on 5 ½ inch casing plungers.
