POLISHED ROD FAILURE PREVENTION

Rodney Sands
Harbison-Fischer Manufacturing Company

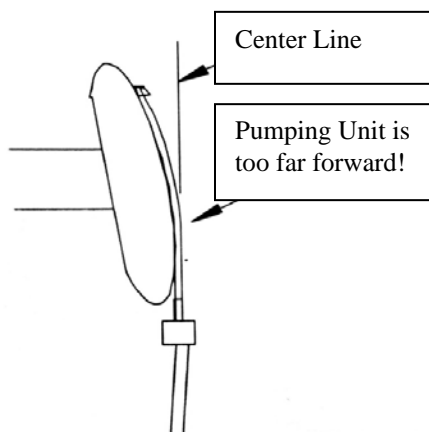
Figure 1

- ☐ From the side of the pumping unit, look to see if the polished rod is tracking straight up and down. See figure 1.
- ☐ From the front of the pumping unit, look to see if the polish rod is in the center of the horses head. Also, look at where the bridle marks are on the horse's head. Are they in the same place, or does it look like the wear pattern has moved indicating a problem with alignment? See figure 2.
- ☐ Make sure the bridle is installed correctly and is not damaged. Also check that there is the correct amount of free bridle recommended by the pumping unit manufacturer. Check the carrier bar with a spirit level; look for uneven bridle length causing the carrier bar to be uneven. See figure 3.
- ☐ Stop the unit at the top and bottom of the stroke, using a spirit level; check the polish rod for vertical plumb from the front and the side.

If any of these appear to be wrong, have the pumping unit inspected to see what is causing the misalignment.
