CONTINUOUS ROD SCANNING USING LV-EMI™ PROPRIETARY TECHNOLOGY

Enio Oliveros, L.J. Guillotte Jr., and Anne Marie Weaver, LPS Jared Jensen, Chevron

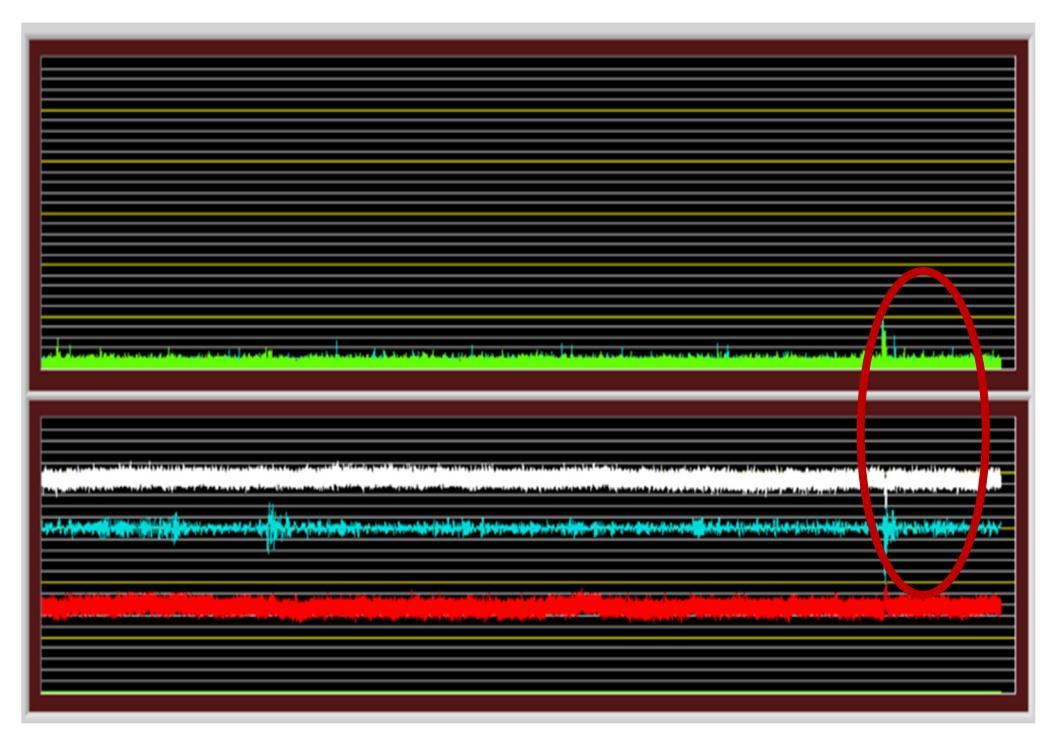
Figure 2: Accelerometer Display Field Results (blue signal)

The accelerometer is utilized with every continuous rod scan. Field scan results are shown in Figures 2, 3, and 4. The blue line in the bottom portion of the graph represents the accelerometer, the additional lines represent sensors on the EMI unit. The circled spots on Figures 2, 3, and 4 display that the accelerometer signal (blue) coincides with the EMI spikes indicating that the EMI signal is likely noisy (false signal) due to movement in the rod string and not due to a defect (true signal).

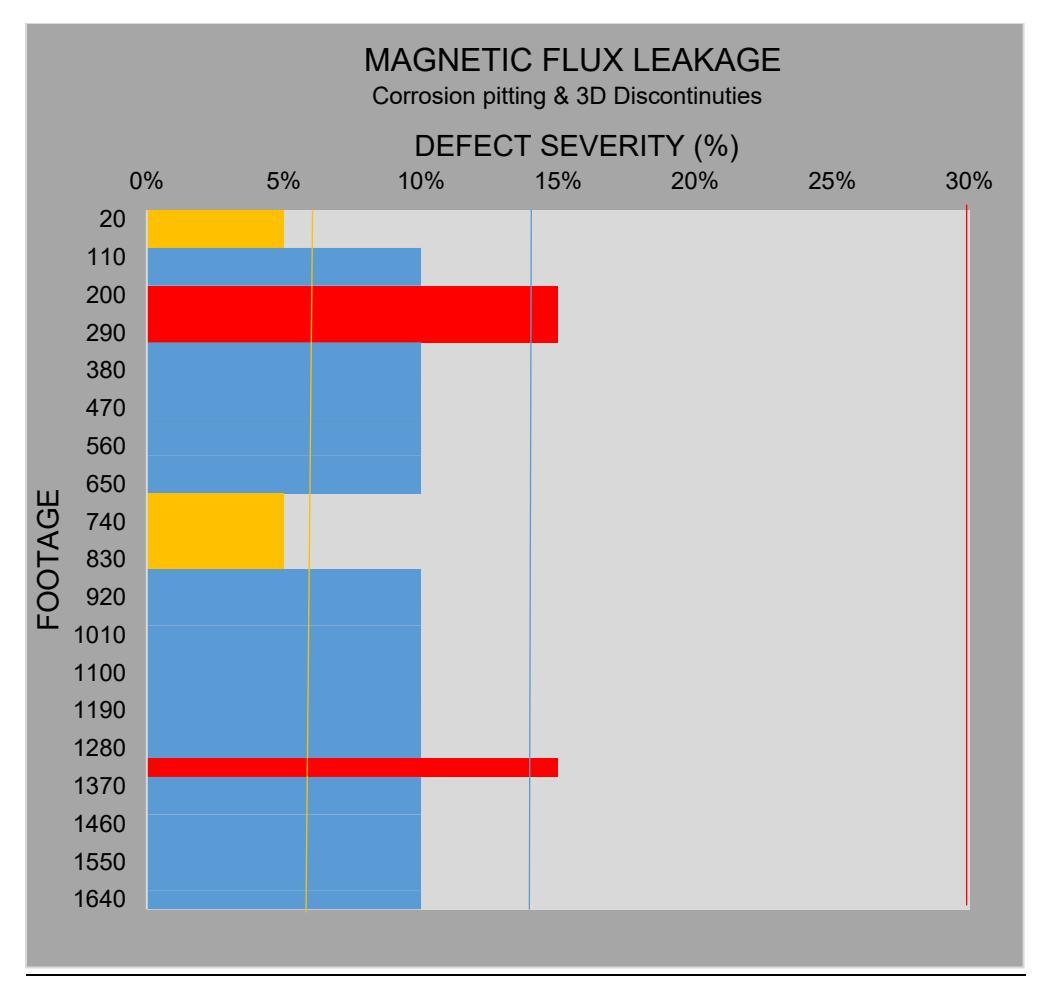
Figure 5: Magnetic Flux Leakage (MFL) Indications for Well No. 1

According to the magnetic flux leakage (MFL) chart in Figure 5, indications of 30 thousandths or 6% to 60 thousandths or 15% of the rod diameter were observed throughout most of the rod string. Visual inspection revealed what appeared to be moderate corrosion pitting throughout most of the rod string. Corrosion pitting of 60 thousandths of the rod diameter was observed between 150' to 300'. Photographs confirming this condition are given in Figures 7 and 8.

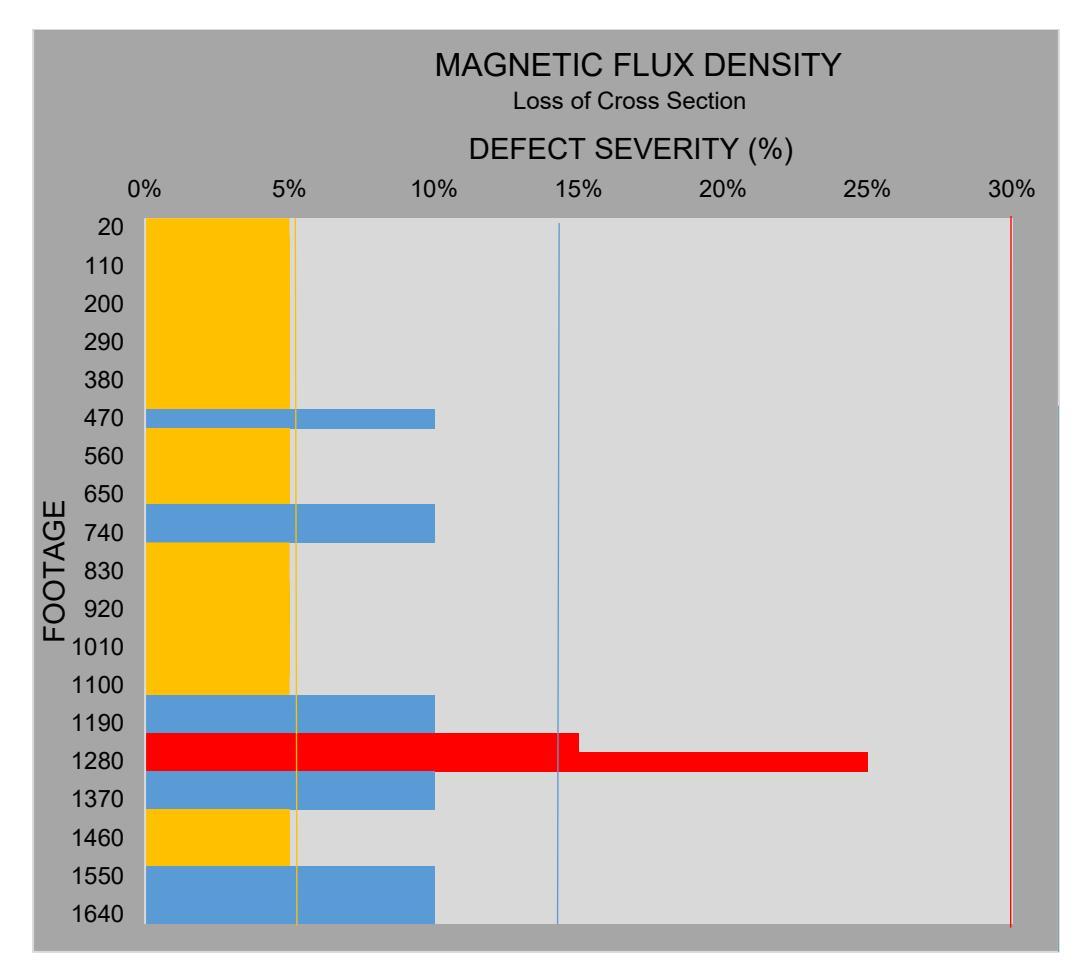
Figure 6: Magnetic flux density (MFD) Indications for Well No. 1

According to the magnetic flux density (MFD) chart in Figure 6, the rod string experienced mild to moderate wear throughout most of the rod string. Severe wear was seen between 1200' and 1300' with up to 25% cross-sectional loss. The minor side of the semi-elliptical rod string has worn to a knife-like edge. Photographs confirming this damage are given in Figures 9 and 10.

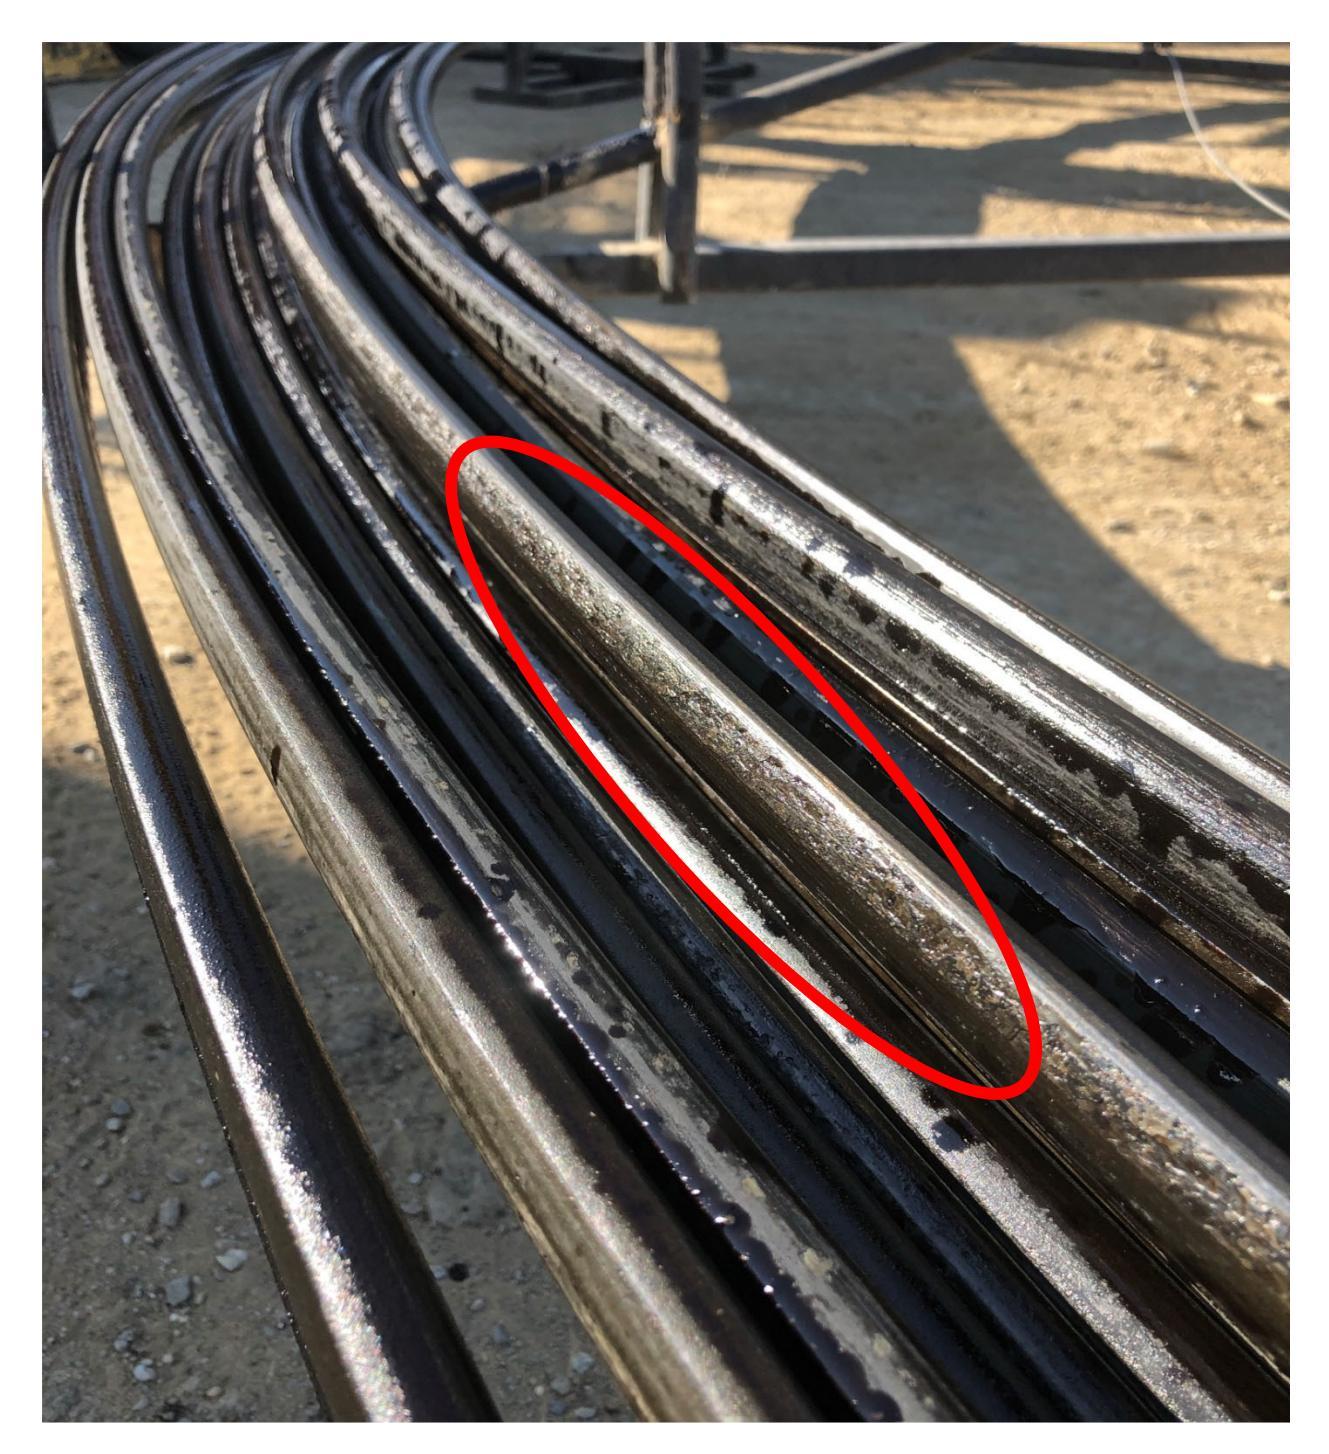
Figure 8: Appears to be corrosion pitting - Well No. 1

Figure 9: Worn to a knife-like edge on minor side – Well No. 1

Figure 10: Worn to a knife-like edge on minor side between 1200' - 1300' - Well No. 1
