METALLURGIC AND COATING SOLUTIONS FOR CORROSION MITIGATION IN ANNULAR FLOW WELLS

Joe Koessler and Joe Alapati, Devon Energy Page Laird, NOV Tuboscope

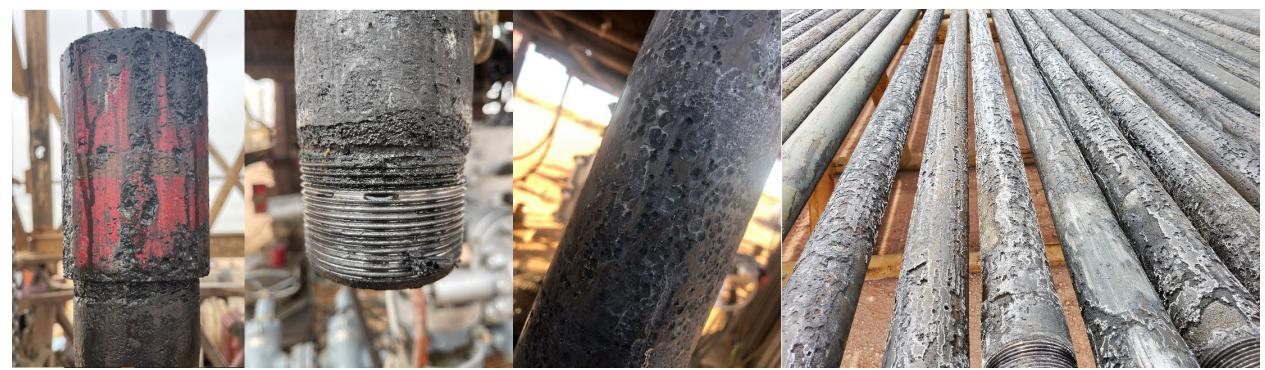
Initial identification of corrosion modes can often come from field-based observation of corrosion morphology. Specifically, the presence and pattern of pits observed on tubulars during workover and conversion of annular flow wells noted higher than typically observed incidence of tubing failure during scanning. Joints discarded because of failed tubing scan were visually inspected for proximal cause. While wall loss occurred, the presence of pitting over entire joints of tubulars suggested a more aggressive style of attack was occurring in annular flow wells.

Figure 1 – Corrosion morphology in annular flow wells from Bone Spring and Wolfcamp formations in the Delaware Basin

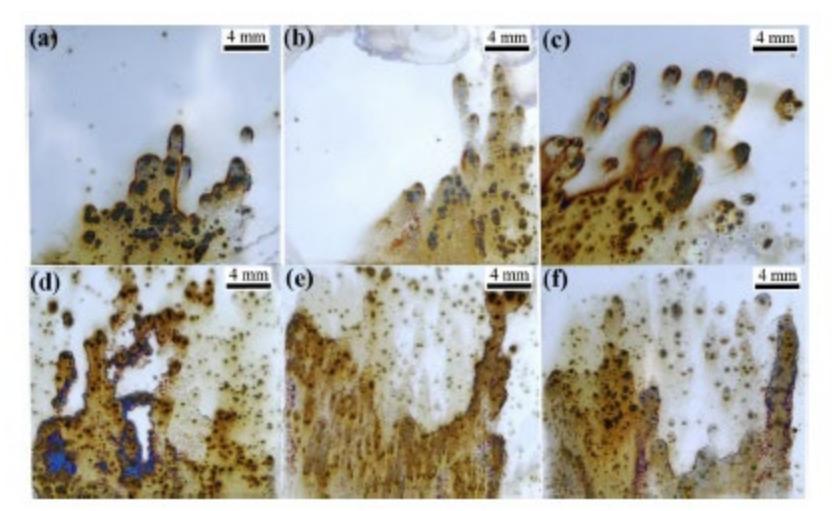
Figure 3 – Oxygen pitting corrosion morphology observed by Su et al. after 6 hour immersion in 3.5% by weight NaCl solution.

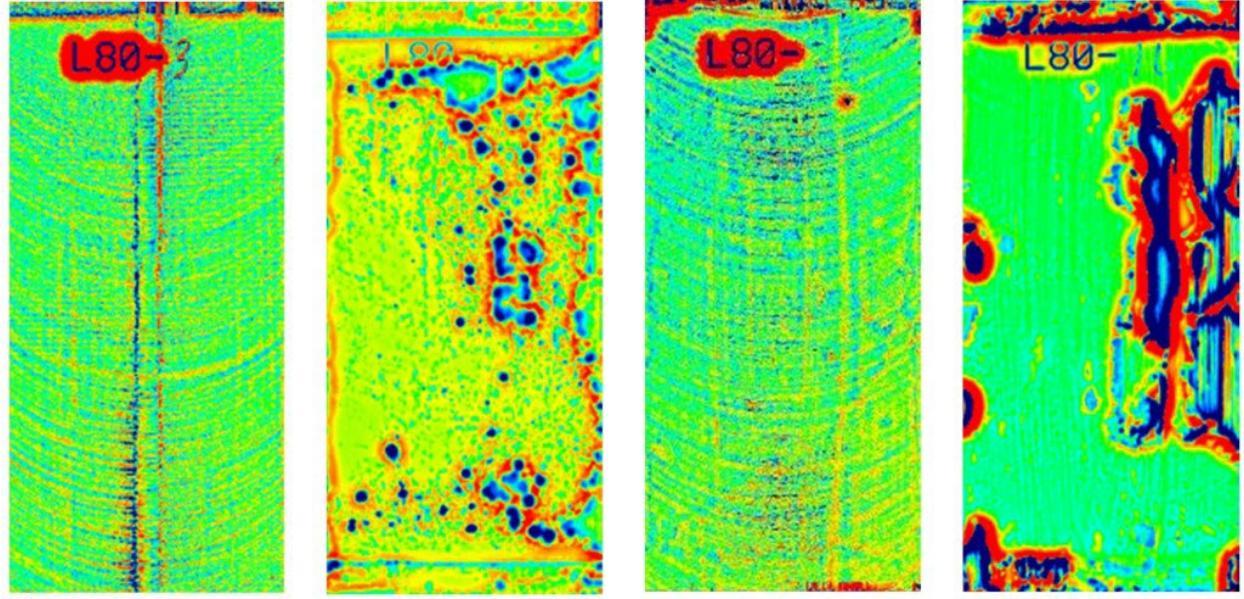
Beyond these published examples, further testing using the chemistry and shear rates of typical annular flows wells was conducted as part of inhibitor testing. Specifically, field fluids in a 80/20 water to oil ratio were heated to 150°F in a laboratory setting. Expected partial pressures of CO2 were applied to the test cell (~2.5 PSI) to mimic carbonic acid formation commonly seen in low CO2 partial pressure environments. Finally, oxygen was introduced to the flow cell with flow cell testing of L80 samples conducted at 320 Pascals. Control cells from this testing exhibited corrosion morphology consistent with field-based observations from annular flow wells.

Figure 4 – L80 corrosion sample results exhibiting pitting morphology during 14-day flow cell testing in an autoclave. The left samples were control. The right samples were in the presence of corrosion inhibitor chemical, one passed (left) and one failed (right).

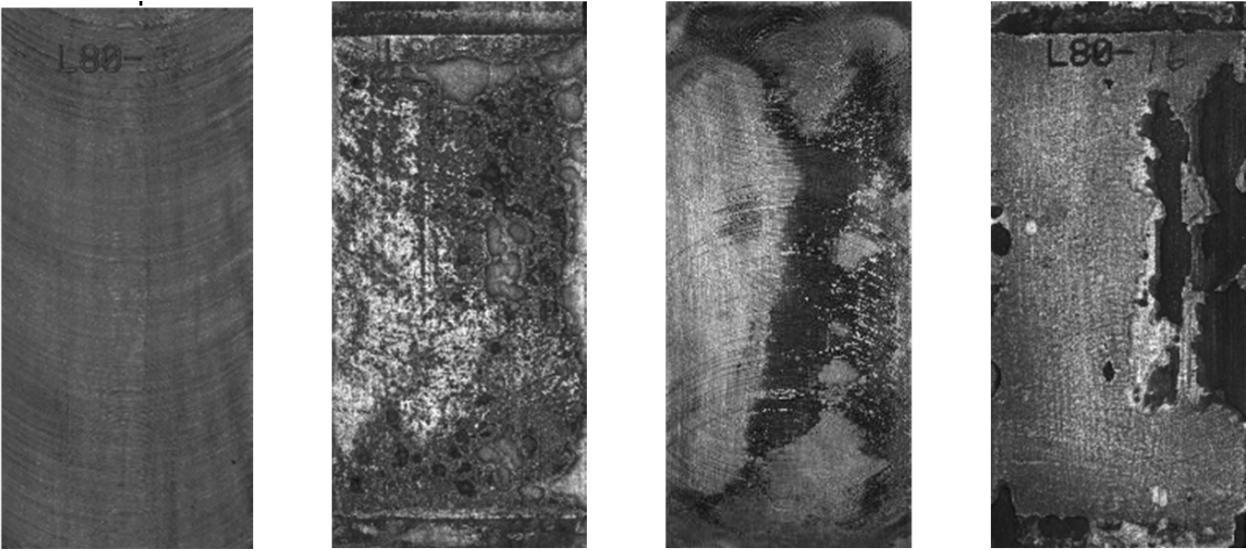
Figure 5 – Photographs of the same L80 samples showing corrosion morphology.

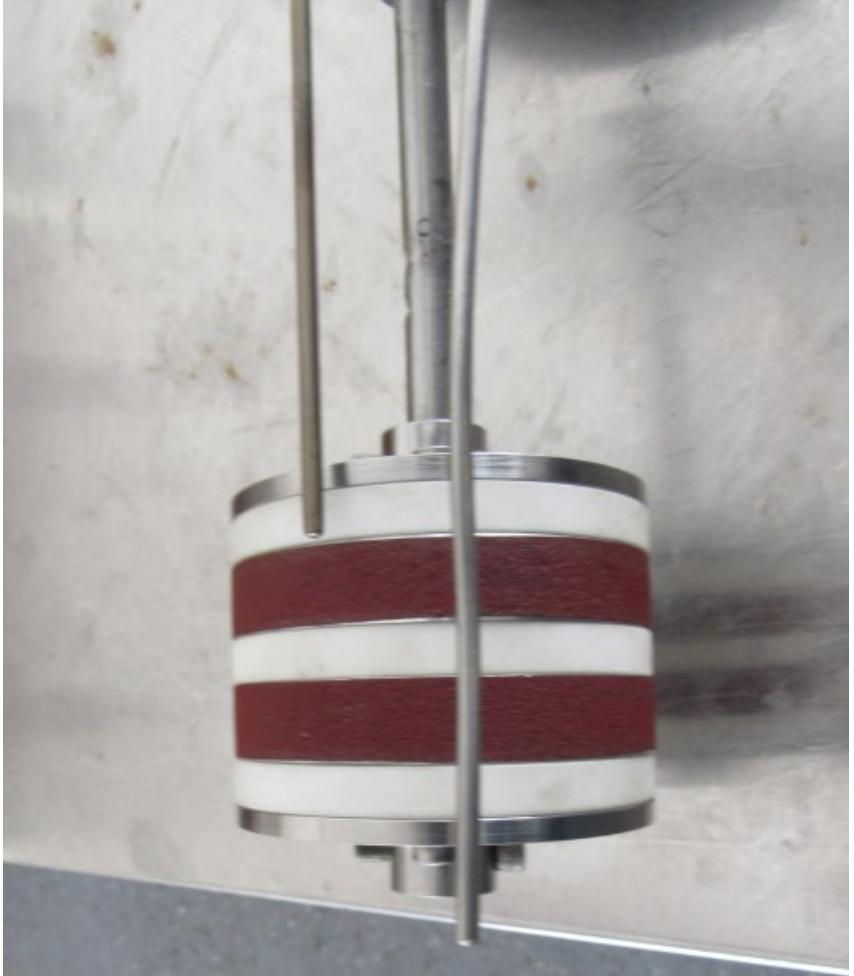
The spray metal coating was tested in the same autoclave solution, but the application of the coating prevented a side-by-side test to the tubing metallurgy coupons. Specifically, a rectangular coupon could not be coated with the coating equipment. As such, a circular sample was extracted from a coated 2 7/8" L80 pup joint and installed in the autoclave.

Figure 6 – Autoclave testing of a spray metal coating applied to 2 7/8" L80 tubing.

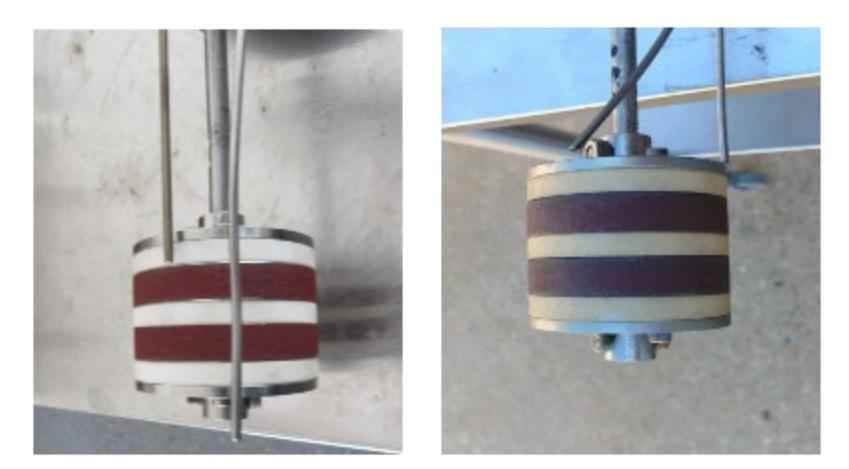
Results from the autoclave testing showed no incidence of pitting corrosion to the test sample. As such, a weight comparison of the sample before and after the autoclave test was the best measure of corrosion rate available. Those results effectively showed no corrosion to the sample during the autoclave test.

Figure 7 – Spray metal autoclave test results. Pretest (left) and posttest (right)

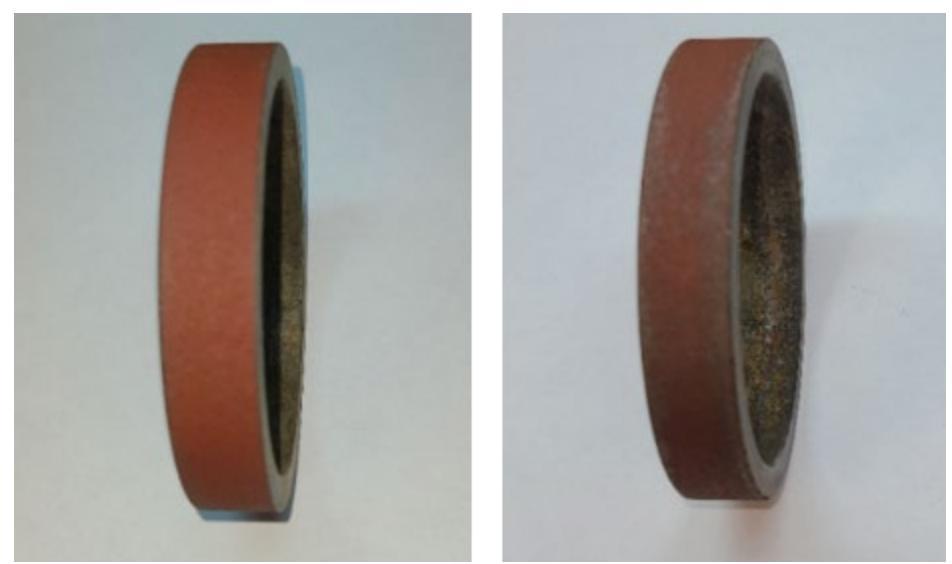
Figure 8 – Spray metal autoclave test results. Pretest (left) and posttest (right)
