HIDDEN COMPLEXITIES OF ROD ROTATION: UNDERSTANDING TORQUE BUILDUP IN SUCKER ROD SYSTEMS

Walter Phillips, WANSCO Nick Hooper, Continental Resources Justin Bates, Echometer Company

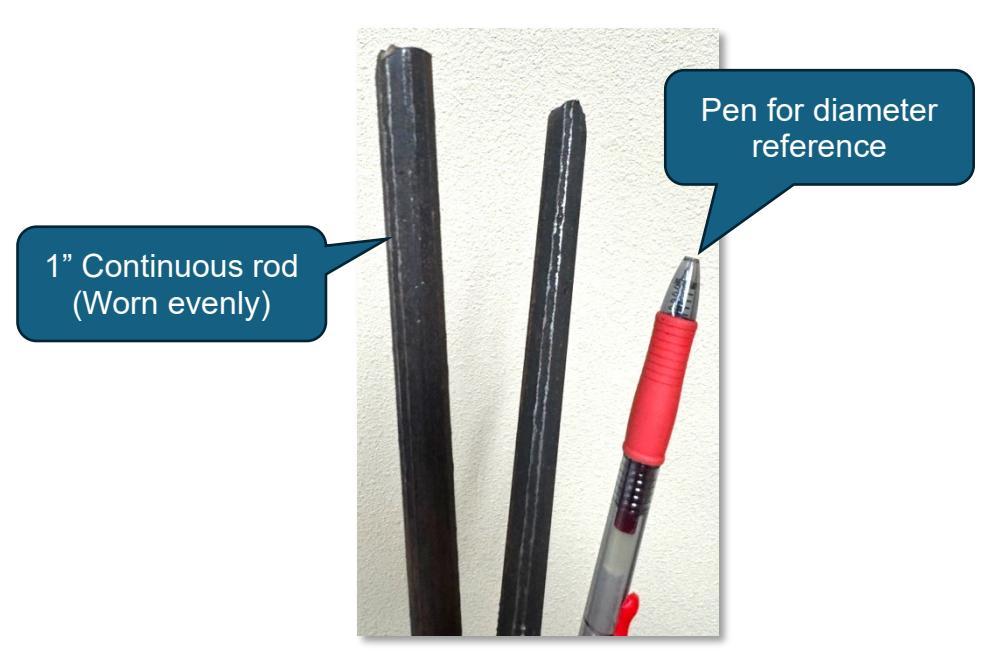
Figure 1 – The rod pictured was originally a 1" continuous rod (shallow well, big bore pump). This section of rod was worn down to approximately 3/8" and shown next to a pen for perspective. Even though this rod is worn "evenly," clearly showing evenly distributed wear (i.e., effective rotation), there are indications that the rod has several wear "tracks" or lines which indicates a leading edge. This well failed due to a rod part.

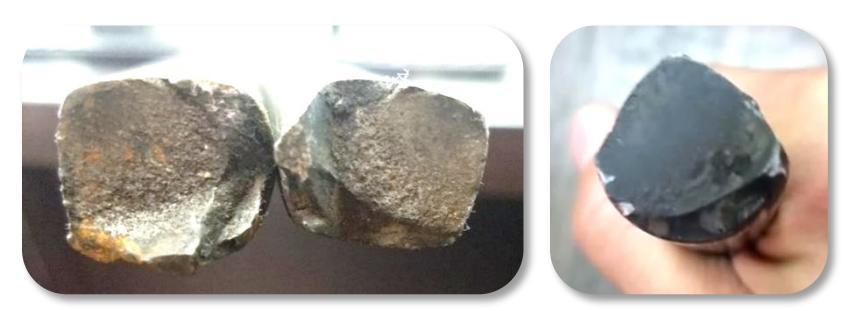
In short a "flat spot" is a section of rod, coupling, or guide, that is unevenly worn on one or more side. Both Figure 2 examples, particularly the "square" rod, show a form of distribution of wear, but this is not evenly distributed over the entire circumference. Figure 2 shows the rotator was clearly functioning, but something is causing the wear to be focused on specific "sides" of the rod. By "even rod wear" we intend to describe a wear pattern that leaves the rod, coupling, or guide substantially round (i.e. Figure 1).

Figure 2 – Rods may wear unevenly, resulting in interesting wear patterns The rotator was rotating the rods in both images, but that rotation was not "effective" or "evenly distributed." While the wear pattern is not fully explained, there are likely other wear points in the same well that would alternatively catch and release the rotational motion of the rods. In both of these images, rotating the rod would require some appreciable amount of torque to overcome the "edges" to lift the rod off the flat spot and onto the higher adjacent portion. The rod would then fall into the next flat spot and the cycle repeats.

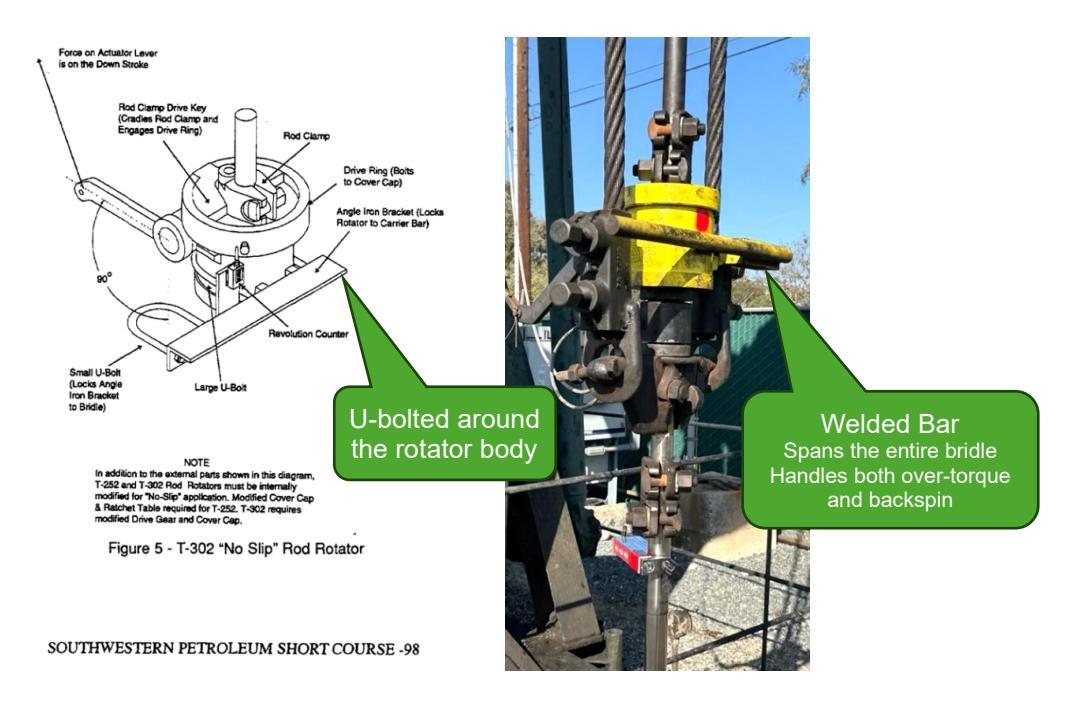
Figure 5 – Anti-rotation bars are a simple solution to keep the rotator aligned. Torque or "backspin" can move the entire rotator assembly which can cause subsequent failures of the ratchet and/or cable. The bar can be welded (suboptimal on a cast housing, but effective), or a large U-bolt can be used around the body of the rotator. Other methods are available to keep the rotator body stationary. Figure reference: (Smith, 1988). No-slip style rotators should include shear pins, especially when used in conjunction with an anti-rotation bar, to prevent excessive torque.

- Uneven clamp installation or a non-level bridle may also result in a slipping clamp or rotator body. These conditions should be addressed before considering a positive engagement rotator or anti-rotation bar (Figure 5). The central premise of this paper is that forcing the rods to turn when they are not freely turning may be problematic with little benefit.

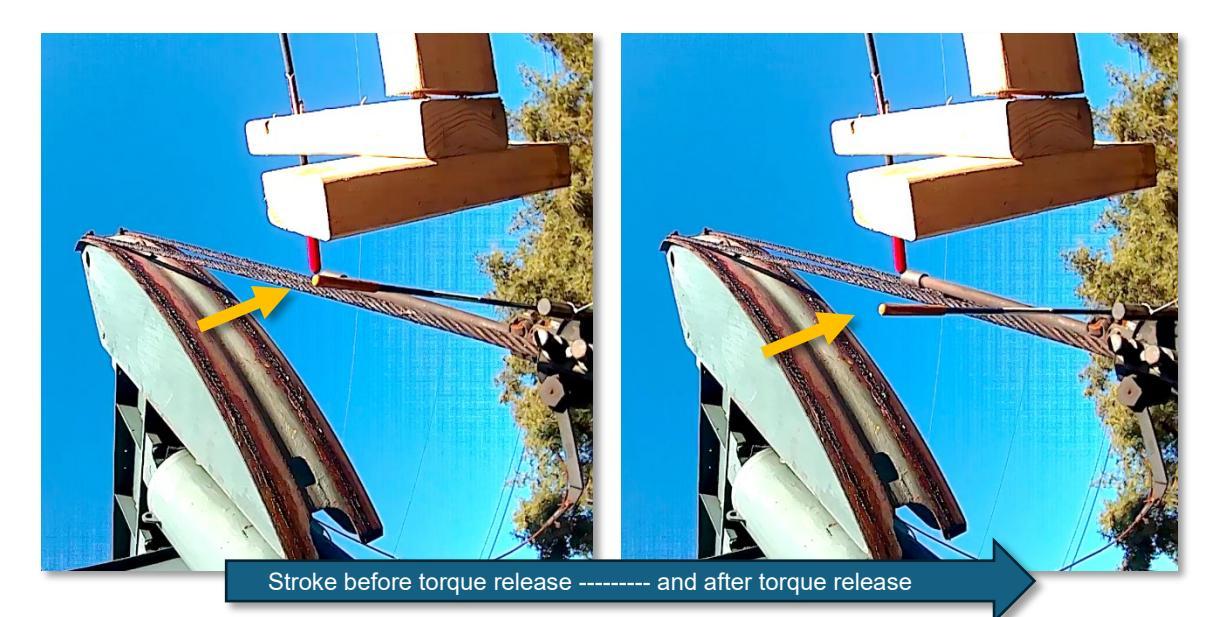
Figure 6 visually shows what was observed and correlated in sensor data (Figure 7). The bridle slowly deflects, or twists. Each pull of the rotator ratchet increased the torque on the rods and, because of a downhole rotational restriction, this increasing torque manifested in the bridle angle progressively deflecting more on each stroke. Once the downhole rotational restriction is overcome, the bridle substantially relaxes, or "un-twists".

Figure 6 –Visual indication of bridle torque change. A probe was attached directly to the bridle (yellow cap) and moves up and down, but also rotates with any torque-induced deflection, which is what we intend to visualize. The stationary probe (red cap) was set near the path of the bridle to provide a fixed reference. These are selected frames from a video captured over several hours, and show 2 consecutive pump strokes. The yellow probe moved (rotated/twisted with the bridle) closer to the fixed red probe over many strokes. The picture on the left shows the stroke just before the torque release when the bridle was at maximum torque deflection. The rotating probe (yellow) was closest to the fixed probe (red). The picture on the right shows the very next stroke at (or following) the torque release. The yellow probe moves ever so slightly, but this is evident and measurable. A change in applied torque from a downhole "flop-over" event is the reason the bridle "relaxed." In this well, a single rotation's worth of torque was released downhole at each event.

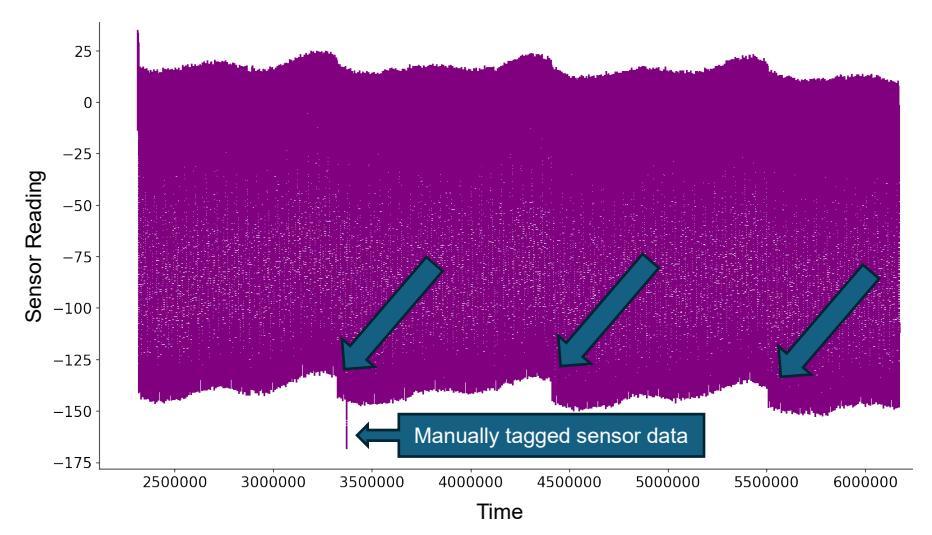
Figure 7 – Sensing torque release. The above visual example (Figure 6) was also caught in raw magnetic field sensor data. This plot illustrates sensor readings over approximately 600 strokes, or just over 3 complete rotations. The sharp change in sensor reading indicates a change in bridle deflection (highlighted by the 3 arrows). These events also occur at the same point in the overall rotation indicating the same downhole restriction is resisting the rotation and the same amount of torque (via the rotational angle) is required to overcome that restriction. While visually monitoring the well during the test, the physical change in bridle deflection was observed. A few strokes later it was realized that the sensor data could be tagged to correlate the visual observation with the logged sensor data for confirmation. Similar plots could be derived from accelerometer or gyroscope measurements (US Patent No. 11,814,948, 2018).

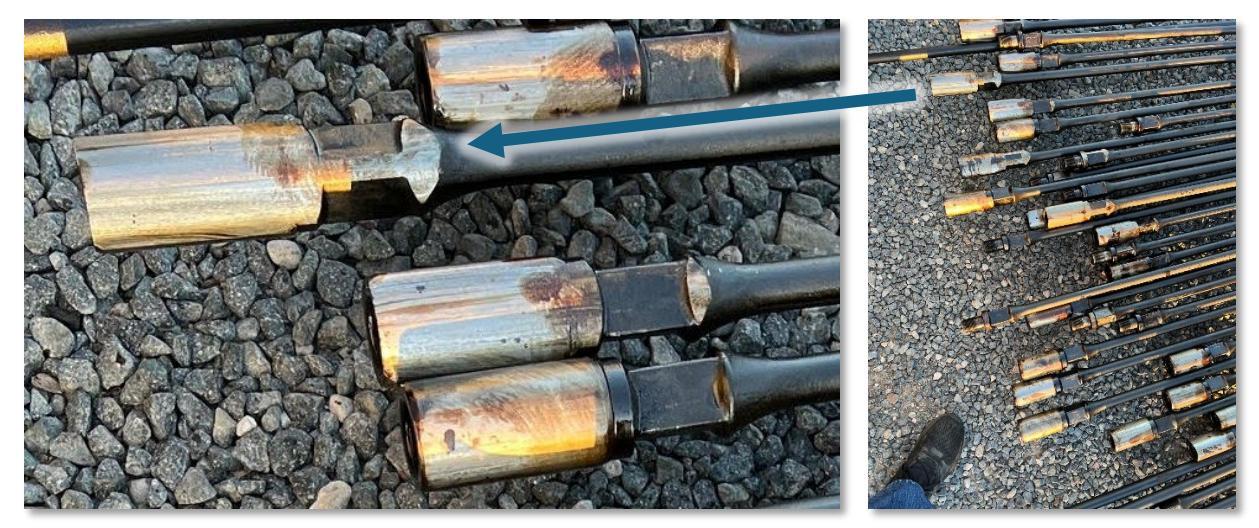
The hole in tubing was near the bottom in a deviated section. Specifically, a tubing section was worn through by the rods and a corresponding flat section of rod couplings which are shown in Figure 8. While this failure was ultimately due to rod wear on the tubing, the well ran for over a year in this "torque and release" condition. Specifically, this was a year from when the condition was first observed using sensor data. It is likely the condition was present long before that. It should be further noted that a rotator failure was documented (and fixed) prior to the first observation of the "torque and release" on the bridle.

- Rotator failure caused the rod couplings to wear flat, as this condition went undiagnosed for some period.
- Rotator was repaired Rotation resumed, but the "flat couplings" were not addressed.
 - Once a flat spot occurs, there is virtually nothing that can be done to "fix" this condition short of pulling the rods (and tubing).
- Subsequent rotations caused a periodic increase in side-load as the flat spot must be overcome during each rotation over the flat spot.
 - This portion of the failure mechanism is speculative. It is unknown if the runtime would have been better or worse had the rotator remained disabled after the flat spot had developed, or if immediately repairing the rotator would have prevented the flat spot from developing in the first place.
 - It is thought the persistent rotation against the flat spot may have accelerated tubing wear.

Figure 8 – Worn rod couplings are shown from Case Study #1. This is strongly believed to be the source of downhole rotational restriction observed a year earlier in Figure 6 and Figure 7. The tubing failed, but the rods themselves, even though the coupling wore flat, likely would have continued pumping. The rod-string was observed to torque and release, and the flat spot on the couplings shown above is likely the cause of the rotational restriction. It is unknown if forcing the rods to turn imparted an additional wearing force on the tubing, accelerating its wear.

Given that a flat spot is unrepairable once developed, an urgency should be placed on detecting and repairing rotator failures to prevent flat spots from forming. Case Study #2 is an attempt to determine how long it takes for a flat spot to occur and to determine loads relative to rotational dynamics.

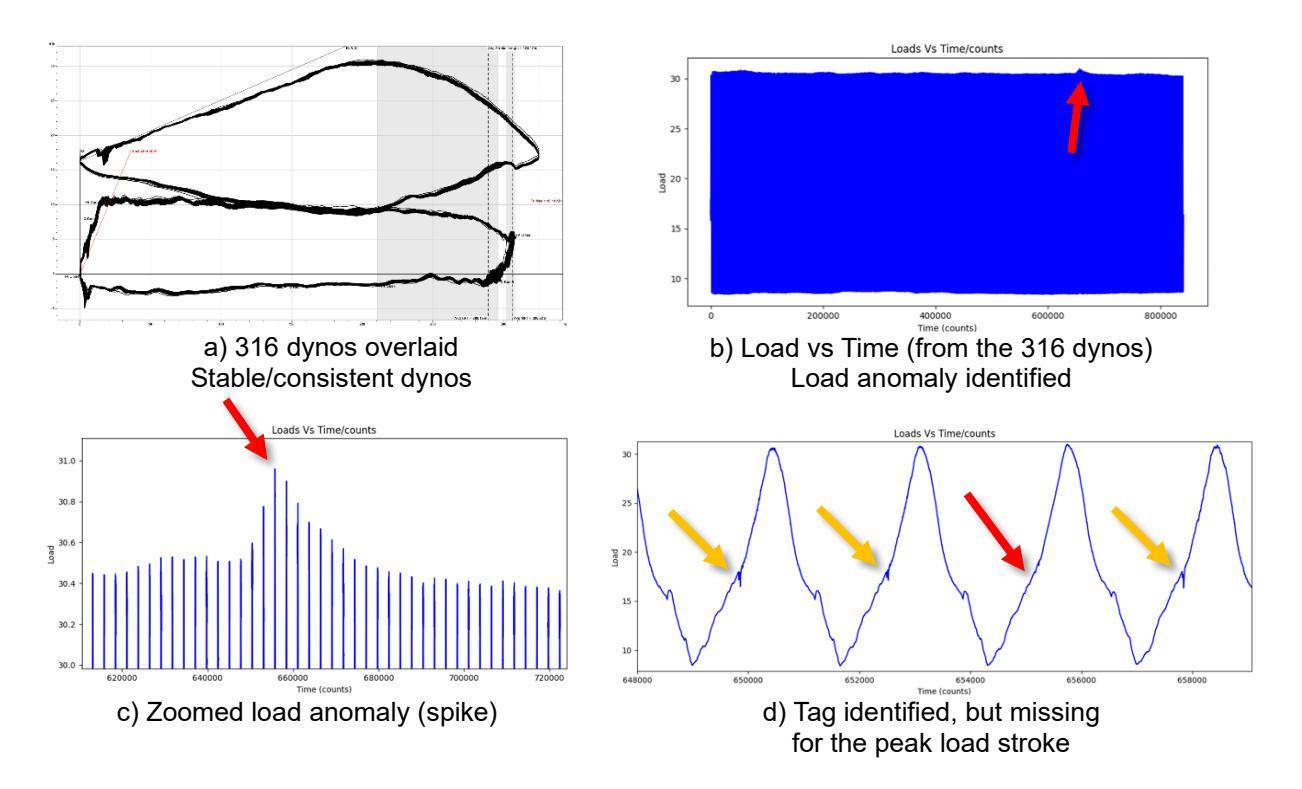
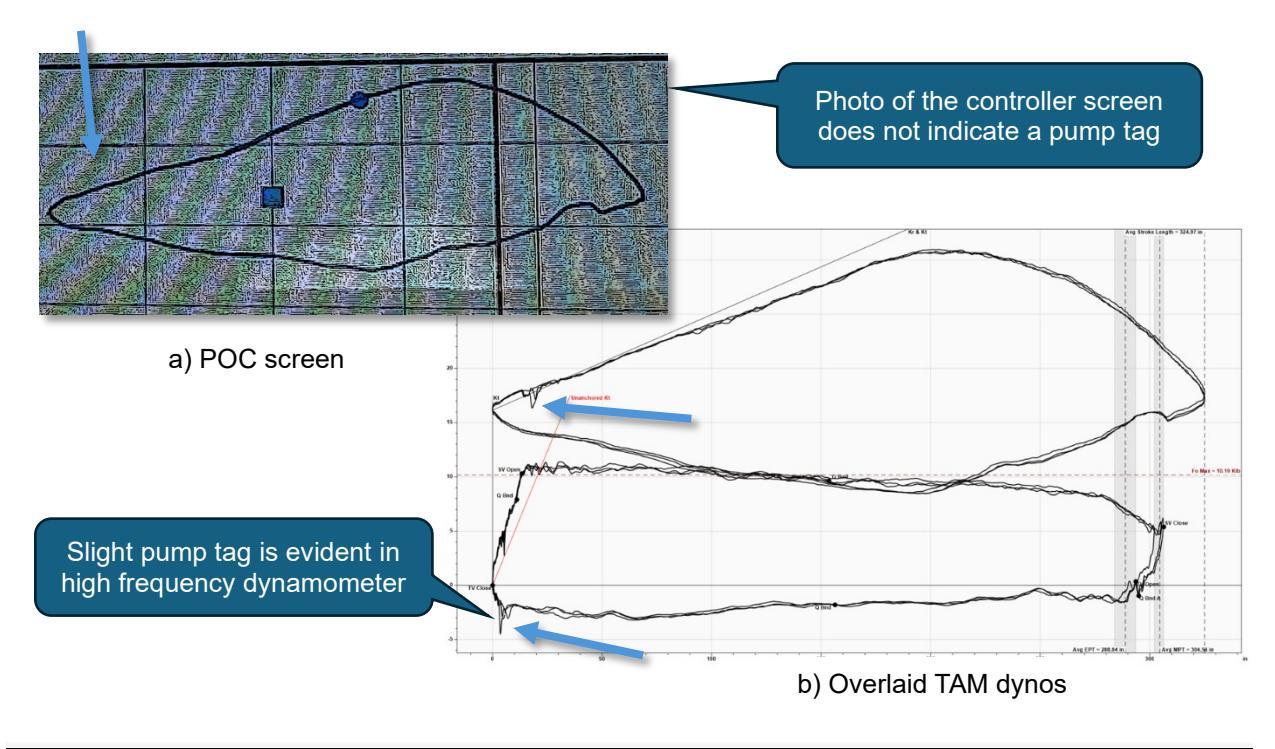
Figure 10 shows dynos gathered during what is thought to be a flop-over event, following the start of rotation. These dynos were gathered during a period when the well was producing stability. This is important because load and/or stroke changes due to changing well conditions could easily be mistook for the rotational-related change we are looking for. In short, the theory is that a rotational event downhole, i.e. a "flop-over" would result in some change in polished rod loads as the mechanical friction, side-load, or some other phenomenon, alters the dynamics during that event. Figure 10, a) shows a sequence of 316 dynos overlaid and shows there was very little variation across this sequence.

To see the load variation, the dynos were exported so they could be plotted versus time and zoomed (Figure 10 b & c). What is particularly interesting in this well, during this period is there was a persistent "slight" tag. Originally it was thought this would corrupt the test (a tag could potentially "jar" the rotationally restricted rods loose). In other words, a pump tag might affect the rotation. In this dataset, however, the tag disappeared for one single stroke (Figure 10 d), corresponding to the peak of increased loads. The increased loads themselves may be attributable to some other source, but it is believed this corresponds to a flop-over event because the well was functioning in a particularly stable state during this sequence of dynos.

What could cause a load increase over approximately 10 strokes, wherein the peak load stroke also corresponds to a "skipped" tag is subject to discussion. It is believed, however that the act of releasing a downhole rotational restriction caused a change in loads. This could be an increasing side-load as the leading edge of the flat rod is forced against the tubing wall. This in turn would alter mechanical friction, which could alter the downhole pump stroke. Rods or pump stroke might have changed length slightly as the rotational restriction was overcome and the rods coiled (slightly) through the flop-over. Figure 10 shows progressively zoomed views of the polished rod load data to illustrate the specific stroke(s) of interest.

Figure 10 – A range of dynos were captured while the well was producing, in a stable state, during what is believed to be a flop-over event. Peak load variations are hard to determine from dynos (Fig. a), but they give a good view of how the well is behaving. Specifically, all dynos look roughly the same which means the well is behaving in a stable manner. The raw data was exported and plotted as load vs. time (Fig. b). A clear load increase is visible. When zoomed it can be seen this load anomaly took place over about 10 strokes (Fig. c). When further zoomed, it is clear a persistent "slight" tag disappeared for one stroke (Fig. d). The surface indicator of the pump tag, i.e. a sharp load variation is highlighted on each stroke. It is believed the stroke identified by the red arrow (Fig. d) is related to the rods flopping over. The load variations before and after this stroke may indicate the surrounding dynamics associated with that event.

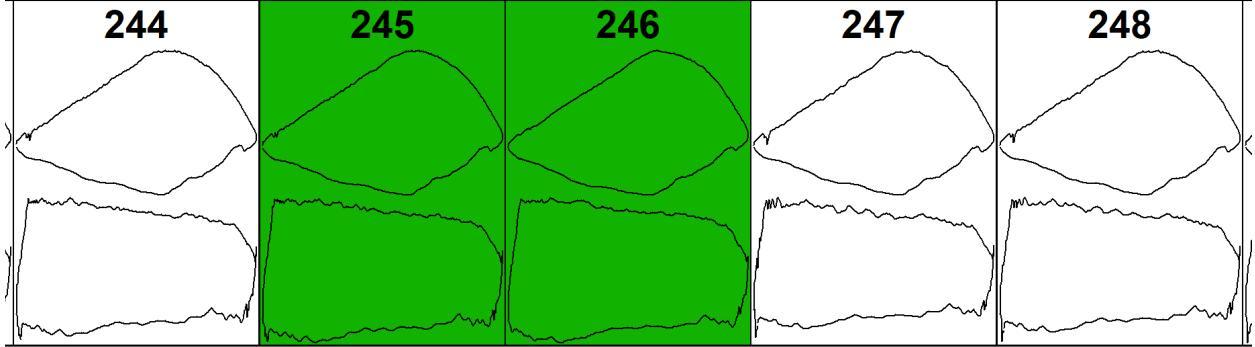
c) Individual cards. Stroke #246 (of 316) is believed to be related to a rotational event. Note: this is the only card in the series of 316 strokes that does not indicate a pump tag.

Figure 11 – The resolution on typical pump-off controllers obscures certain conditions such as a slight pump tag. A photo taken from the controller screen (Fig. a) does not indicate a tag. This is a factor of the sample rate of the controller on the surface card, as well as the method to calculate the pump card. When viewed through the Echometer tools (Fig. b) at a higher sample rate, a very slight tag is evident on all cards in the series except for one (Stroke #246, Fig. c). A random stroke that does *not* tag may seem innocuous, but referring to Figure 10, it can be seen there is a load variation surrounding this. In other words, something is happening that spans several strokes (approximately 10 strokes) but substantially affects one in the middle of the sequence.

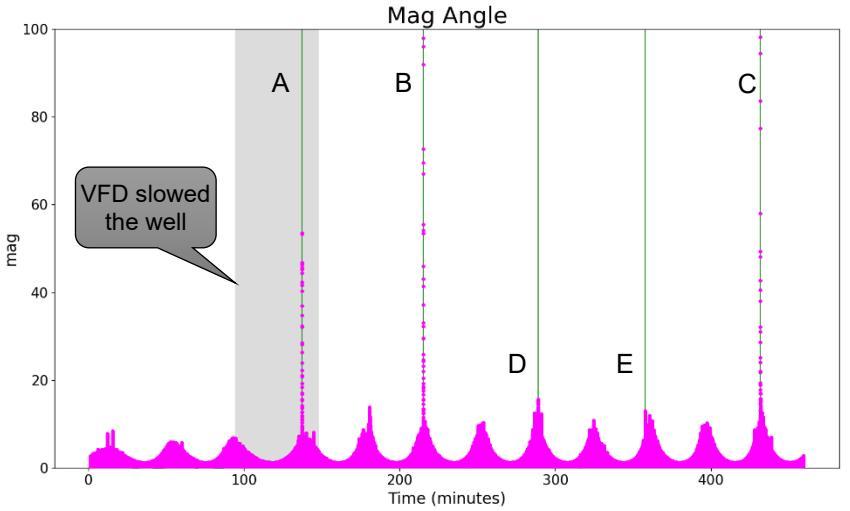
Figure 12 shows the same bridle sensor from Case Study #1 which captured the magnetic field data at the bridle for approximately 8 hours. In this well, the field data was processed to show what amounts to a derivative of the bridle angle over time. Unlike Case Study #1, the raw field data did not immediately indicate the bridle deflection change. This is likely due to the substantially larger stroke length and possibly less bridle deflection because the rods did not have time to wear a significant flat spot. This data was taken after just a few weeks of pumping, following an RTP.

Figure 12 – Sensor data was gathered over approximately 8 hours and processed to illustrate a change in bridle angle. In this dataset, 3 significant events can be seen (labeled as A, B, C). These happen at the same point in the overall rotation (i.e. the polished rod is facing the same angle). Lesser events at D and E occur at the same rotational angle of the polished rod. These events may indicate a rotational event (possibly the rods downhole "releasing" or "flopping over"). The significance of every 2nd stroke may be related to the fiberglass rods being more flexible.
