# THE DOWNHOLE VIDEO CAMERA -- OPEN AND CASED HOLE APPLICATIONS IN THE PERMIAN BASIN

# By Lee Sanders and Cary Joe Burkhart Halliburton Energy Services Midland, Texas

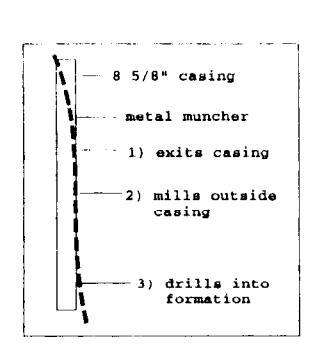
The downhole video camera showed that there were three problems (Fig. 5). The first problem was that the casing had parted and not collapsed as originally thought. Secondly, the "metal muncher" had milled through one side of the 8 5/8" and had milled on the outside of the casing (Fig. 6). Thirdly, the "metal muncher" was actually reaming out a new wellbore (Fig. 7). The original fishing job took 19 days. The downhole video camera allowed the operator to position the fishing tool, remain inside the 8 5/8" casing, and recover the lost string mill.

Figure 5 - This figure illustrates three problems associated with the fishing operation: 1) metal muncher milled through the 8 5/8" casing 2) milled outside the casing string, and 3) drilled into the formation
