# POLISHED ROD FAILURE PREVENTION

# Lior Azulai, BP Rodney Sands, Harbison-Fischer

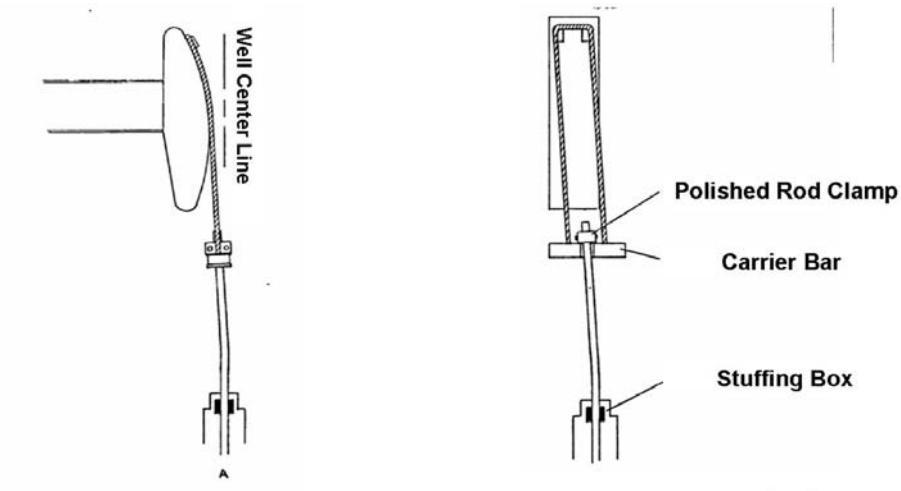
(1) **Misaligned Pumping Units** (Figure 1). Unstable pumping unit foundations, bent structural members on the pumping unit, or improperly adjusted horseheads can cause misalignment. This misalignment will induce bending stresses in the polished rod and could cause premature polished rod failure. Check to make sure pad and pumping unit are level, unit bridle is centered on the horsehead, and head of unit for worn or unadjusted hinges.

Pumping Unit is Right or Left of the Hole Figure 1 – Misaligned Pumping Units

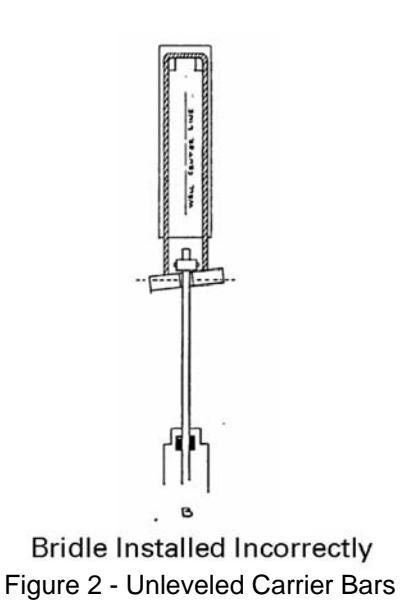
(3) Unleveled Carrier Bars (Figure 2). Carrier bars must be level to prevent bending the polished rod. The load on the polished rod will force the bottom of the clamp flush with the top of the carrier bar and bend the polished rod. Leveling plates can be used to compensate for unleveled carrier bars.

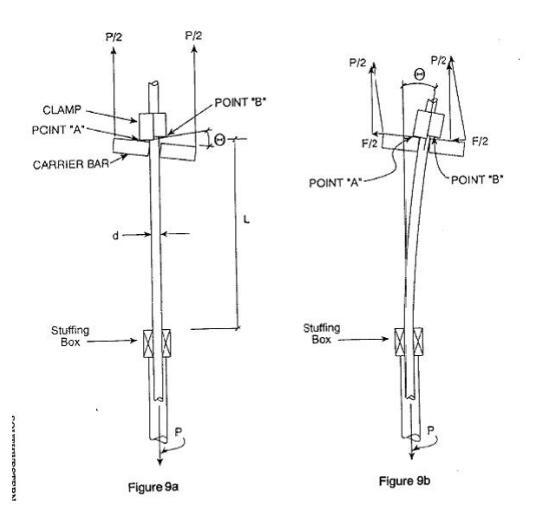
(5) Uneven Polished Rod Clamps (Figure 3). The bottom surface of a polished rod clamp should be flat, in a common plane, and perpendicular to the axis of the polished rod. Otherwise, one side of the clamp will put more pressure on the carrier bar than the other causing bending.

All polished rod clamps have some end play between segments. Care should be taken to insure segments move freely on their hinges before installation and are even on the bottom after the clamp bolts have been tightened. Do not assume segments are even on the bottom just because they are even on the top.

Figure 3 - Uneven Polished Rod Clamps

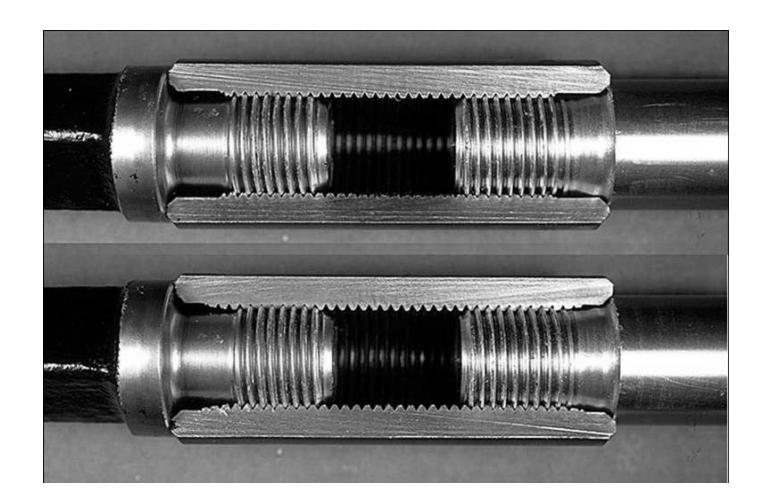
(8) Wrong coupling. Polished rod pin failures generally occur due to the installation of sucker rod couplings instead of polished rod couplings. Polished rod couplings have a shallow counterbore and a 9° taper that conforms to the profile of the polished rod pin. Sucker rod couplings have no taper and a deep recess (Figure 4). These differences lead to two common failures:

Figure 4 - Sucker Rods (Left) and Polished Rods (Right) Engaged In a Sucker Rod Coupling (Up) and a Polished Rod Coupling (Bottom)

The solution to this problem is simple and cheap; **ALWAYS** use a polished rod coupling. Most polished rod coupling manufactures label the coupling in order to differentiate it from the sucker rod coupling, however the couplings can be easily distinguished by a visual inspection of the counterbore.

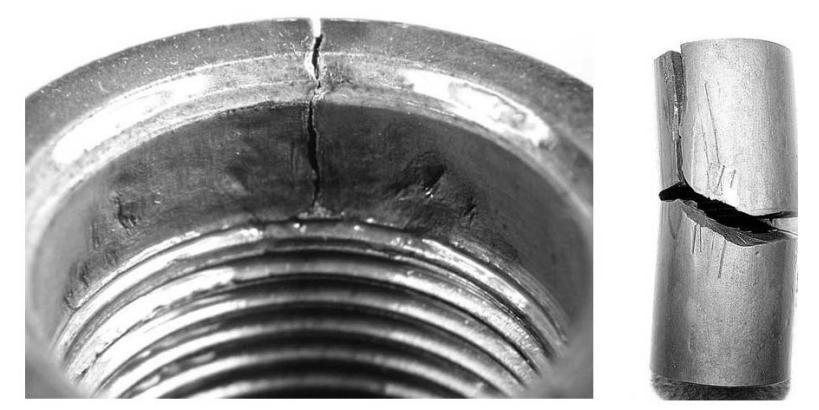
**Sucker rod coupling failure** - The  $9^{\circ}$  polished rod pin creates excess residual hoop-stress during makeup on the inside diameter of the sucker rod coupling near the coupling-shoulder contact face. The stress crack initiates on the inside diameter of the sucker rod coupling and propagates longitudinally, with each applied load, until the crack reaches the area with the highest tensile stress (Figure 5).

Figure 5 - Sucker Rod Coupling Failure

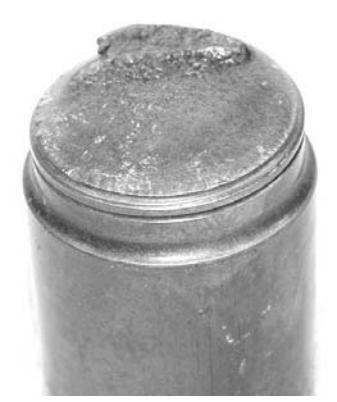
**Polished rod pin failure** - The deep counterbore of the sucker rod coupling fails to engage the last one or two threads of the polished rod pin. Unengaged threads are areas with increased local stress intensity and may lead to failure. Polished rod couplings' shallow recess to the first thread allows every polished rod pin thread to be engaged (Figure 6).

Figure 6 - Polished Rod Pin Failure
