NEW POSITIVE-SEAL SHROUD HANGER DESIGN SOLVES PRODUCTION PROBLEMS IN NEW MEXICO GAS WELLS

Art Pena, Yates Petroleum
Eddie Stewart, Mark Neinast and Paul Wang
Wood Group ESP

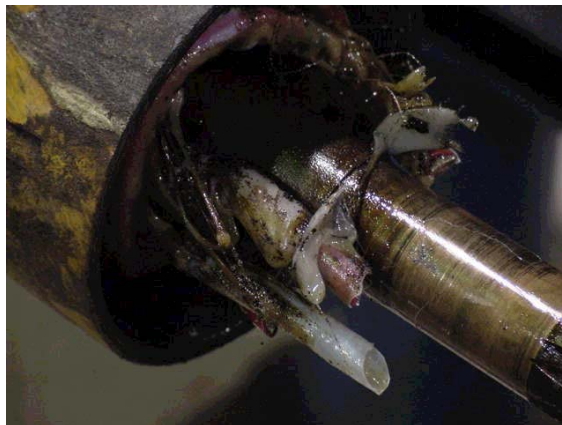
Figure 2 – “Motor Burn”

A typical ESP system is comprised of several components. These components are assembled from the bottom up as follows: a sensor or base, motor(s), seal(s), intake, pump(s) and a discharge head. Typically the system (Fig. 1) is installed in the wellbore above perforations. These systems are designed to allow wellbore fluids to flow around the motor to help dissipate heat. When the fluids do not cool the motor sufficiently, the motor temperature will eventually rise above an acceptable operating range creating overheating, which can result in an equipment failure. This is referred to as a motor burn (Fig. 2).

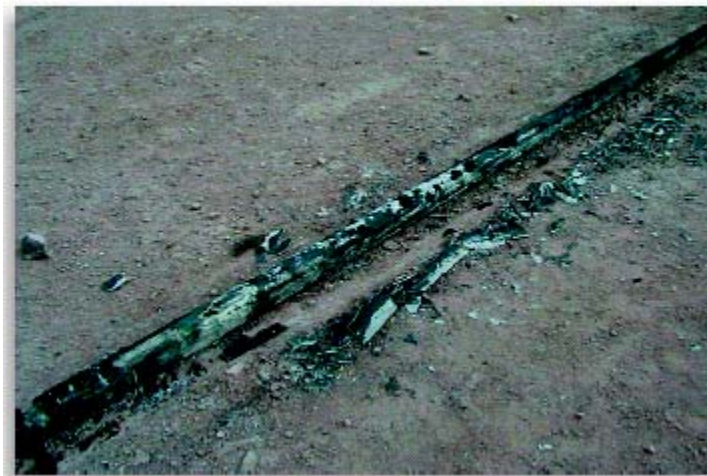
Figure 4 - Scale And Produced Solids Bonded to the ESP Motors Inside the Shroud Causing Excessive Heating And Motor "Burn Out"

- misdirected fluid flow was creating motor heating
- excessive heat caused scale buildup between the motor and the shroud (Fig. 4 and 5)
- optimum water production and well drawdown were not achieved due to scaling
- scale restricted fluid flow, which created additional heat and caused eventual motor failure (Fig. 2)
- there was poor gas separation due to fluid and gas leakage through the conventional shroud hanger
- continuous cycling due to high temperature was effecting motor performance
- gas production was below expectations.

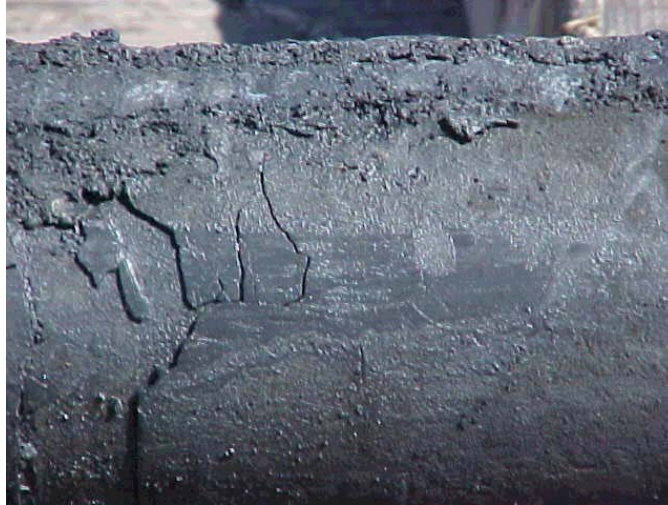
Figure 5 - Another View of Scale and Produced Solids Bonded to the ESP Motor

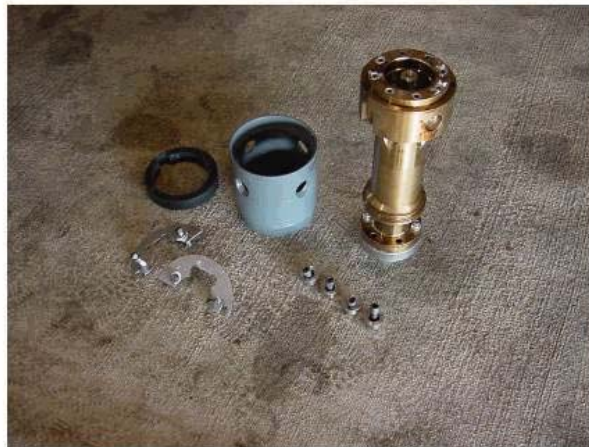
Figure 8 - Components of New Positive-Seal Shroud Hanger

Based on the findings, the ESP manufacturer's engineering team designed (Fig. 7), tested (Fig. 6) and manufactured a totally new intake body and shroud system. In the new design the shroud was hung directly from the intake body, special elastomers were used to seal the gaps between the shroud housing and the intake, and all connections were sealed with a specially designed bolting system (Fig. 8 and 9).

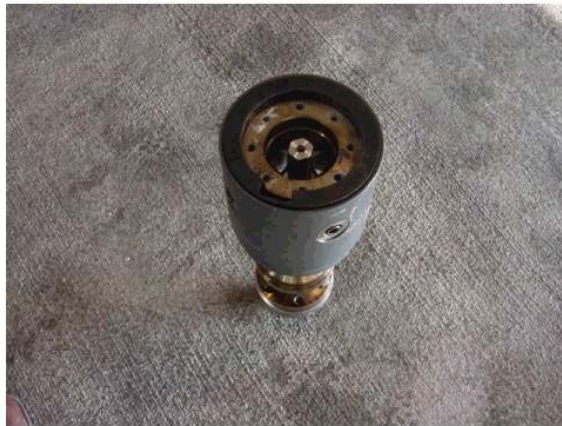
Figure 9 - New Positive-Seal Shroud Assembly

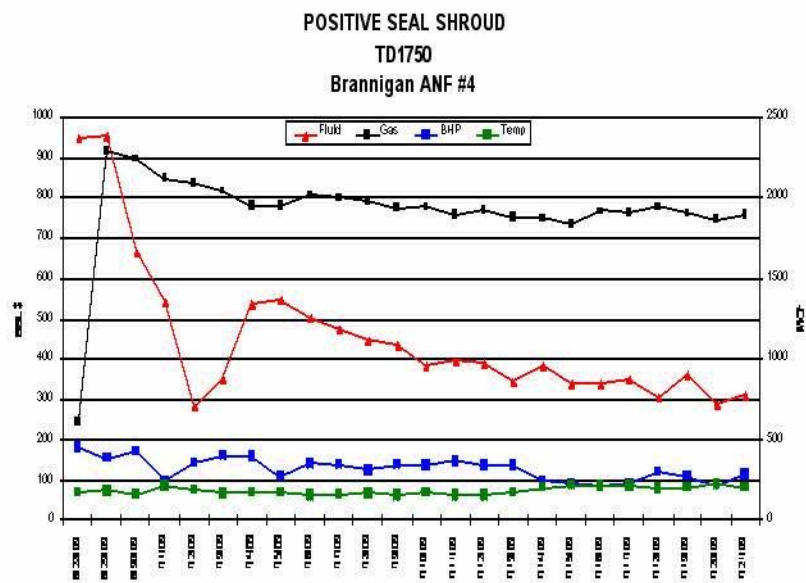
Figure 10 - The Brannigan ANF #4 was pumped-off within the first 24 hours after the initial installation using the new positive-seal shroud and a TD1750 pump.

Initially, the operator was reluctant to downsize the lift system for fear of gas locking and the possibility that the well would not pump down properly. Accordingly, another TD1750 pump was reinstalled with the new PSS and the system performed as anticipated. The well was pumped off within a very short period of time (Fig. 10). In order to achieve a continuous pumping process and to lower operating costs, the manufacturer suggested that the system be pulled and downsized.

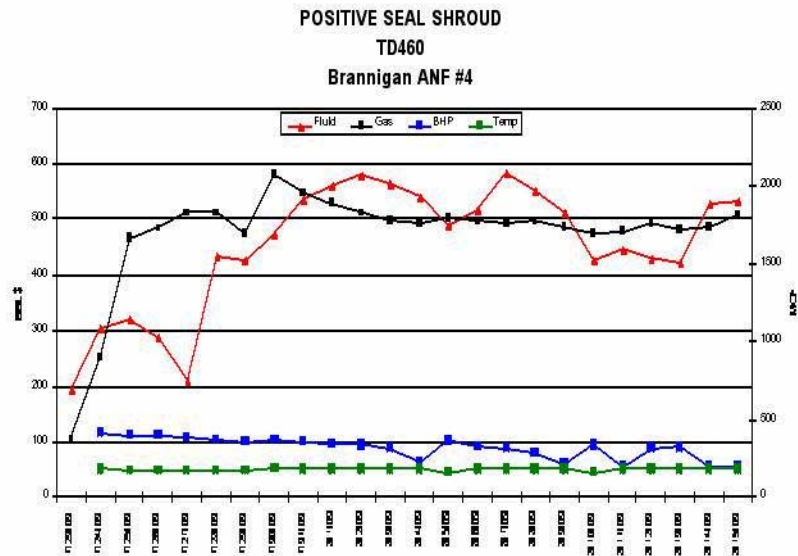
Figure 11 - The Brannigan ANF #4 After Final Installation with the Positive-Seal Shroud and A TD460 Pump

A TD460 pump (a 4-in. OD pump rated at 460 b/d) with the PSS was then installed. The system was optimized by fine tuning the downhole sensor's input parameters via the surface control unit and the well has been continuously monitored (Fig. 11).
