CAPILLARY INJECTION TUBING ANCHOR TECHNOLOGIES

Ben Horn
Weatherford

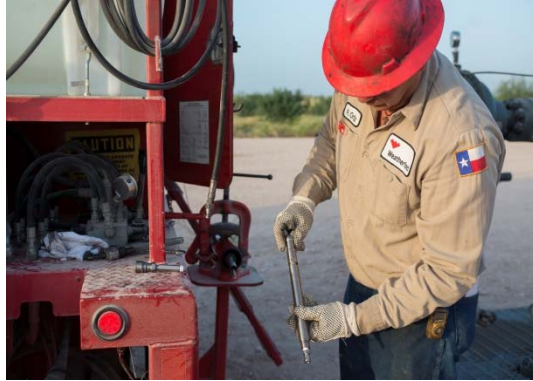
Figure 1 -Chemical Injection Valve

This is banded to the lowest injection point (customer's preference) and controls the flow of injection chemicals and acts as a check valve for the capillary string. Prior to installation the opening pressure of the valve is set by adjusting the tension of its' internal spring so that it remains in the closed position. In this way the valve prevents any possibility of backflow of well fluids into the capillary string.

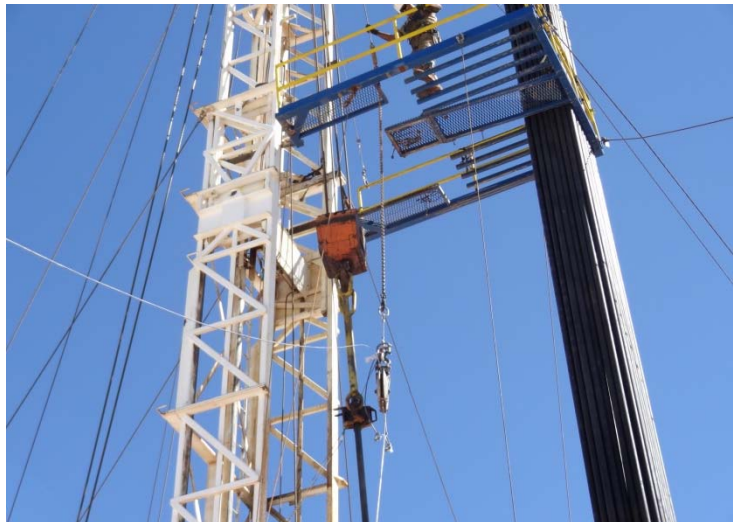
Figure 2 - Derrick Mounted Sheave

This is installed as the production tubing is run, using a derrick mounted sheave (Figure 2.) and a deck mounted spooling unit (Figure 3.) This string is banded to the tubing using either Xeron 100 bands (Figure 4.) or stainless steel cannon clamps (Figure. 5), Band type is determined by well deviation.

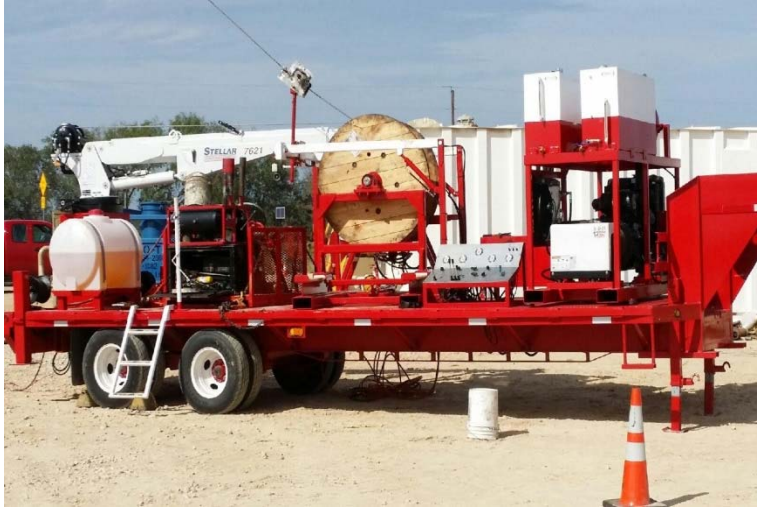
Figure 3 - Capillary Spooling Unit

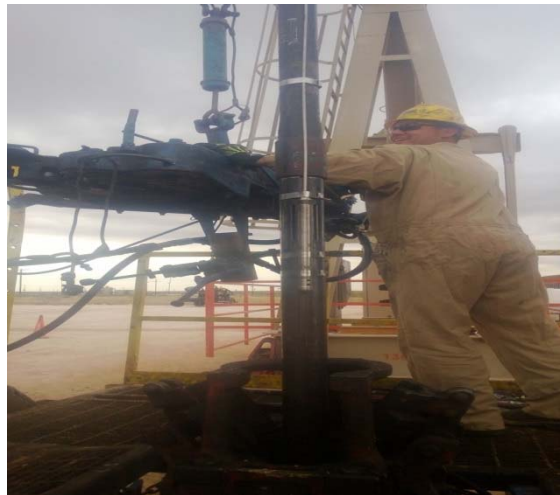
Figure 4 - Zeron 100 band installation

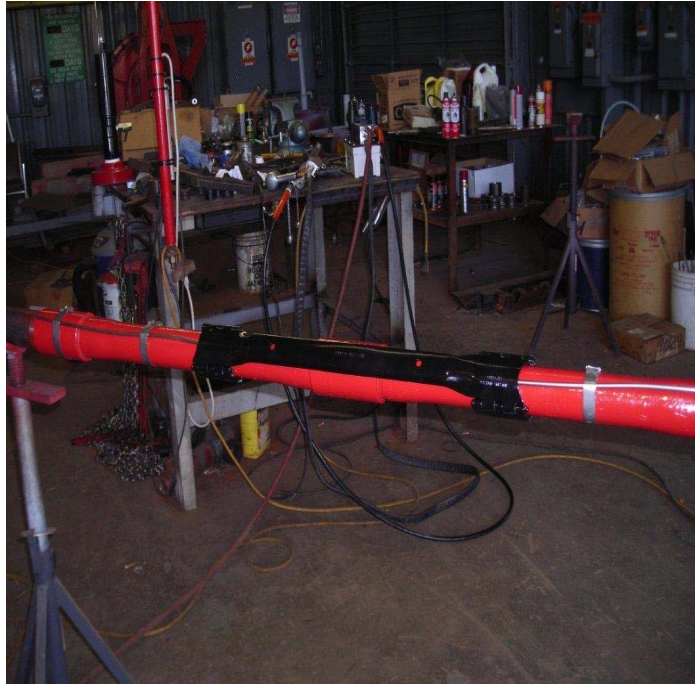
Figure 5 - Cannon clamp band installation

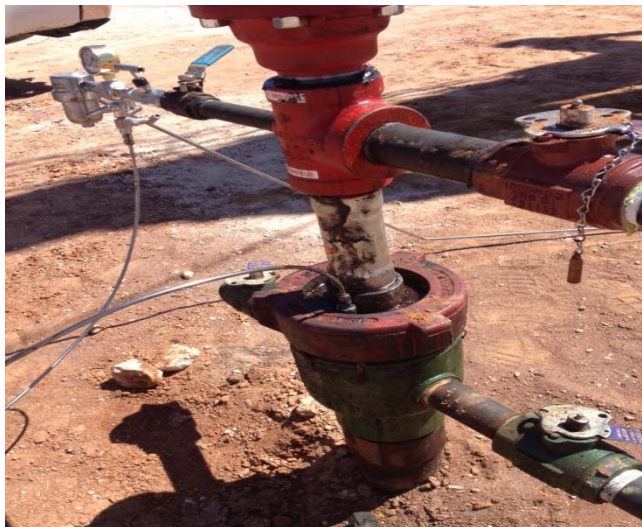
Figure 6 - Wellhead Exit

This normally consists of an extended neck tubing hanger and ported adapter flange as is commonly used in both onshore and offshore applications. Multiple injection ports can be accommodated if more than one injection line is required, and chemical is pumped into the well using a standard pneumatic injection pump.

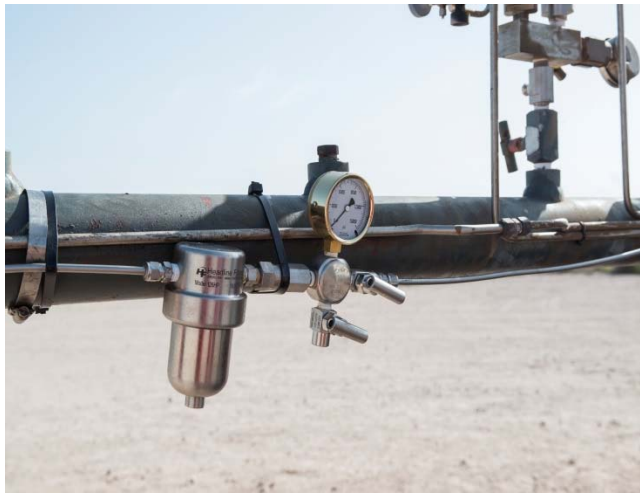
Figure 7 - Surface Injection Manifold

The surface manifold includes a 21 micron filter that insure that no contaminants are pumped downhole. The apparatus includes a pressure gauge to monitor (and record if necessary) the injection pressure and provide an indicator as to the integrity of the capillary string. The functionality of the injection valve and allows for an estimation of the bottom hole pressure. The manifold also includes an anti-syphon device to prevent any suction effect caused by the hydrostatic head of the fluid in the capillary string acting against bottom hole pressure. The manifold can be rated at 5K or 10Kpsi and is usually supplied in 316 stainless steel material.

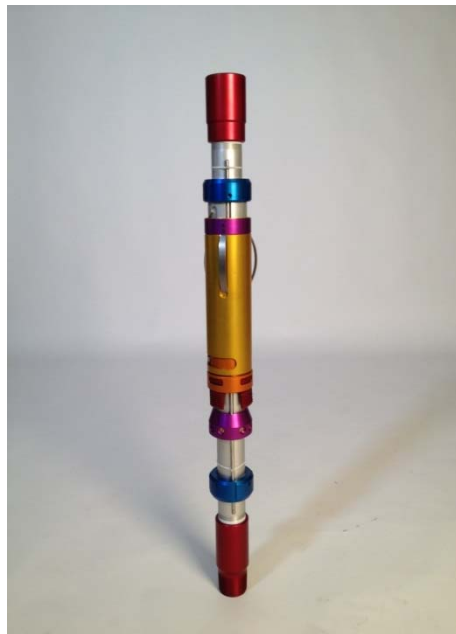
Figure 8 - Capillary Injection Tubing Anchor

This device enables a capillary string to pass through it so that chemical injection can be introduced to the bottom of the well. The by-pass consists of a 5/8" control section encased in the body of the anchor so that a 1/4" or 3/8" capillary string can pass through it to an injection sub and valve located anywhere below that it may be needed. It provides the following features:

- It ensures chemical injection into the well production before it enters the rod pump, thereby providing for protection of the pump and the complete rod and tubing strings.
- It provides for higher pump efficiency and reduced tubing and rod wear.
- It is most commonly used at depths below 5000ft. but can be considered in shallower high volume wells.
- It allows for gas flow into the annulus.
- It incorporates a J-latch setting mechanism to allow it to be set by a 1/4 turn of the tubing string at the tool followed by applied tension as required by the well geometry.

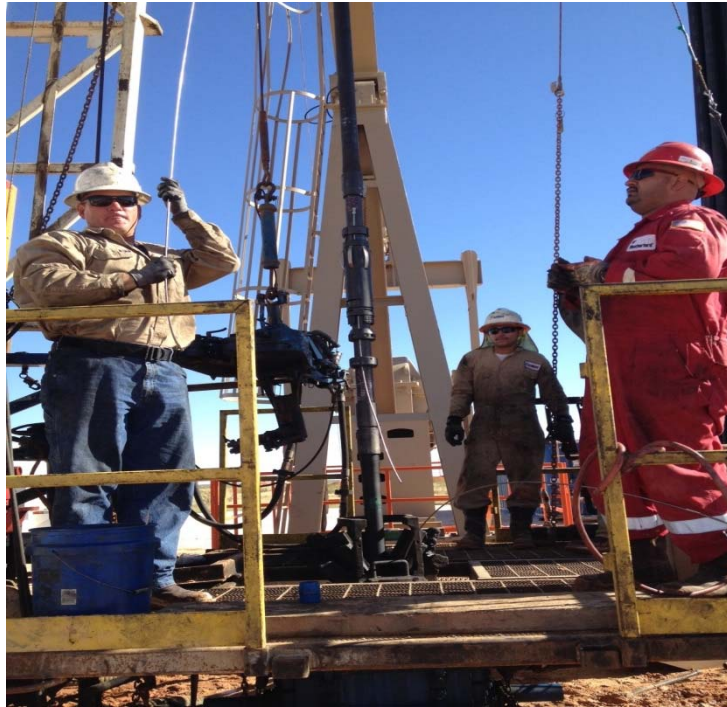
Figure 9 - Rod Pump installation with Capillary Injection Tubing Anchor

The installation is illustrated in Figure 9.
