# Water Analyses—A Basis for the Detection and Prevention of Injection Water Problems

By A. W. BAUMGARTNER  
Bradford Laboratories

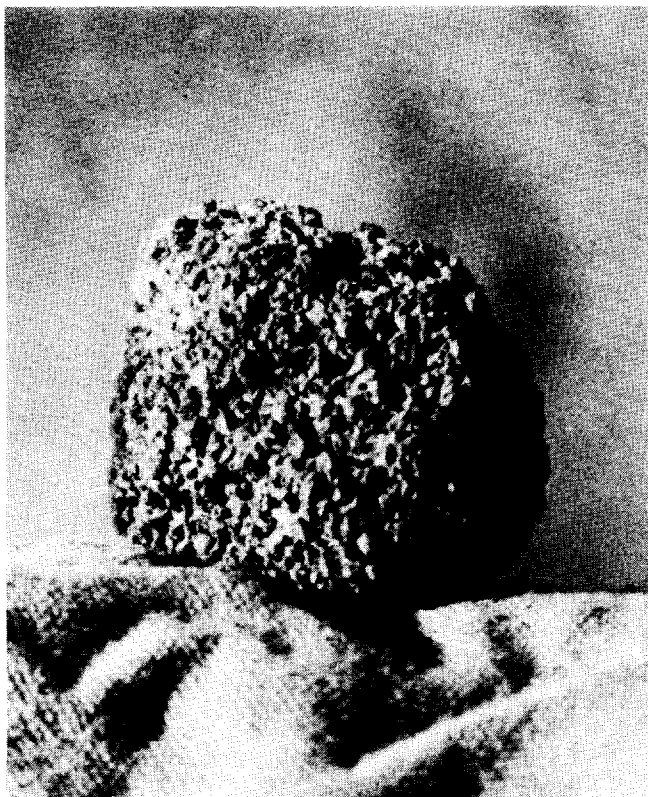
FIG. 2

After only nine months of operation, it was necessary to use six hundred gallons of 15% acid to loosen the cemented filter media (Fig. 2) so that it could be removed and replaced. Acid treatment of most of the lines and wells was necessary in order to inject the desired volumes of water. These workover and remedial procedures cost the operator a large sum of money and an unestimated additional amount of lost profits through lost production.

For example, a plant in West Texas following such a pattern of operation began injecting a water that had a very high content of dissolved carbon dioxide, carbonates, and hardness. When the water was pumped from the supply well, the pressure that kept the carbon dioxide in solution deep in the water bearing formation was released. Most of this gas escaped from the water in the raw water tank and out through the thief hatch. The loss of carbon dioxide and the accompanying increase in the pH value of the water resulted in a lowering of the solubility of calcium carbon-

ate. Thus, calcium carbonate was deposited in the filter bed, on the pressure lines, and on the sand face.

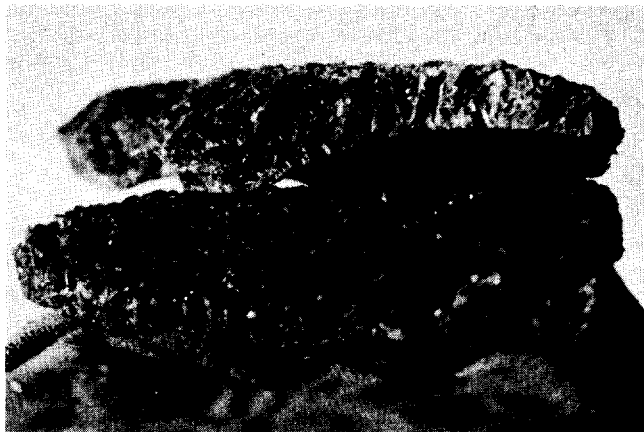
FIG. 3

During a routine pulling job, the operator was shocked to find a one-half inch thick layer of scale coating the tubing and pump surfaces (Fig. 3). The scale was removed rather easily since the petroleum products laid down with the scale held the crystals apart and produced a relatively soft deposit. The pump had been placed in

operation for only twenty-one days when it was necessary to again pull the well this time due to its complete inability to pump fluids. The operator had the scale analyzed and it was reported to be primarily calcium sulfate.

To correct this situation, a few pounds of controlled solubility phosphate were poured down the annular space. The well completion was ideal for this simple type of treatment as there was ample circulation of fluids to cause proper dissolving of the phosphate. Periodic phosphate determinations on the produced water enabled the supervising engineer to recommend weekly chemical charges. This well and others in the field so treated are still operating. The pumps are now pulled only for routine mechanical workovers and they come out clean with no evidence of any scale formation.

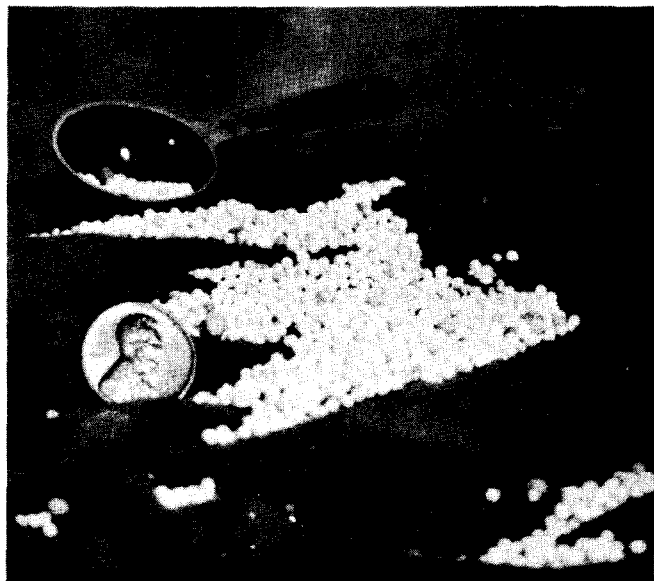
FIG. 4

The high pressure lines were opened at a number of points and considerable carbonate scale was found to have been deposited. An examination of the filter media was made. As suspected, this material had been cemented into a solid mass by the deposited calcium carbonate. Considerable quantities of acid were required to loosen the media so that it could be removed and replaced. Some of the injection well tubing was so severely plugged, logging gear could not be run into the hole.

Needless to say, the calcium carbonate deposits

seriously hampered water flood operations and considerable expenditures were necessary before the system was finally restored to working order.

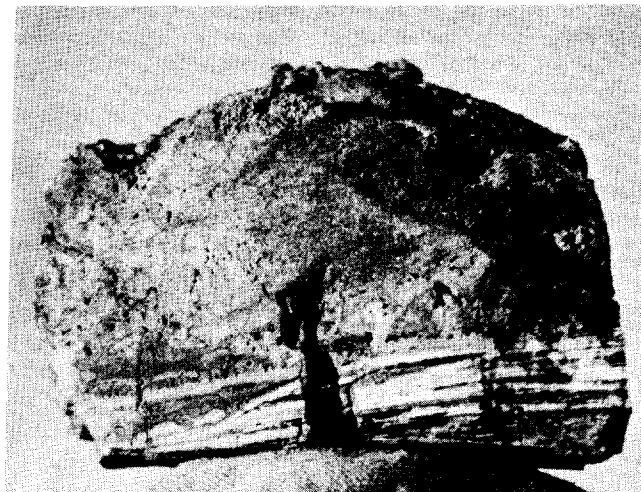
FIG. 5

A final type of scale problem may be illustrated by a heater treater problem in which the U-tube was periodically coated with a heavy scale (Fig. 5). Deposit analysis demonstrated the scale was mainly calcium sulfate with smaller amounts of calcium carbonate and traces of iron sulfide. To prevent further scale deposition, a portion of the produced fluids entering the treater was by-passed through a bed of controlled solubility phosphate in a by-pass feeder. Scale ceased to be a problem as long as the proper biweekly charges

were added. Water samples were sent to the laboratory on a regular basis to determine the actual amount and rate of dissolution of the phosphate. Any variation in the desired phosphate residual was compensated for in subsequent additions to the feeder.
