ARTIFICIAL LIFT PRACTICES IN A HOSTILE ENVIRONMENT – POSTLE FIELD CO₂ FLOOD

Geoff Stafford and Robert McNaughton
Whiting Petroleum Corporation

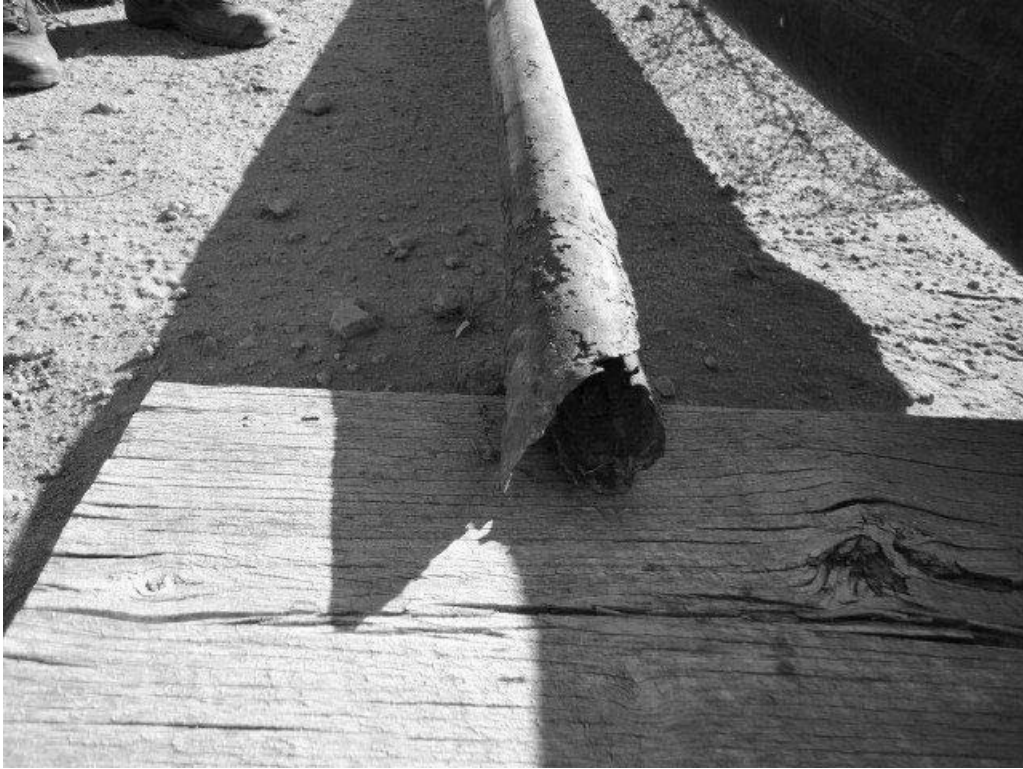
Figure 1-1: Example of bare steel tubing after six weeks

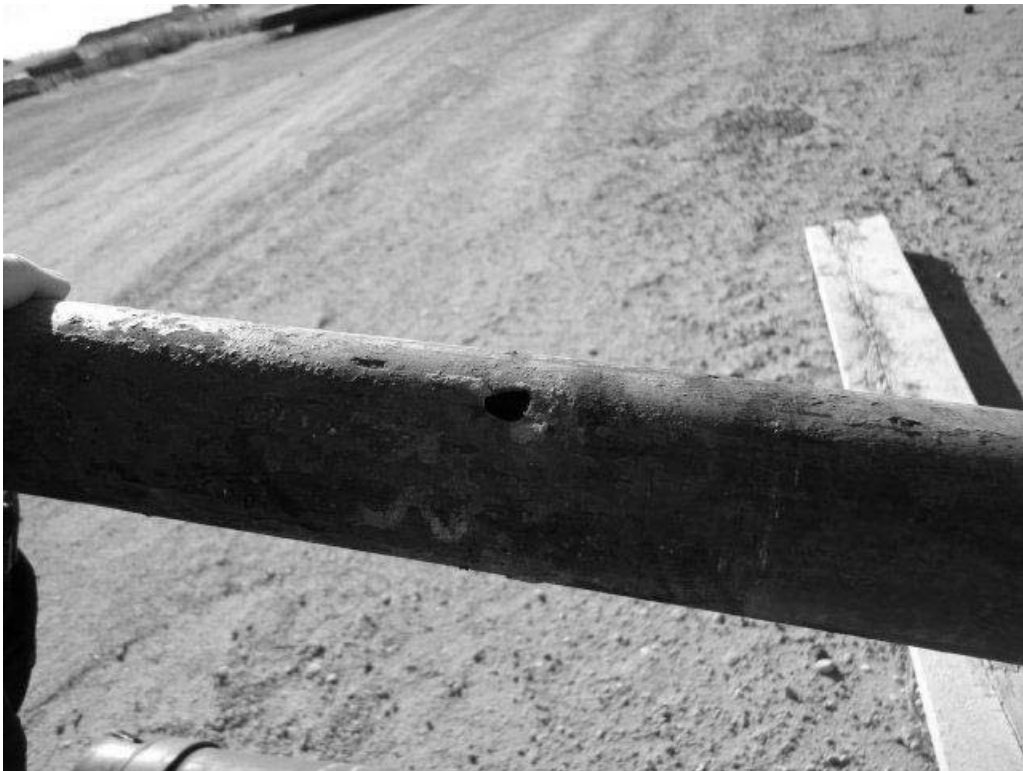
Figure 1-2: Hole in IPC tubing. A regular occurrence at Postle.

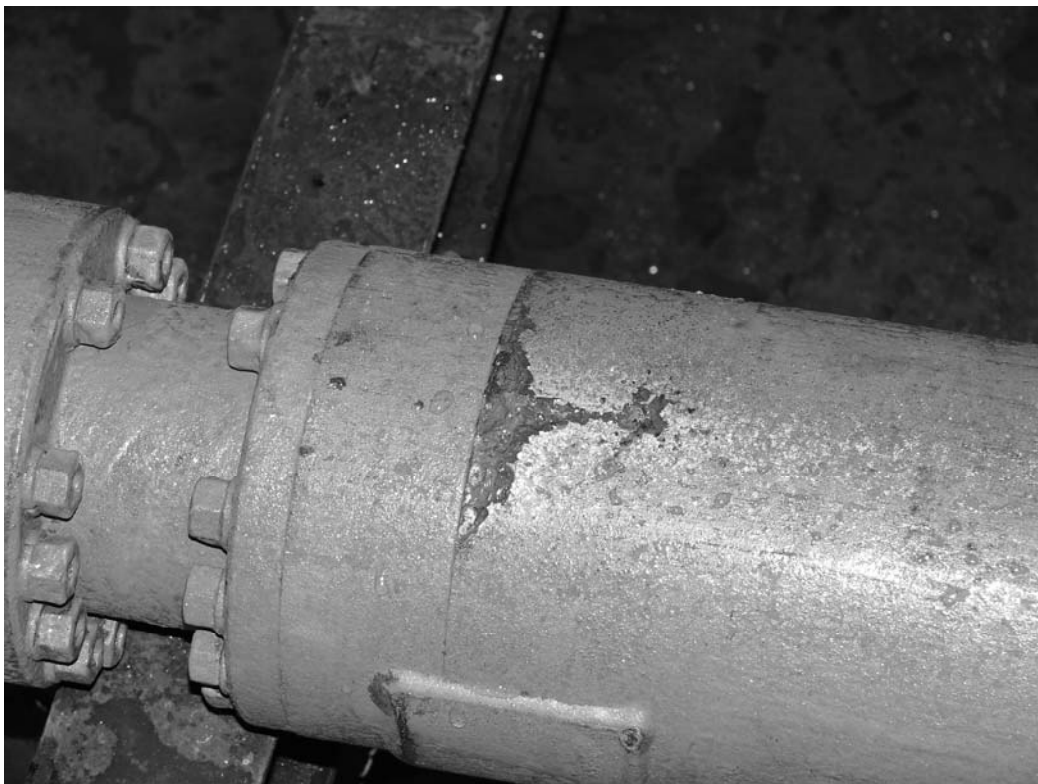
Figure 1-3: Corrosion on ESP motor after six months of CO₂ exposure. Manufacturer claimed this was the first time they had ever seen corrosion this bad on a motor. A band can be seen in this picture that is welded across the housing, this prevents threads from backing off, but makes it very hard to fish.

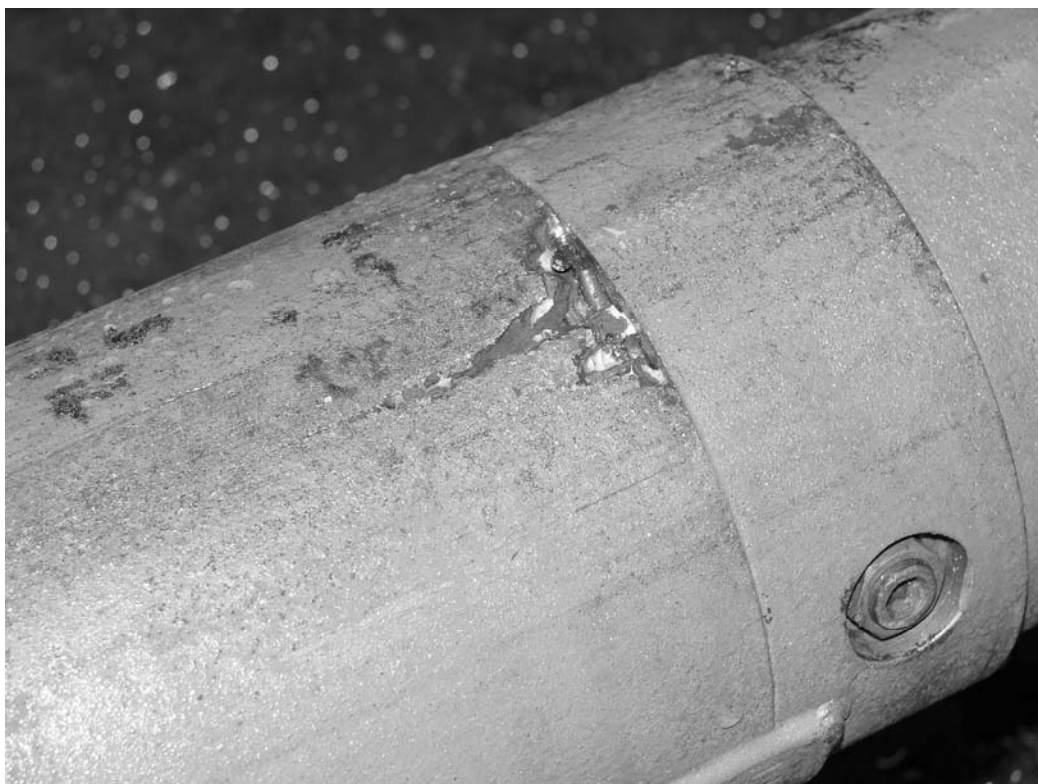
Figure 1-4: More corrosion on the same ESP.

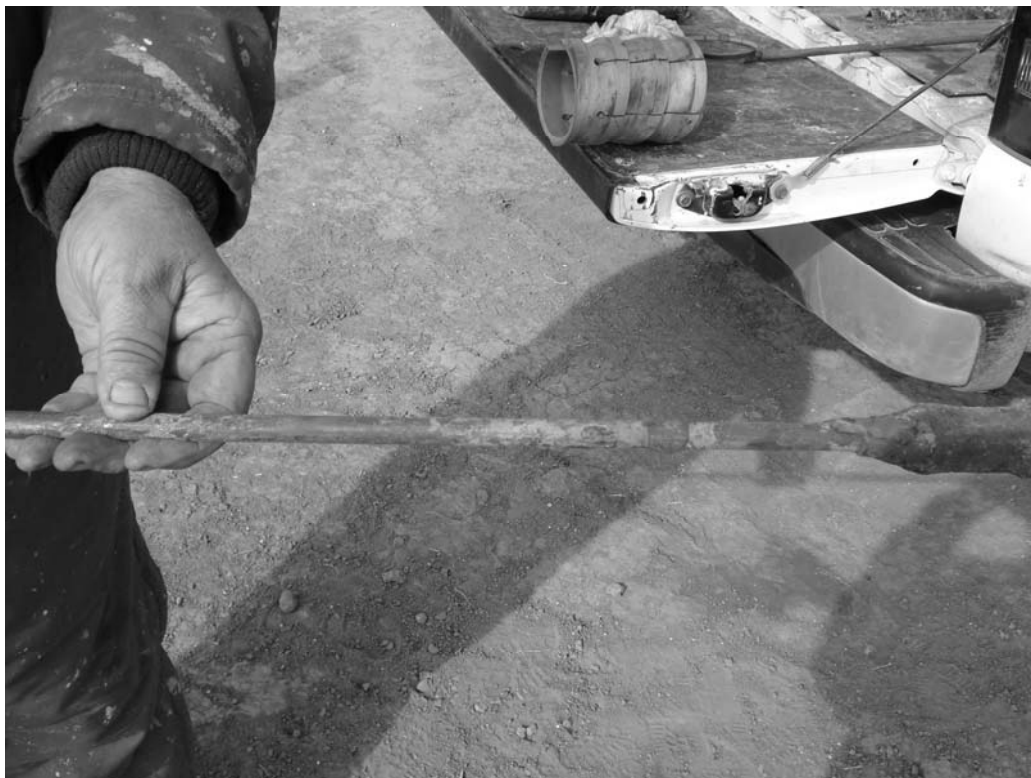
Figure 2-4: $\frac{3}{4}$ " steel rod with severe corrosion and pitting

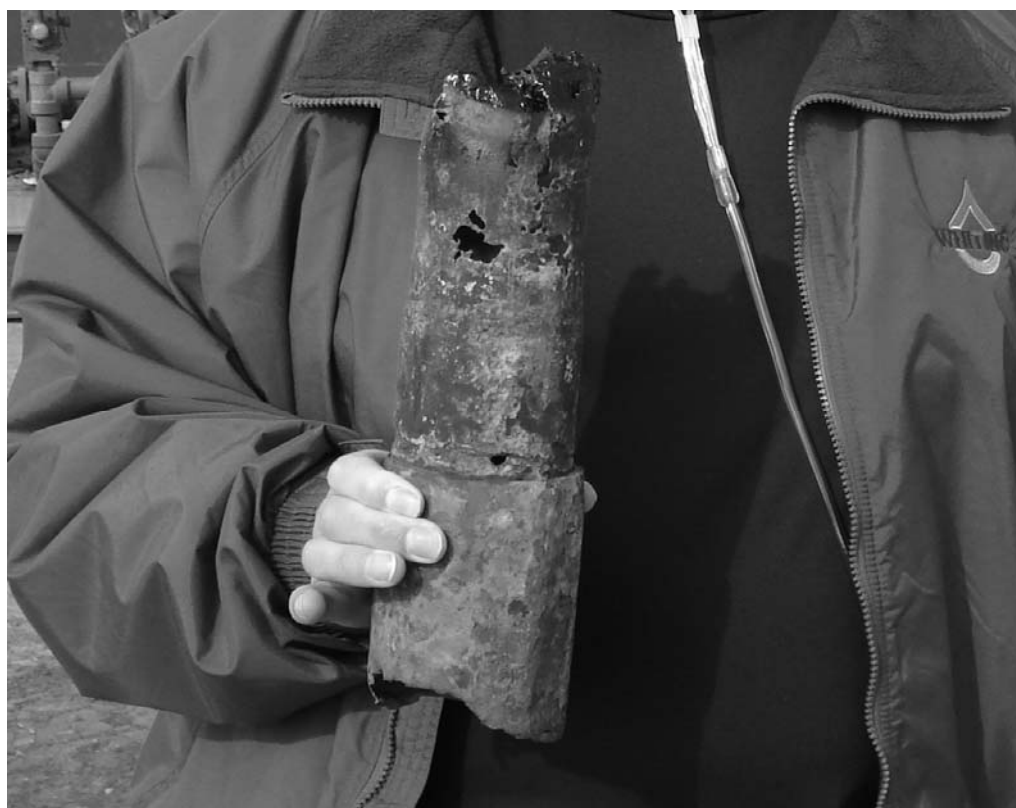
Figure 2-5: Corroded 2-7/8" collar. Paper thin wall with pits and holes.

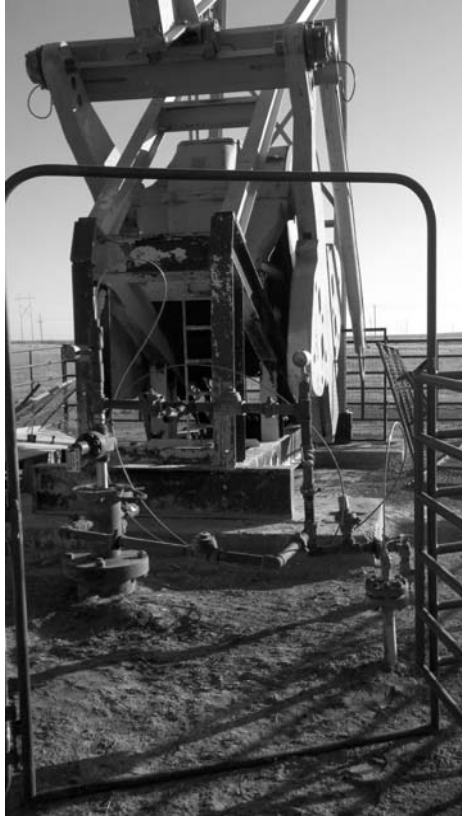
Figure 4-1: "Poor-Boy" Gas Lift assembly at the wellhead. 3/8" stainless steel capillary string is connected to a CO₂ supply line from the nearest injector. Gas lift has been able to replace many pumping units at Postle.

Our poor-boy gas lift is the pride and joy of Postle. The poor-boy gas lift is a stainless steel capillary string (3/8"-3/4") with a check valve ran to a depth of 4,500 feet in the IPC tubing. A CO₂ supply is run to the wellhead from the closest supply line or injector, usually 1/4 mile away (see attached picture of assembly at the wellhead, figure 4-1 & 4-2). Anywhere from 100 to 300 MCFPD is injected through the capillary string, which helps lift fluid to the surface. The average gas lift uses 120 MCFPD at Postle. This is an inexpensive and low risk way to lift fluid to the surface. There is no corrosion involved with this process. The gas used is instantly produced, recycled and reinjected throughout the field. Therefore, no CO₂ is wasted.

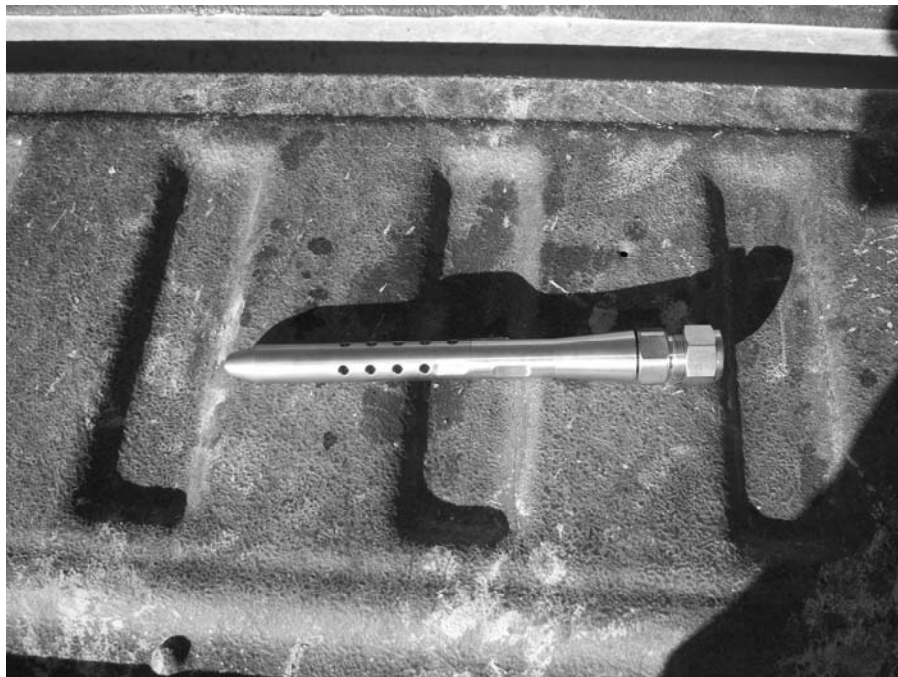
Figure 4-2: Check valve that is installed at the end of the capillary string 4500 feet down in the tubing
