FROM ZONE ABANDONMENT TO RESTORING WELLBORE INTEGRITY: MODERN EPOXY RESIN TECHNOLOGY WELL REMEDIATION CASE STUDIES

Olvin A. Hernández, Paul Jones, and Brandon Kimble
Halliburton

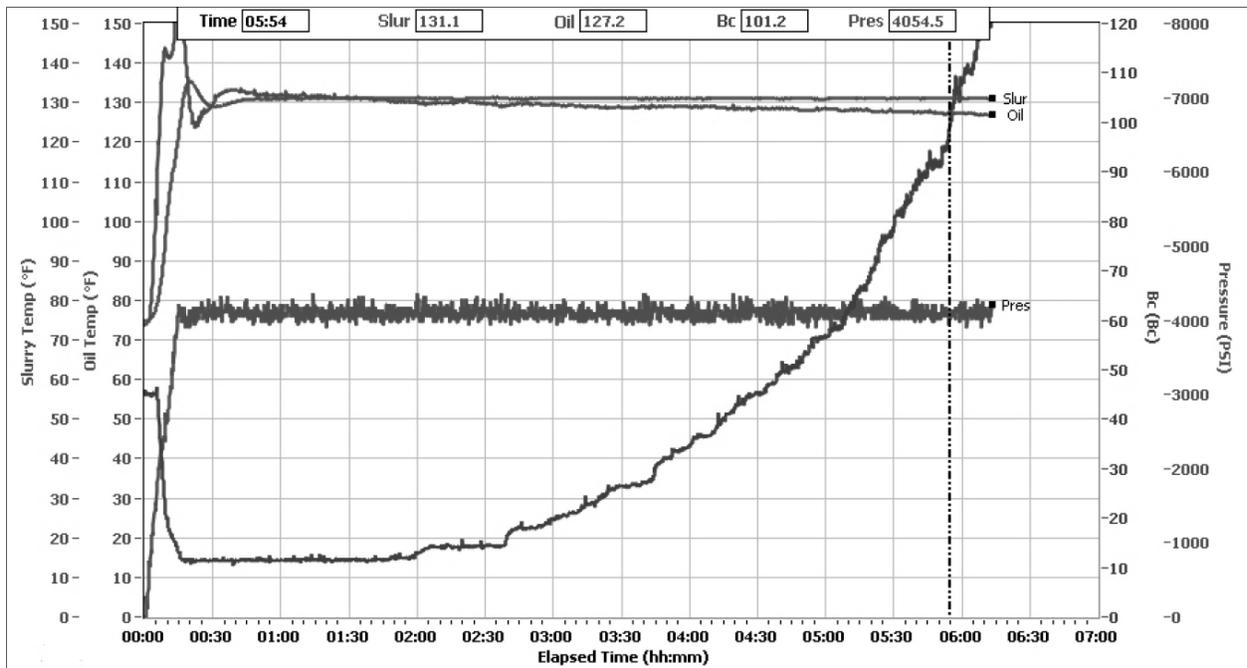
Figure 1 – Case Study 1: Epoxy resin thickening time test.

A thickening time test was conducted on a high-pressure/high-temperature (HP/HT) consistometer at a 132°F BHST and a bottomhole pressure (BHP) of 4,100 psi to simulate downhole conditions and determine optimal placement time. To account for any adverse effects that might occur as a result of static shutdowns during pumping, a 1-hour shutdown was included in the thickening time. Table 1 displays the final epoxy resin design, and Figure 1 shows the thickening time graph. To determine the amount of WOR time to set before drillout, destructive compressive-strength tests were conducted. The resin system exhibited substantially high compressive strength and was able to sustain a high amount of strain without failure. After mixing, the resin was poured into three 2×2 ×2-in. cube molds and cured in a water bath at 132°F. After 24 hours, the resin cubes were removed from the molds, and a crush compressive-strength test was conducted on each cube. Figure 2 shows a stress vs. strain chart of this test. Because of safety considerations, the crush compressive-strength tests were stopped at 10,000 psi, without the resin failing. The mechanical compressive strain at that point was approximately 3.7%, illustrating the higher strain-to-failure values obtained with epoxy resin systems compared to Portland cement (Figure 3).

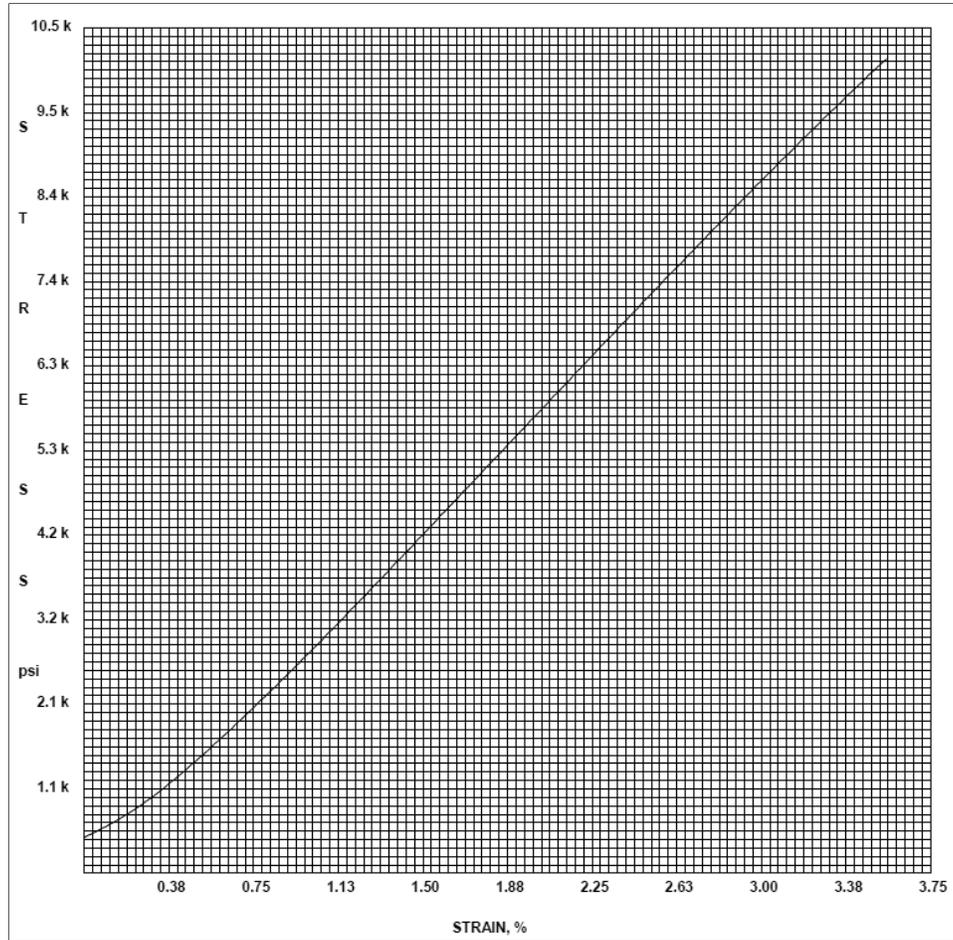
Figure 2 – Case Study 1: Epoxy resin unconfined compressive stress vs. strain chart.

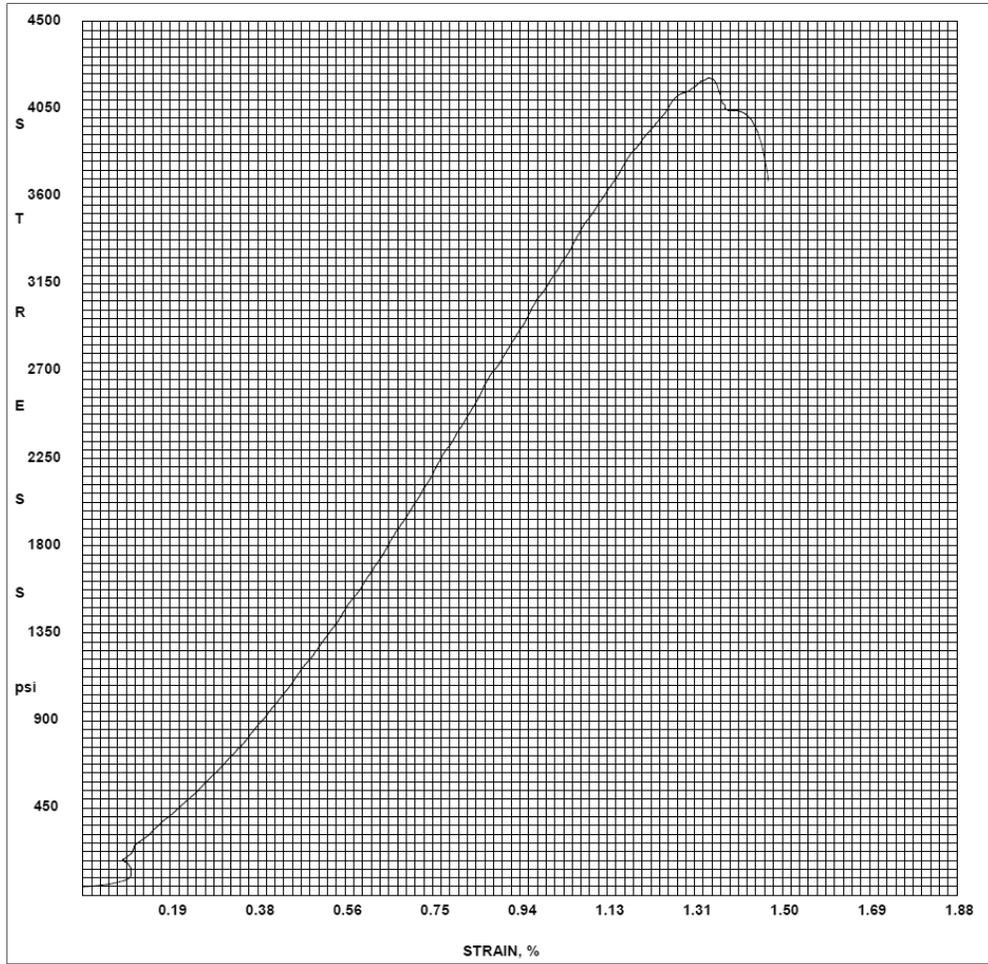
Figure 3 – Case Study 1: Class H cement unconfined compressive stress vs. strain chart.

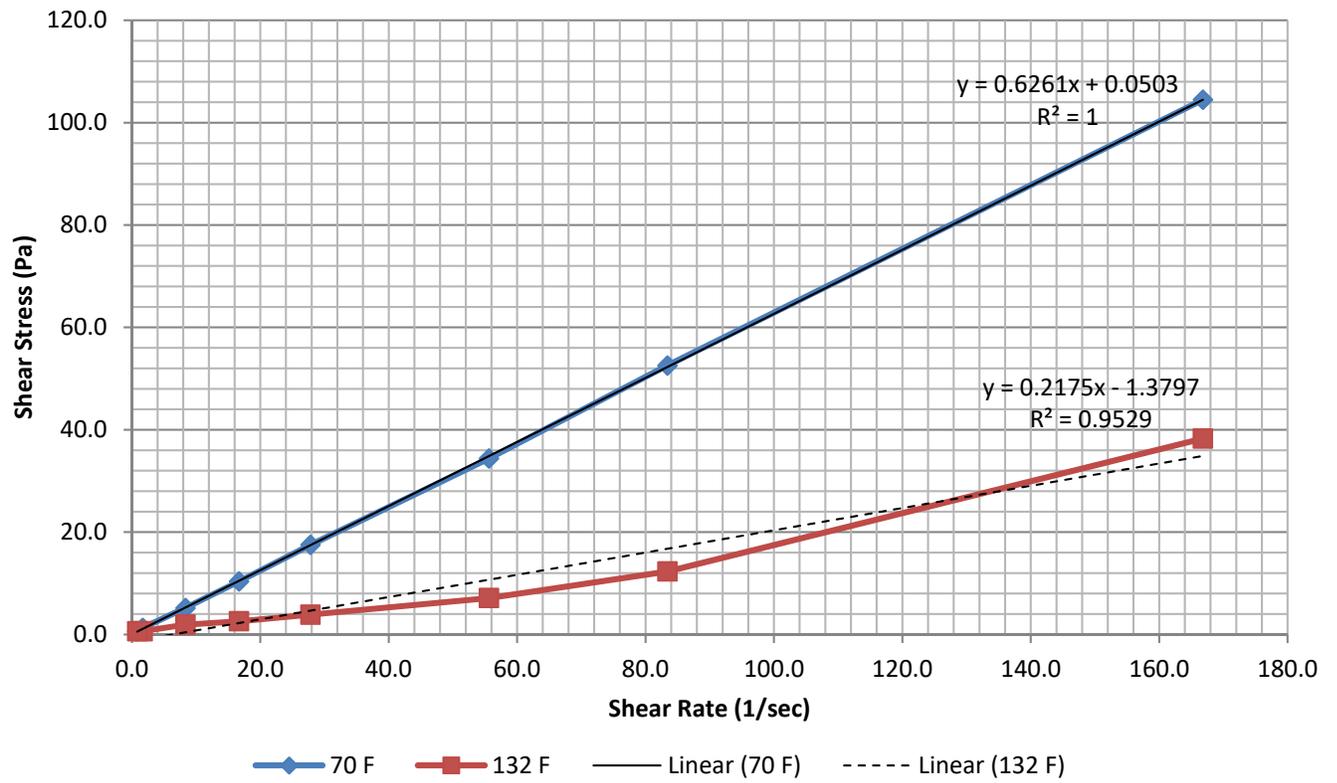
Figure 4 – Case Study 1: Epoxy resin shear stress vs. shear rate chart.

Unlike Portland cements slurries that exhibit Bingham-plastic rheological behavior, the resin system typically exhibits a Newtonian flow behavior, having little-to-no yield stress, thus allowing flow under extremely low forces (Jones et al. 2014). Rheological tests were conducted to help ensure that the system exhibited these properties, to squeeze it into the small leak in the multistage tool. The resin viscosity was such that measurements using a Fann® yield stress adapter (FYSA) with a Fann Model 35 viscometer provided a better rheological profile than the regular bob and sleeve configuration. The FYSA provides accurate rheological measurements of complex cement slurries and unconventional systems, such as epoxy resin (Gordon et al. 2007). The results are compiled on Table 2 and Figure 4.

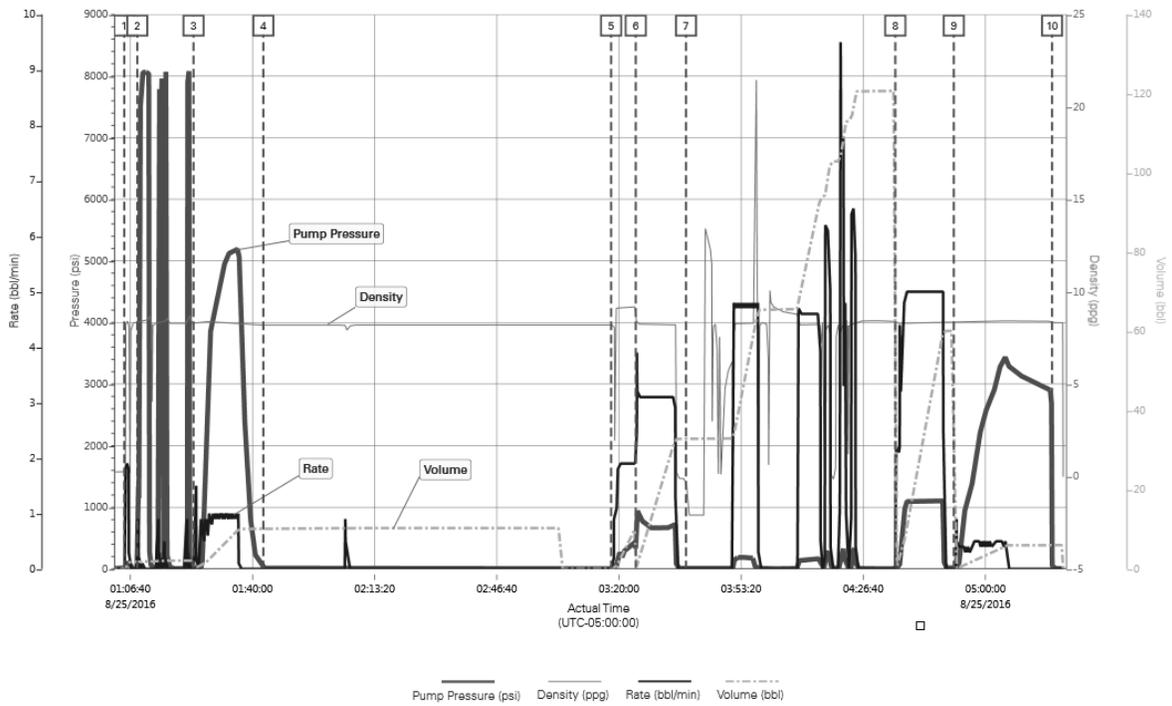
Figure 5 – Case Study 1: Epoxy resin squeeze operation summary (See Table 10).

For logistical considerations and as a safety factor, a volume of 10 bbl of resin was selected. Because of the low injection rate of the leak, a bradenhead squeeze (also known as a “spot and squeeze”) was selected as the remediation method. On a bradenhead squeeze, there is no cement retainer or packer, which helps reduce costs, drillout time, and the number of trips into the hole. The treatment is spotted across the leak; therefore, no wellbore fluids are squeezed ahead, and the squeeze pressure is applied to the entire column of fluid (Nelson et al. 2006; Rike et al. 1981). A cast-iron bridge plug (CIBP) was set approximately 49 ft below the leak at 6,020 ft MD. Although the epoxy resin is resistant to contamination, the well fluid was replaced with fresh water to help ensure the density hierarchy. Tubing was run in the hole and the CIBP was tagged. The maximum pressure for the squeeze operation was set at 5,000 psi. To mix the epoxy resin on site, 330-gal chemical totes were delivered to the location where a forklift was used to gravity feed the necessary amounts of the epoxy resin system components into a batch mixer blender. During this stage, the epoxy resin was mixed by agitating the paddles of the batch mixer blender at medium speed until a clear and homogenous mixture was achieved. The accelerator component is available in 5-gal pails, and it was added to the epoxy resin system last. At this point, the final epoxy resin system was mixed for 15 minutes. Table 10 and Figure 5 summarize the treatment schedule. The 10 bbl of resin were boosted to a regular cementing pump trailer and spotted downhole across the leak using the balanced plug method. After placement, tubing was pulled slowly out of the balanced plug at a rate of 90 seconds per stand to help ensure the balanced plug was not disturbed. Tubing was pulled 1,000 ft above the calculated epoxy resin top to approximately 5,100 ft MD. Subsequently, the tubing was reversed out with fresh water to clean any epoxy resin residue. The blind rams of the blowout preventer (BOP) were closed and the bradenhead squeeze operation began (Figure 6). A rapid increase in pressure indicated the casing was full and pressure was being applied to the entire column of fluid, thus pushing the resin treatment into the leak. Because of the solids-free design of the epoxy resin and different chemical composition, a squeeze pressure typical of a cement remedial operation could not be achieved. In this scenario, there was a risk of overdisplacing the resin treatment and thus accurate displacement volumes were crucial. A total of 6 bbl of resin were counted as being injected into the leak with a maximum pressure of 3,500 psi. Subsequently, the squeeze operation was shut down, and the well was shut-in after pressure decreased to almost 2,900 psi.

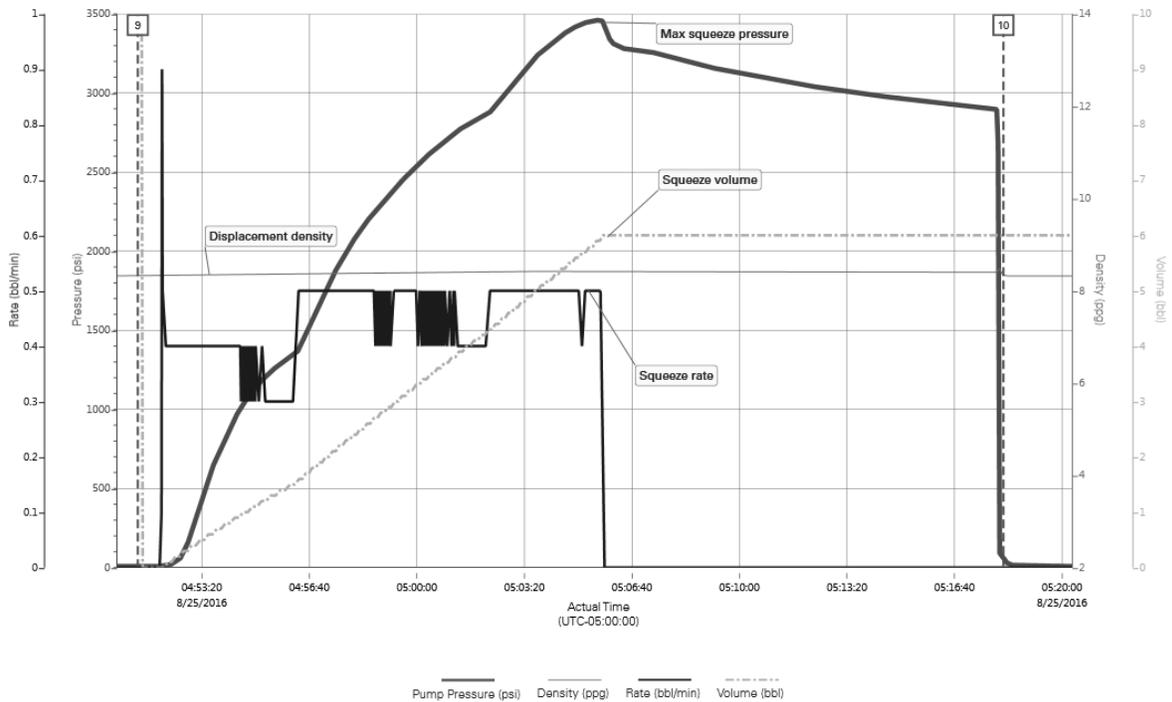
Figure 6 – Case Study 1: Epoxy resin bradenhead squeeze pressure up close up (See Table 10).

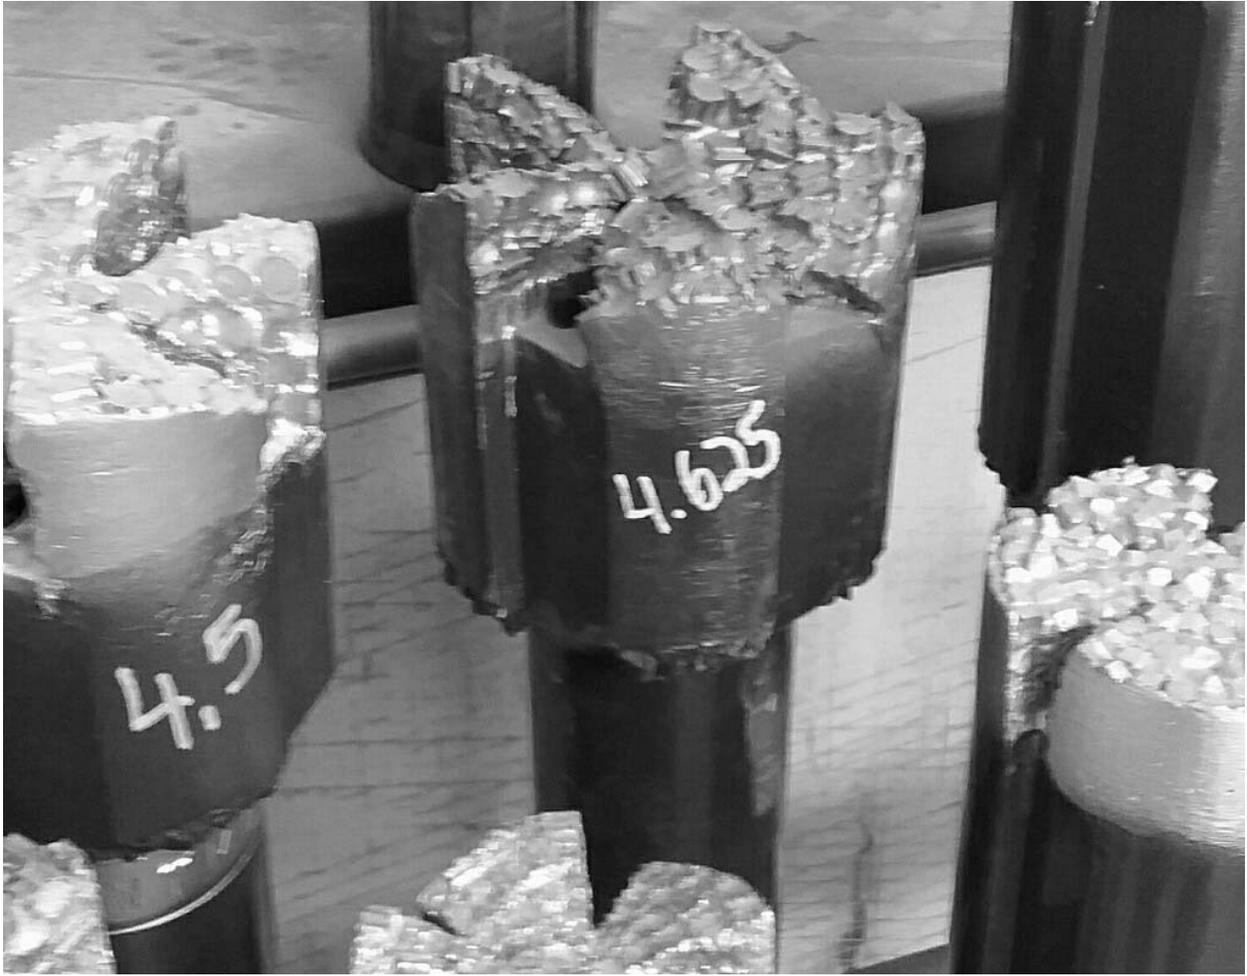
Figure 7 – Case Study 1: 4 5/8-in. junk mill used for epoxy resin drillout.

The well was shut-in with 2,900 psi for 24 hours to allow sufficient time for the resin to cure. Before drilling out the epoxy resin, a pressure test of 5,000 psi was conducted to help ensure the leak was isolated. A 4 5/8-in. junk mill (Figure 7) was run on 2 7/8-in. 6.5 lbf-ft L-80 tubing. This size mill was 99.4% the drift of the 5.5-in. 20 lbf-ft P-110 casing. The remaining epoxy resin inside the casing was drilled with 500 to 1,000-lb_f weight on bit at 90 RPM to the top of the CIBP in nearly 10 hours. Subsequently, the well was pressurized to 9,800 psi for 30 minutes with no leakoff, thus successfully passing the MIT.

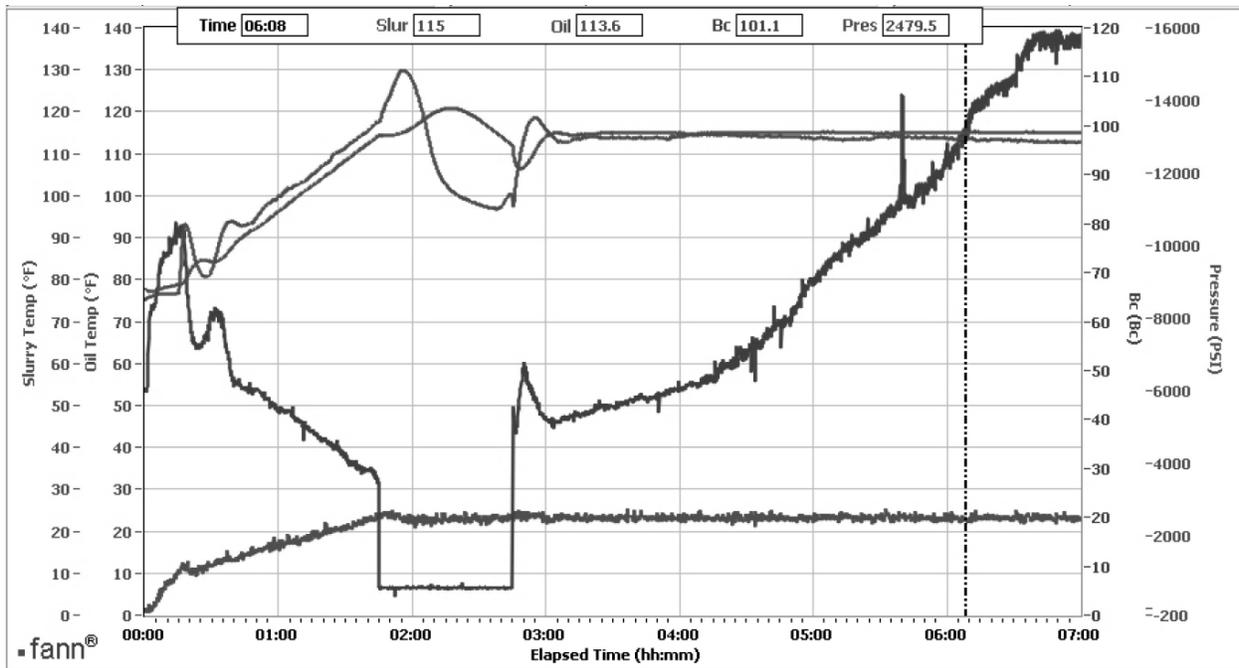
Figure 8 – Case Study 2: Epoxy resin thickening time test graph.

selected for the plugs was 20/40-mesh premium brown because of availability and logistics considerations. Laboratory testing was conducted to determine the optimal breaker concentration to help ensure the gel broke down in the allotted time and sand settled at the bottom of the wells. To help ensure further compaction and a better transition from sand to epoxy resin at the top of the sand plug, finer 200-mesh sand was used as a weighting agent for the epoxy resin. A thickening time test for placement time was conducted, which included a mixing period and a static period, plus a safety factor in case the dump bailer charge failed and an additional trip was necessary. Table 6 and Figure 8 show the final epoxy resin design and thickening time test graph, respectively.

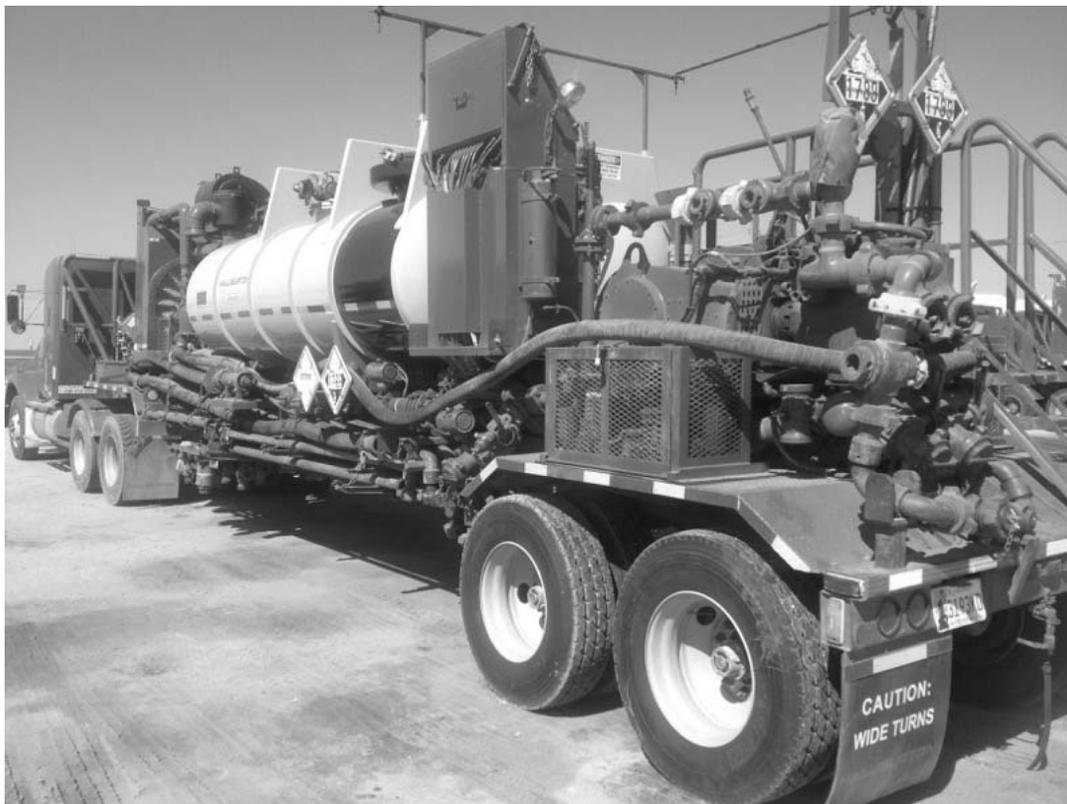
Figure 9 – Case Study 2: Single-pump acid pumping trailer.

The operation for both wells was broken down in two days. On Day 1 the sand plugs were pumped to the planned heights and the wells left on injection overnight to compact the sand. On Day 2 additional sand would be pumped, if necessary to achieve the necessary height, along with the dump-bailed epoxy resin cap. Because of the relatively small amount of materials necessary, a single-pump acid pumping trailer was used to pump the sand plugs. This trailer unit has a CLAM™ (constant level additive mixer) tub that enables the addition of additives on the fly. Figures 9 and 10 show the trailer unit and the CLAM. The gel was prehydrated in the pumping trailer tanks, followed by the addition of breaker, 20/40-mesh sand, and crosslinker through the mixer tub before going downhole. After pumping the planned amount of sand in Well 1, the pumping trailer unit was moved to the Well 2, while waiting on the gel to break and the sand to settle on the Well 1. A wireline unit would then run in the Well 1 to tag the sand top. After achieving the desired sand coverage in both wells, the wells were put on injection until the next morning to compact the sand and provide a stable base for the resin cap. On the second day of operations, a wireline tag run was conducted on both wells to measure the height difference after the expected compaction. Both wells needed more sand. Therefore, additional sand was pumped and dump bailed to achieve the final coverage. A total of 2,100 lbm of sand were pumped in Well 1 and 2,250 lbm in Well 2. After achieving the final top of sand, the epoxy resin was mixed in a 5-gal bucket using an electric power drill with a paddle adapter (Figure 11) and then loaded into the wireline dump bailer (Figure 12). The dump bailer was then run in the wells to place the epoxy resin caps.

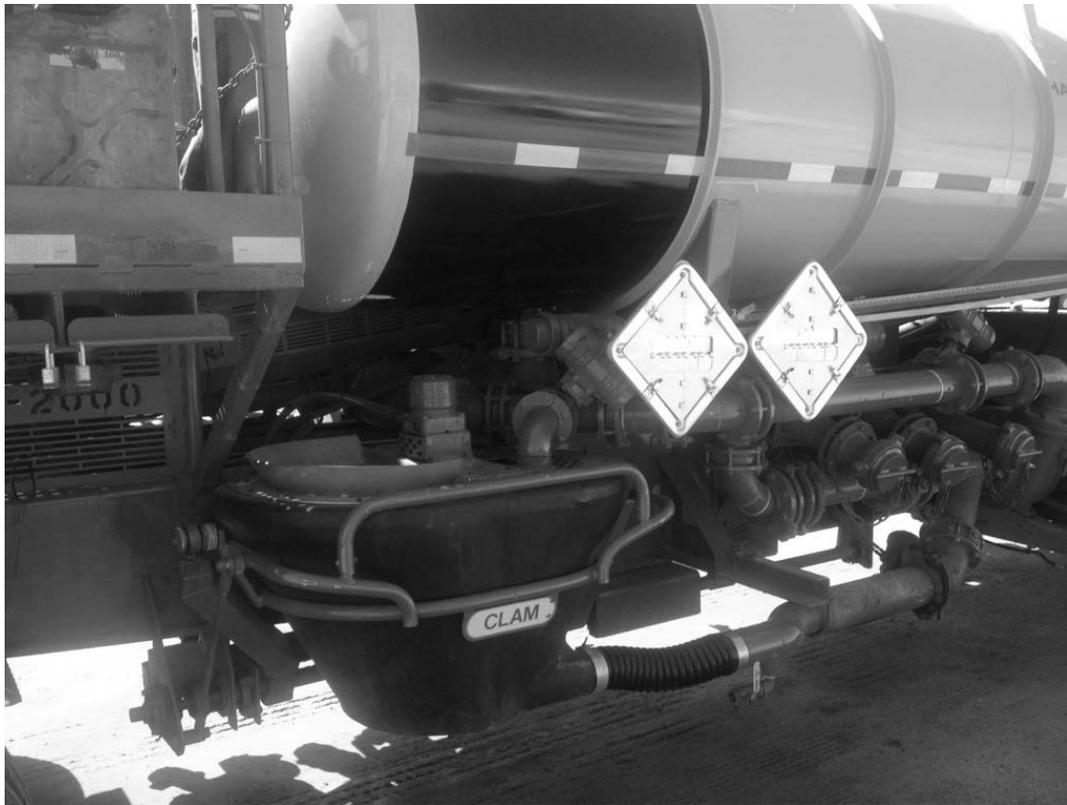
Figure 10 – Case Study 2: CLAM tub on passenger side of single-pump acid pumping trailer.

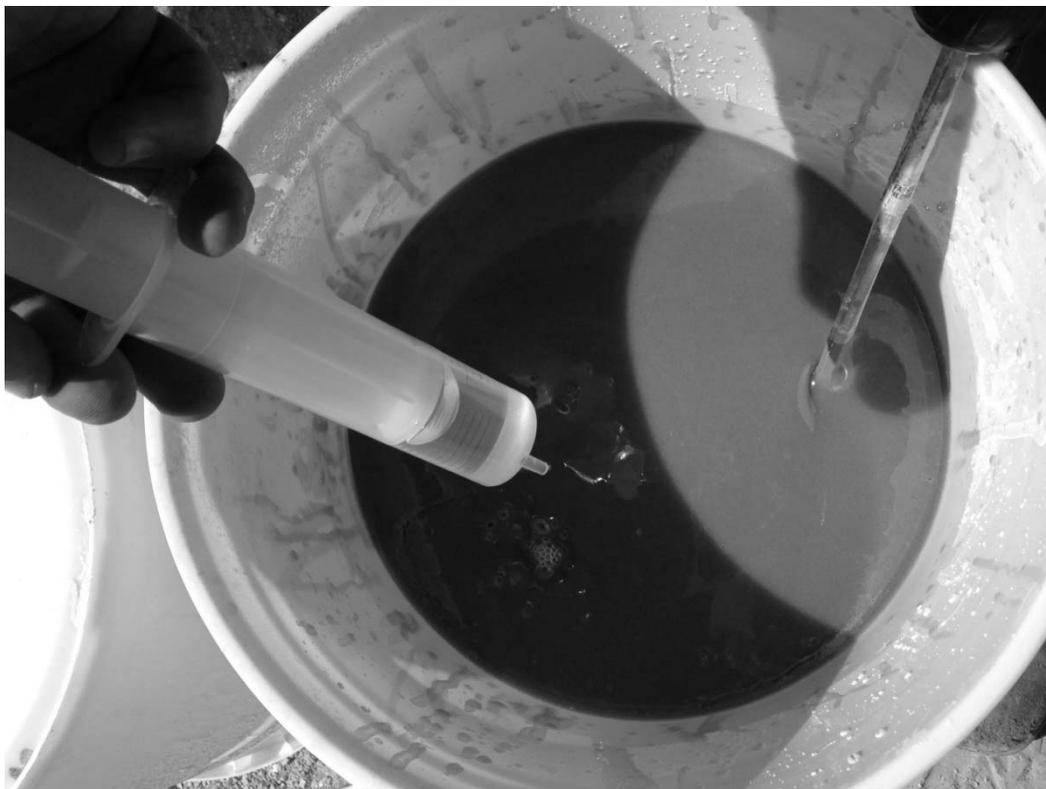
Figure 11 – Case Study 2: Low volume epoxy resin mixing in 5-gal bucket.

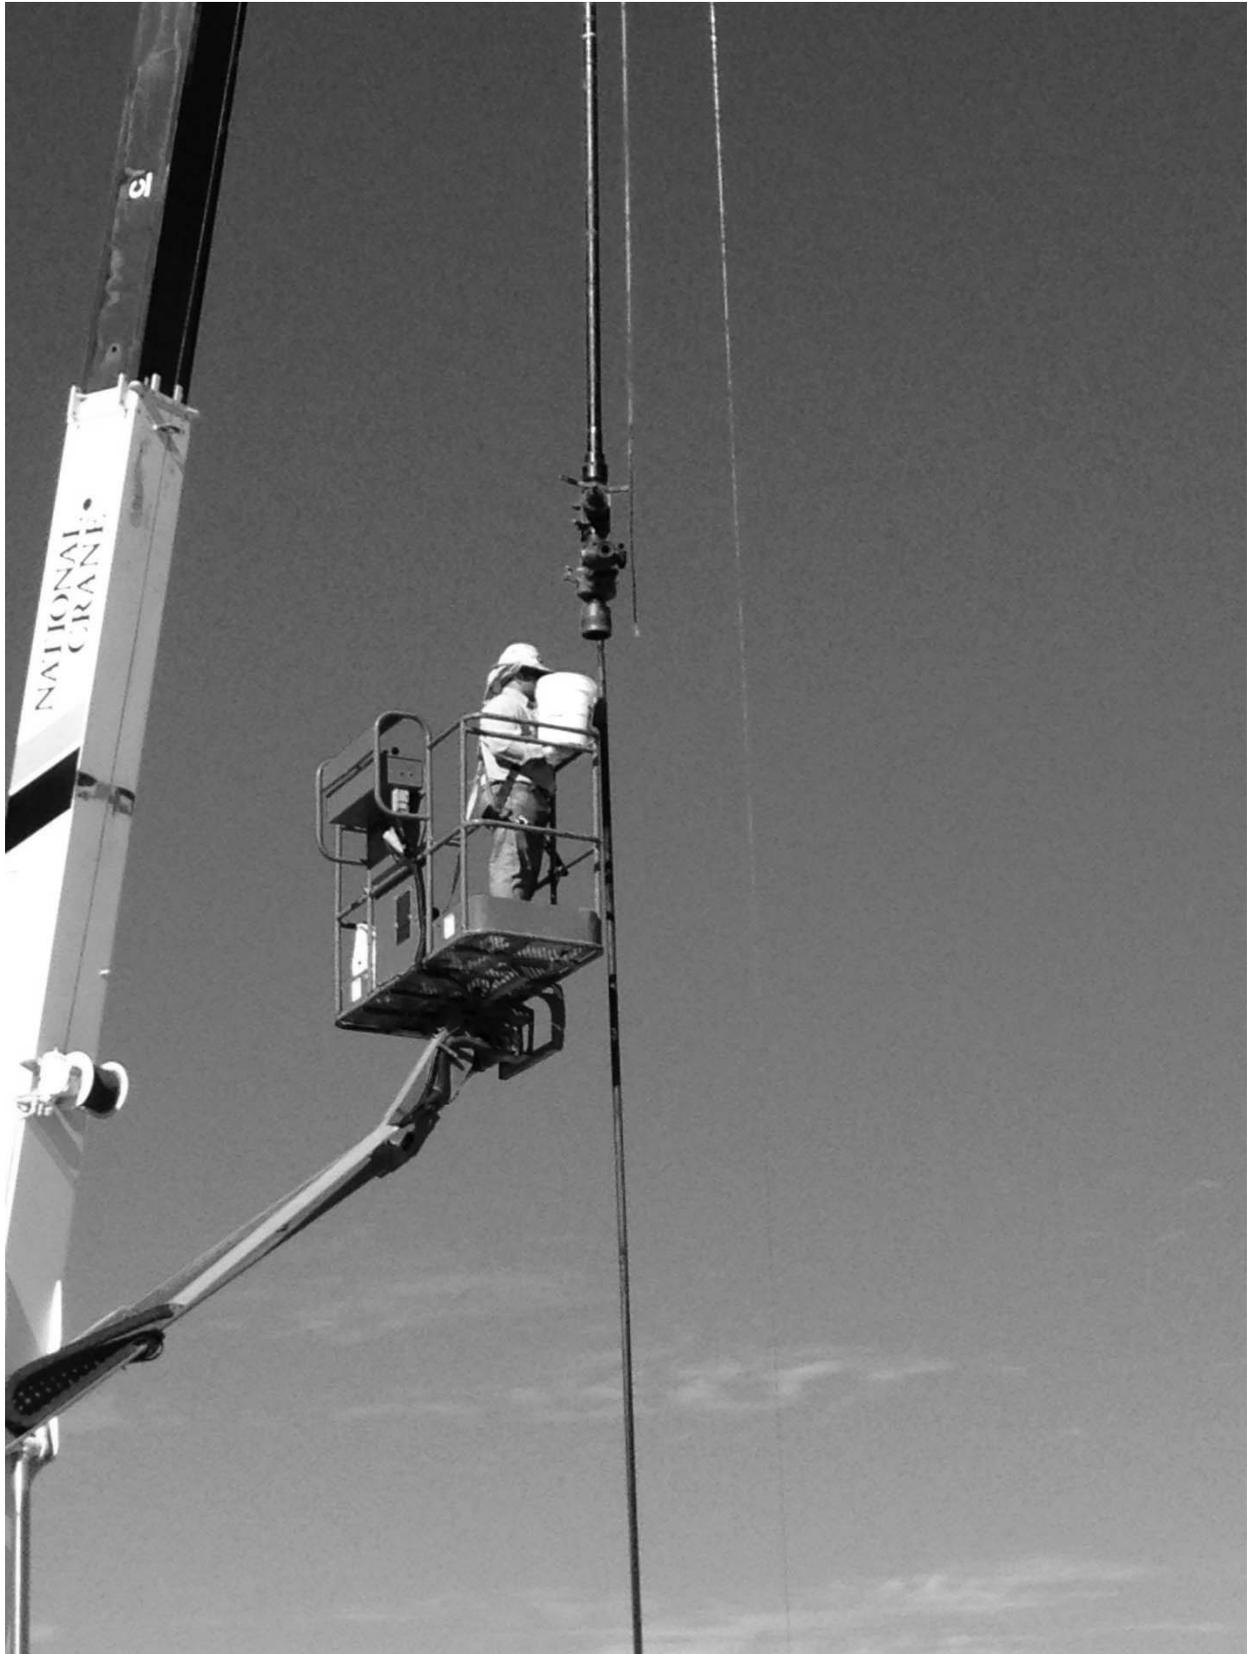
Figure 12 – Case Study 2: Loading of epoxy resin into 1.5-in. dump bailer.

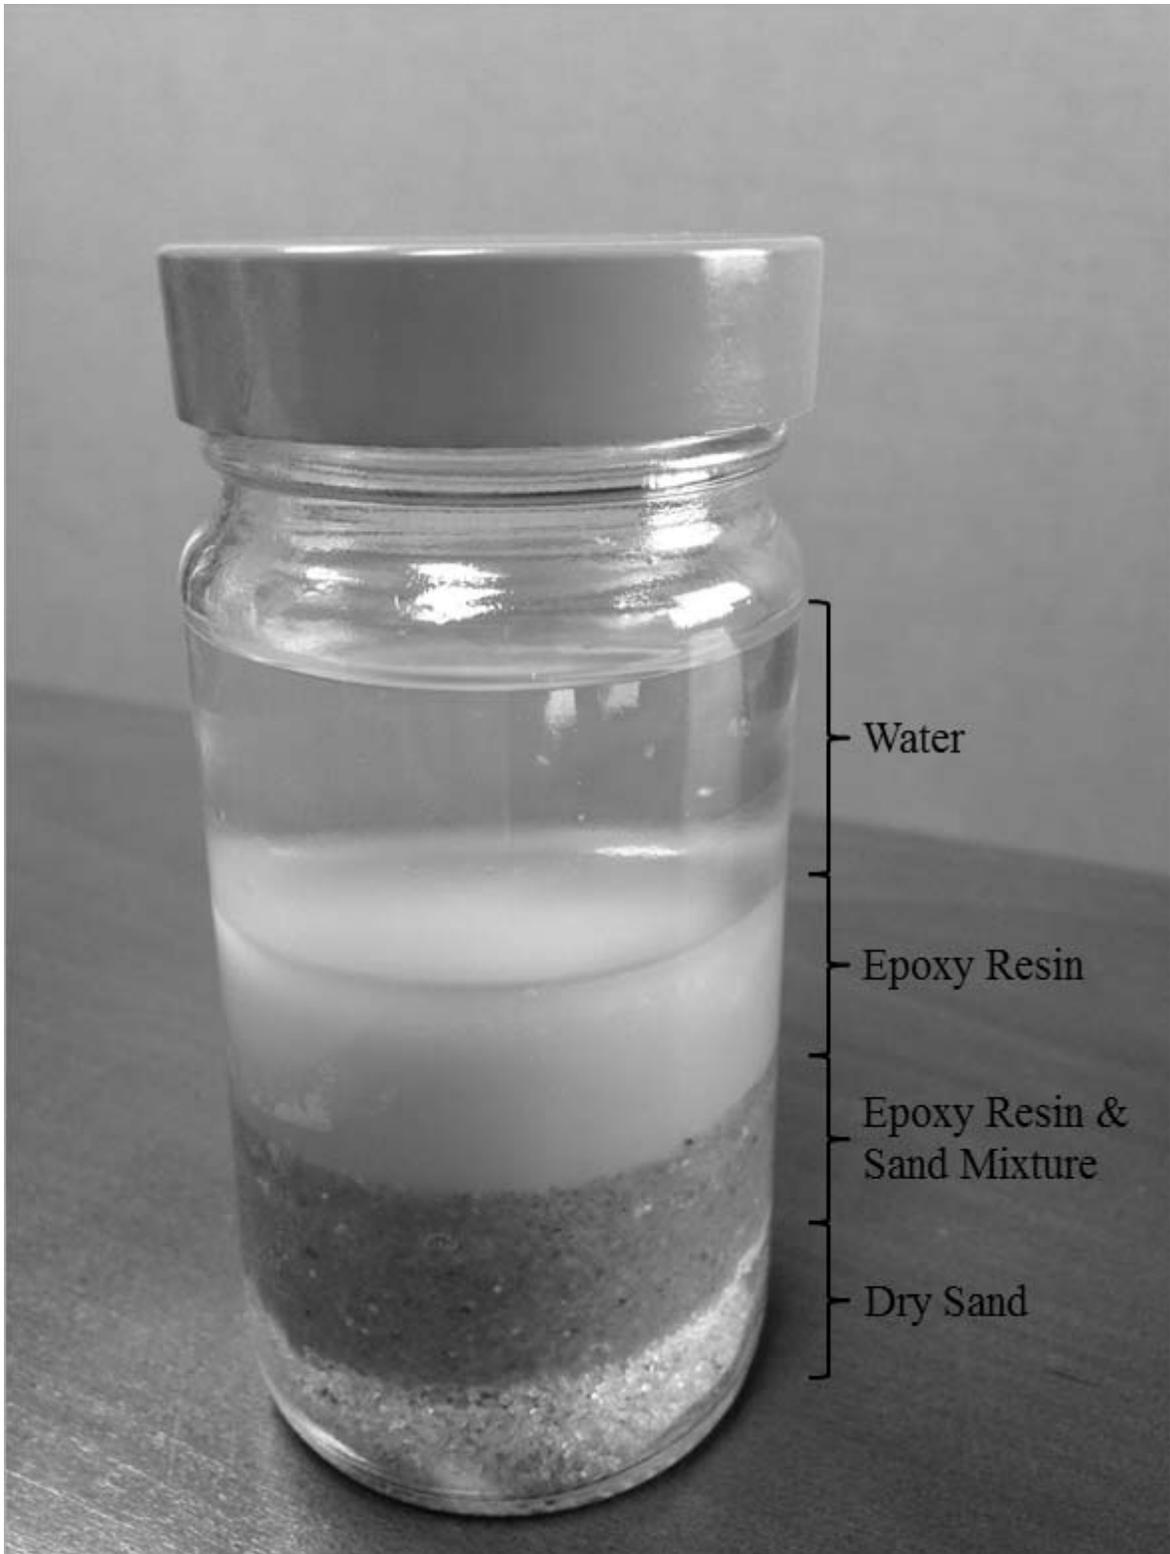
Samples of the sand and epoxy resin from location were collected into jars to monitor the epoxy resin setup. Figure 13 illustrates one of these samples with water added for effect, showing an impermeable seal between the water and the sand. The epoxy resin provided an impermeable seal on top of the sand plugs in both wells and isolated the bottom set of perforations, thus improving the injectivity profiles as indicated by the pre- and post-job injection rates in Figure 14. The data shows a decrease in injectivity on both wells proportional to the amount of fluid that the newly covered thief zone took historically.

Figure 13 – Case Study 2: Location sample of set epoxy resin and 20/40-mesh sand, with water added for effect.

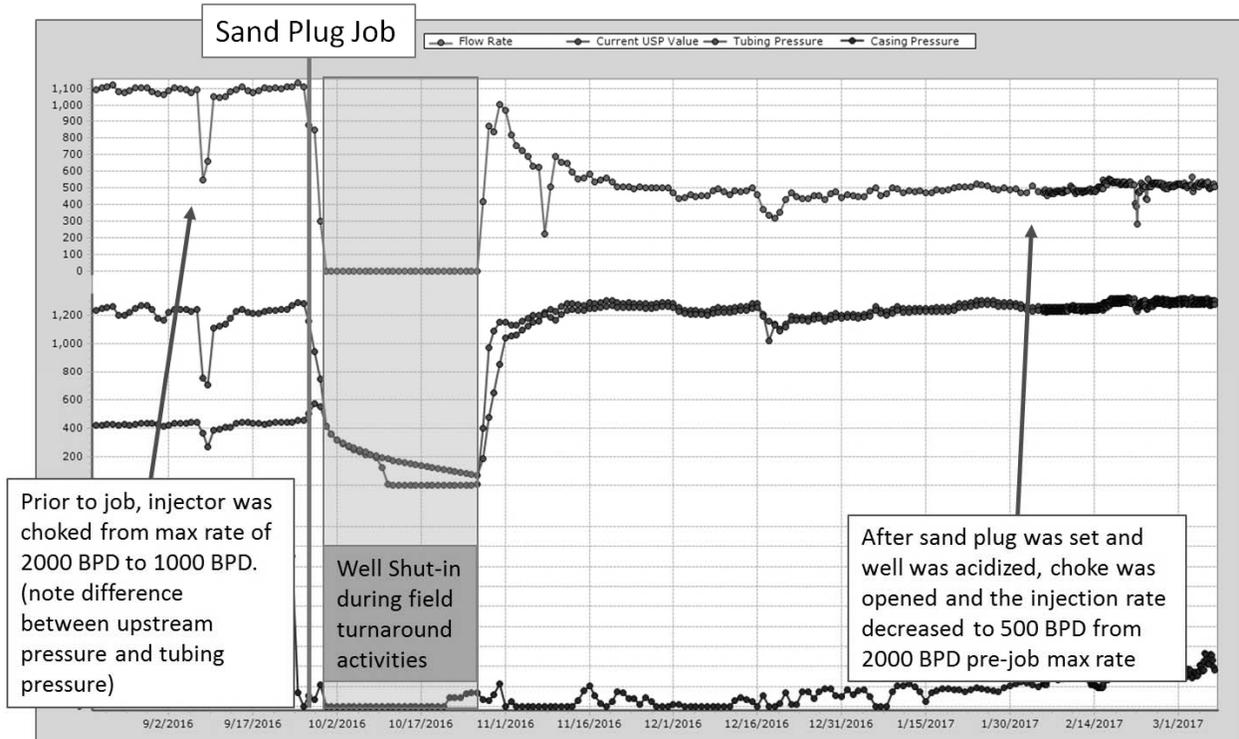
Figure 14 – Case Study 2: Pre- and post-treatment injection rate and pressure data for Well 1.

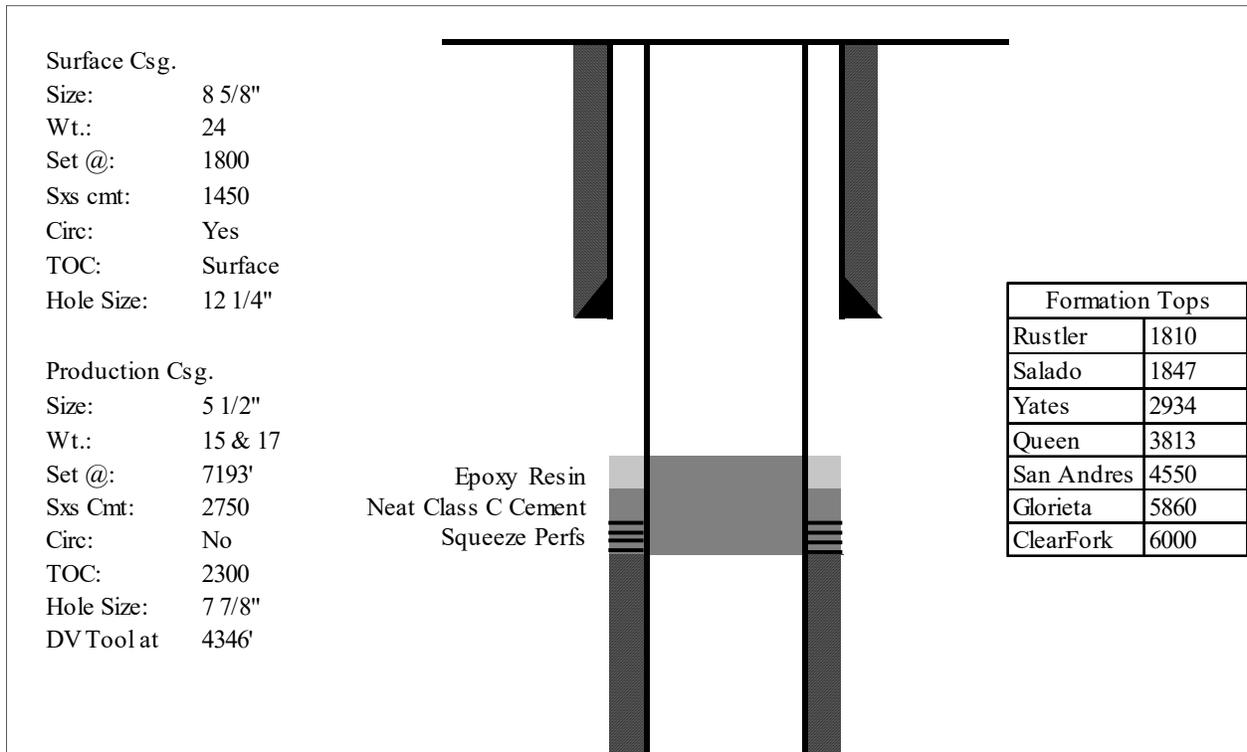
Figure 15 – Case Study 3: Gas-tight annular plug and wellbore diagram.

To abandon a well in Gaines County, Texas, an operator had to shut off 300 psi of bradenhead pressure in the production casing annular. Because of inadequate primary cementing coverage on the 5.5-in. 17 lbf-ft production casing, gas was migrating from the Yates formation. The estimated top of the Yates formation in that area is around 2,930 ft MD. To shut off the gas migration, a novel gas-tight abandonment treatment was developed. This treatment consisted of shooting perforations above the production casing top of cement (TOC) and pumping 3 bbl of epoxy resin and neat Class C cement into the annulus, followed by just neat Class C cement inside of the casing. Figure 15 shows a wellbore diagram.

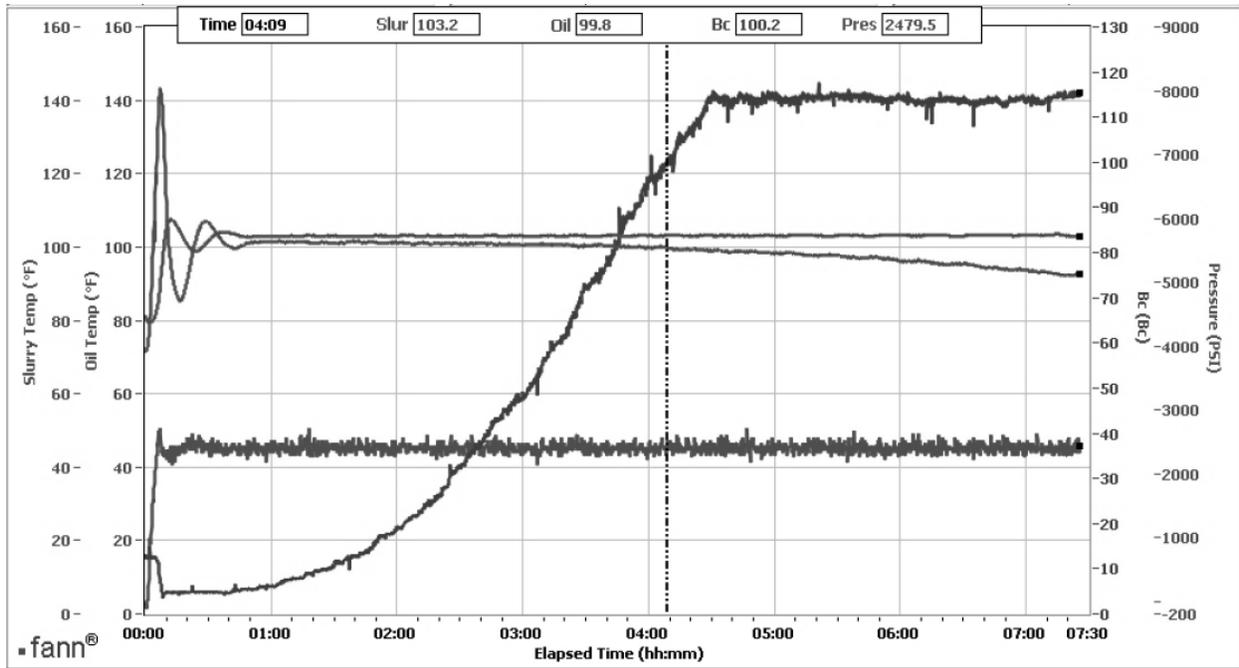
Figure 16 – Case Study 3: Epoxy resin thickening time test graph.

A thickening time test for the epoxy resin was conducted at 103°F and 2,400 psi on a HP/HT consistometer to simulate bottomhole conditions. Table 7 and Figure 16 show the final epoxy resin design and thickening time graph, respectively. Because the epoxy resin was going to be pumped adjacent to neat cement, several tests were conducted to help ensure the compatibility and stability of an 80% neat cement and 20% epoxy resin mixture. A thickening time test of this mixture (Figure 17) resulted in no compatibility issues or erratic behavior and pumped off at 3 hours 26 minutes. This was slightly slower than the neat epoxy resin pump time of 4 hours 9 minutes but well within design parameters. A free fluid/stability test (Figure 18) was conducted and showed no separation, streaks, or discoloration that would indicate incompatibility between

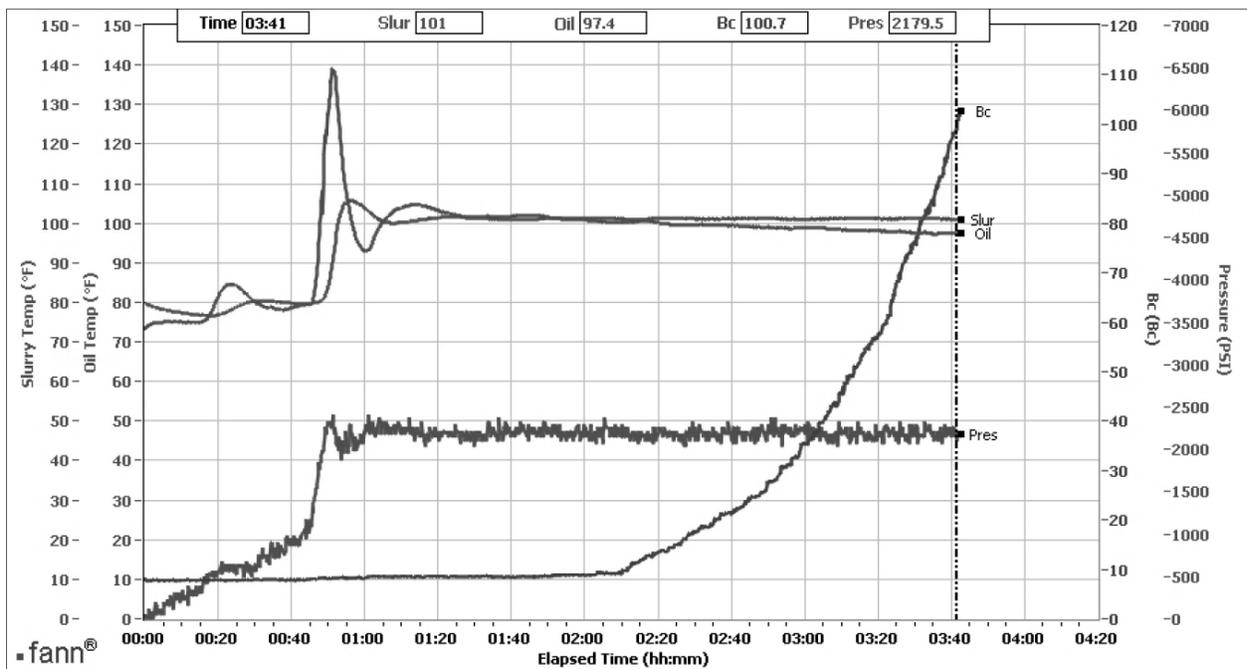
Figure 17 – Case Study 3: Class C cement and epoxy resin mixture thickening time test graph.

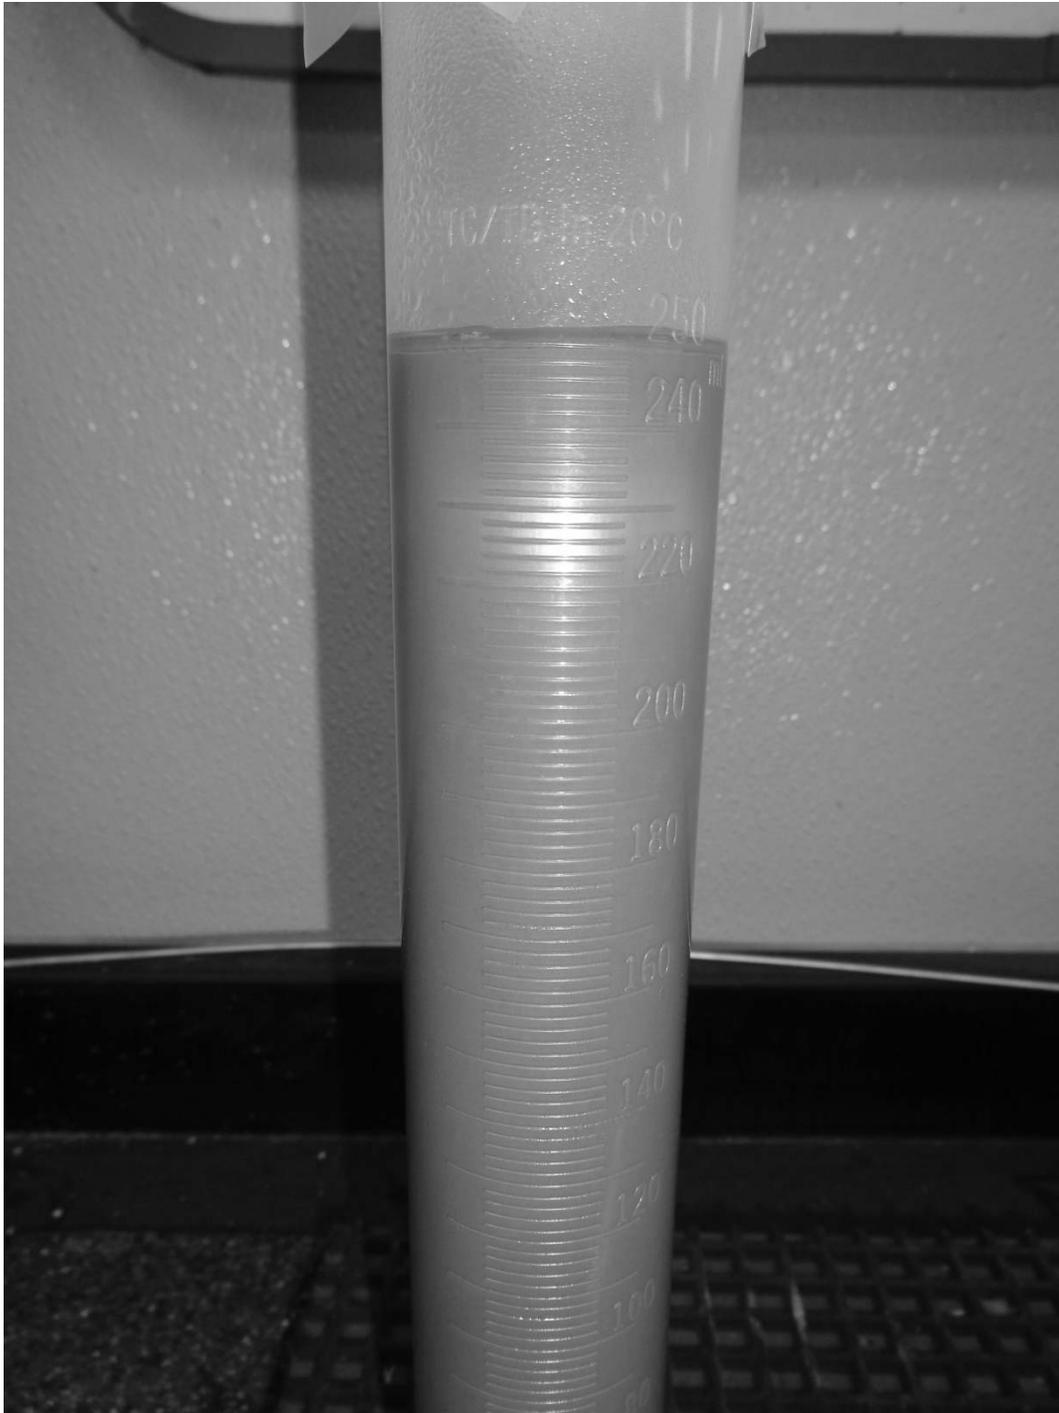
Figure 18 – Case Study 3: Class C cement and epoxy resin mixture free fluid/stability test.
