FROM ZONE ABANDONMENT TO RESTORING WELLBORE INTEGRITY: MODERN EPOXY RESIN TECHNOLOGY WELL REMEDIATION CASE STUDIES

Olvin A. Hernández, Paul Jones, and Brandon Kimble
Halliburton

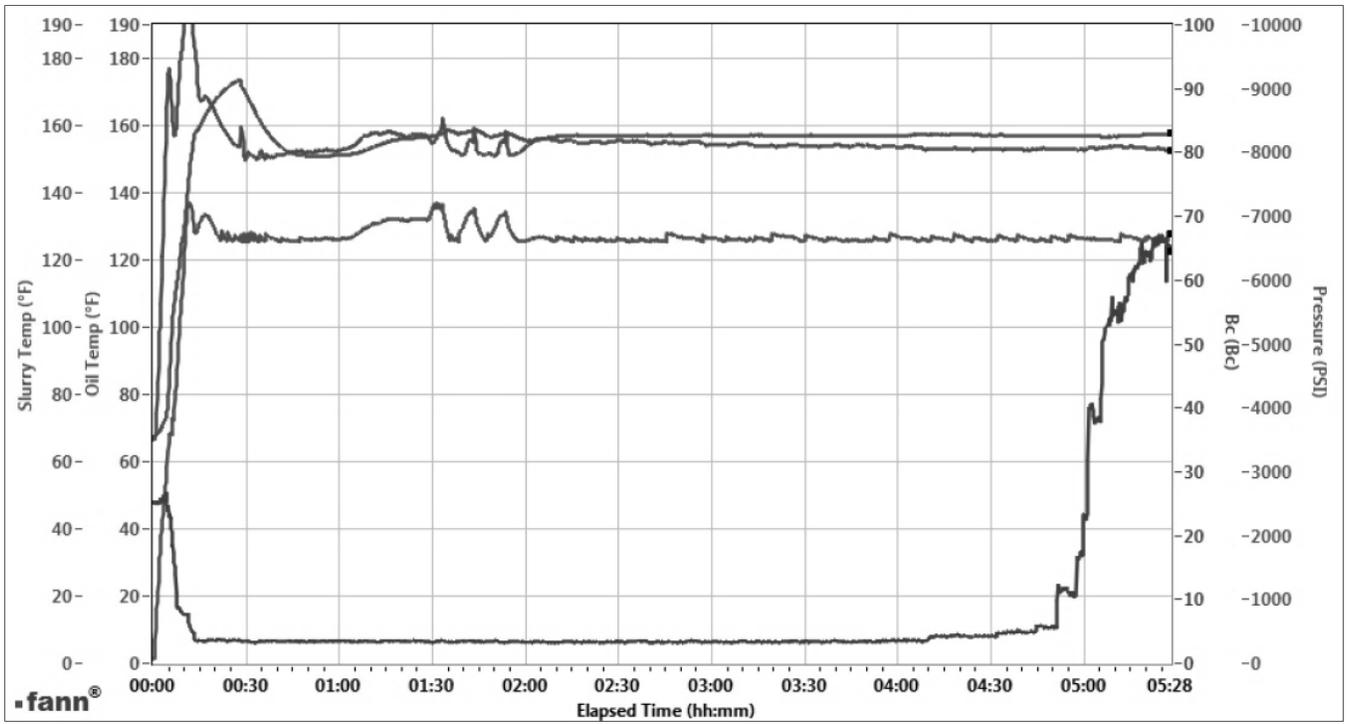
Figure 19 – Case Study 4: Epoxy resin thickening time test graph.

A thickening time test was conducted at 157°F and 6,900 psi in a HP/HT consistometer to simulate bottomhole conditions. This test included sufficient time to mix and pump the epoxy resin, reverse circulate the tubing, and a safety factor. Figure 19 shows the test results, and Table 9 shows the final epoxy resin design and volume. The epoxy resin design called for no accelerator at this temperature, resulting in a working placement time of 5.5 hours.
