MITIGATING PARAFFIN BUILDUP IN UPTON COUNTY, TEXAS – HARNESSING INNOVATIVE TECHNOLOGY TO PREVENT PARAFFIN BUILDUP FROM CAUSING AND CONTRIBUTING TO WELL FAILURES.

Matt Berkebile
Diamondback Energy

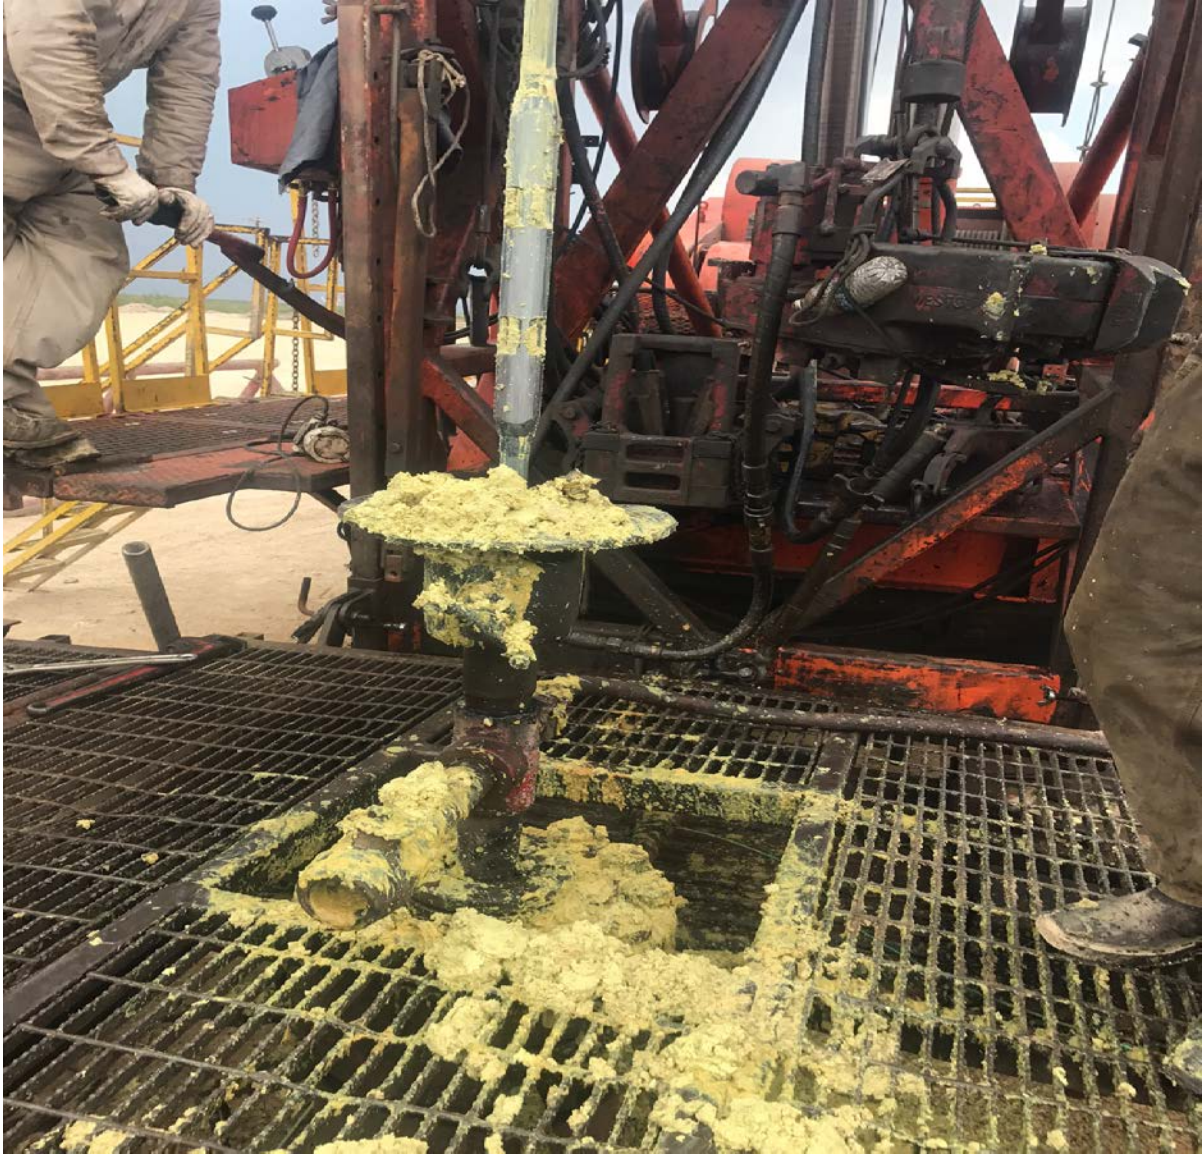
Photo 2 Illustrates paraffin stripping while pulling out with rods on a typical workover in Bloxom.

Photos 1-2 in the appendix are example well pulls that show the level of paraffin we deal with on wells that were being treated with conventional paraffin chemical on either weekly or biweekly scheduled treatments. The last photo is the most significant as it illustrates very thick paraffin engulfing the rod and occupying every void space between it's outer diameter and the inner diameter of the tubing.

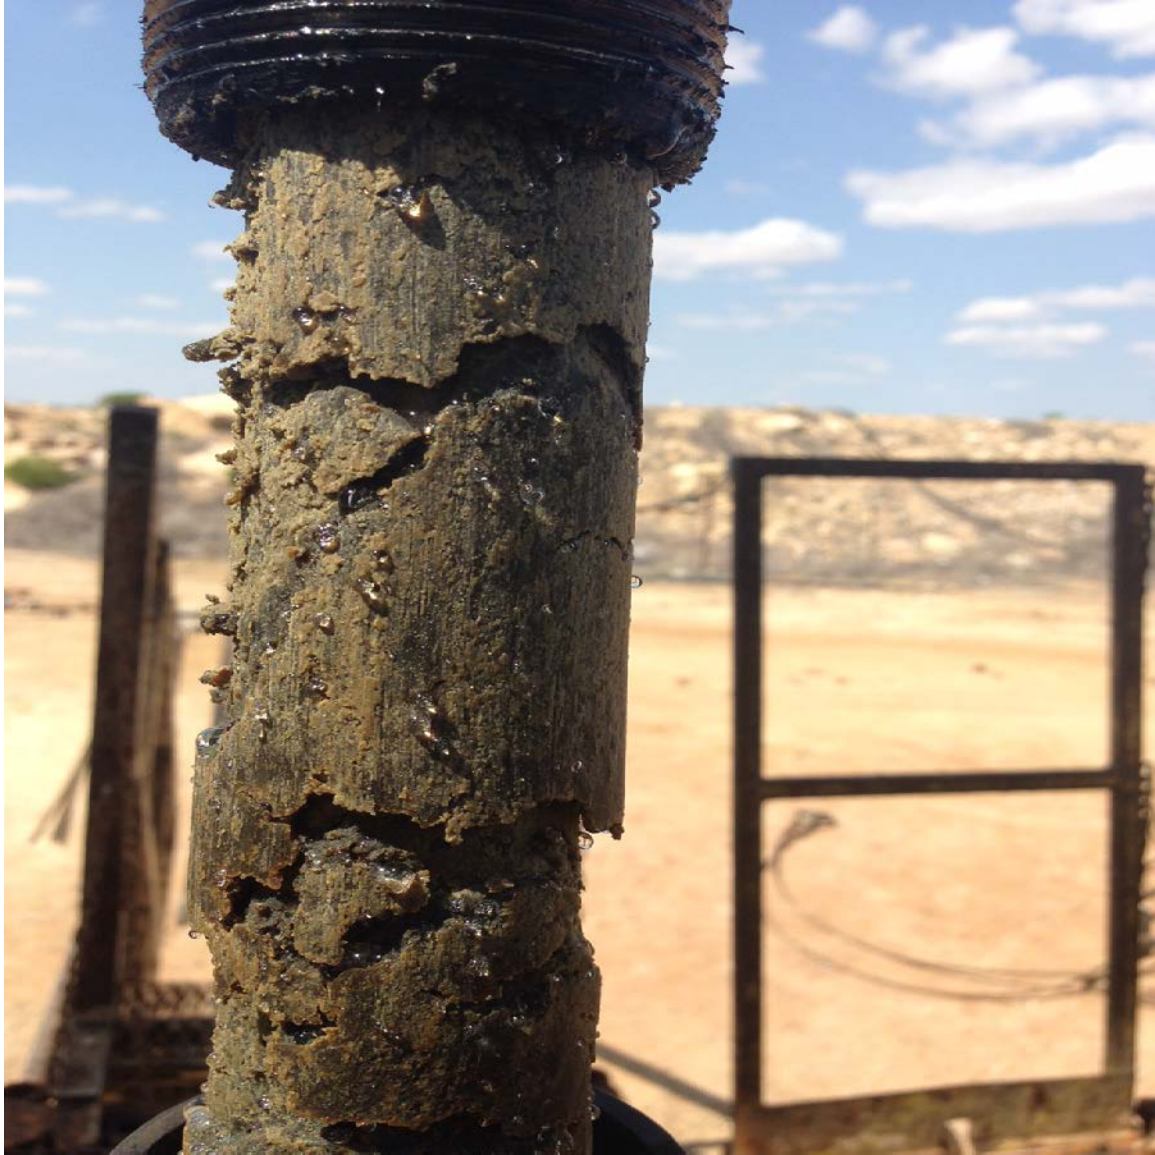
Photo 3 Illustrates paraffin occupying every void space between the rod and tubing during a recent workover.

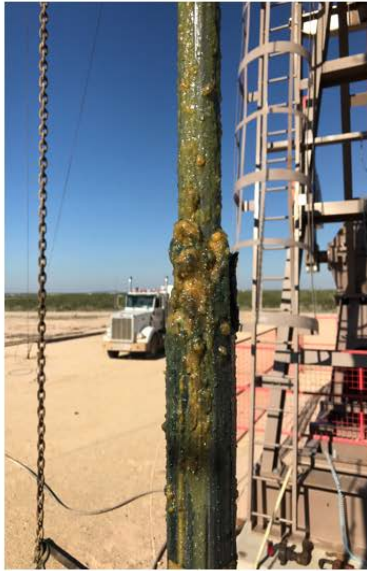
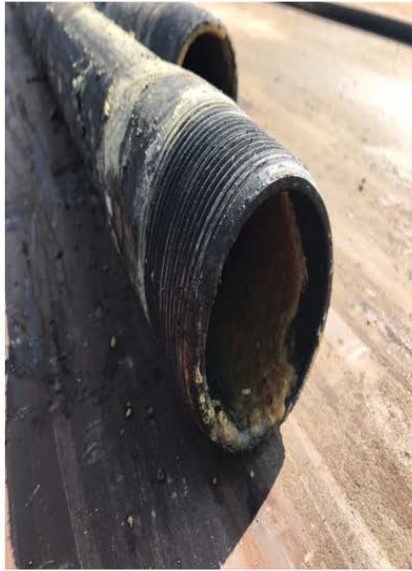
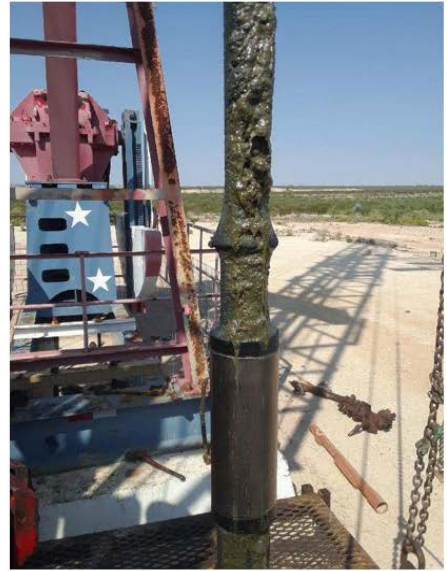
Photos 4-6 illustrate results of three unconventional chemical methods during a paraffin treatment trial test that took place during a three month duration.

After the 3 month period concluded, we began to pull the test wells unannounced to keep all contenders on an equal field. Evaluation proceeded. Rods were pulled without help of any external factors, such as hot watering or rod stripping. We found that in some instances paraffin formation began regenerating within 2 weeks of initial circulation. One of the companies had varying pressure and flowrate trend changes after the application of each subsequent treatment. Another of the contenders showed clean surface samples throughout the test period yet had to work fairly aggressively for several hours to unseat the pump due to the paraffin accumulation on the rods. All results contained light to moderate hydrated paraffin with some examples involving moderate chunks of paraffin. None of these options were any more beneficial than our existing methodology.

Photos 4-6 illustrate a sample of results after the three month trial with the 4 chemical companies. So there we were, unsatisfied with the results. None of the options worked any better than what our existing treatment could yield. It was time to think differently. The credit going forward goes to one of our geologist, who happened to see Revelant at a conference. He mentioned the encounter and that's when Diamondback was introduced to Revelant's Enercat tool.

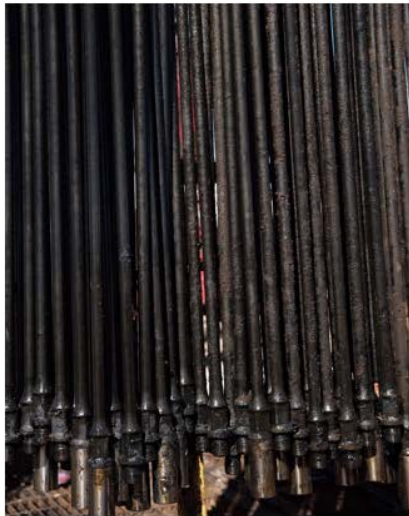
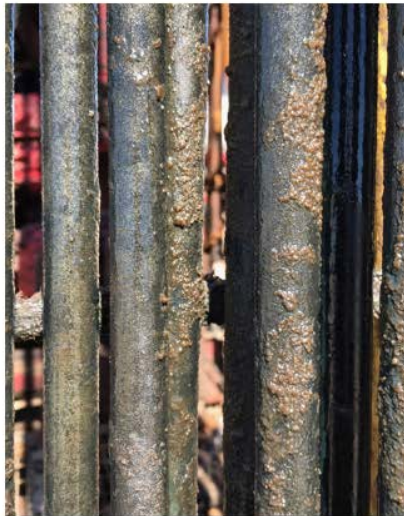
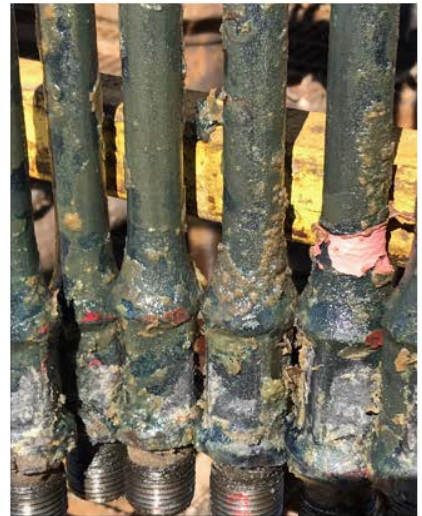
Photos 7-9 Show the post test rod pull on the Betty Ruth #3.

The first install was in the Betty Ruth #3. The communication was a little unclear during this first installation. We ended up installing the tool beneath the intake. But ultimately it didn't appear to make any clear difference. We had to zoom in on the photos on to find traces of paraffin (see Appendix, **photos 7-9**). The tools were placed above the pump intake and below the seat nipple in the remainder of the examples. Slight nodules were present on the Neal 8 #7, but hardly any build up occurred on the rod upsets. The Janey 16H, Diamondback's first horizontal well, had to be pulled early at 2 months into the test due to a failing pump. However virtually no paraffin was present on the rods. We had to pull the tubing on this well but had no presence of paraffin during that trip out either (see Appendix, **photos 10-11**). When pulling the Janey #3, all rods were hydrated with slight traces of non uniform paraffin on the bodies. The Janey 4H, another horizontal well, also yielded no paraffin. At the later point of this timeframe, our rig was able to conduct a roundtrip with the rods in addition to rigging down and moving on to the next well in about 8 hours. The savings in time and rig associated costs became blatantly obvious. Our last well was the Crystal #1. This well was down, not pumping for a week prior to the workover, and **that's important** because it's possible that paraffin also forms when a well is not moving fluid, but here we see it wasn't an issue. We later found an electrical issue in the drive box preventing the well from pumping. Interestingly though, with no fluid moving for a week, this well had only miniscule non-uniform sheath of paraffin on a few rods at it's worst – none of which were problematic (See Appendix, **photos 12-13**)

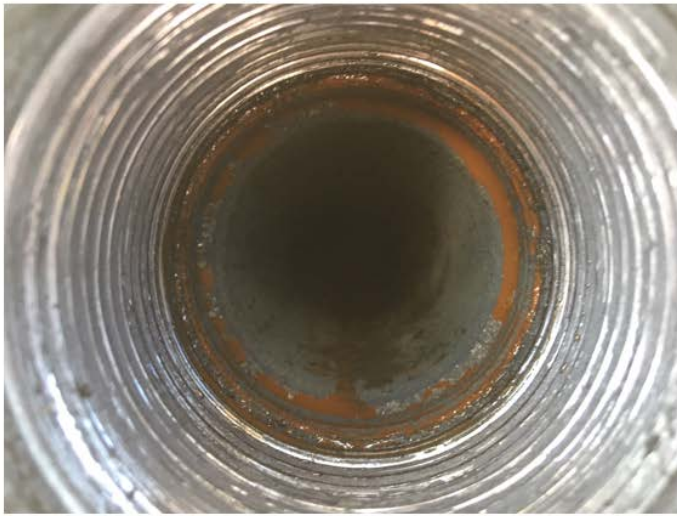
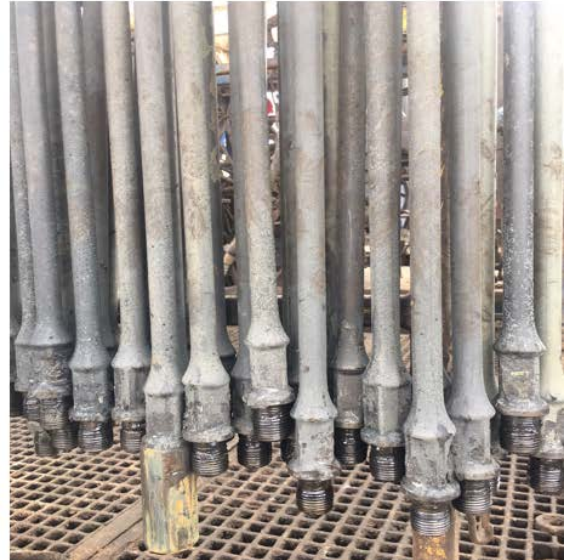
Photos 10-11 Demonstrate the Enercat's work on the Janey 16H, clean rods and clean tubing.

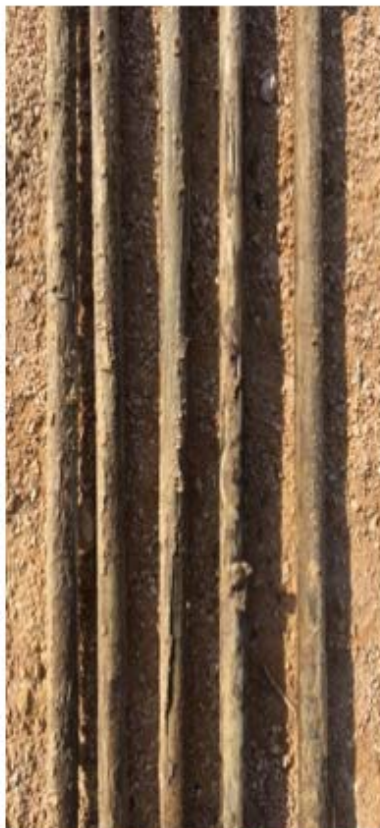
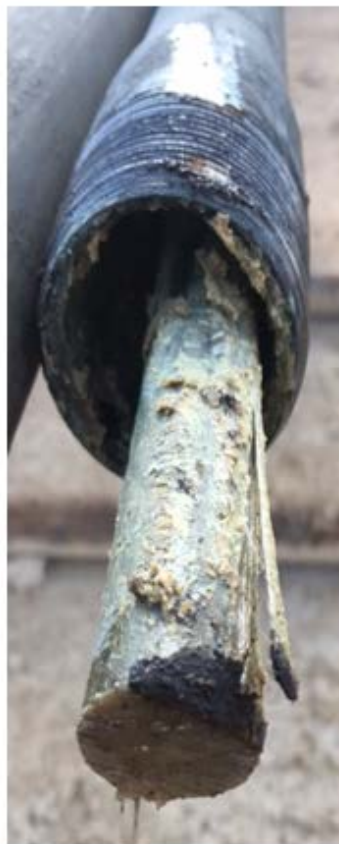
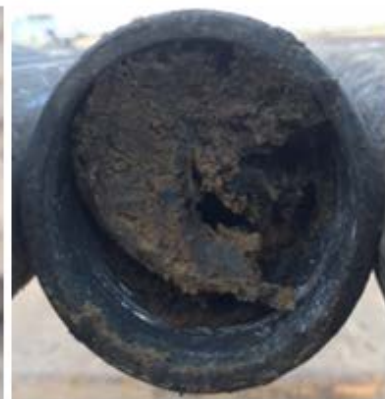
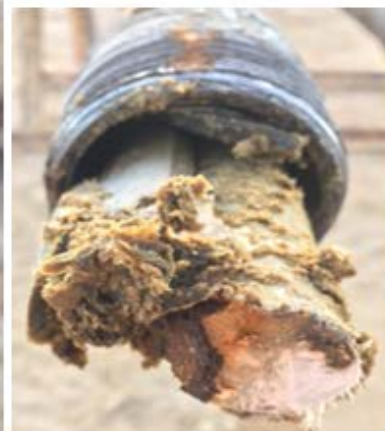
Photo 12 Shows the paraffin level in the Crystal #1 prior to the Enercat installation.

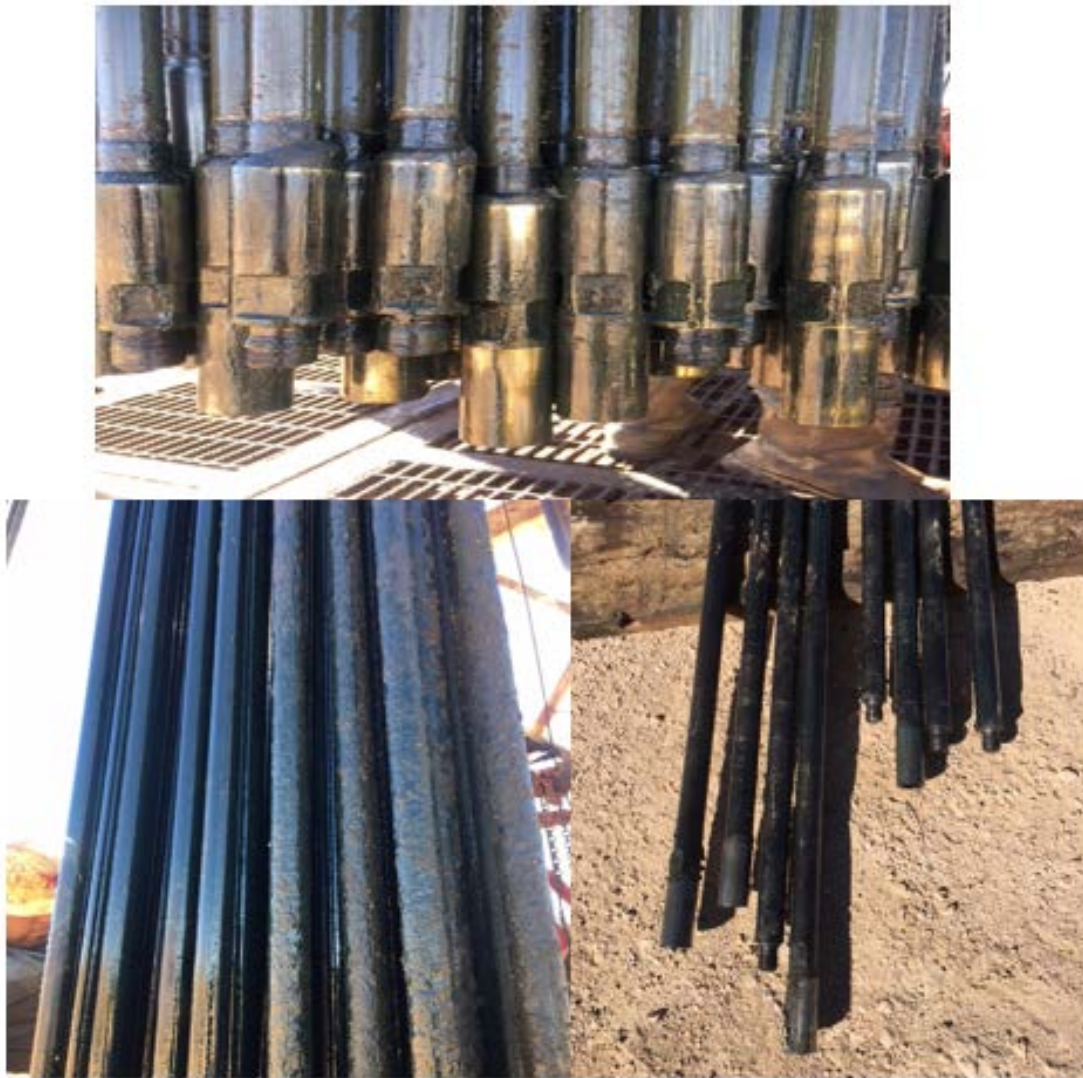
Photo 13 Shows the results of the three month test on the Crystal 1 rods.

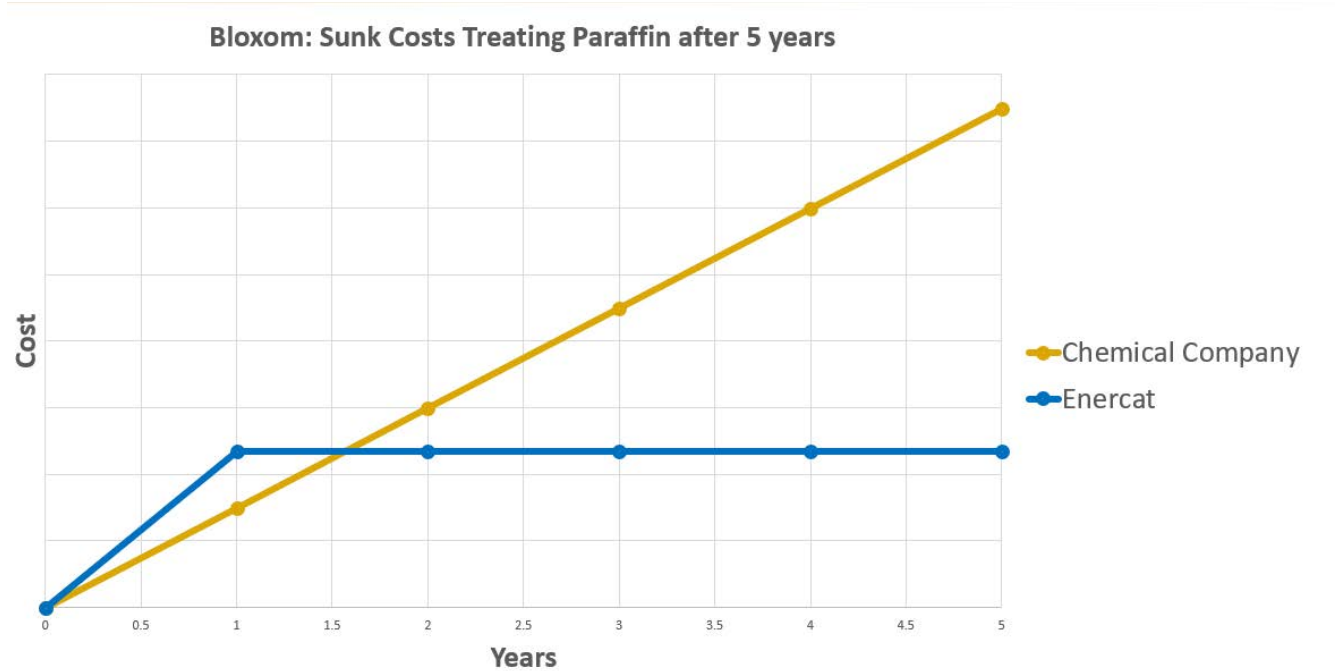
Plot 1 Illustrates the cost savings over time comparing the Enercat vs. an aggregate of conventional methods for treating paraffin.

Moving on toward the most important thing, cost. The cost of the Enercat tool is a onetime purchase represented by the blue curve on **Plot 1** in the Appendix, Whereas our aggregate expense dealing with paraffin conventionally is ongoing. Diamondback's conventional method cost is comprised of 3 things: annualized batch treatment costs, annualized costs dealing with paraffin during workovers, and annualized cost of equipment replaced during workovers due to paraffin. As can be observed in the plot, Diamondback's conventional method costs, in the orange curve, accumulate over time whereas the Enercat method involves a one-time expense. Payout time is slightly more than 1.5 years when compared to the conventional method, but the cost savings averages about 2-3 times over a 5 year period.
