# **FIELD TRIAL DATA DEMONSTRATES BENEFITS OF METALLIC COATING THAT ACTIVELY PROTECTS ROD STRINGS AGAINST CORROSION IN CHALLENGING WELL ENVIRONMENTS**

Alex Perri, ChampionX Artificial Lift  
Angela Sultanian, Pro-Rod Coiled Rod Solutions

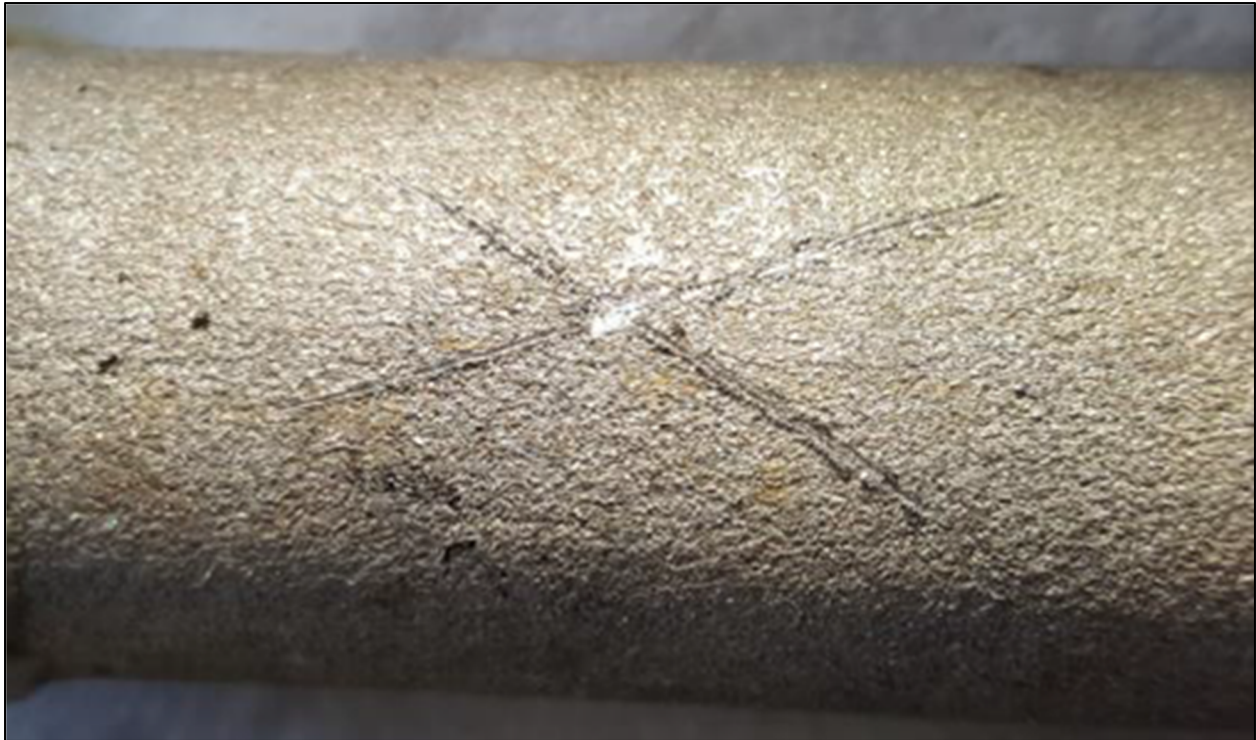
**Figure 6 – X-cut evaluation of coating corrosion test**

Considerable laboratory corrosion testing has been performed on the anodic coating. Samples of the coating were subjected to NACE TM0185<sup>3</sup> corrosion testing. The autoclave test consists of exposing a length of coated product to three phases of fluids for 30 days. The chloride, H<sub>2</sub>S, and CO<sub>2</sub>-containing environment and other test conditions are presented in Table 1. After 30 days of exposure, the coating demonstrated excellent adhesion to the base material (Figure 6). The same test was performed with samples containing simulated damage to the coating. The coating demonstrated a lasting protective effect even when removed by 50% of the circumference (Figure 7).

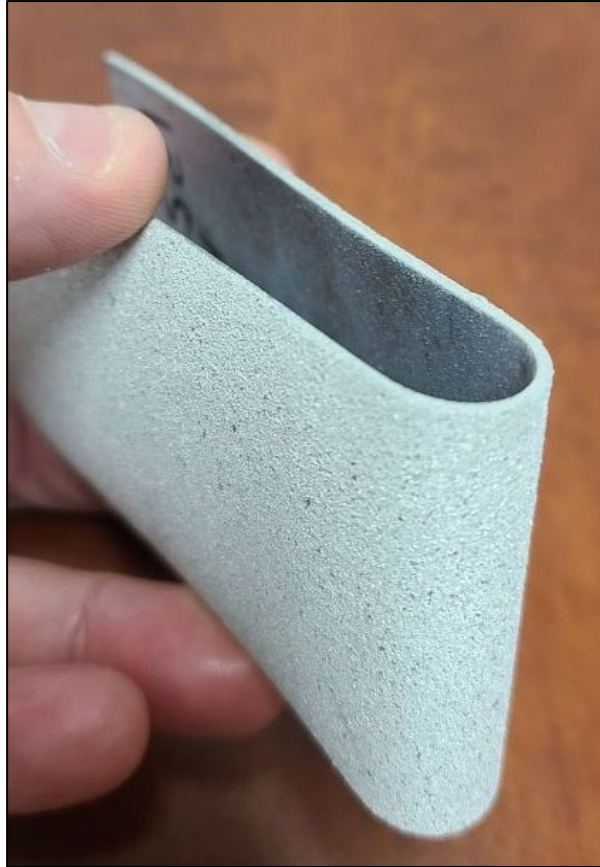
**Figure 8 – Coated test panel bend testing**

The coating has demonstrated a high degree of flexibility (Figure 8). Rotating-bending tests at 500 rpm produced a 22-foot radius of curvature (equivalent to 40% of the ultimate tensile strength of the base material) (Figure 9). The samples exhibited no cracking within the coating or disbondment from the base material after 3 million cycles.

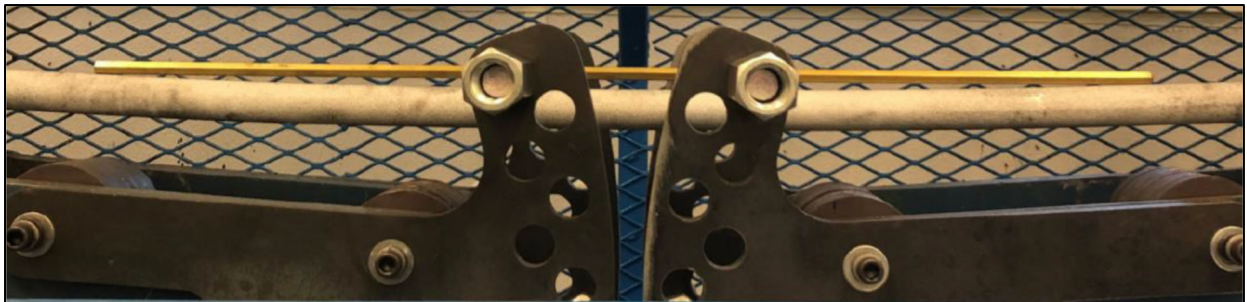
**Figure 9 – Coated rod rotating bend testing (brass rod used to demonstrate rod curvature)**

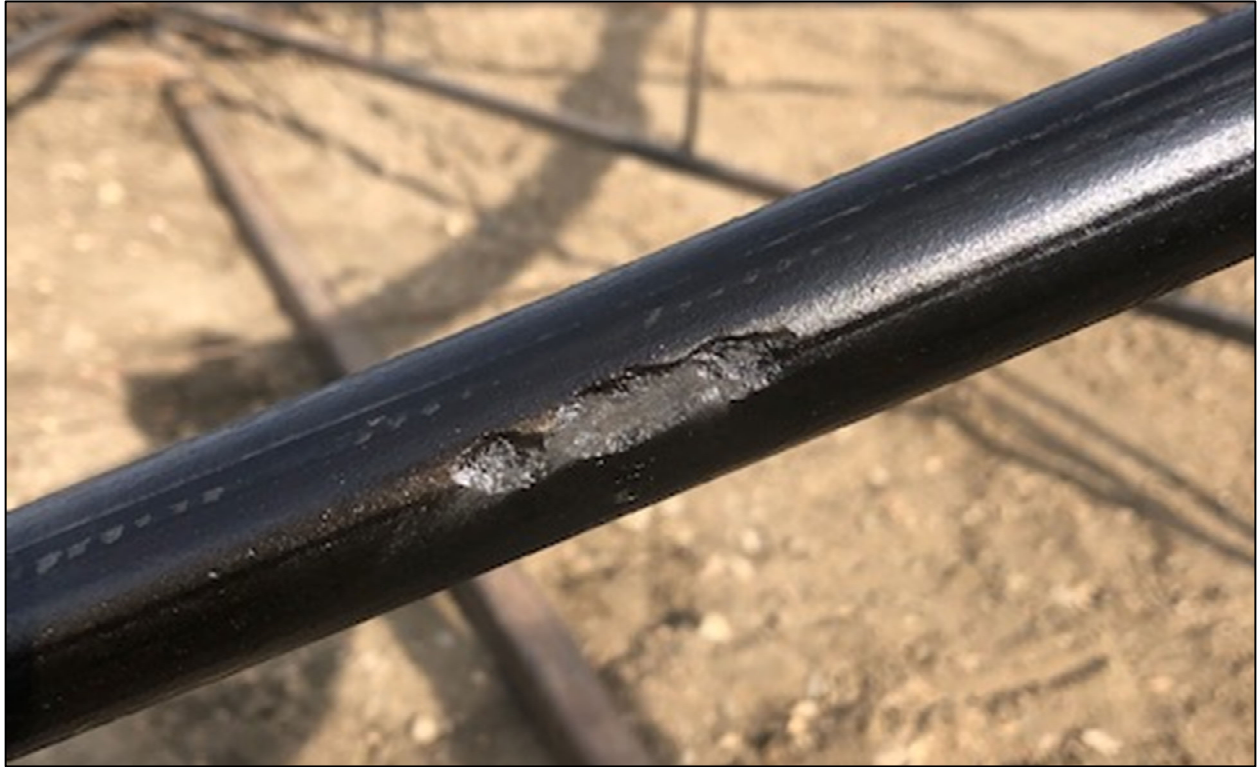
**Figure 11** - Uncoated rod exhibiting corrosion damage at 22 weeks

Surpassing the historical MTBF, the rod string was pulled after 22 weeks of service to inspect its condition. Sections of the 820-ft uncoated rod exhibited corrosion damage and wear from tubing contact (Figure 11). The rod diameter was reduced to as low as 1.075 in. At approximately 885-1,150 ft depth (within the coated portion of the string), there was wear damage detected at the tubing collars but no corrosion damage

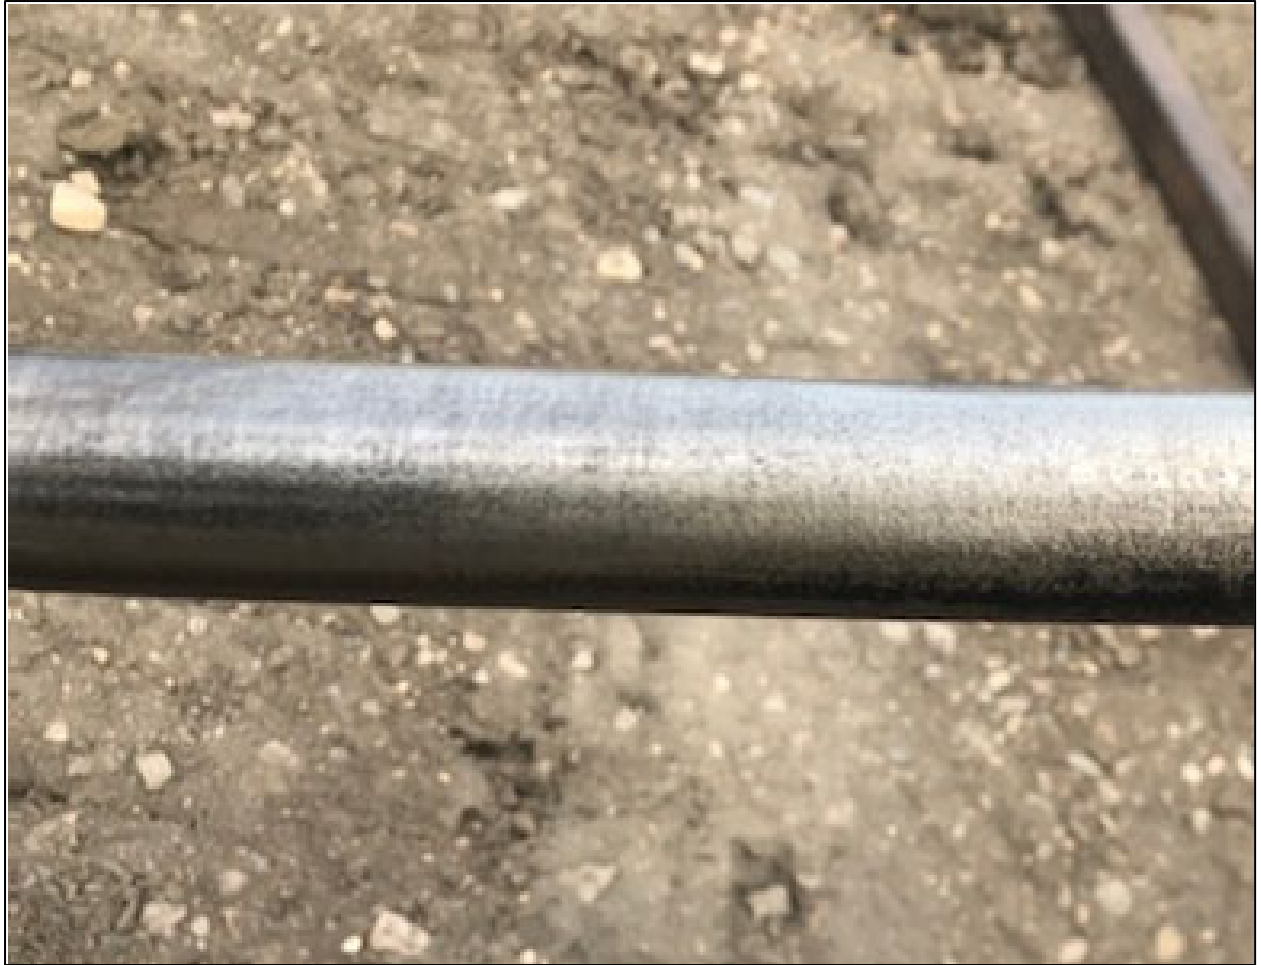
**Figure 12** - Uncoated section exhibited wear near coated section (22 weeks)

identified even at these worn areas (Figure 12). From 1,150 ft to the bottom of the rod string, there were areas that were becoming polished due to tubing contact, but no significant wear was discovered. The coating appeared polished due to its self-healing properties and it remained well-adhered, even in areas exhibiting wear damage (Figure 13).

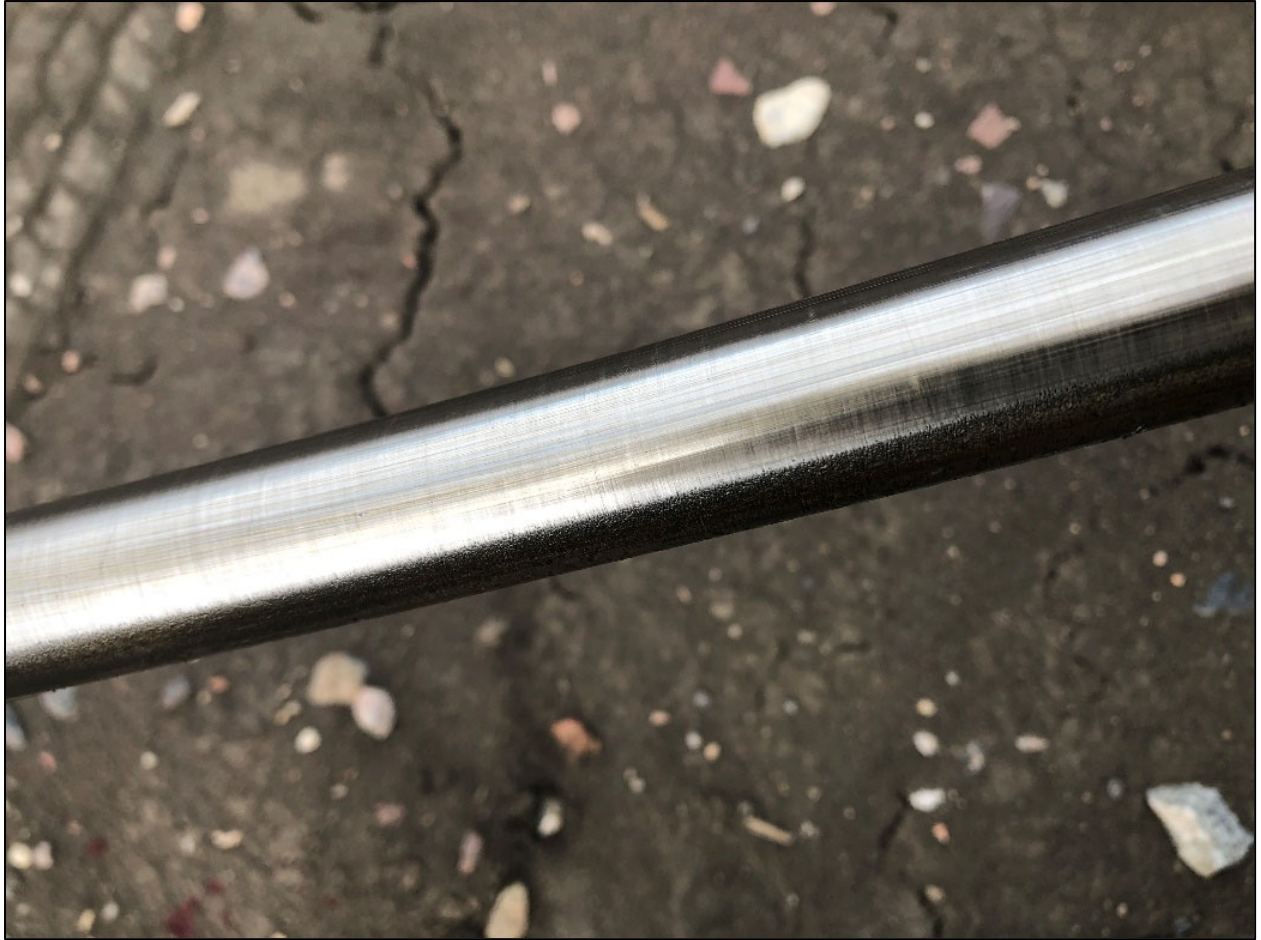
**Figure 13** - Coated section exhibited light wear (22 weeks)
