# **NON-CABLE ACTUATED ROD ROTATOR: TECHNOLOGY DEVELOPMENT AND FIELD EXPERIENCES**

Nicolas Gayubas and Martin Ruiz Palero, DALTEC OIL TOOLS  
Rodrigo Ruiz, DUXAOIL TEXAS LLC

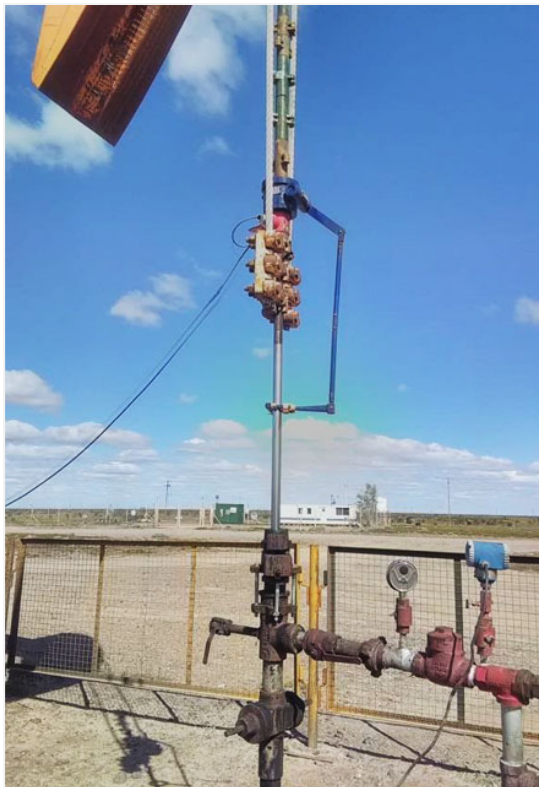
Figure 5: Installations at Conventional and Belt Driven Units

RR01 in a Conventional unit

- Testing goal: Evaluate the equipment on field conditions and in both type of pumping units, conventional and long stroke belt driven units (See Figure 5)

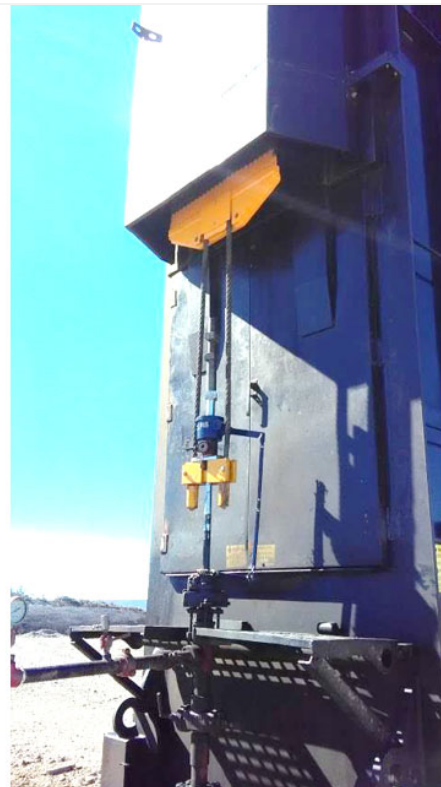
RR01 in a Belt Driven Unit

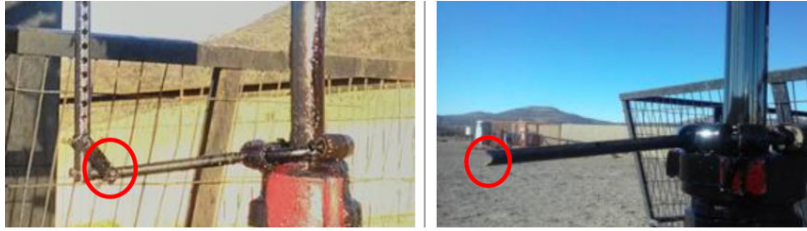
Figure 6: 1<sup>st</sup> and 2<sup>nd</sup> Shoe Generation.

1<sup>st</sup> Shoe Generation Failure at Well 3

- Installation: 12/15/2016
- Validation Test Closure Date: 10/10/2017 (299 days)
- Conclusion of the field trial A:
  - The field trial pushed the boundaries of the initial shoe design. It led to premature failures but through FEA evaluation and the new cast molding the new design demonstrated being robust and reliable (see Figure 6 on 2<sup>nd</sup> Shoe Generation implementation and Table 3 for a summary of the operator A trial wells).
