# THERMOGRAPHIC INSPECTION OF OPERATING PUMPING UNITS IN PERMIAN BASIN OIL FIELDS

Richard E. Witte  
Witte Energy Management

Thermographic inspection, through the use of portable infrared imagers and non-contact spot radiometers, has been performed on approximately three thousand pumping units in many active Permian Basin oil fields within the past two and one-half years. Infrared imagers with camera adaptability were used to inspect saddle or Sampson post bearings, equalizer or tail bearings, wrist pin bearings, exterior gear box bearings, electric motor and related switch gear on each beam-type pumping unit. In many instances, pole-mounted transformers were scanned for thermal differentials, completing the wellsite inspection.

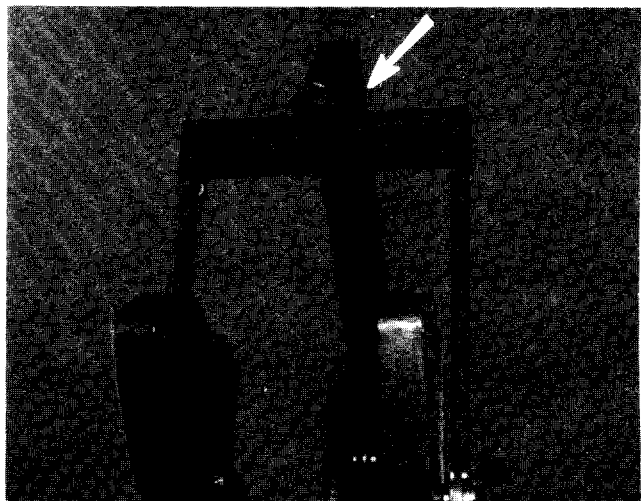
Fig. 1-Photograph of tail bearing.

Figures 1 and 2 present a case for thermal imaging as a quality control or warranty device. The subject pumping unit was 45 days old. The temperature in the bearing was found to be 60° F. above ambient. Failure was imminent. The manufacturer was notified, the bearing replaced at no cost to the customer, saving him approximately \$2,000.

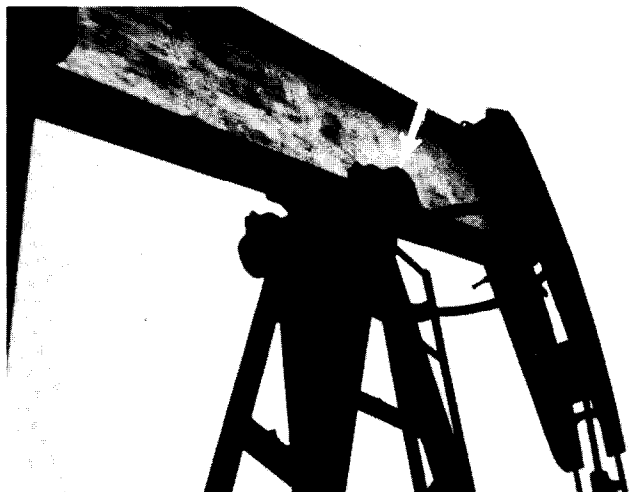
Fig. 5-Photograph of saddle bearing.

Figures 5 and 6 graphically display failure of one bearing on the saddle while the other continues to operate at normal temperatures. Temperature in the bearing is 33° F. above ambient.

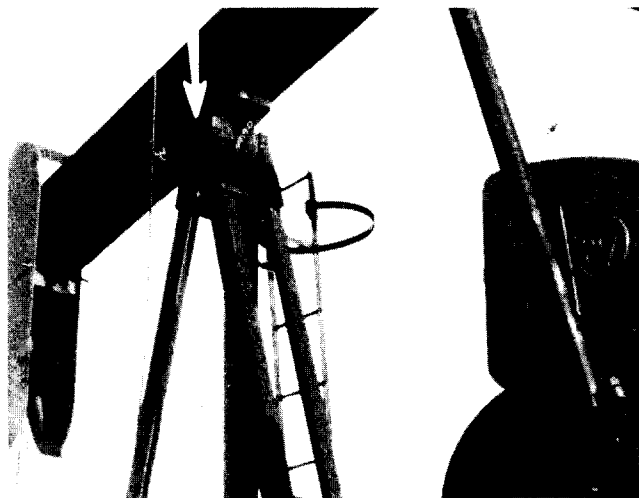
Fig. 7-Photograph of teflon saddle bearing.

This saddle bearing example (below) is typical of the temperature pattern and heat transfer that occurs in a teflon-base sleeve bearing. This bearing replaced a steel sleeve bearing.

The left clamp supporting this saddle bearing has a 49° F. temperature above ambient metal, while the right clamp has a 37° F. rise. The higher temperature is on the cooler side of the unit, indicating greater wear on the left. Recommendation: Replace bearing.
