# **THERMAL/INFRARED INSPECTION OF OPERATING PUMPING UNITS REVISITED**

***RICHARD EARL WITTE  
WITTE ENERGY MANAGEMENT  
MIDLAND, TEXAS***

Thermal/Infrared Images of Problems Specific to Beam-Type Pumping Units

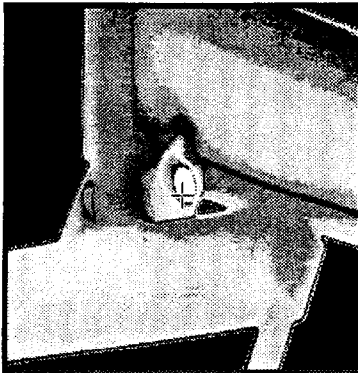
**Teflon (PTFE)  
Equalizer Bearing**

Although steel and bronze sleeve bearings have been used for decades, a development in sleeve bearing design is the use of a composite teflon-based material (polytetrafluoroethylene). Teflon can be used at temperatures up to approximately 550 degrees F., limited by the thermal capabilities of the other materials making up the bearing composite. Teflon is strong, impervious, tough, readily machined, and resistant to nearly all chemicals and solvents. It also has a low coefficient of friction, making it ideal for many oil-less or greaseless applications. For purposes of structural fabrication, teflon bearings have certain desirable properties not possessed by metals. They display excellent characteristics as electrical insulators and also as thermal insulators. It is here that the performance of thermography by analogy becomes high risk. Thermal radiation from a teflon sleeve bearing through the bearing wall is nearly nonexistent when compared to a similar steel sleeve bearing.

The heat generated within the bearing bore of a teflon bearing must escape in some manner. Its exit, however, totally confuses the analogous assumptions made from the extension of empirical data--both visual and numerical--obtained from steel sleeve bearings by thermography. These temperature patterns are a consequence of the physical phenomenon occurring within the bearing systems and establishes the fact that radiation from similar surfaces depends upon other than the measurement of surface temperature, and that diagnosis of the cause for a particular surface pattern requires a considerable talent and knowledge, not only with the use of thermal sensing systems, but also with the systems being analyzed.

Since teflon is thermally resistant to heat transfer, the energy created by the oscillating or rotating action within the bearing bore is largely removed through the bearing shaft or pin. In turn, this radiant energy moves into the clamps that hold the shaft in place. From the clamps or plates this energy is passed into the atmosphere by radiation and convection. However, the expansion of the bearing shaft that takes place through retention of a larger component of frictional heat adds another dimension to the proper or satisfactory application of a teflon sleeve bearing. Retention of more energy in the shaft causes a greater change in the expansion of the shaft. As the shaft expands radially, it fills more of the teflon bearing bore. Ideally, the shaft should not make contact with more than 160 degrees of the bearing wall, at the shaft's maximum temperature, since no load-bearing component occurs beyond this point in an oscillating bearing application on a beam pumping unit. However, if tolerance stack-up occurs, along with a high coefficient of expansion in the bearing shaft material, the entire bore of the teflon bearing is filled by the shaft. If the tolerance stack-up is great enough and sufficient pressure is exerted radially on the bearing wall for the total circumference of the bore, a significant increase in temperature will exist. This temperature is not likely to reach the thermal softening level of the teflon; however, the coefficient of friction is greatly increased in the bearing. This may cause the bearing to split, or to rotate in the housing. Additional horsepower is required to overcome the friction component. Higher horsepower demands more electric current. The overall result is an increase in the utility charge for operating the well, and reduced life for the bearing. Catastrophic failure is the ultimate result.

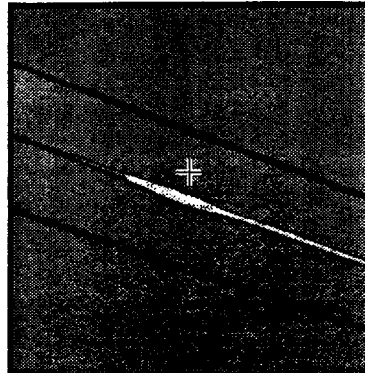
**Arcing - Secondary  
Line Splice**

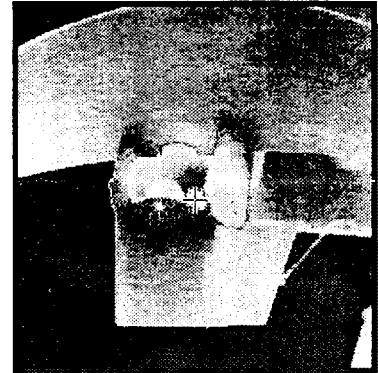
**Structural Bearing  
Equalizer Assembly**

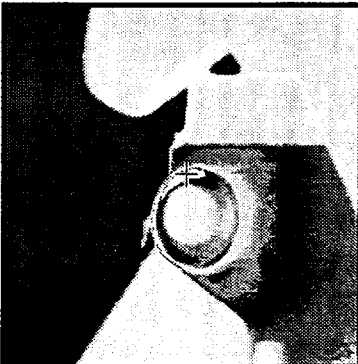
**Overheated Parking  
Brake Assembly**

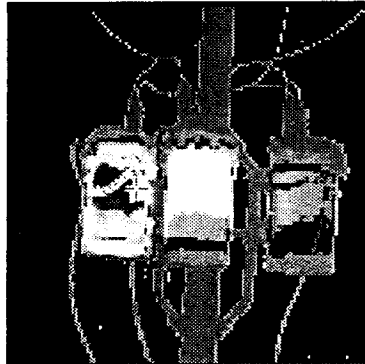
**Transformer  
Fatigue Failure**

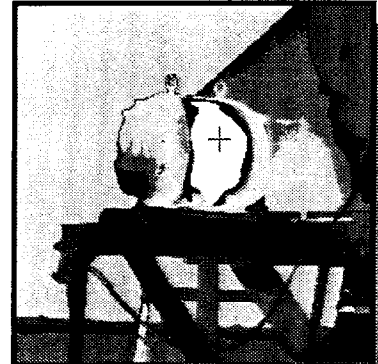
**Motor Overload  
or Breakdown**

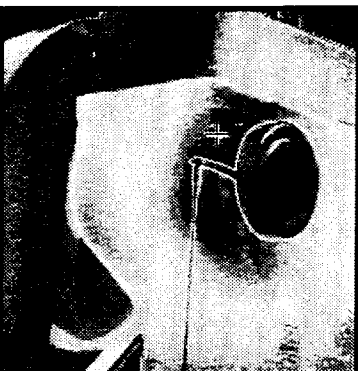
**Evidence of Gear  
or Bearing Problem**

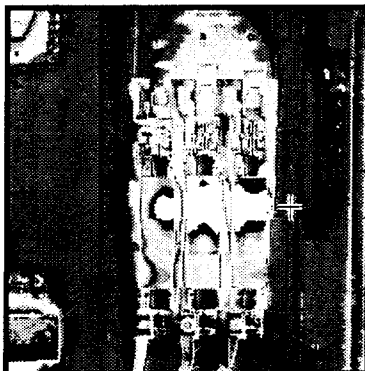
**Overheated Fuses  
- Fatigue Failure -**

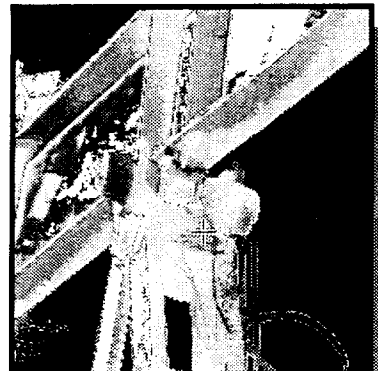
**Teflon (PTFE)  
Saddle Bearing**
