A NEW APPROACH TO CONTINUOUS ROD IN THE PERMIAN BASIN

Anthony Allison, Oxy

Taylor Krenek and Reed Vogt, Lifting Solutions

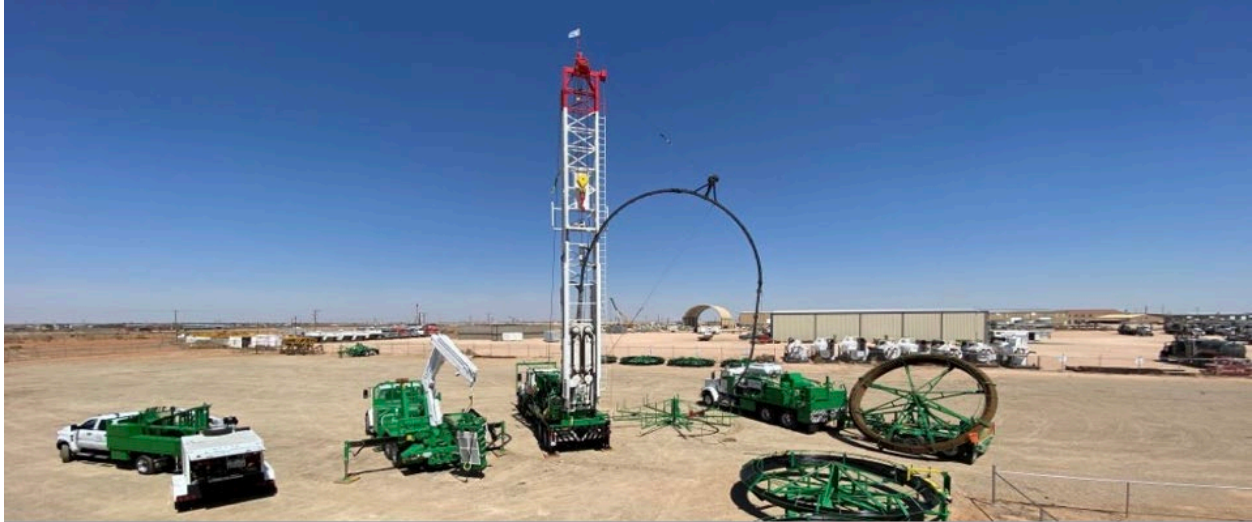
Figure 2—Continuous rod servicing equipment.

Finally, service availability has been addressed with a combination of equipment permanently based in the Permian and sufficient personnel available to manage the servicing of continuous rod. The personnel dedicated to this operation are a combination of local employees and rotational employees from other regions. The rotational employees provide both additional manpower and significant experience that is valuable for training new employee. Prior vendors would supplement their personnel on an as-needed basis, potentially causing extended downtime after a well failure. The new approach continually rotates employees through the Permian, so personnel availability is no longer an issue.

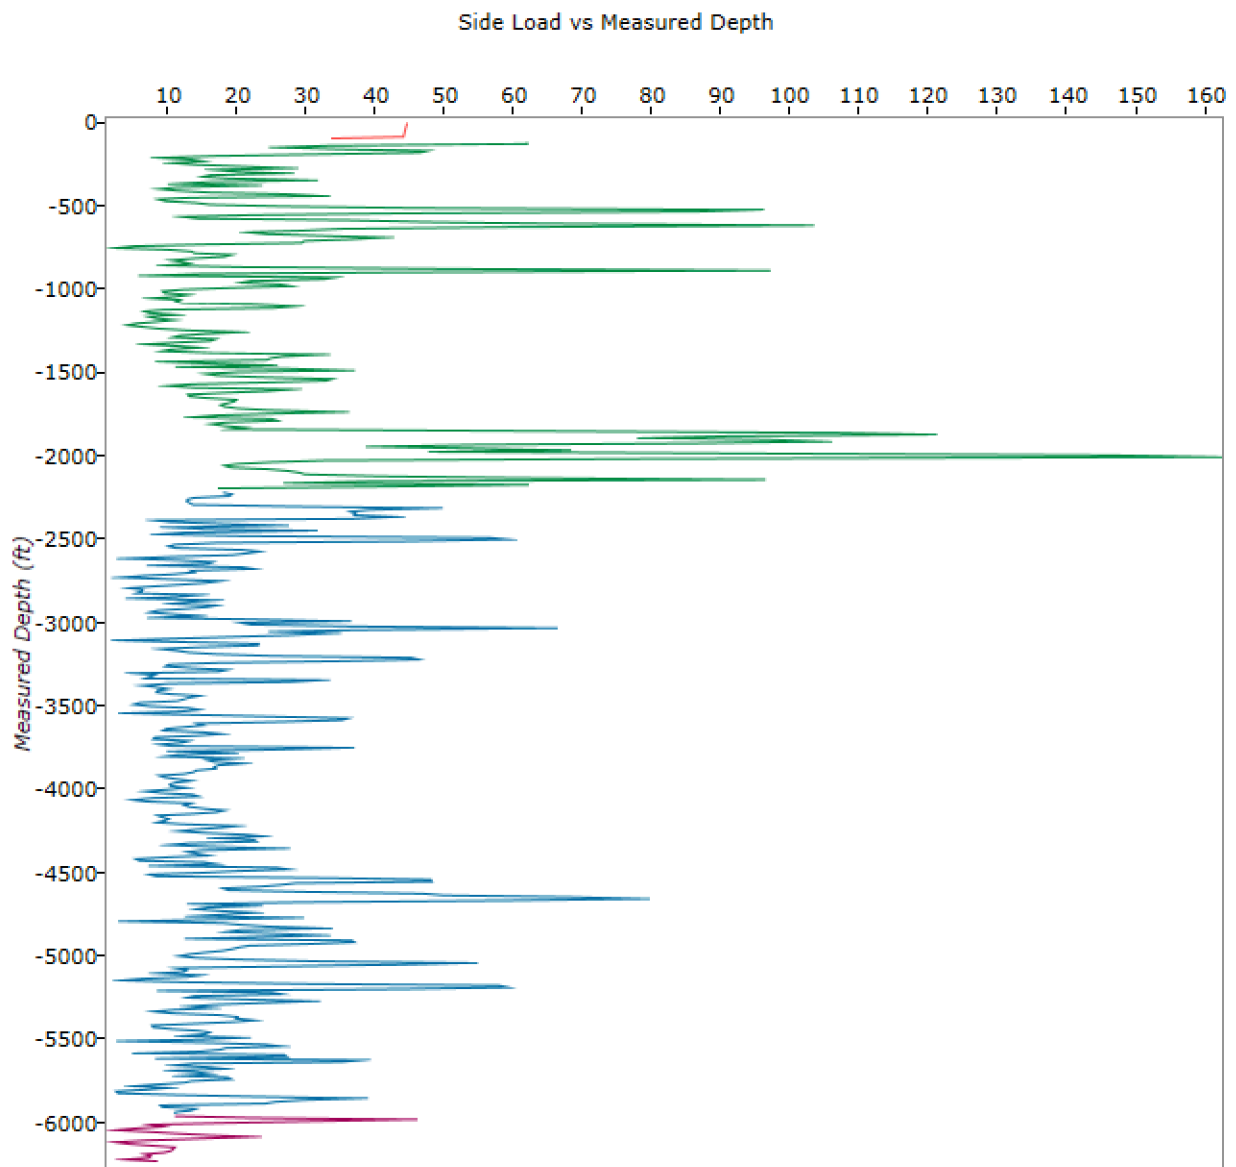
Figure 3—Well S31 side load vs. depth.

Well S31 was converted in November 2021. Though the average well tests for the prior ESP installation were 171-bbl/D oil and 281-bbl/D water, the last well test prior to conversion had declined to 59-bbl/D oil and 109-bbl/D water. The side-load plot in Figure 3 shows an example where continuous rod may be considered over guided rods. Though the maximum side load is within the range that conventional guided rods might be used, it is the sudden transition from low side loads, to significantly higher side loads, and back to lower values that is of concern. Such areas increase the likelihood of concentrated wear on the rod guides and compression of the rods above that deviation. Production from Well S31 with the rod pump installations has exceeded the pre-conversion amount. The only failure has been a polished rod failure, which is easily repaired with minimal expense. The total run days on rod pump is now within one month of matching the previous ESP runtime.

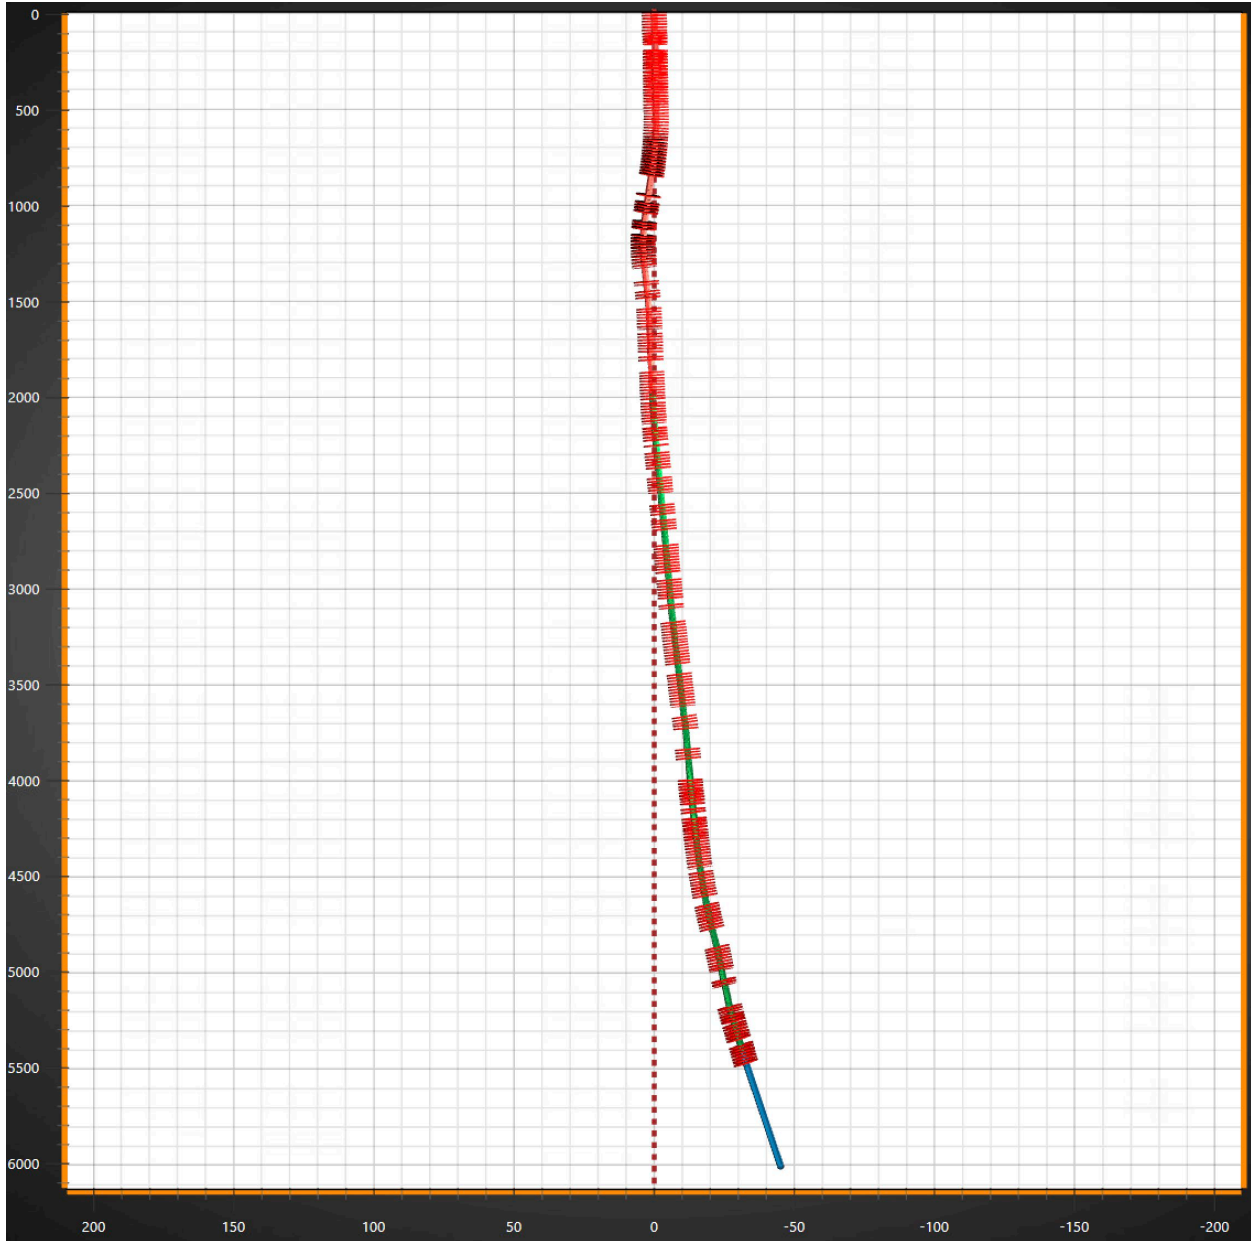
*Figure 6—Well A north-south view.
Red markers indicate side loading greater than 50 lb.*

Well A was converted to rod pump in December 2021. The pump plugged with asphaltenes 60 days later, but has now run for over 350 days since being repaired. This exceeds the runtime of three of the last four ESP installations, which failed to reach 150 days of operation. A maximum side load of 286 lb, along with significant side loading of 50–100 lb throughout the entire wellbore, led to the selection of continuous rod for this conversion.

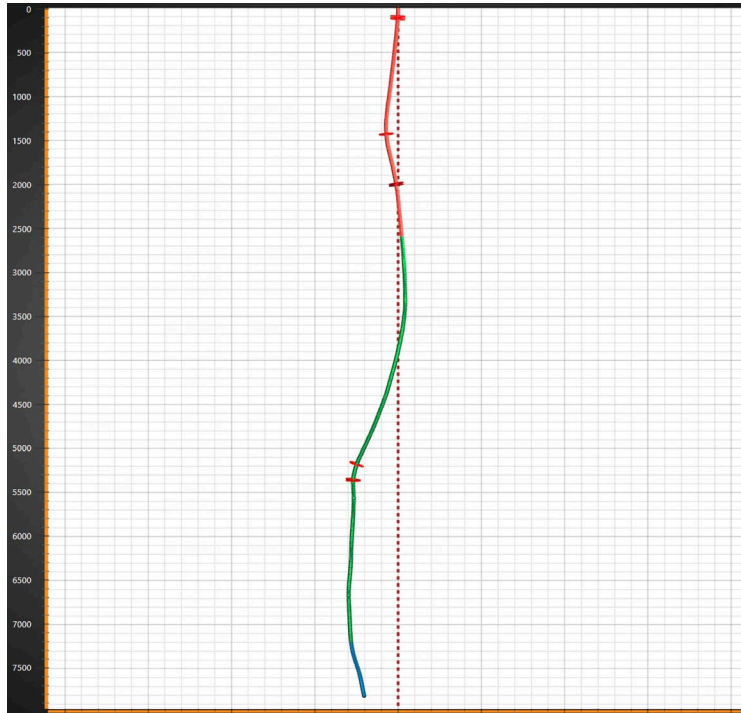
*Figure 7—Well S3 north-south view.
Red markers indicate side loading greater than 100 lb.*

Well S3 illustrates how both inclination and azimuth combine to create areas of high side loading. After multiple runs of less than two months on ESP, this well was converted to rod pump. Continuous rod was chosen because of the generally high side loading throughout the wellbore, but especially the peak of 236 lb near 2,000 ft. The north-south view does show some inclination changes, however the plan view shows how the areas of side load greater than 100 lb are where changes in inclination and azimuth both occur at the same time. These combined changes in direction make not only rod pumping hard, but make it difficult to install long ESP assemblies and ESP cable without damage.

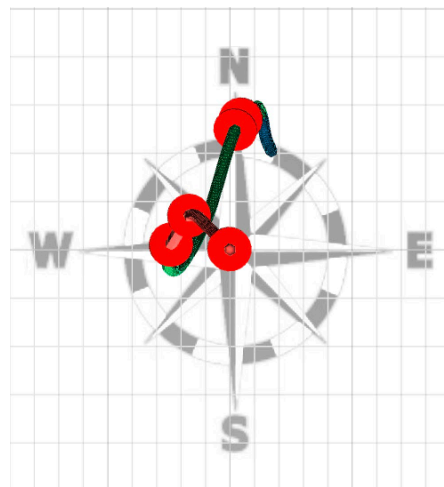
Figure 8—Well S3 plan view showing azimuthal changes of the wellbore.

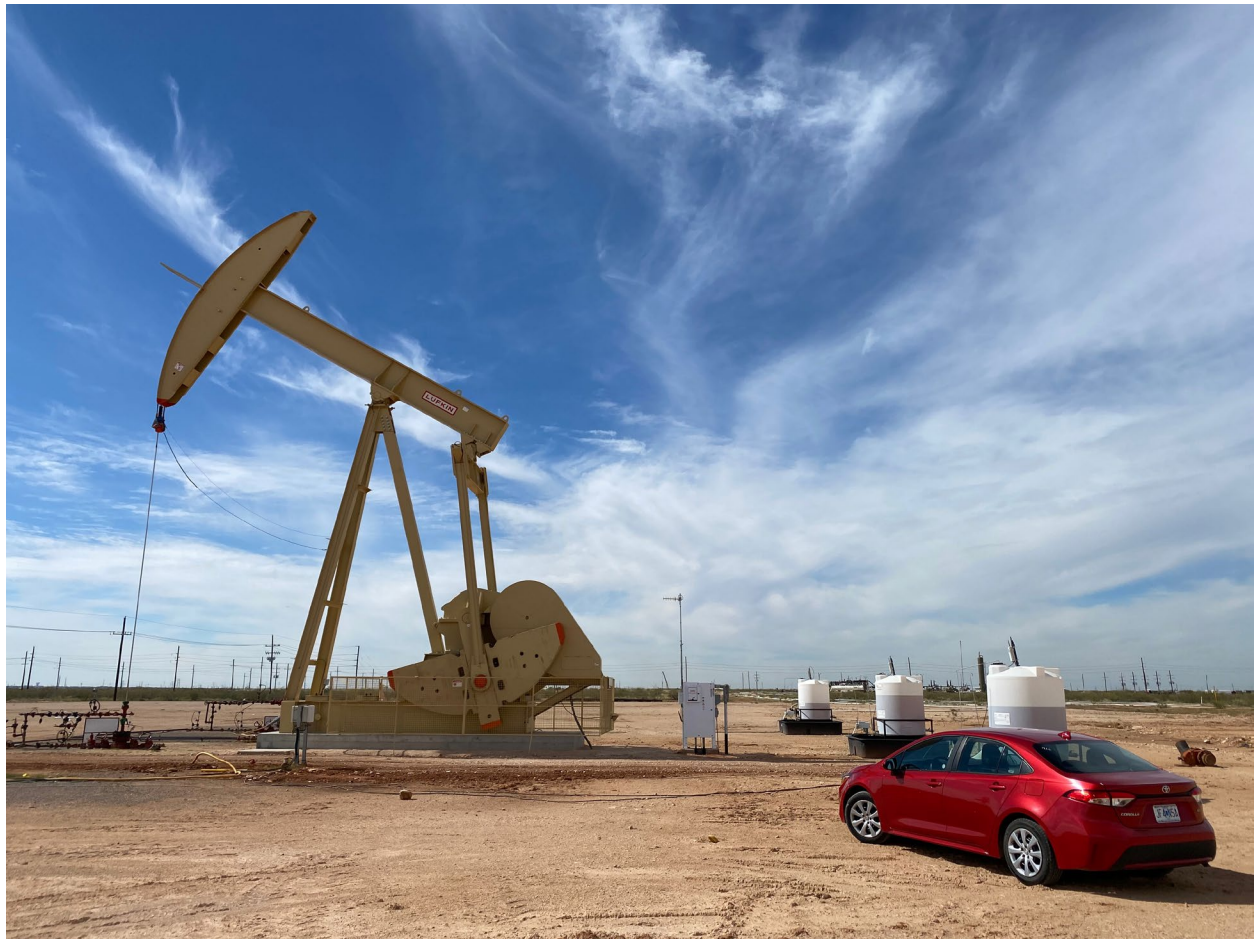
Figure 9—2560–500–320 conventional pumping unit next to a very small rental car.

A new area of interest for selecting continuous rod is long-stroke, high-volume rod pumping applications. Well S34 and Well L were designed to move 400–500 bbl/D total fluid from 7,000–8,000 ft, after accounting for poor pump efficiency due to gas interference. Both installations used a 2560-500-320 pumping unit, a 2-in. insert pump and a 97 continuous rod design. Using 1 1/8-in. continuous rod at the top of the taper allowed for the use of a KD-equivalent grade of rod. Running a guided, conventional rod string would have required the use of high-strength materials that would be more susceptible to corrosion-fatigue.
