ACIDIZING FOR WELL STIMULATION WITH A CHROME SRP BARREL DOWNHOLE – HOW WORRIED SHOULD YOU BE?

Pinar Karpuz-Pickell, Ph.D., Levins Thompson
Lufkin Industries

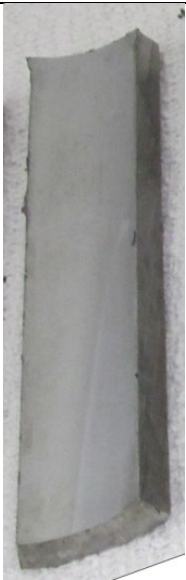
Table 1. Characteristics of Chrome coatings A, B and C

Chrome A has a bright appearance, does not have macrocracks and has very high hardness. Microcrack density is measured to be 4400 cracks per inch (cpi). Chrome B has a dark and dull appearance, with the magnified structure revealing surface defects. The structure has macrocracks and has a relatively lower hardness. Microcrack number could not be determined due to possible excessive nodulation and other defects on the surface. These defects are most likely caused by ineffective pre-treatment, plating, or post-treatment processes. Chrome C has a shiny appearance and the macrocracks were not observed throughout the cross section. It has a lower microcrack density of 1700 cpi.

Coating on ID

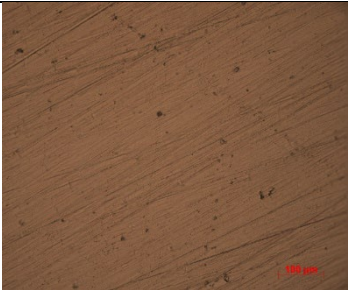
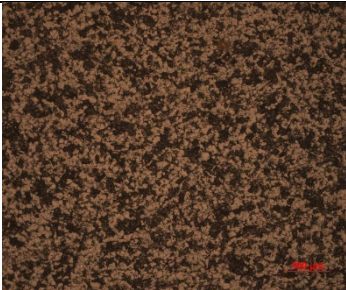
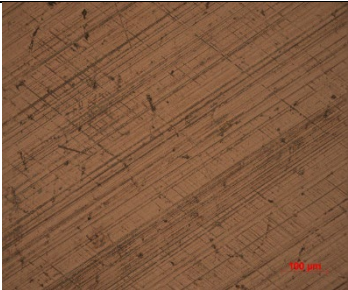
Coating Thickness	101.4 microns	64.4 microns	169.0 microns (Double Chrome)

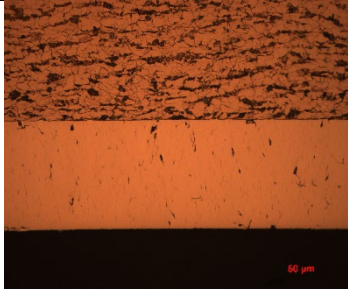
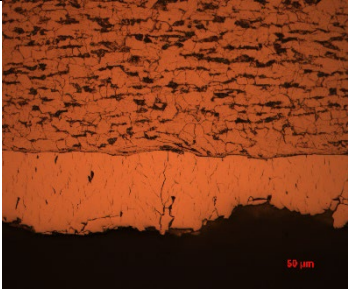
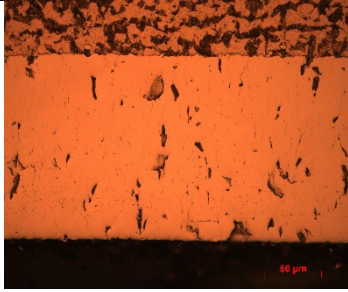
Coating Hardness (HV100)	1046.7	926.0	971.1
Coating Cross Section

Three Chrome coated barrels; Chrome A, Chrome B and Chrome C, are used in this study. Test specimens are sectioned at around the central region of the barrels. Cross sections are prepared according to ASTM E-3 Standard. Crack structures are revealed by reverse electro-etching. Zen Core software is used for quantitative measurements methods.

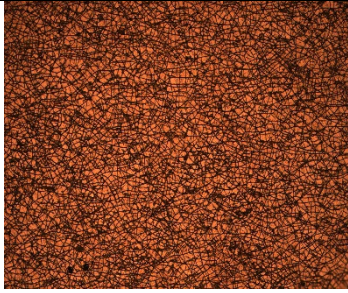
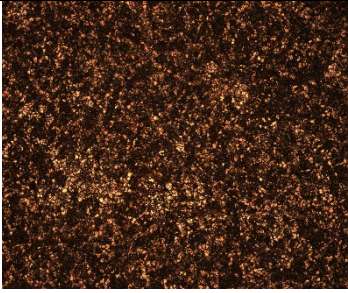
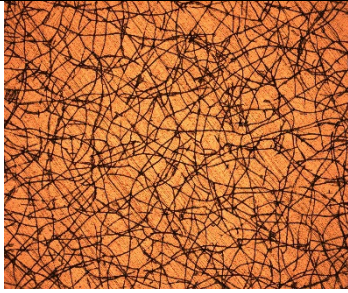
Coating Microcrack Structure

Coating Microcrack Density	4400 cpi	N/A	1700 cpi

The significant superiority of Chrome A over Chrome B and Chrome C in resistance to HCl attack can be attributed to its high hardness and high microcrack density. Chrome B clearly has macrocracks and other plating defects, which led to almost instantaneous HCl attack in concentrations higher than 0.1%. Chrome C did not have the macrocracks or visible plating defects, and performed slightly better than Chrome B despite not performing as good as Chrome A with the highest hardness and microcrack density.

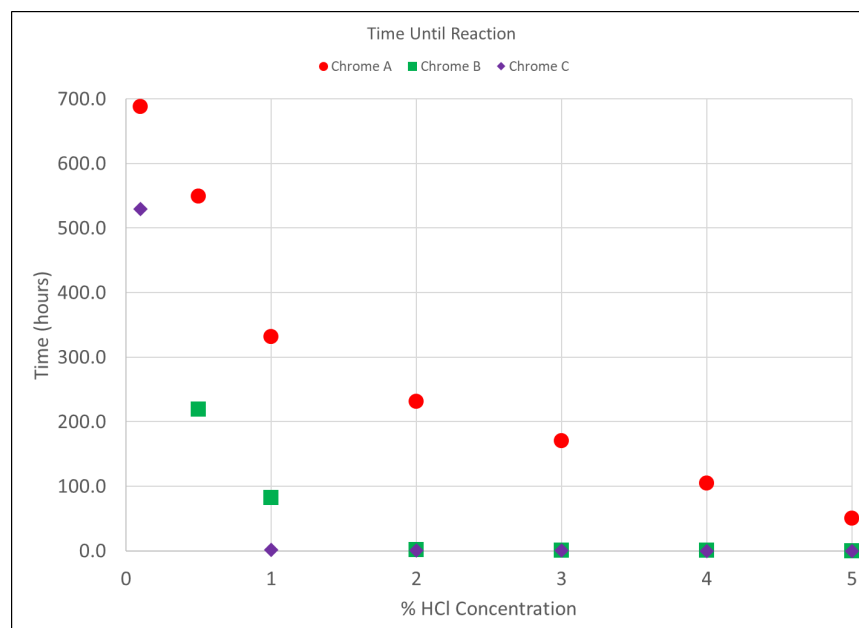
The average reaction times are plotted against HCl concentration for all 3 Chrome coating samples, as given in Figure 1. The results are also presented separately in Figure 1 (a), (b), and (c), as the details of the data points could be missed for Chrome B and C due to the large reaction time scale for Chrome A.

Figure 1. Average reaction time (days) vs HCl concentration (%)
(Note: Some datapoints are overlaid due to scale)

Studying the experimental data and plots, it is observed that the time elapsed before the first signs of deterioration increases exponentially with decreasing HCl concentration. This time can also be associated with the destruction of the protective oxide layer, as Chrome would start to react with HCl immediately on contact once the protective barrier layer is gone. This effect is clearly observed in Chrome A, whereas for Chrome B and Chrome C, exposure of the Chrome coating to HCl occurs very fast for all test concentrations above 1%. Regarding all the data, 1% HCl can be considered a threshold value for oxide layer deterioration, when there are no macrocracks or other visible coating defects are present in the coating. HCl concentrations below this value require longer exposure times for the dissolution of the Chrome coating at room temperature, regardless of their behavior at the concentrations above 1% HCl.

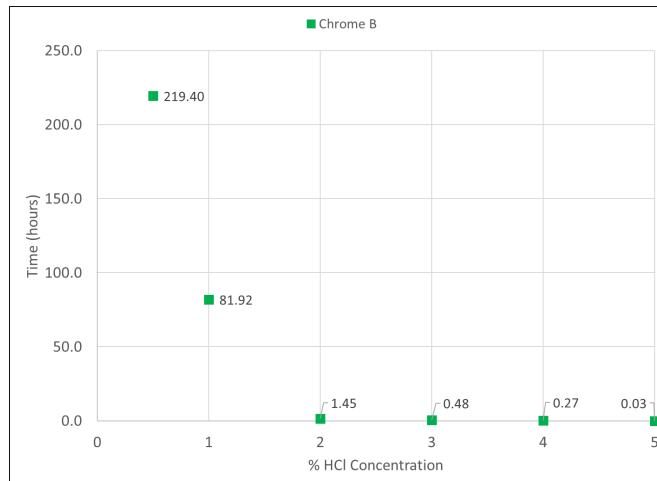
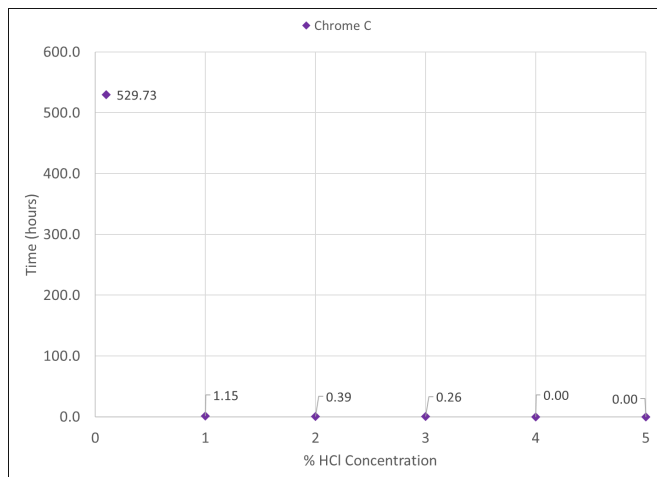
Figure 2. Average reaction time (hours) vs HCl concentration (%) for (a) Chrome coating A, (b) Chrome coating B and (c) Chrome coating C
