BORONIZED ROD PUMP BARRELS – AN EFFORT TO REDUCE PUMP FAILURES DUE TO EXCESSIVE WEAR & ABRASION ON BARRELS

Mike Murray
Exceed Oilfield Equipment, Inc.

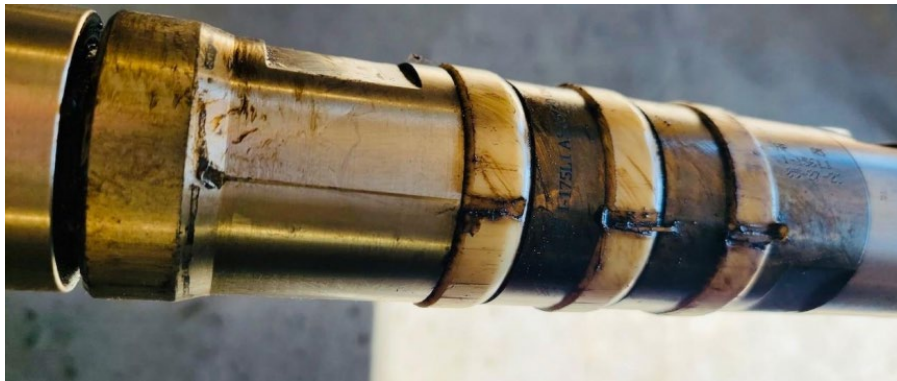
[Image7]

- Boronized Barrel Install Date 8/31/2021
- 11/16/21 - Sucker Rod Failure at 78 Days – Pump sent to local pump shop for teardown and inspection.
- Barrel Mic'd All 1's and was Rerun. Performed camera run down and saw no signs of scoring.
- No sacrificial wear on plunger from contact with boronized barrel.
- TPA and Travel Cage Galled to plunger and plunger was replaced.
- The Cups were worn and abrasion cut.
- Hold Down was abrasion cut and replaced.
- Seat plug had thread damaged and replaced
- Valve Rod Collet Nut tagged and replaced.
- Switched to continuous rod for well.
- Pump was repaired and taken back to the well on 11/16/21.

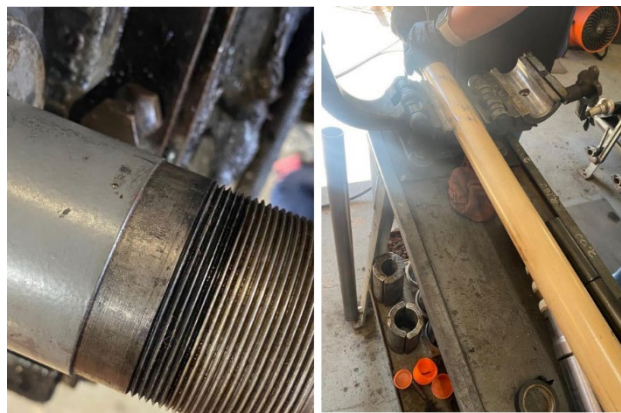
[Image8]

- 2/23/2022 - Continuous Rod Failure
- Boronized barrel mic'd all 1's again and was put aside for a new well install.
- "Chum" barrel replaced boronized barrel to be used on new well. Divesture candidate.

- Plunger still showed no signs of preferential wear.
- Collet nut and guide were damaged.
- No solids found in pump.

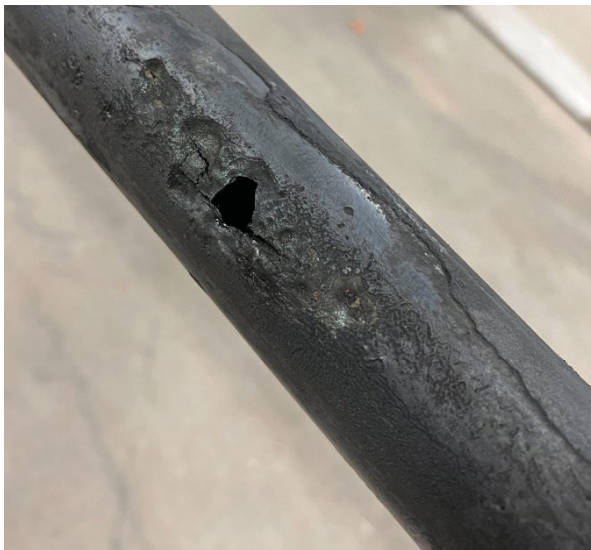
- Workover History – Plunger and Barrel Worn & Cut
- Boronized Barrel Installed 1/12/2022.
- 12/20/2022 Pump Failure – Corrosion. [Image9]
- This was the only barrel installed in a water-flood. All other barrels in CO2 floods.
- Corrosion through TK750R Coating. [Image9, Image10]
- Corrosion through 1026 exposed thread neck. [Image12]
- Cut the barrel and split to examine ID. “Boronized ID looked to be in very good shape with no wear or corrosion” [Image11]
- OD Corrosion was always the concern with these barrels and finding an economic coating that will hold up is the next goal.
