# **A NOVEL TECHNIQUE TO MAXIMIZE CORROSION FATIGUE RESISTANCE OF SUCKER RODS**

Jordan Anderson, Esteban Oliva, Edgardo Lopez, and Martin Buhler  
Tenaris

## **PROBLEM STATEMENT**

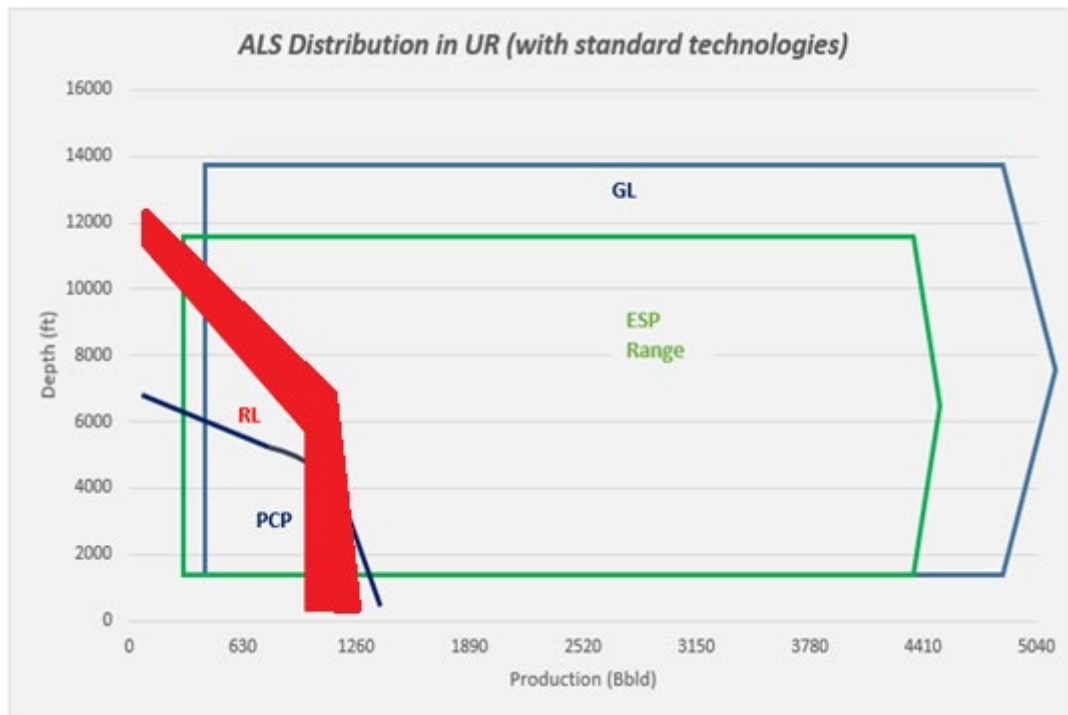
Figure 1 Artificial lift application range – The shaded red area depicts the potential production increase to RL with the incorporation of new technologies

The strategy following the development of the Critical Service (CS) grade was to engineer an ultra-high strength rod grade (HS) targeting those applications that challenged all the system components and even pushed the limits of the application range of reciprocating rod lift into deeper well depths and higher production ranges (Figure 1). These applications include early life unconventional wells, shallow high-volume wells, and highly deviated wells with so much deviation induced friction that they were thought to be un pumpable by reciprocating rod lift.

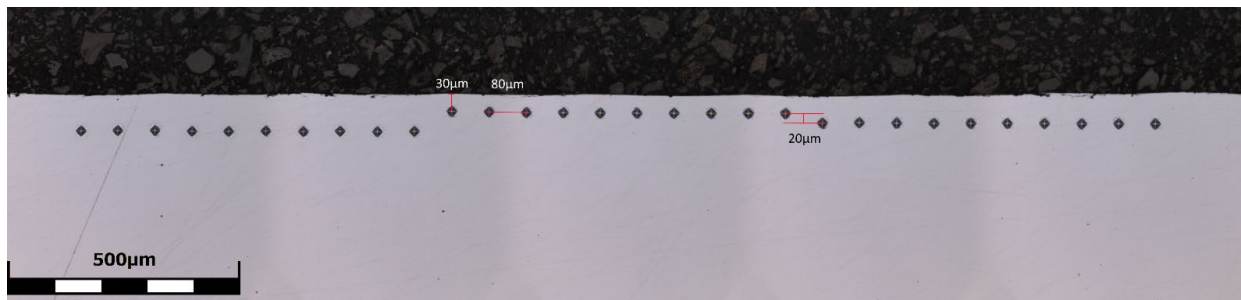
Figure 9 Micro Hardness inspection

Important complementary information to assess heat treatments, textures and finishings or hardening depths.

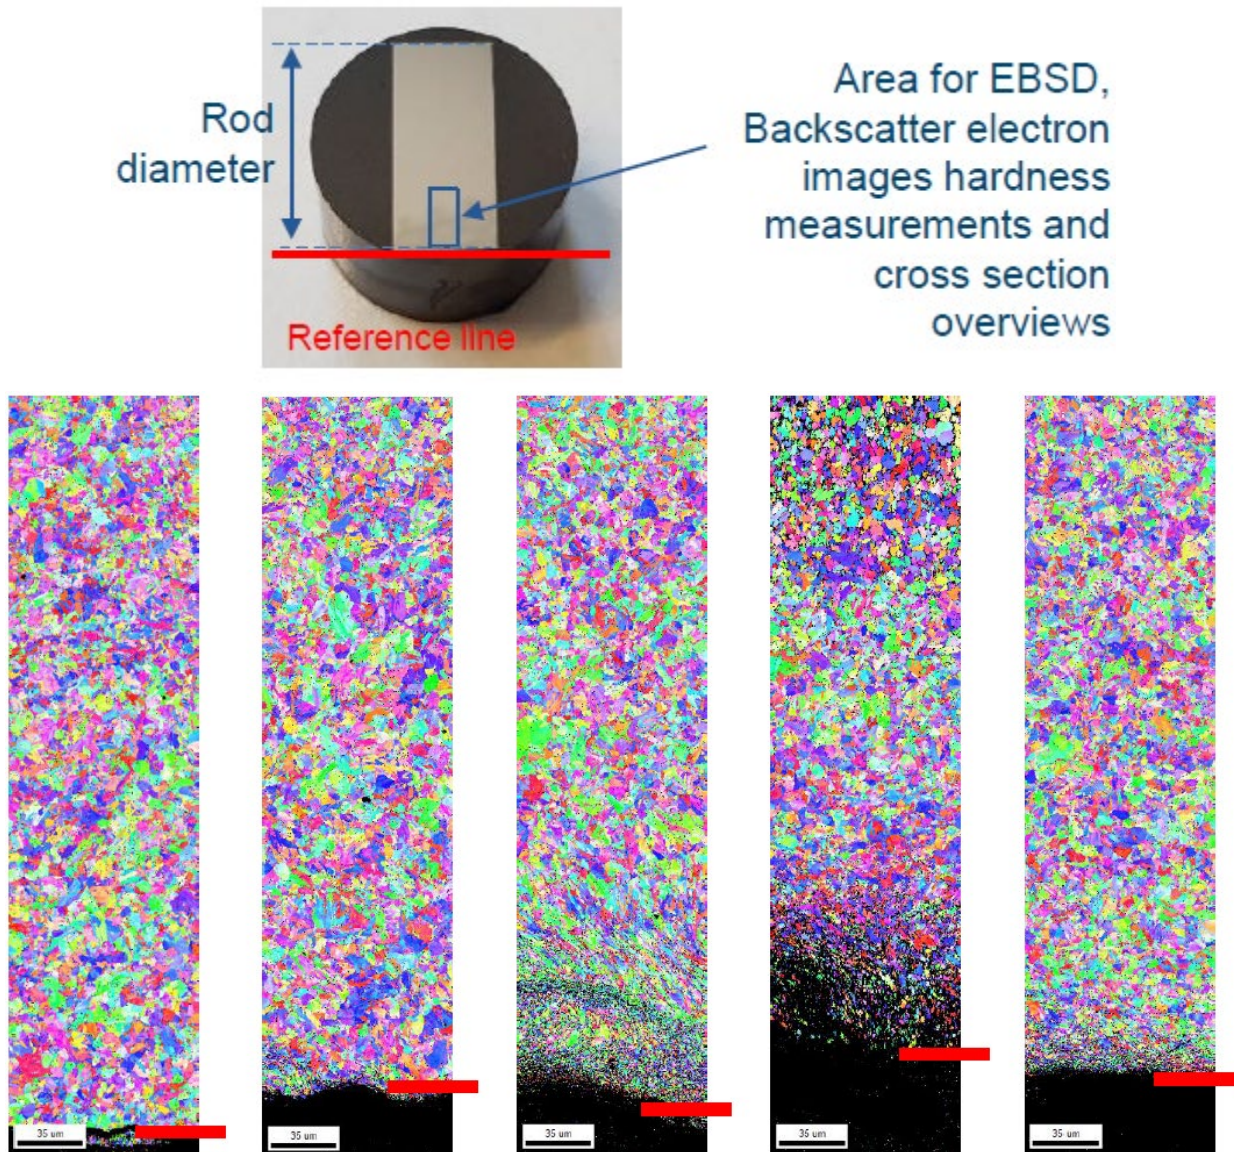
Figure 13 Comparison of several ST&F processes via EBSD

Crystallographic investigations can be performed using EBSD system

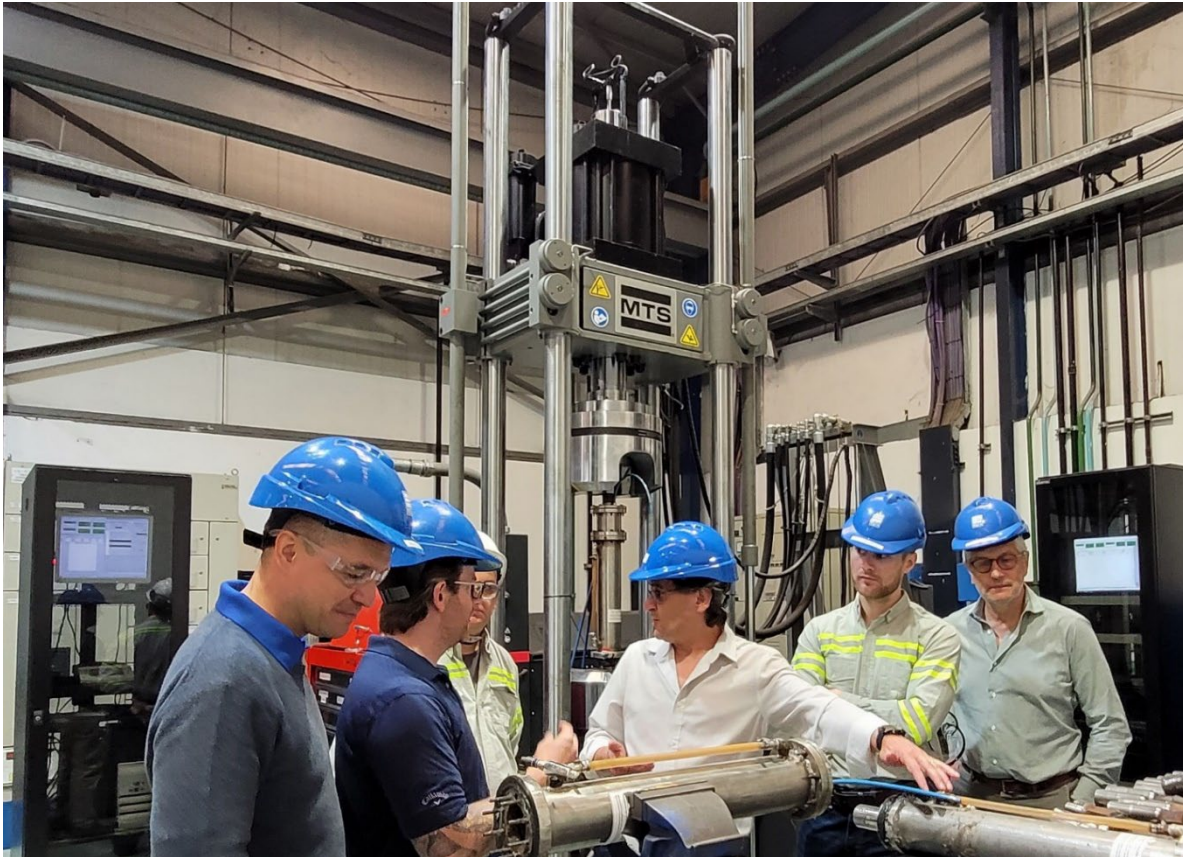
Figure 14 Corrosion fatigue testing machine and test chambers

Once a set of ST&F were selected using the above testing, 40+ HS grade pony rod samples were processed with various ST&F and tested using in-house tensile-tensile axial corrosion fatigue testing machines (Figure 14).

As shown in the above figure, there is a test chamber that can contain a corrosive fluid, in this case 5% NaCl in distilled water at room temperature. The test loads used were 153% of the Modified Goodman of the HS grade and at 1Hz frequency to get test results in a timely manner. The results of that testing are shown below in Figure 15.

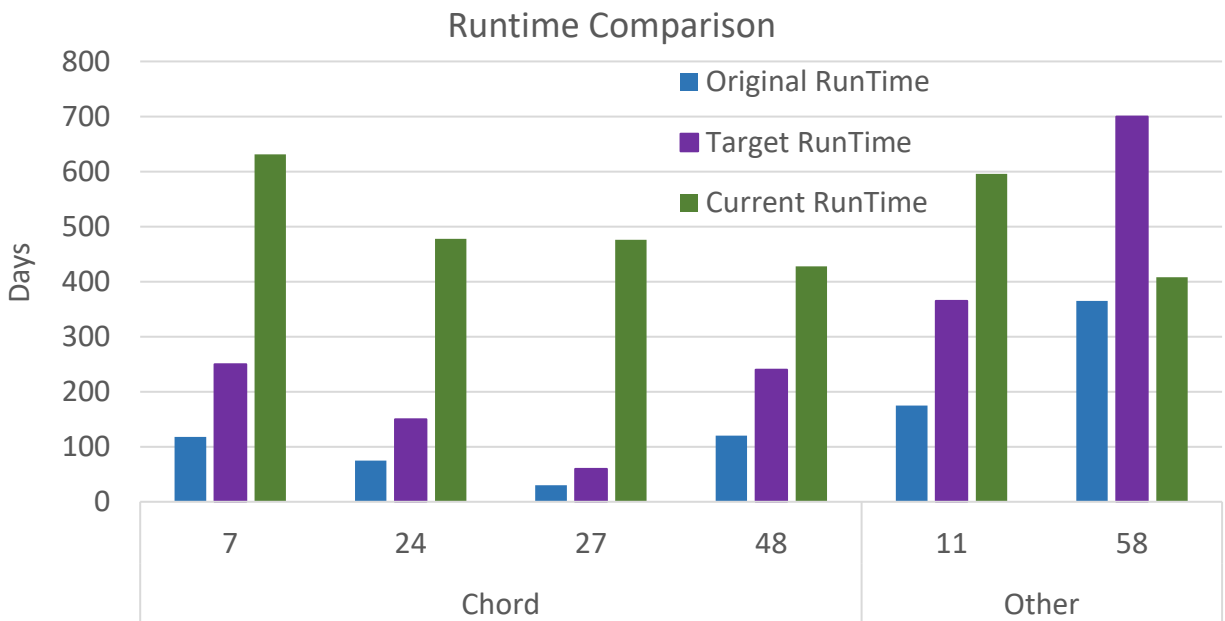
Figure 16 Run time comparison of previously installed rod grade and ST&F

The next steps in confirming the performance of the optimized ST&F product were field trials, and for this, over 4000 rods were prepared. Trial wells were carefully selected that fit the criteria of a corrosion fatigue mechanism failure with less than 1 year run time in any quenched and tempered rod grade. Additionally, it was preferred to make minimum changes to the design and operation of the well as possible and replace with full strings or full tapers. The rods were installed in 6 ideal trial wells and the run time comparison in those wells is shown below in Figure 16. After the first 6 trial wells, the remaining rods were installed in a variety of 10 other more “typical” wells, including high run time wells, to have a higher sample size. 5 out of 6 of the trial wells had little to no changes from the previously installed rod designs (Table 1).

The current run time shows the average run time before rod failure of the previously installed rod grade(s) and the target run time was double original run time. All installs are currently exceeding original run time and only one has not yet reached target run time. There are no failures in any of 16 wells as of March 2023 and current run times of the original 6 trial wells have increased at a rate of almost 3 1/2 times, from an average run time of ~147 days to an average of 500 days and counting. Average run times of all installs is also approximately 500 days.
